GRACETOWN, PREVELLY, GNARABUP, GRUNTERS, WESTERN
AUSTRALIA

LIMESTONE CLIFF RISK ASSESSMENT

Shire of Augusta Margaret River

Job No. PER2023-0291AB | Rev 1

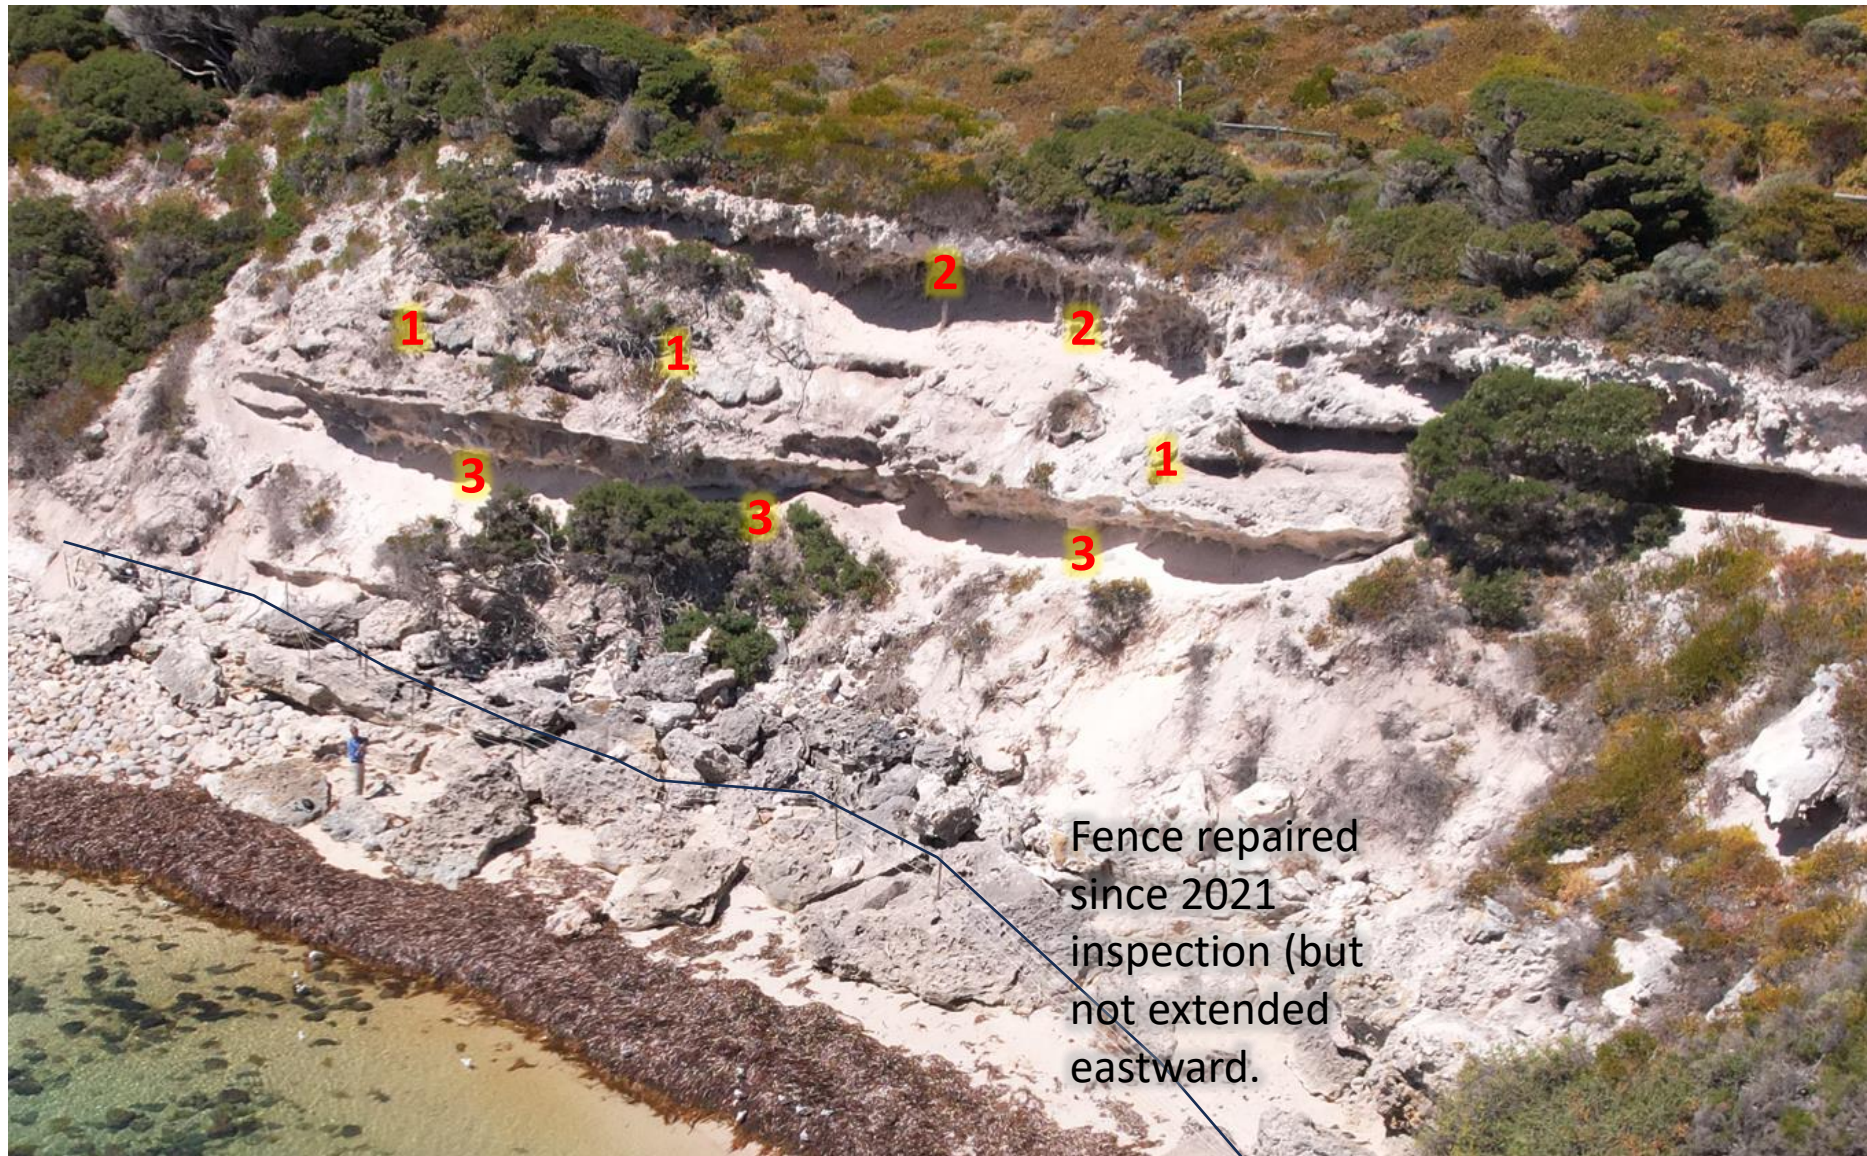
Hazards

1 - Slabs and boulders of rock could slide/roll off steep slope

2 - Slotting occurring in zone of roots could result in parts of ledge like overhang dropping off

3 - Slotting lower in profile could ultimately result in large scale (whole of cliff) instability

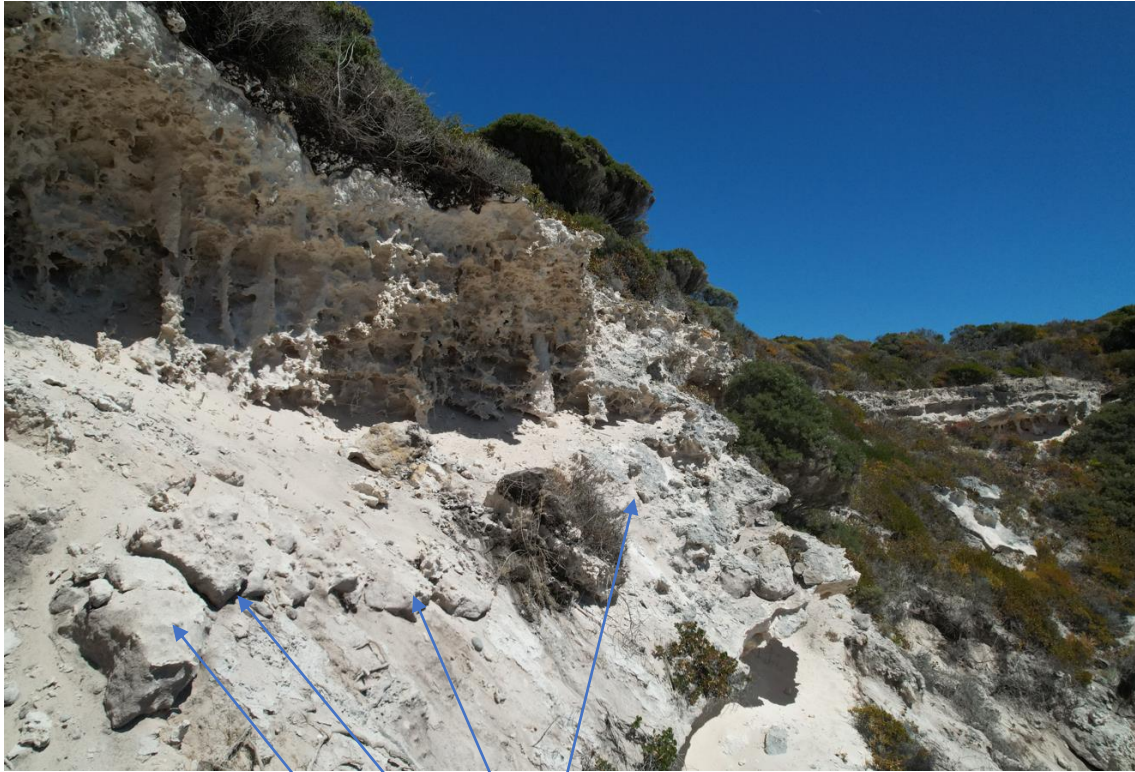
Hazard 1 – Boulders and slabs with potential to roll and slide.

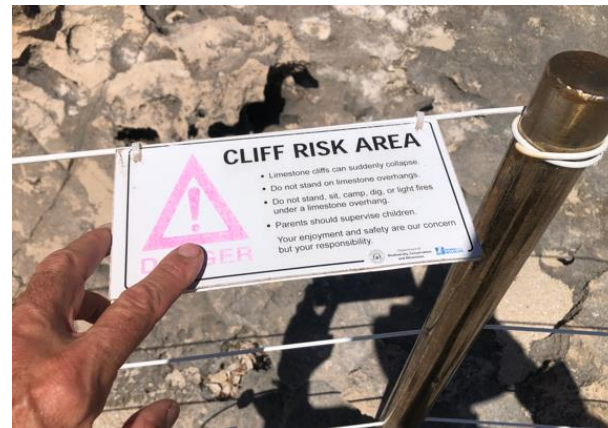
It is noted that the only warning signs at GC3-50 are postcard-sized signs (refer to inset photo on Slide 3). A person would need to already be in the hazard zone that extends outside the existing fence in order to read this sign.

Signage at base of cliff.

In addition to the informative signs, it was also recommended in the March 2022 report that large "Rockfall Hazard Area" signs be installed at each end of GC3-50 to further warn the public against traversing the area.

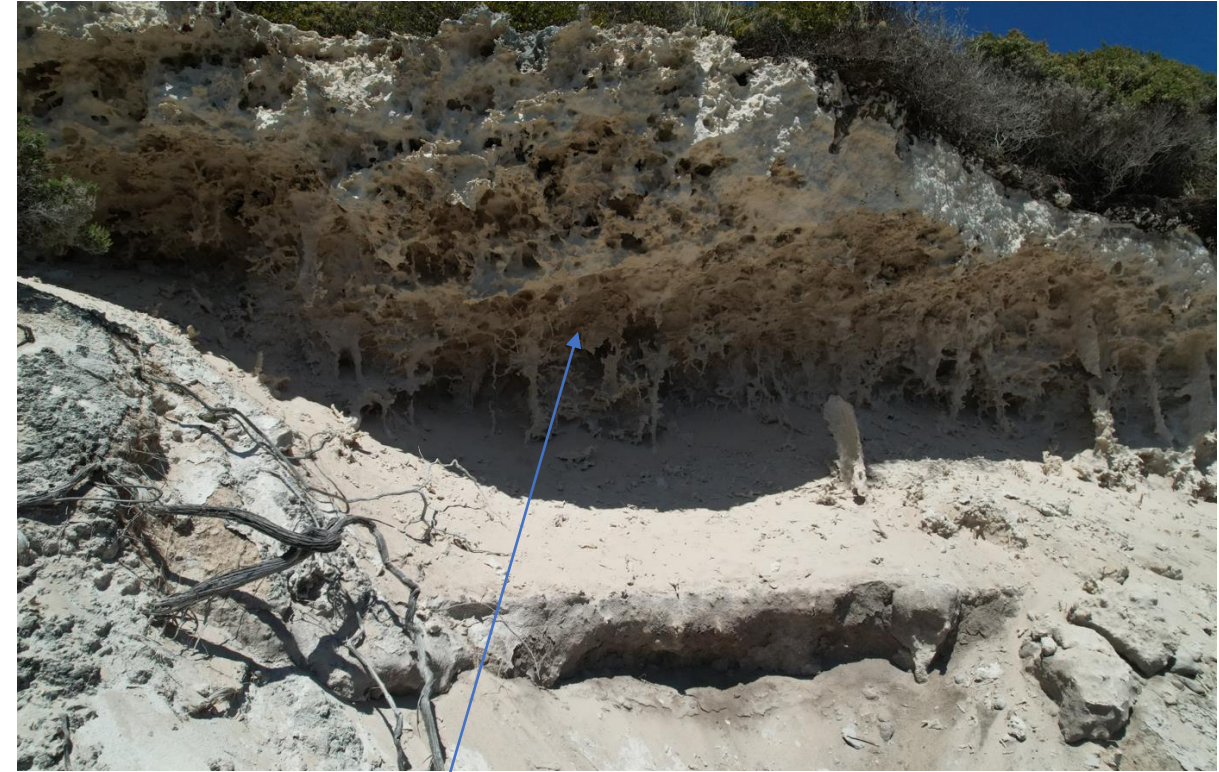
Hazard 2 – Overhang experiencing active slotting with potential to locally collapse.

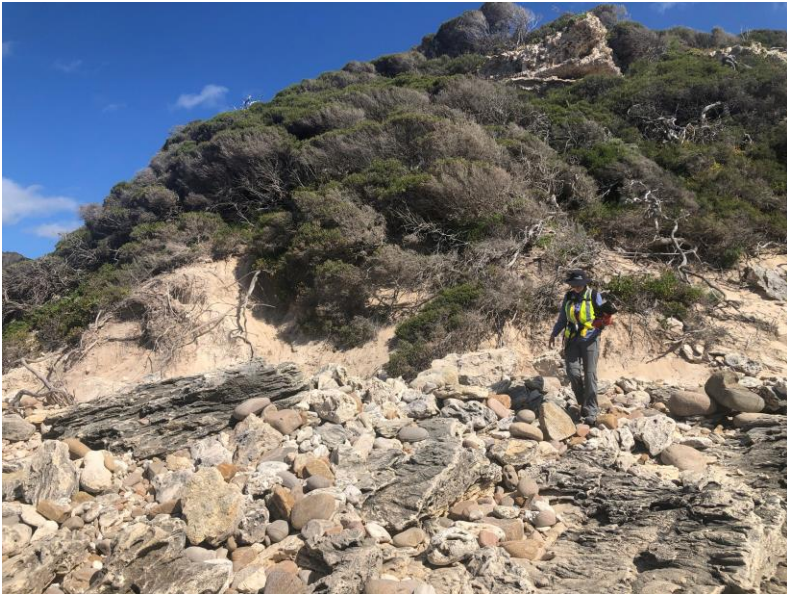
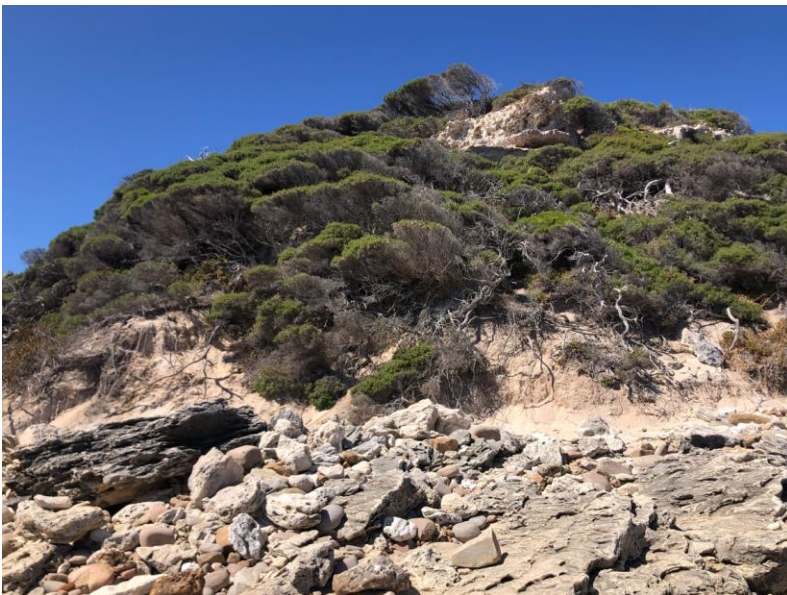
No significant
changes to
hazard or risk
since 2021.

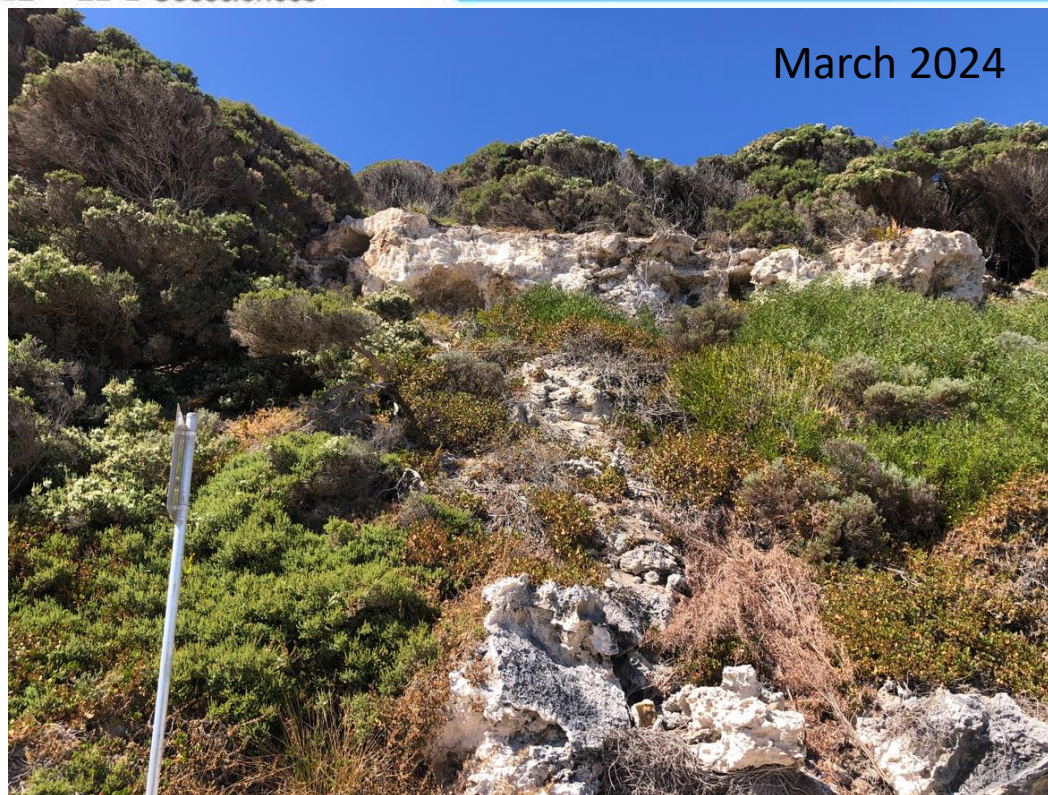
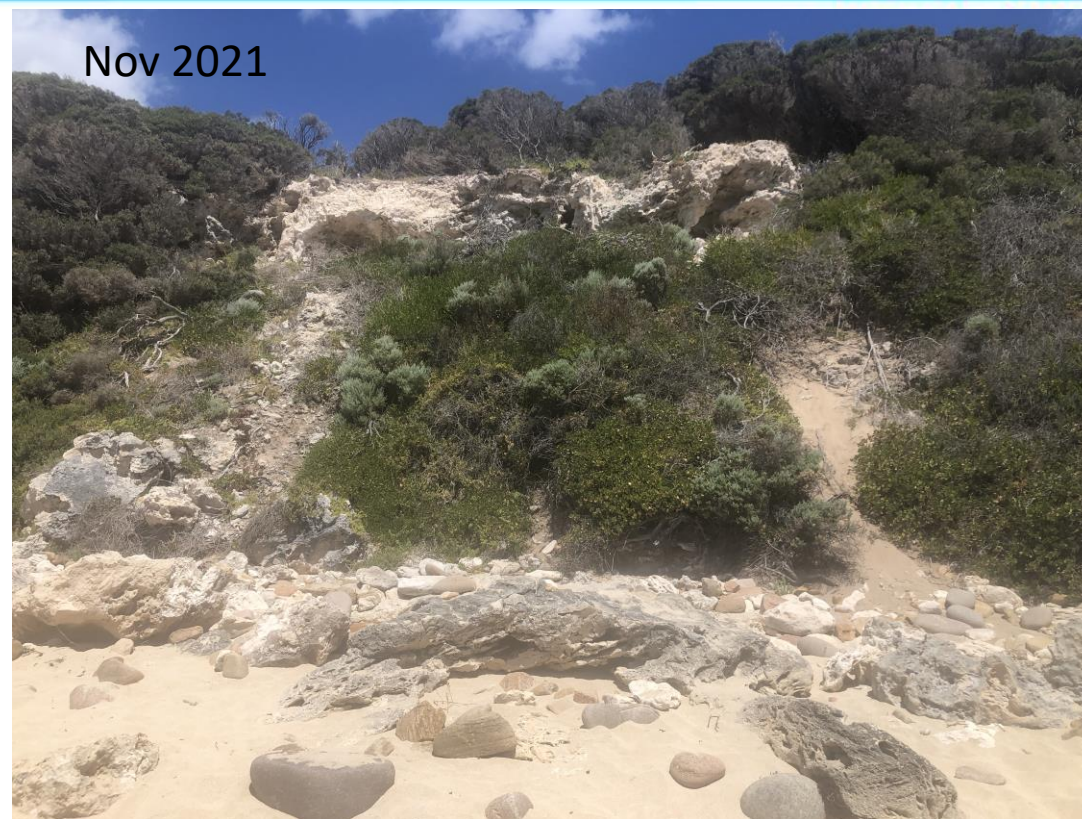
Remedial works (removal of overhang) occurred in May 2020. Subsequently the Level of Risk to Individual Most at Risk (R_{DI}) has reduced to 1.2×10^{-7} and has not change since 2021.

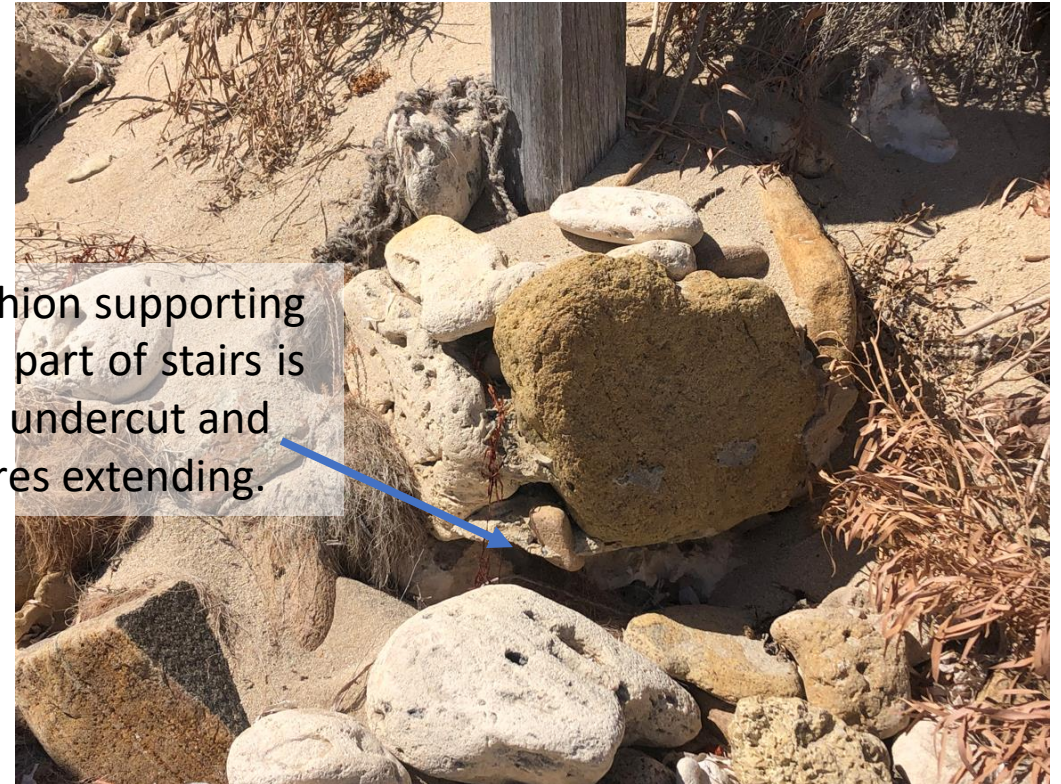
In this context, the March 2024 inspection noted one supporting stanchion is being undercut and will soon require remediation (see Slide 10).

Stanchion supporting lower part of stairs is being undercut and requires extending.

Minor coastal erosion has occurred since Nov 2021. This includes the undercutting shown above and stress to vegetation.

Monitor situation on beach, place riprap or other beach erosion control measures as and when required.

Extend stanchions to stairs if they become undercut – example of stanchion about to be undercut is illustrated above.

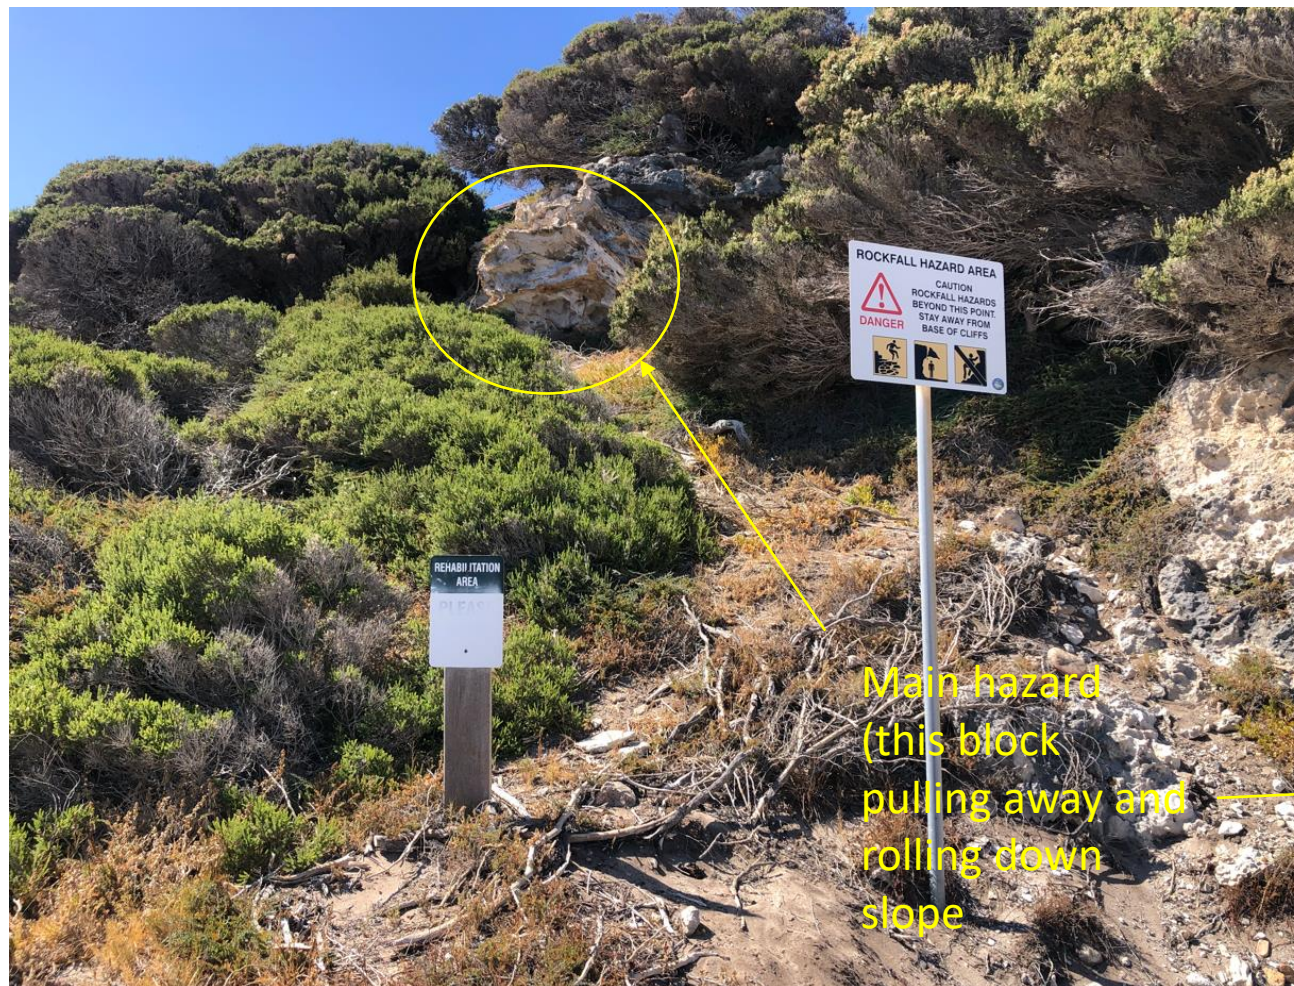
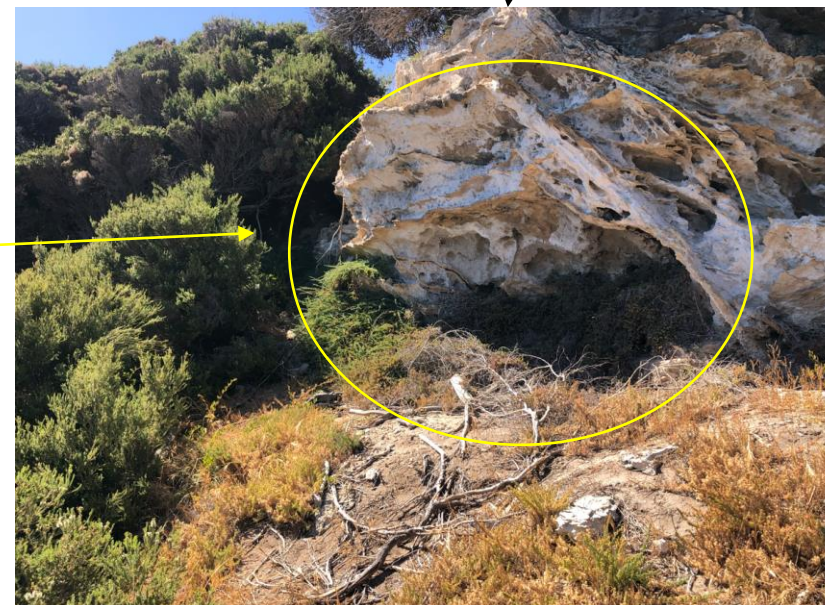
Note: Since 2017 Golder inspection the lookout that sat on top of this potentially unstable block was removed. Existing steps to beach are a sufficient distance back not to be impacted by this hazard.

Level of Risk to Individual Most at Risk (R_{DI}) relates to a person traversing the rocky foreshore below the hazard rather than the steps above the hazard: $R_{DI} = 2.9 \times 10^{-6}$. No change since 2021.

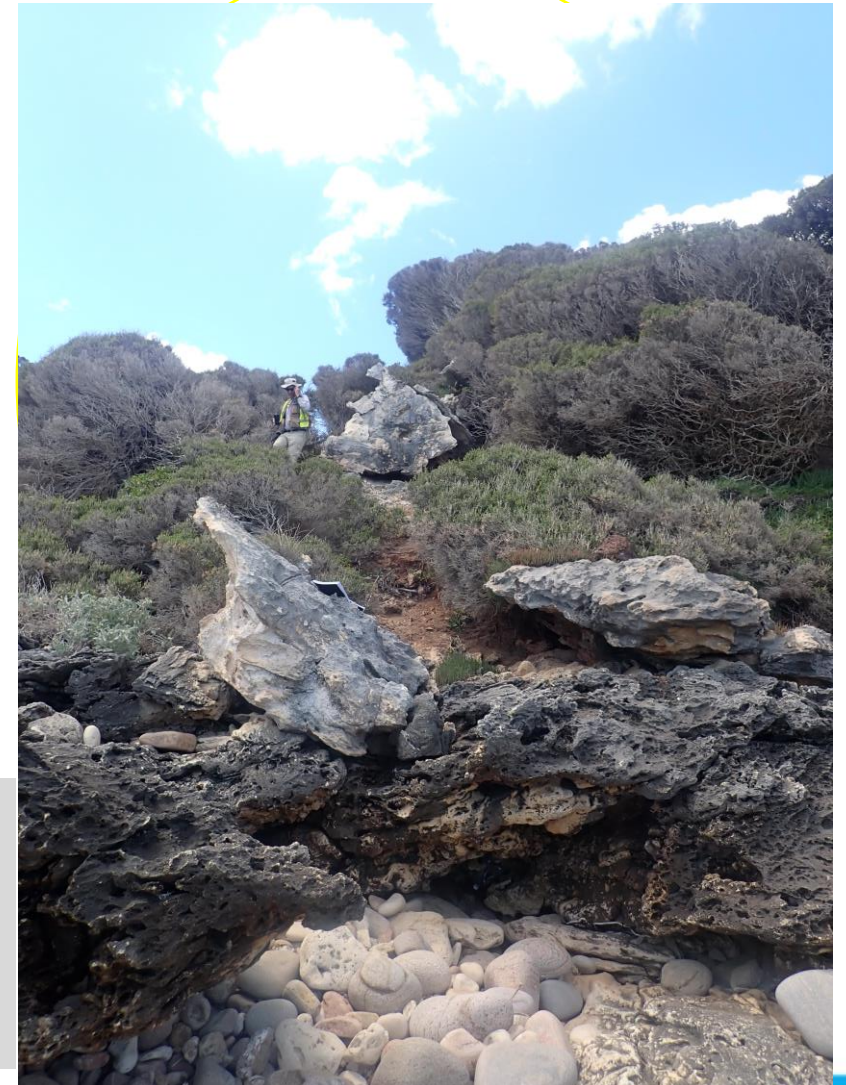
No apparent retrogression of
embankment to west of GC6-60 since
2021.

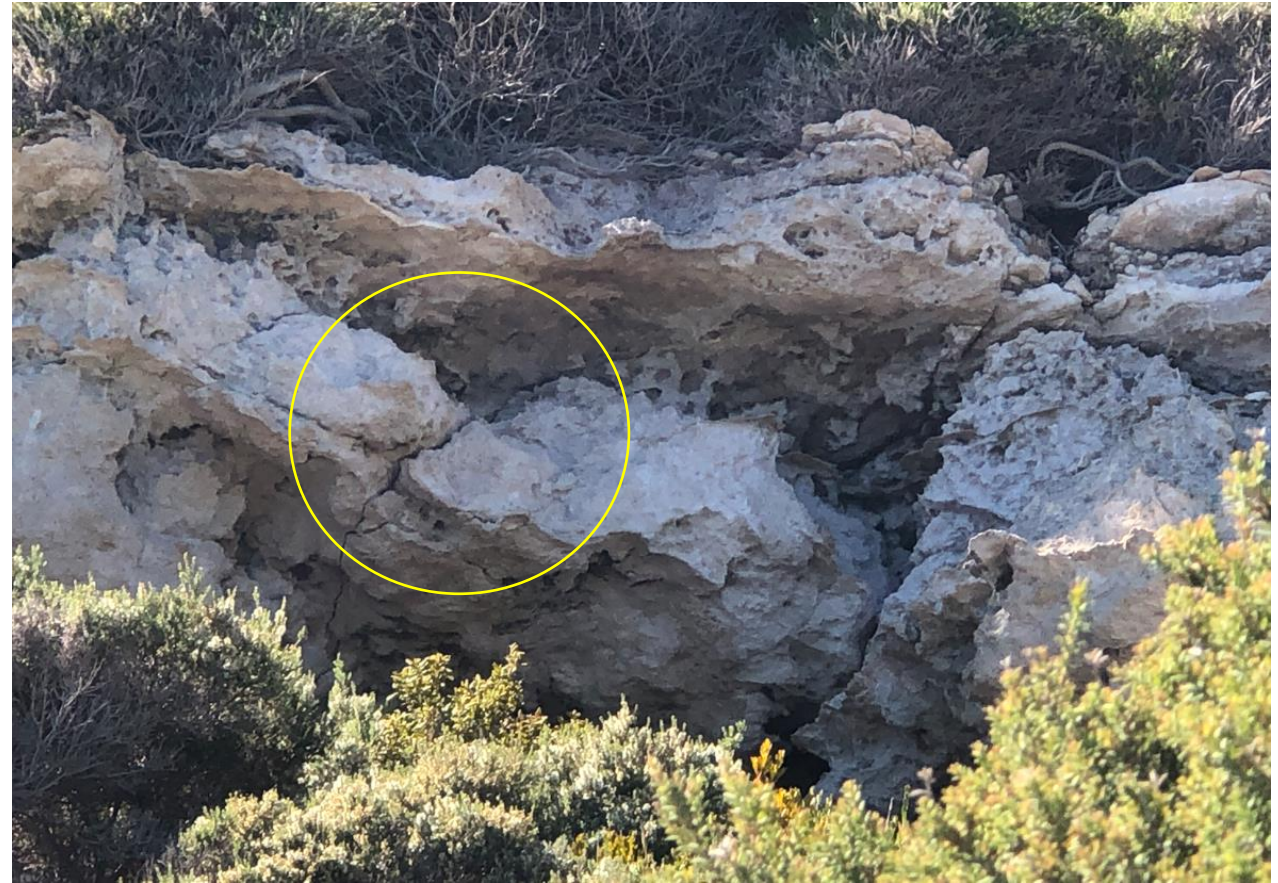
Negligible change to fracture pattern since November 2021.

Level of Risk to Individual Most at Risk (R_{DI}) Nov 2021 = 9.75×10^{-7} .

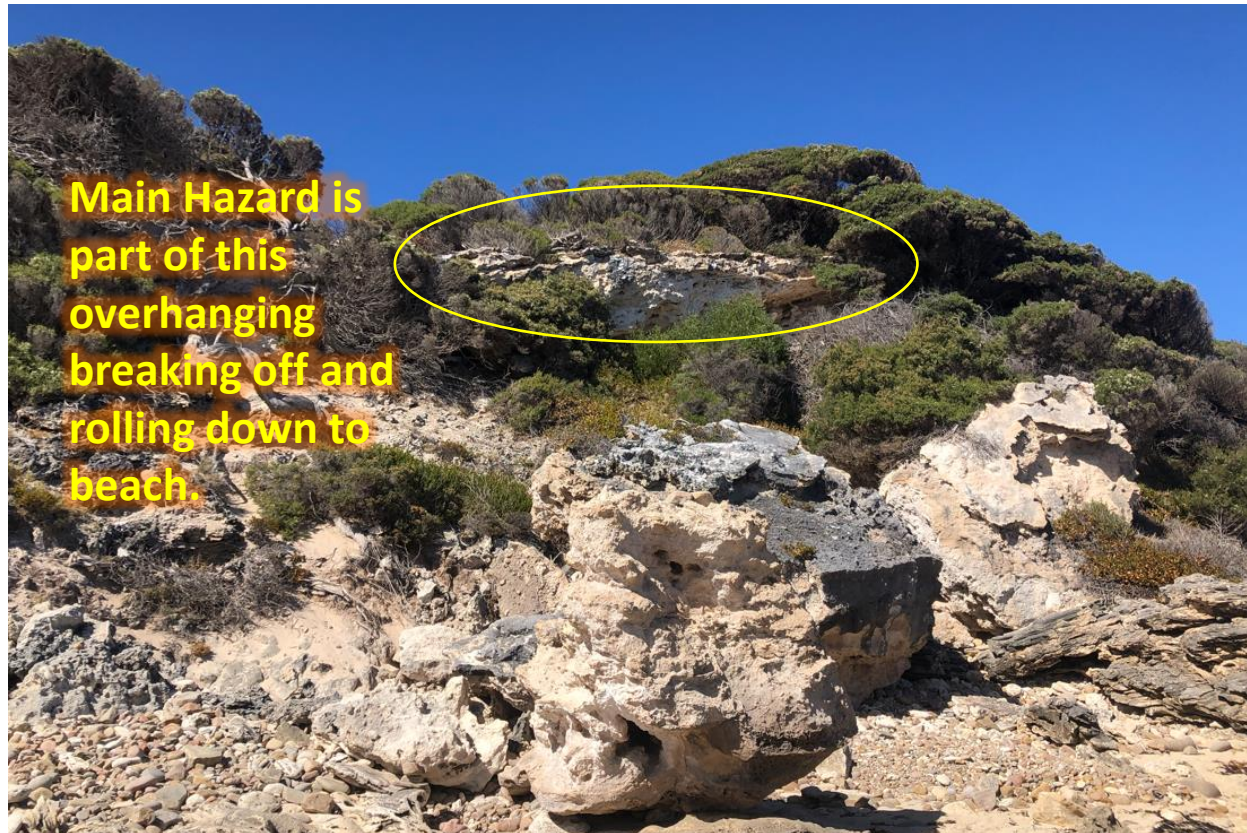
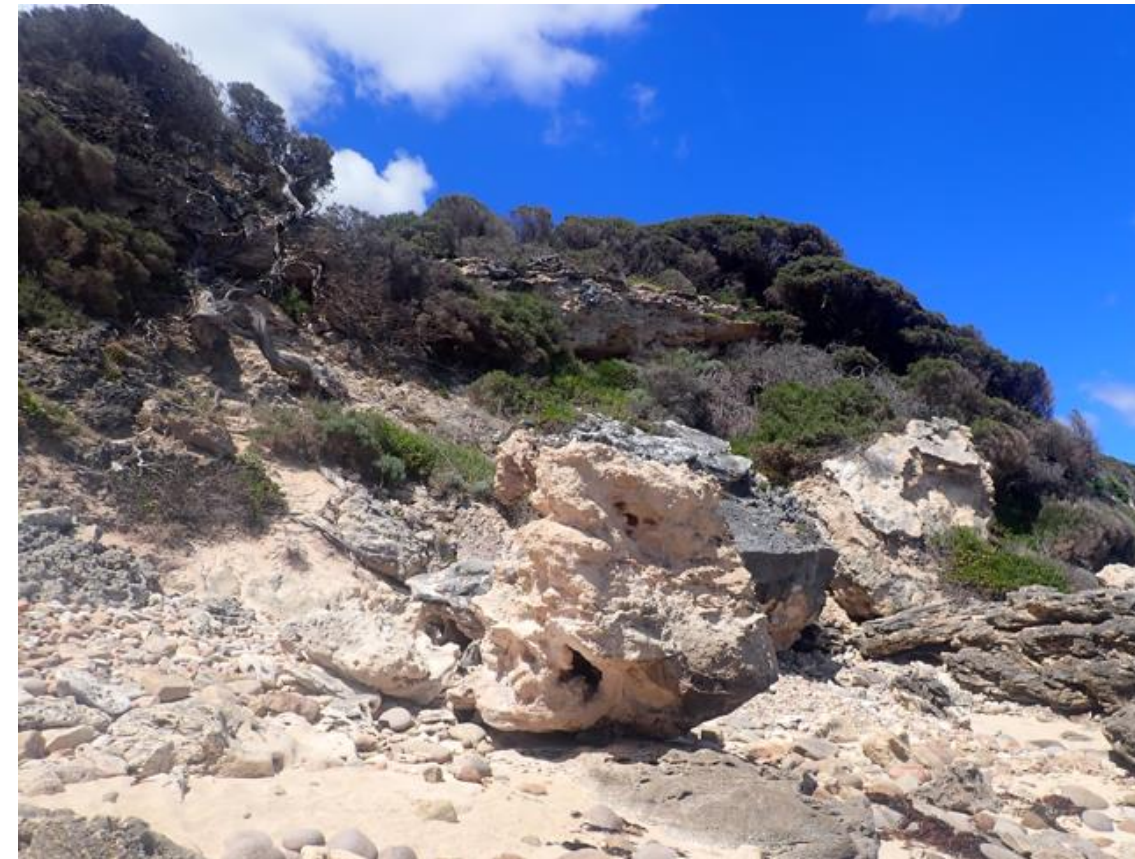
Negligible change noted between two inspection dates.

Level of Risk to Individual Most at Risk (R_{DI}) not changed since previous assessment – March 2024 risk level is $R_{DI} = 8 \times 10^{-7}$.

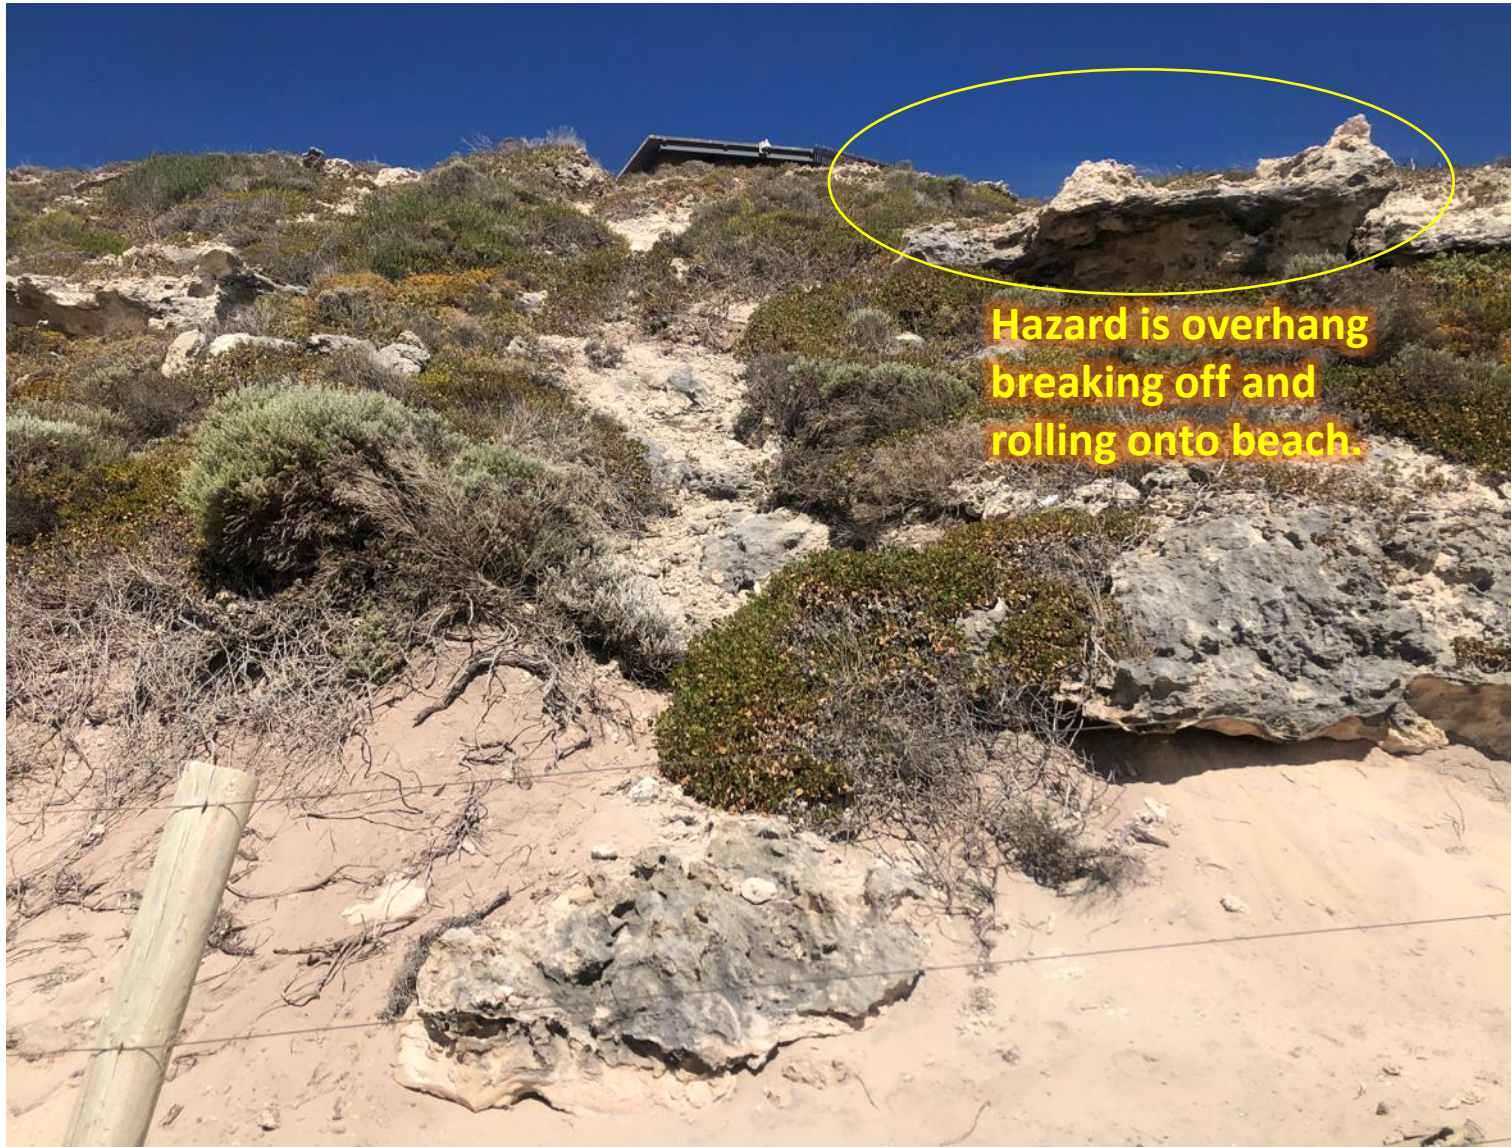
Risk to Individual Most at Risk (R_{DI}) not changed since previous assessment in 2021. $R_{DI} = 1.5 \times 10^{-6}$.

Coastal erosion is occurring and there is an informal path (see next Slide) both with potential to increased level of risk if erosion continues.

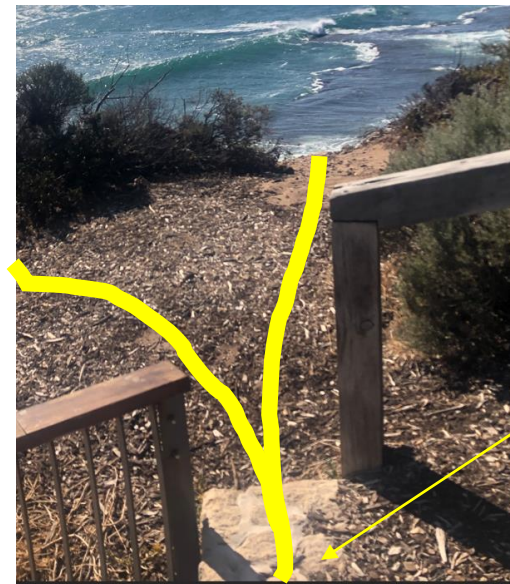
Coastal erosion undercutting fence south of PR3-165.

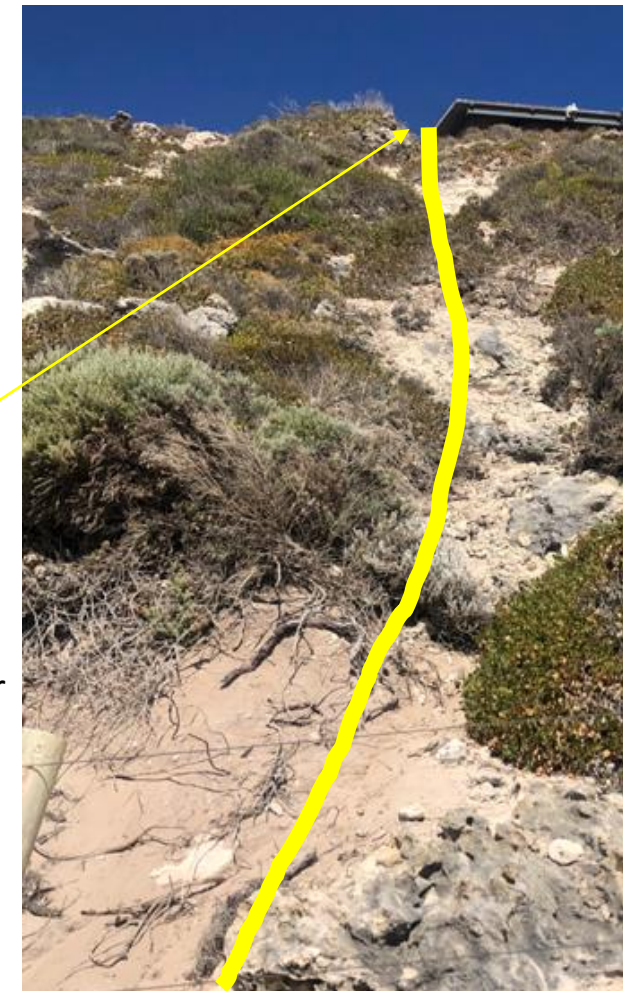
Gap in fence south of picnic/barbecue shelter is used to access informal path down limestone slope with potential to cause erosion and increase risk at this location.

Carry out maintenance to fence to keep people off slope and away from limestone ledges - place brushwood across informal path and close gap in fence at picnic area.

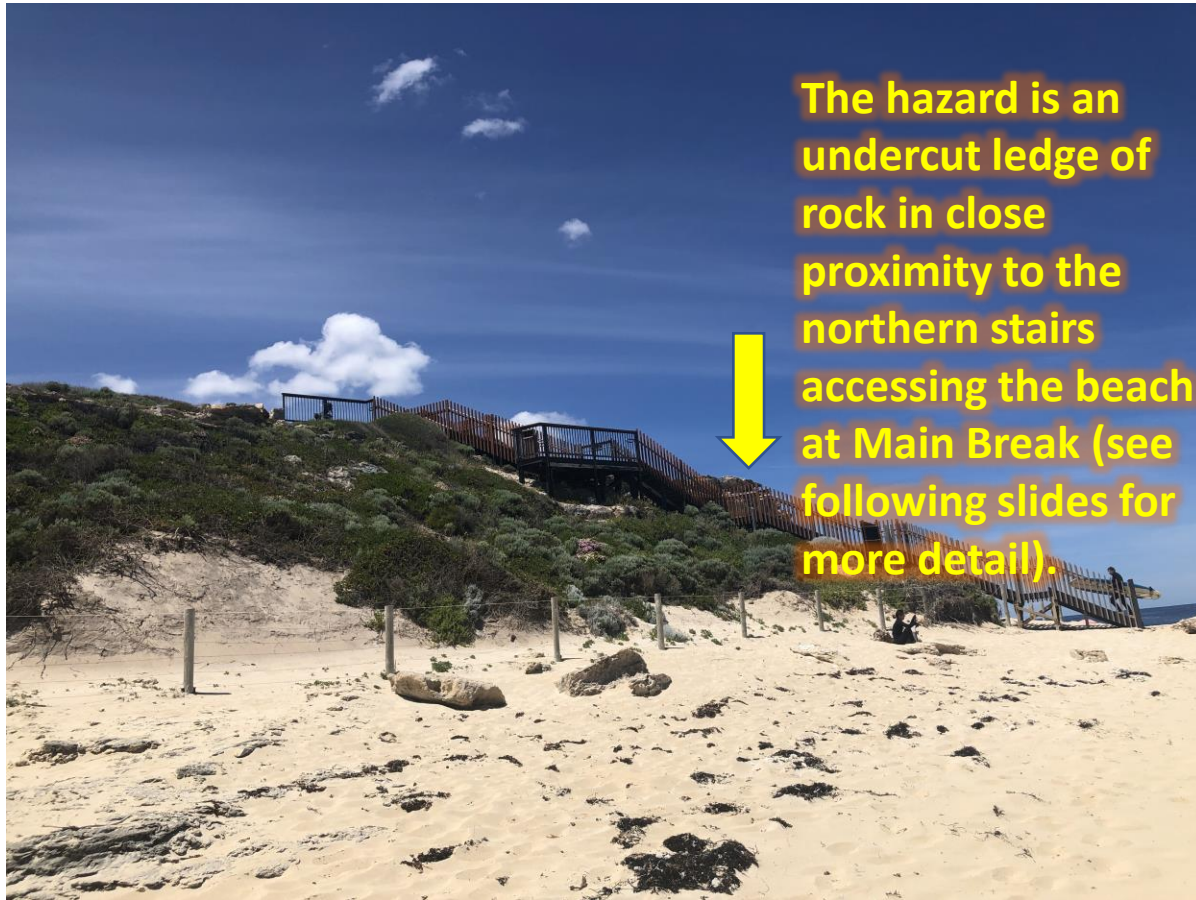
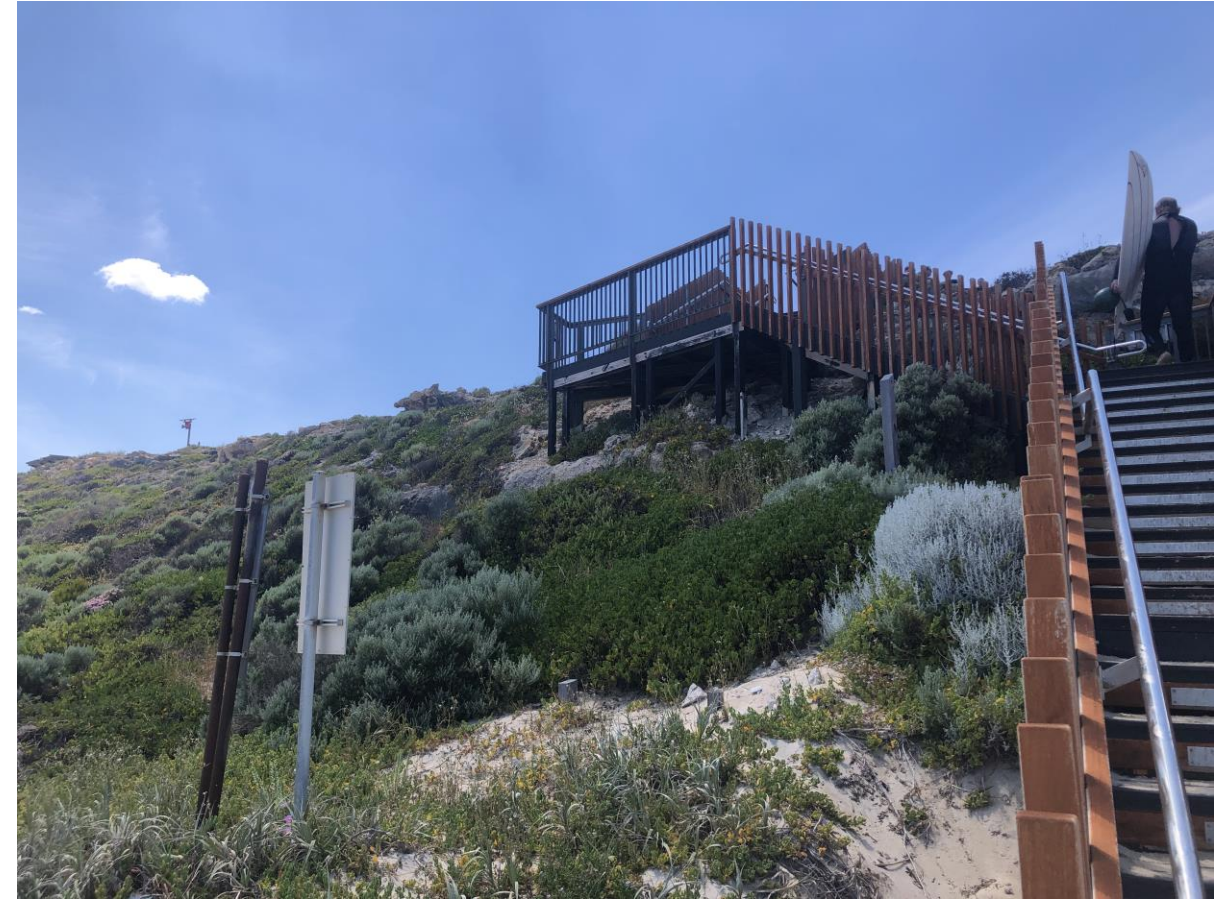
Vegetation cover in front of rock ledge and protecting the ledge from wind erosion is similar to the previous (2021) inspection.

Main risk is to people sitting on top of this rock ledge if it was collapse – however signage and general healthy growth of vegetation suggests few people are accessing the rock ledge.

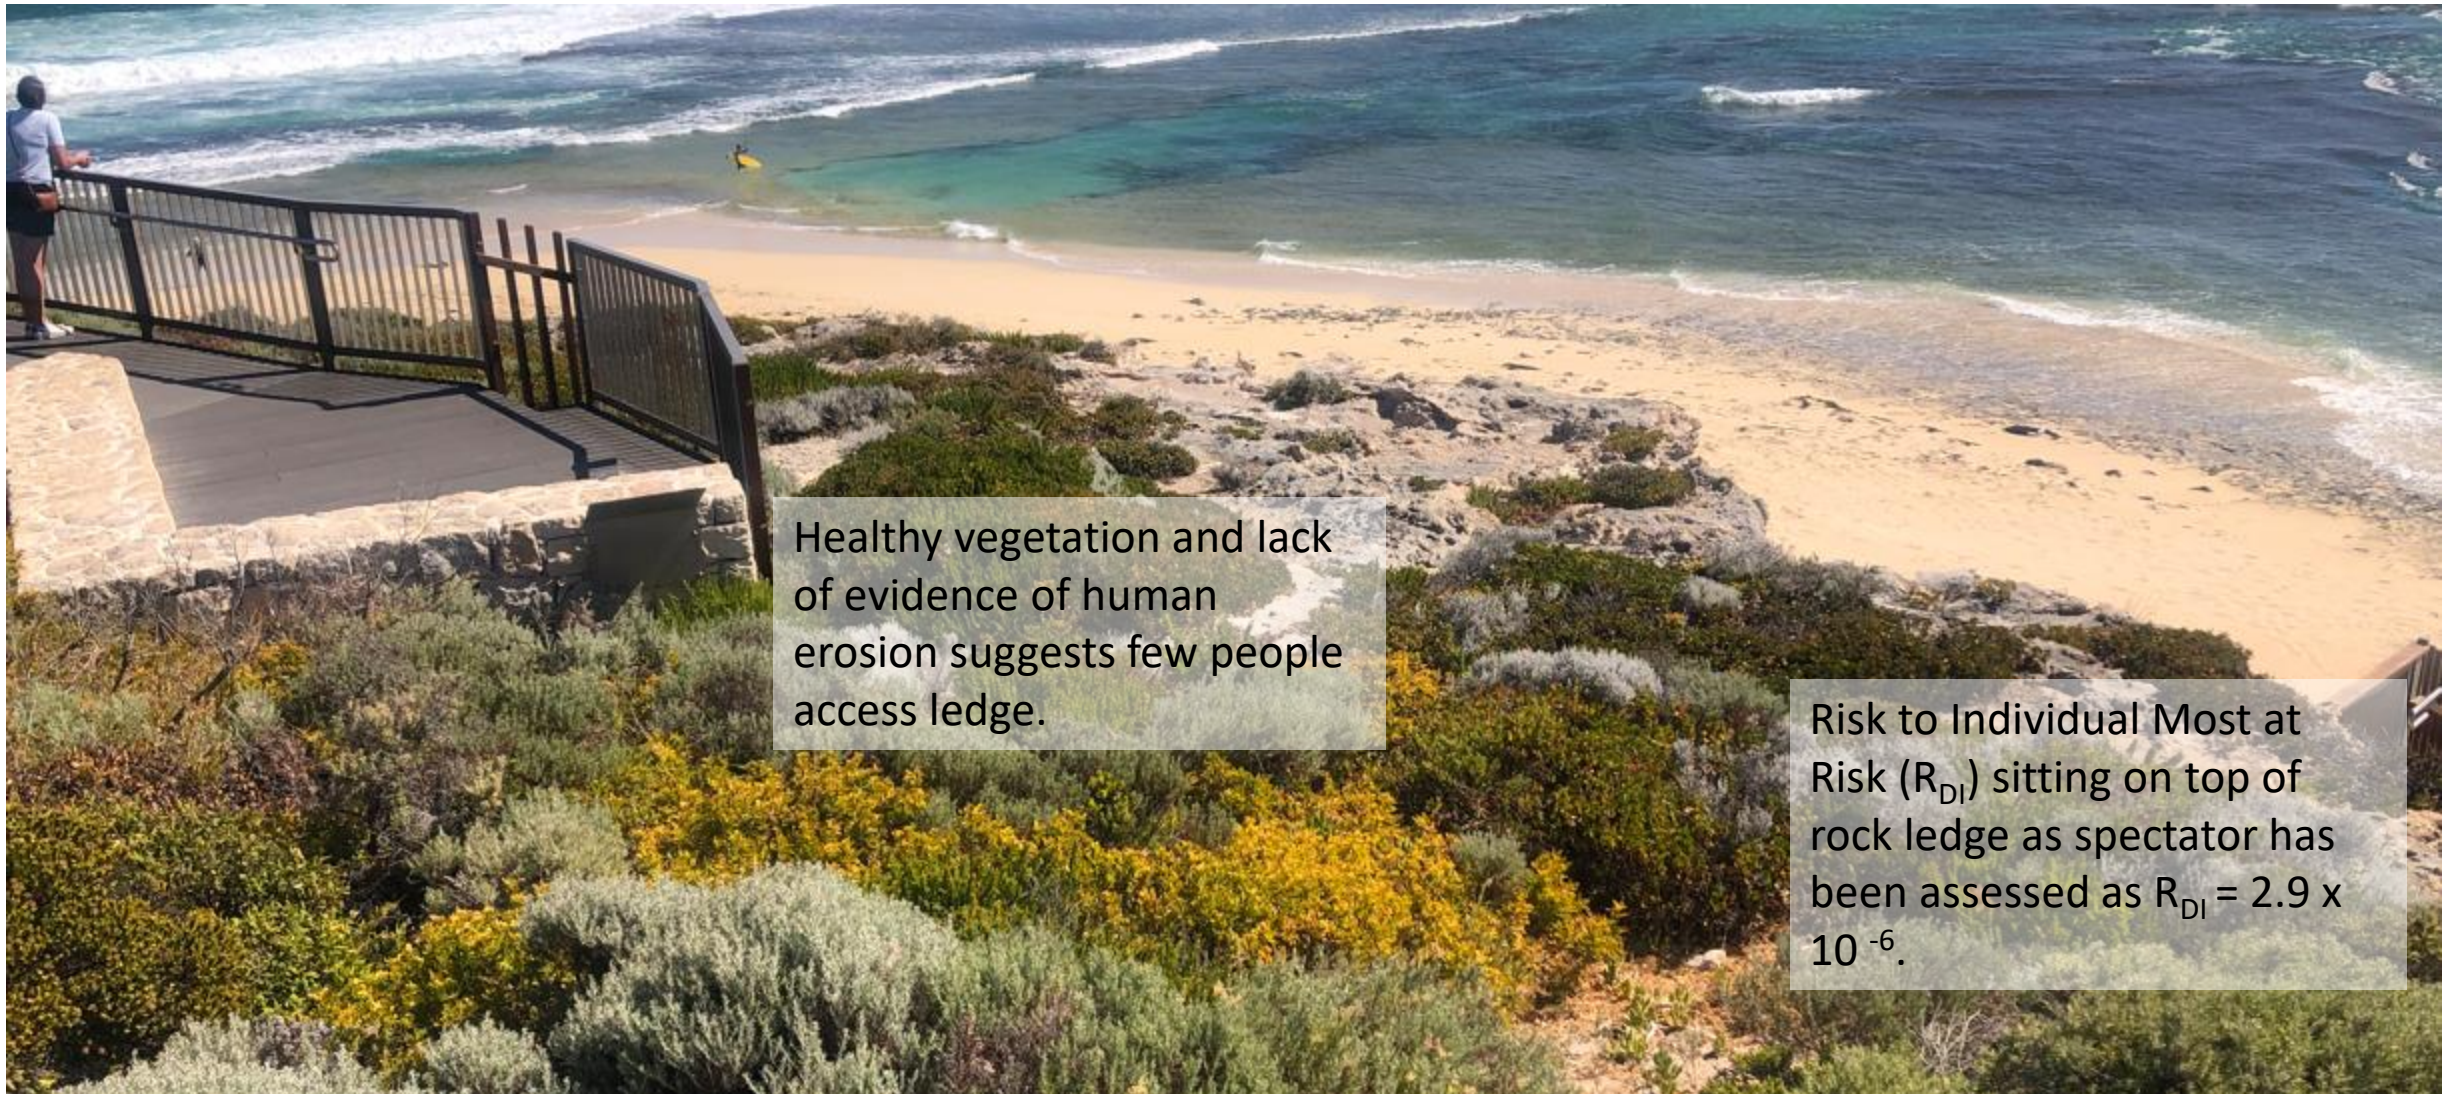
Healthy vegetation and lack of evidence of human erosion suggests few people access ledge.

Risk to Individual Most at Risk (R_{DI}) sitting on top of rock ledge as spectator has been assessed as $R_{DI} = 2.9 \times 10^{-6}$.

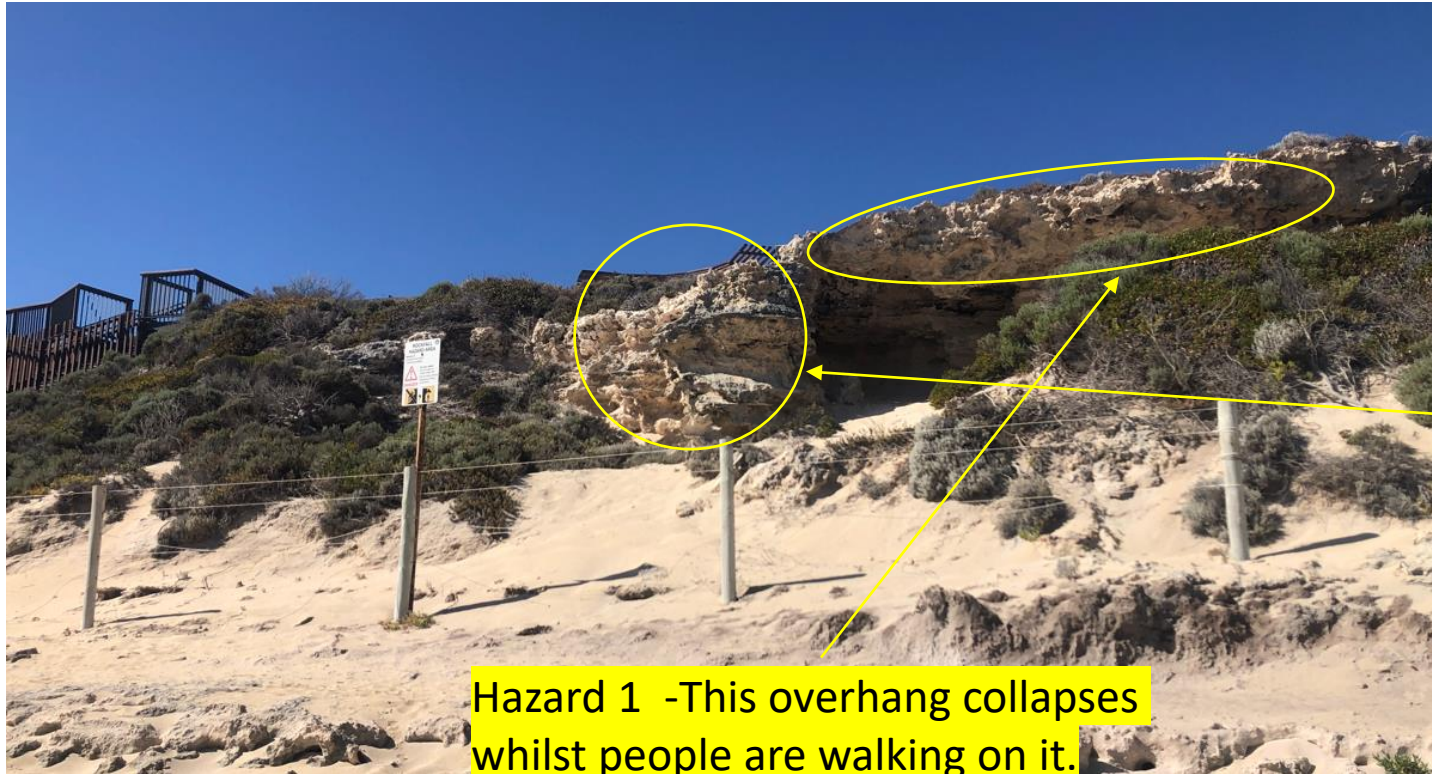
Hazard 1 -This overhang collapses whilst people are walking on it.
Note: Informal path traverses along the top of this overhang.
