GRACETOWN, PREVELLY, GNARABUP, GRUNTERS, WESTERN
AUSTRALIA

LIMESTONE CLIFF RISK ASSESSMENT

Shire of Augusta Margaret River

Job No. PER2023-0291AB | Rev 1

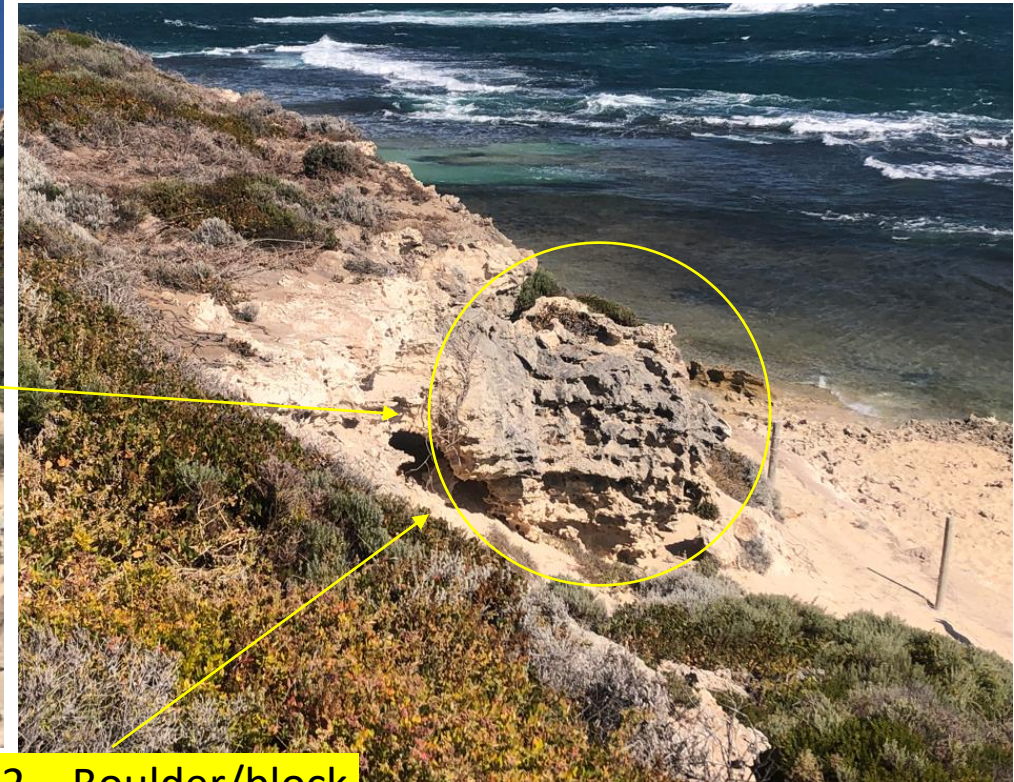
Hazard 2 – Boulder/block breaks away and rolls to beach.

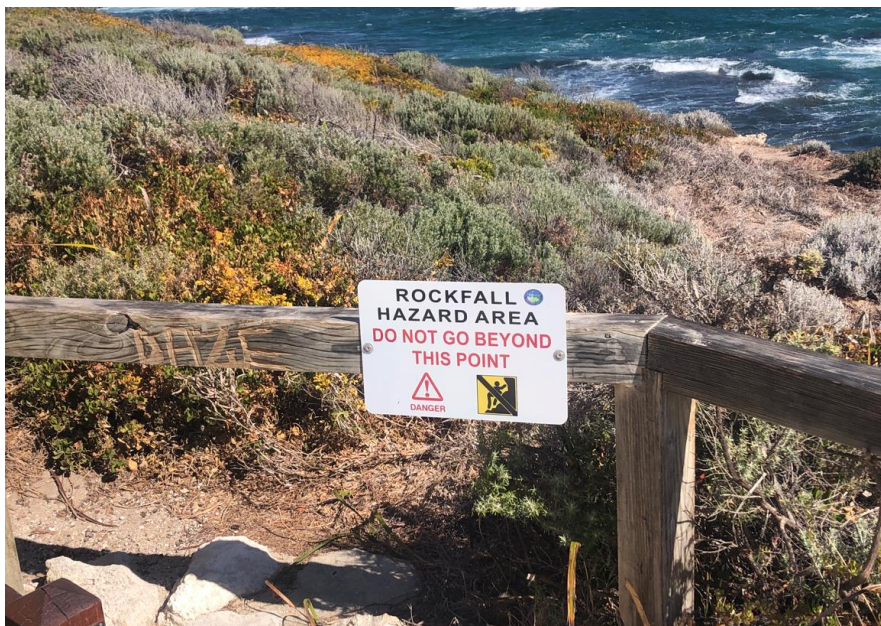
Evidence of pedestrian traffic continues, although there has been improved signage since Nov 2021 inspection.

Brushwood has also been placed.

Further placement of brushwood is recommended to further discourage access and minimise risk. The fence in the photo above could include a mesh fence panel to stop people ducking under it. Fence at beach level requires repair/maintenance.

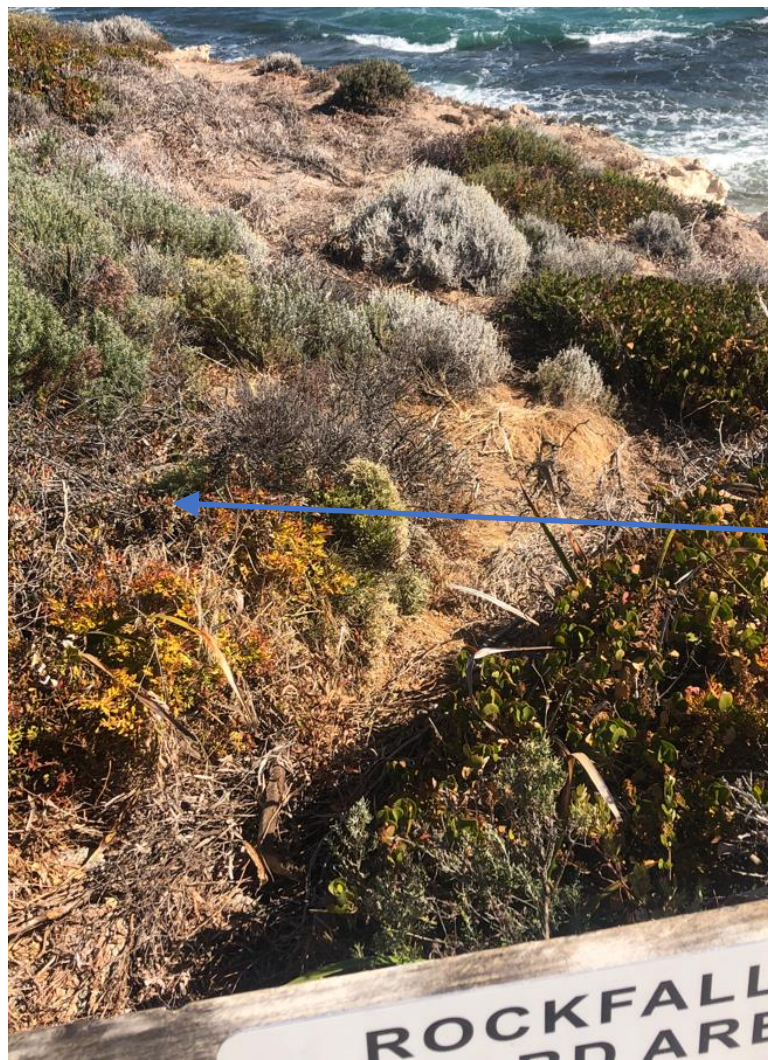
Risk to Individual Most at Risk (R_{DI}) remains same as previous assessment: $R_{DI} = 4.8 \times 10^{-6}$

Path from picnic area to hazard less distinct as brushwood has been placed.

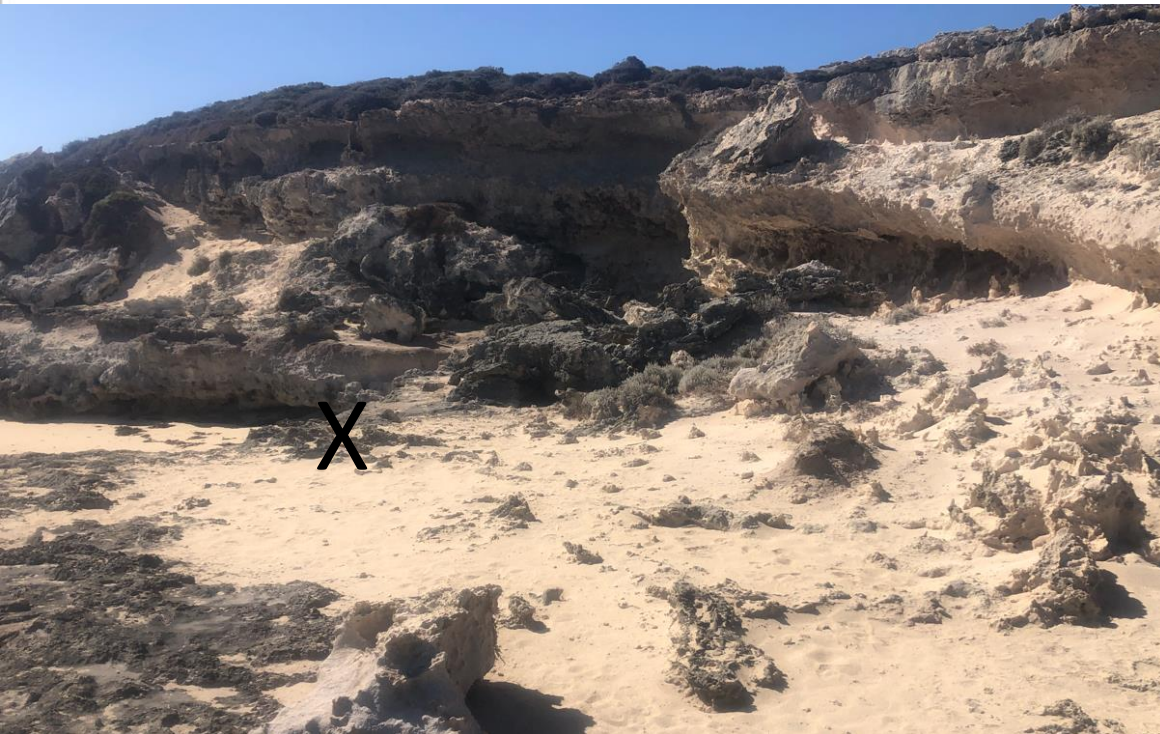
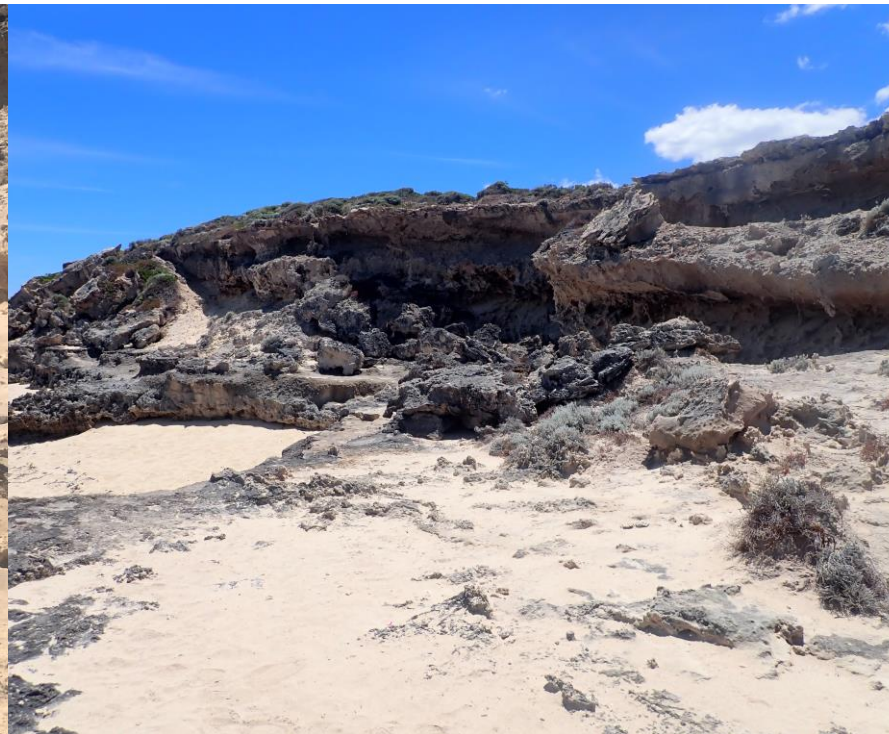
Site conditions similar to 2021 assessment.

Install rockfall hazard sign 5 m from hazard at edge of cliff - at location marked 'X' above.

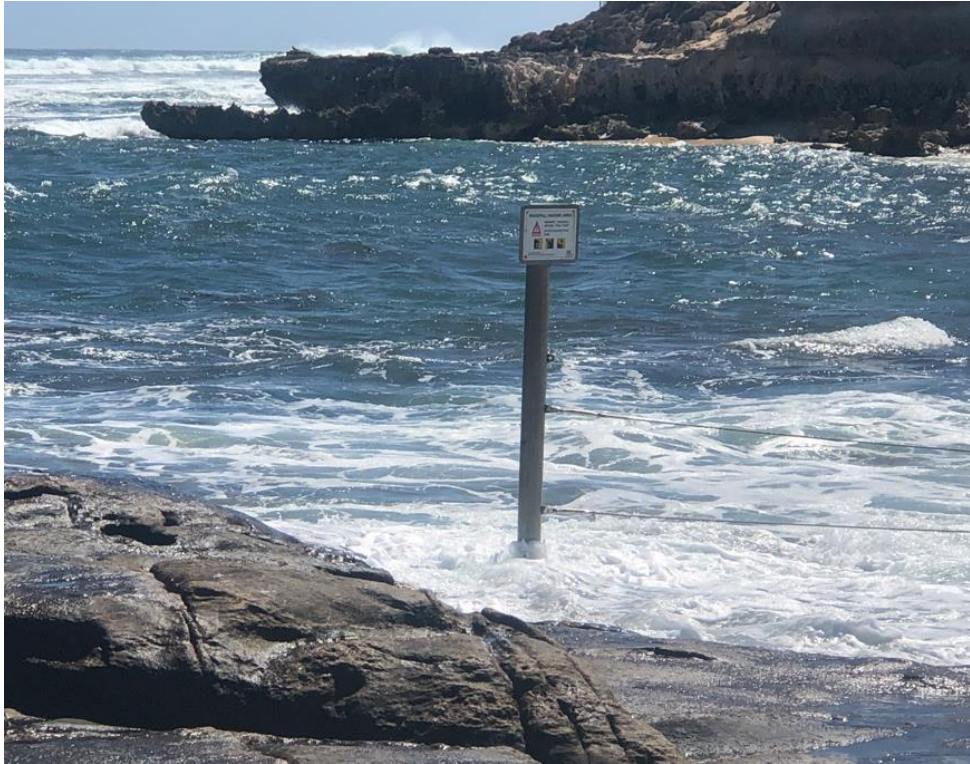
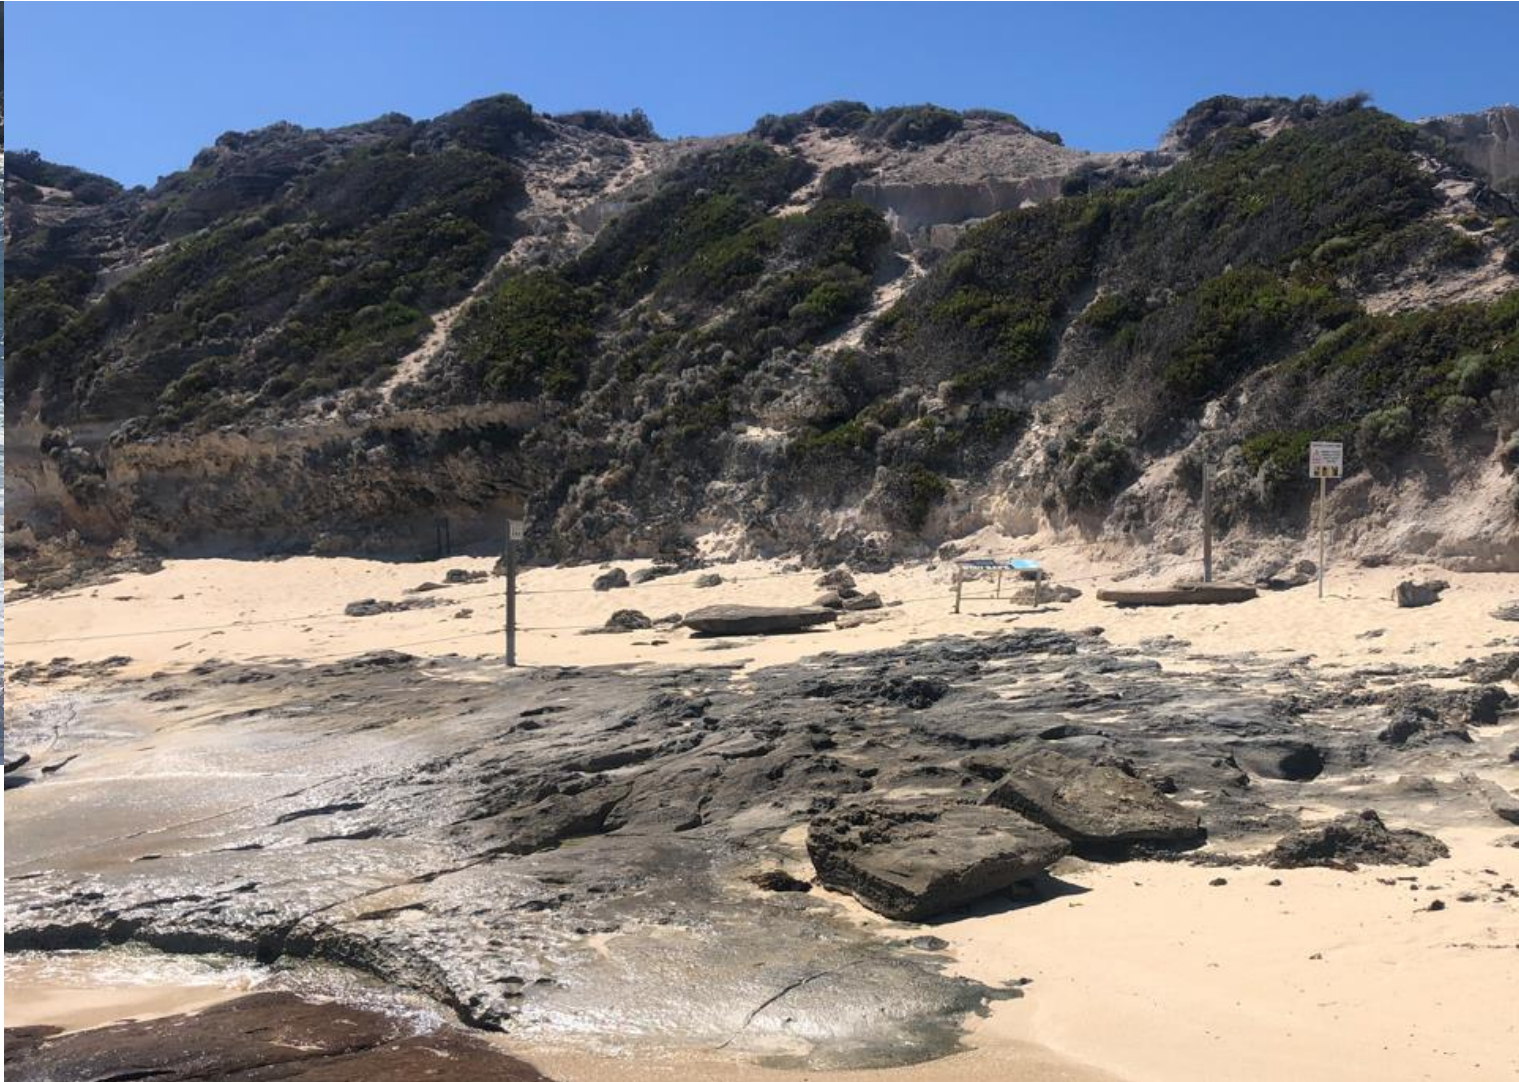
Fence and signage including informative sign in good condition.

Fence seems to be effective in discouraging access to section of beach below PR6-85 and PR6-140 – nobody was accessing beach at time of inspection.

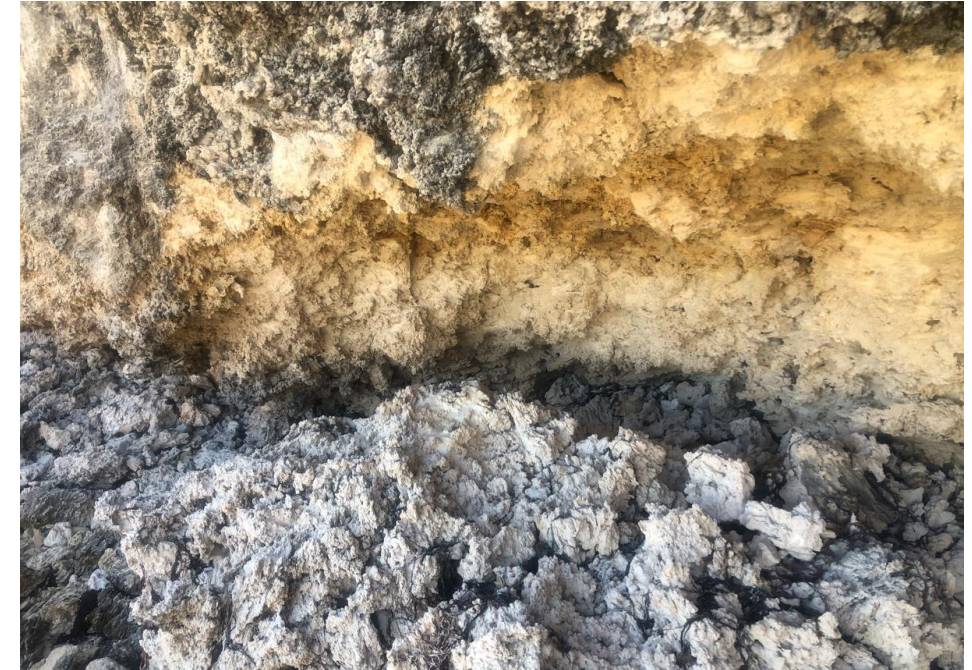
Evidence of spalling of cliff – cliff is being actively undercut at this location and future rockfalls in this location are expected.

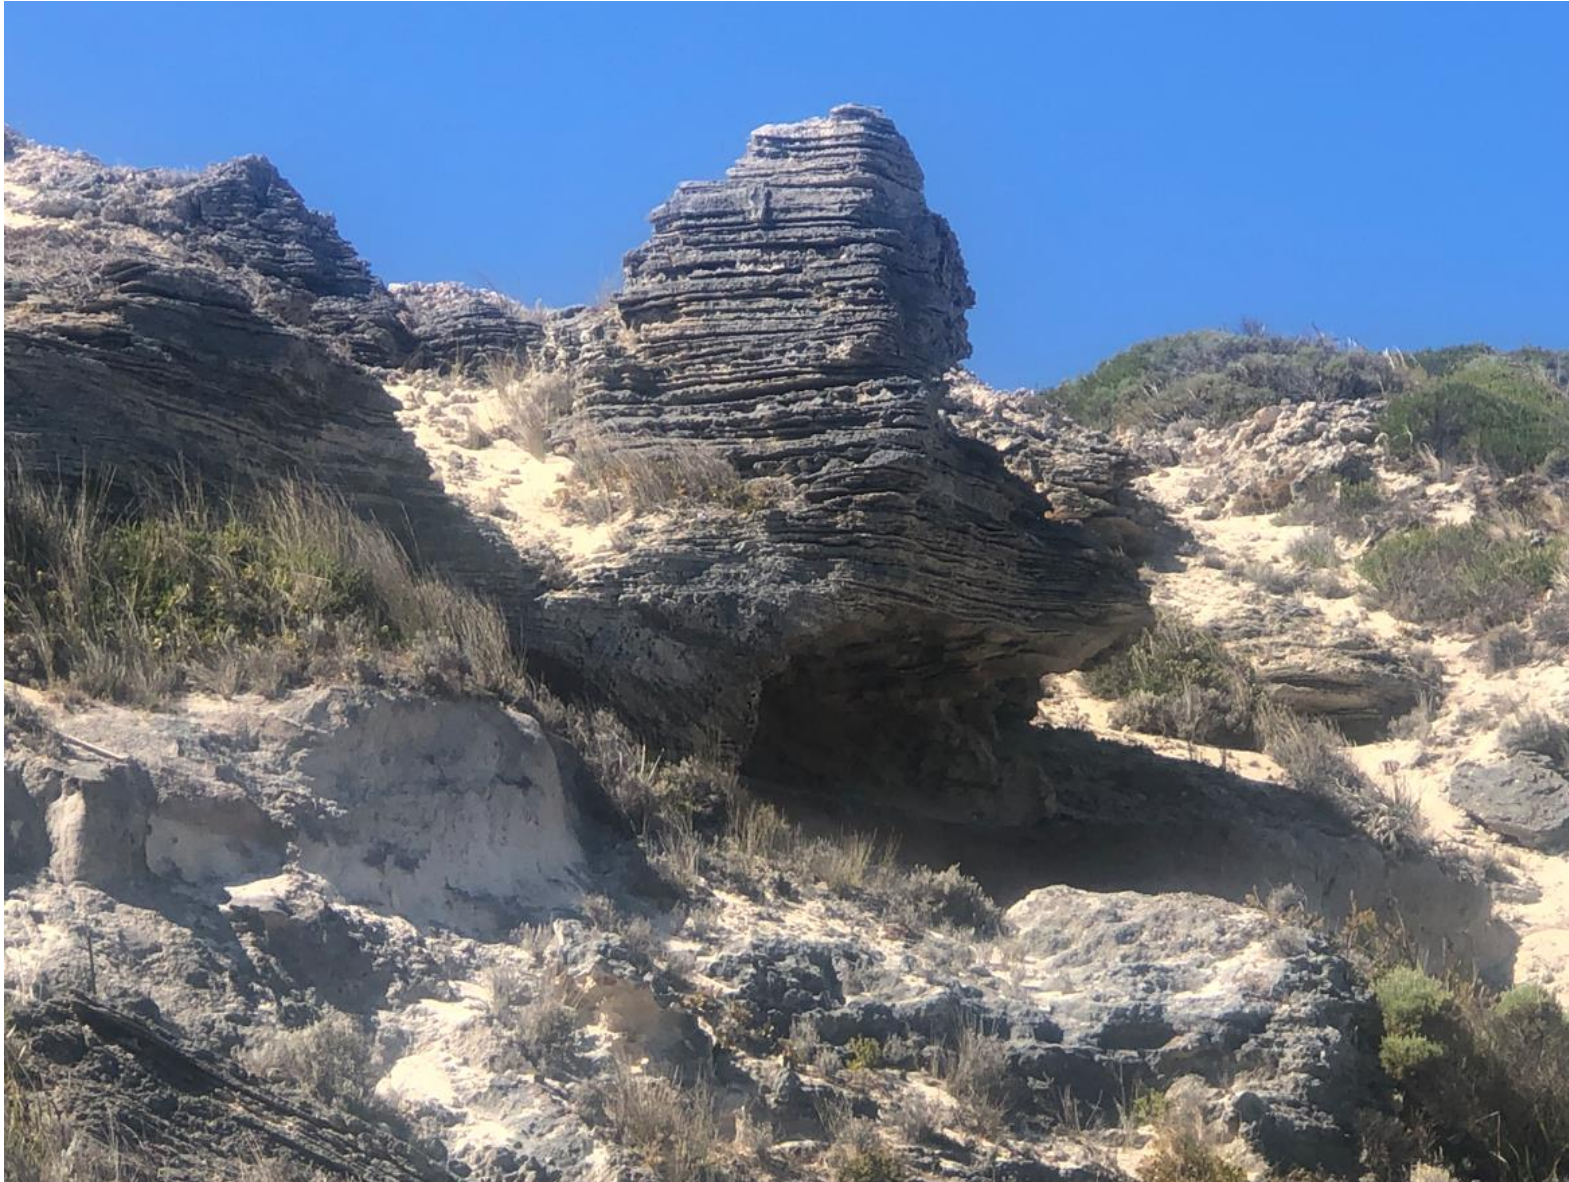
Pinnacle of bedded aeolianite partially uncut. Evidence of wind erosion can be seen around this feature.

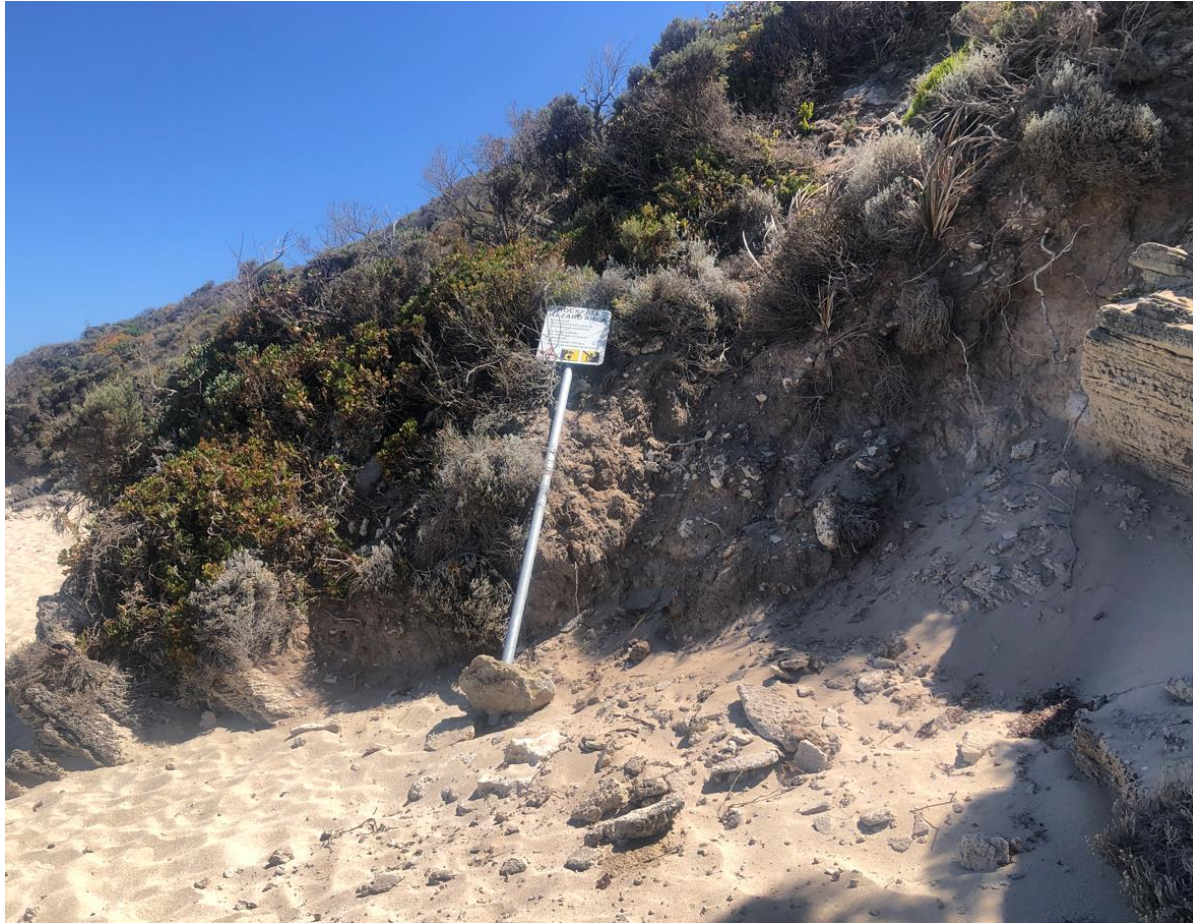
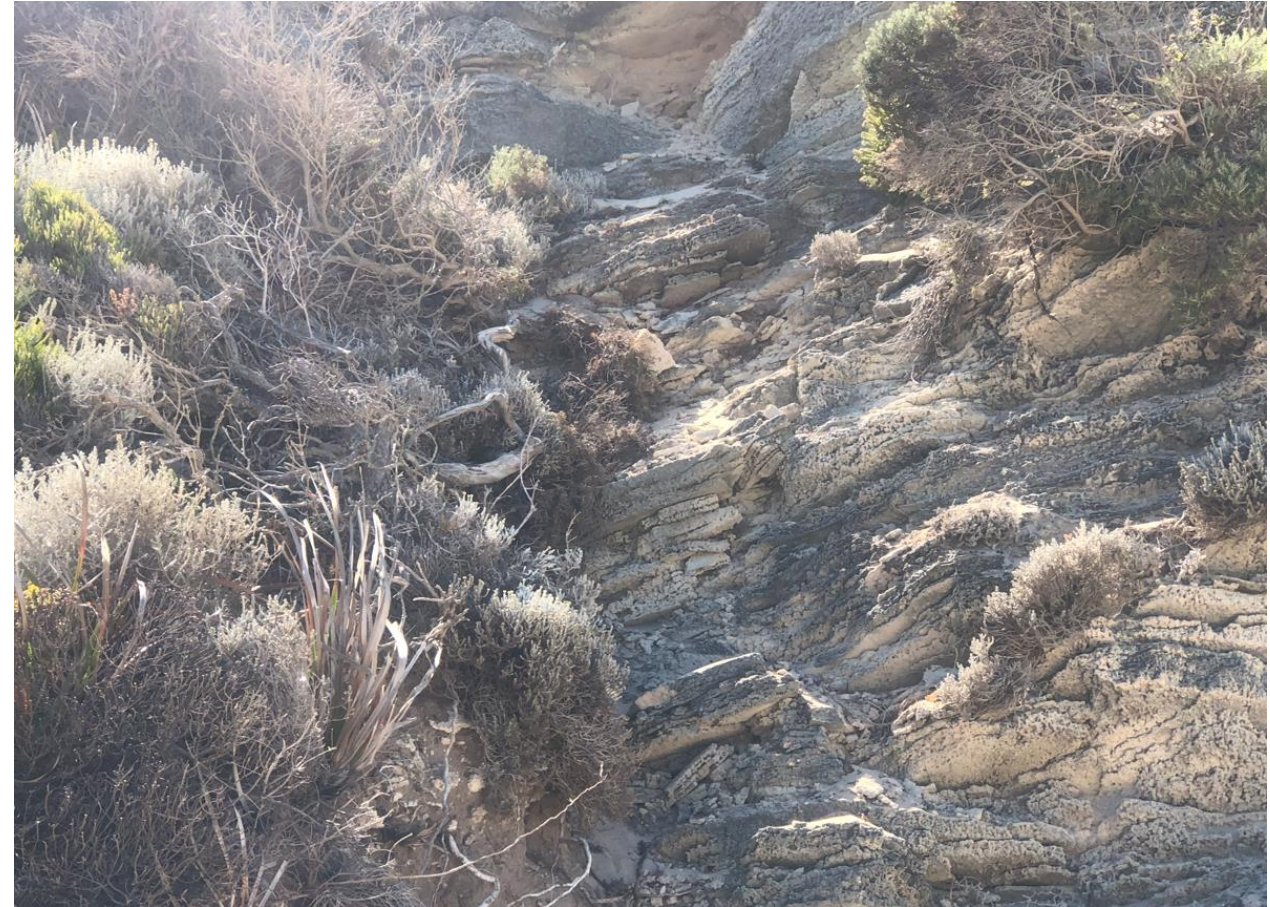
Vegetation and shallow gradients in front of hazard reduce likelihood of rockfall reaching beach.

Some small rocks are reaching beach in vicinity of sign.

Risk to Individual Most at Risk (R_{DI}) has not changed since previous assessment (2017): $R_{DI} = 2.0 \times 10^{-7}$.
New rockfall hazard risk was installed but has been damaged and requires re-installation.

Damaged sign requires re-installation.

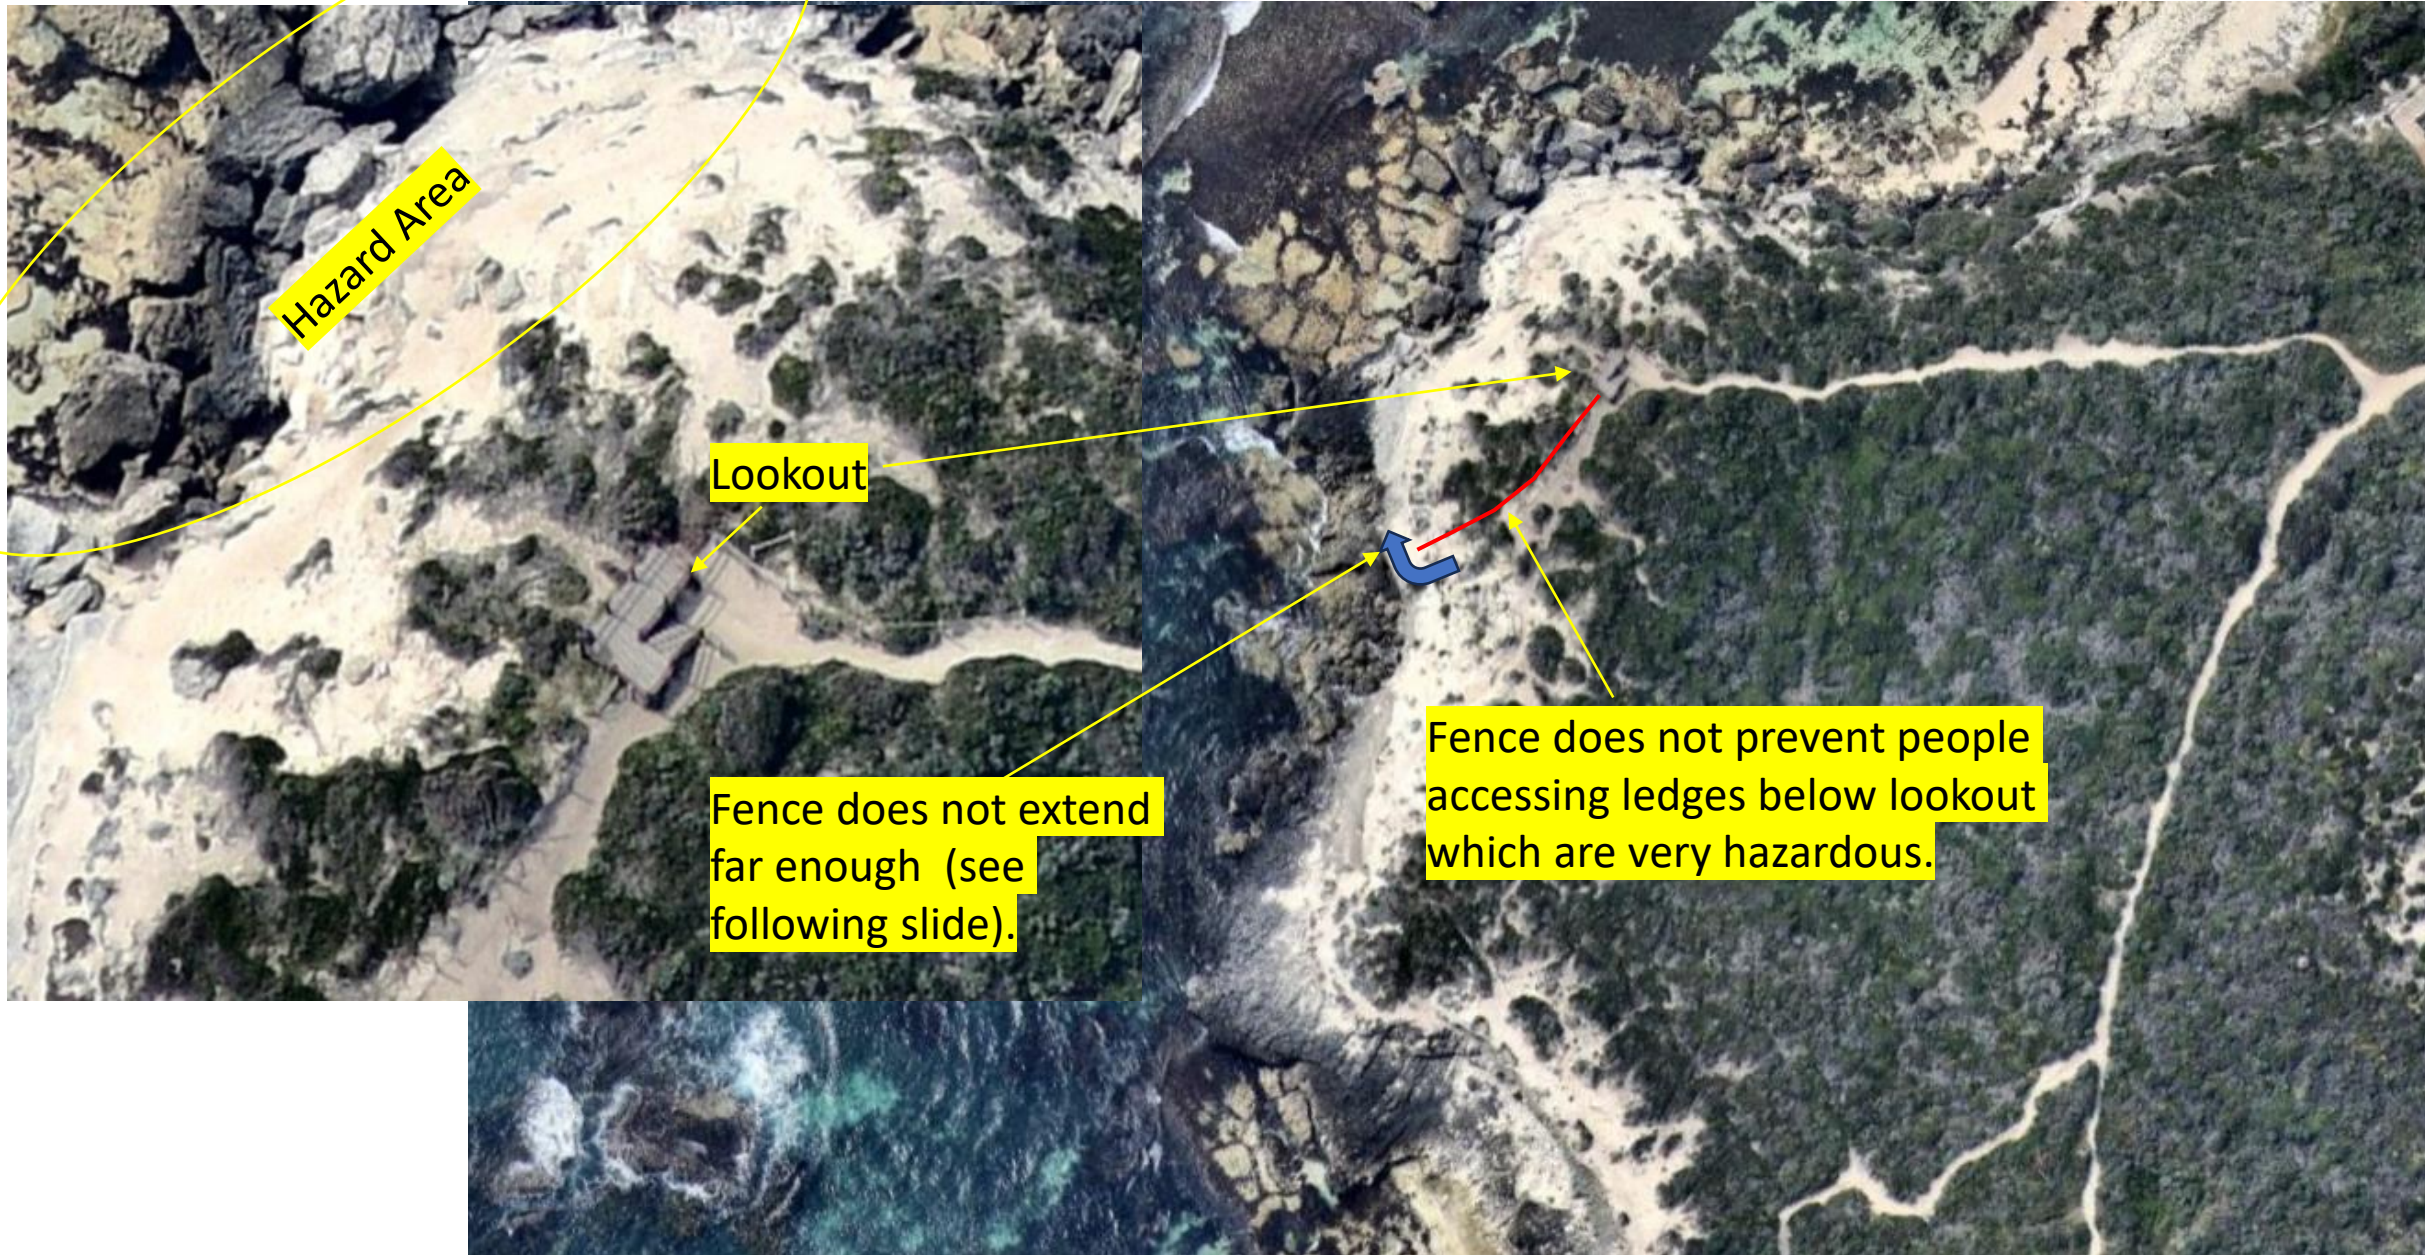
People are accessing the lower bench (straight arrow) – this access leads to an undercut section. People are also accessing the upper bench (kinked arrow) resulting in access along the top of undercut ledges.

Add brushwood and/or revegetate to discourage informal pedestrian access and promote vegetation growth in area below lookout. The fence should be extended as a matter of urgency to prevent access.

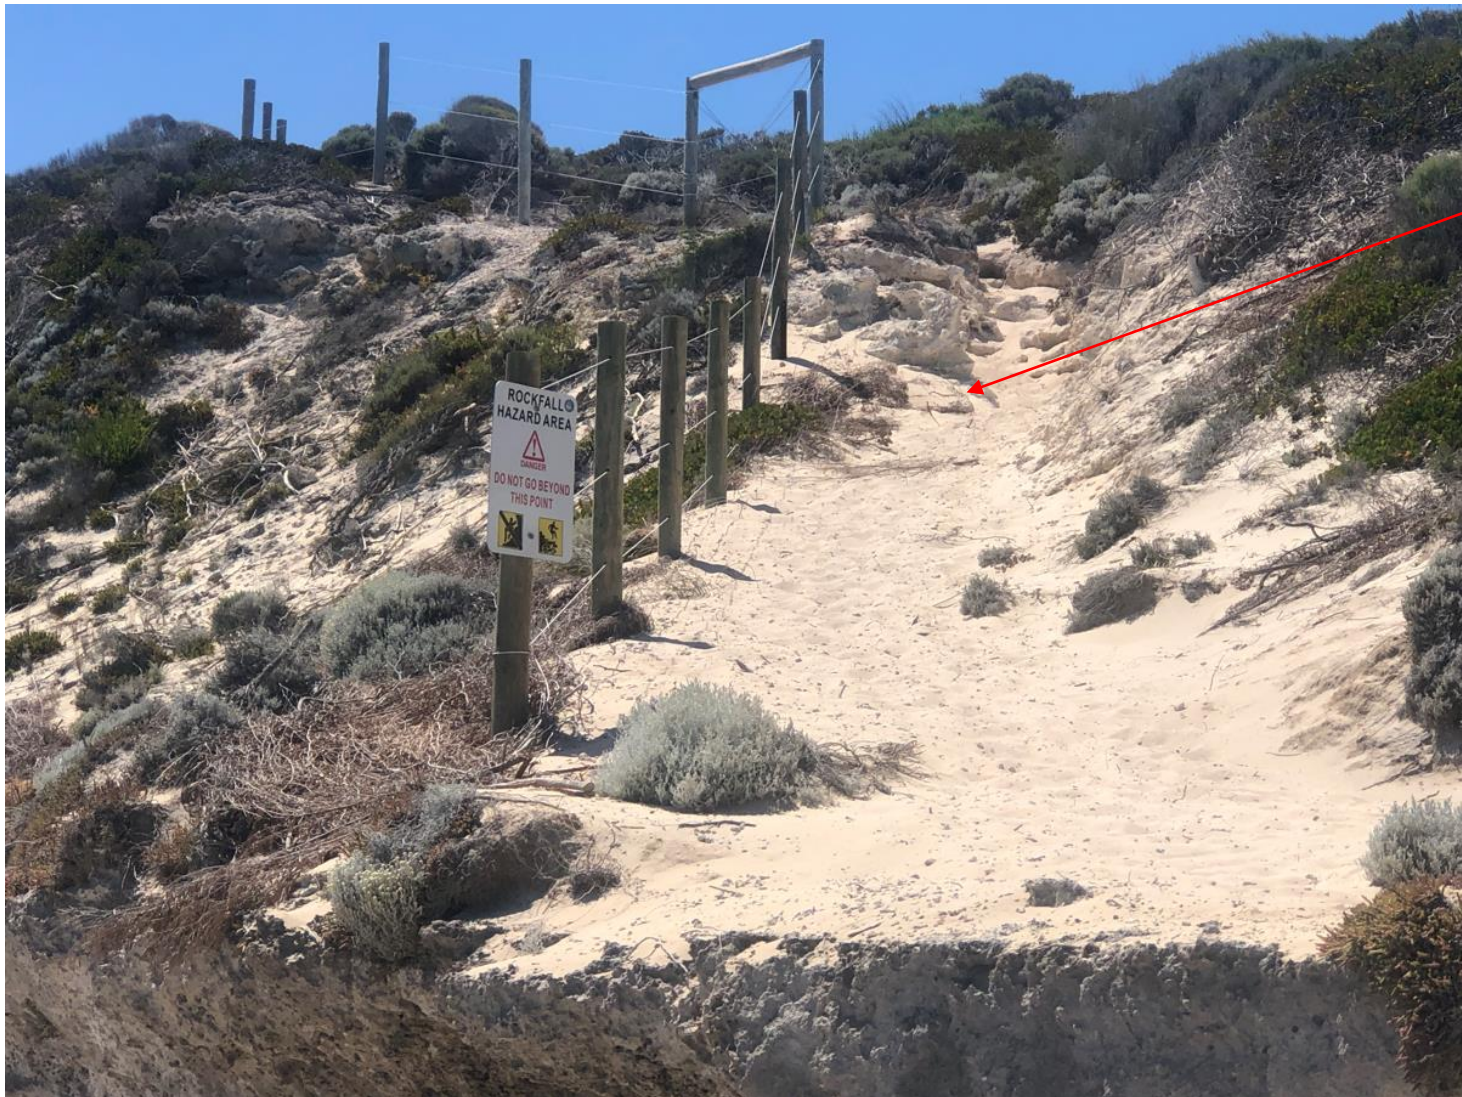
Heavily trafficked informal path.

Either access should be restricted, or this path should be formalised (steps and boardwalk towards Back Beach) to prevent erosion from enlarging hazard zone.

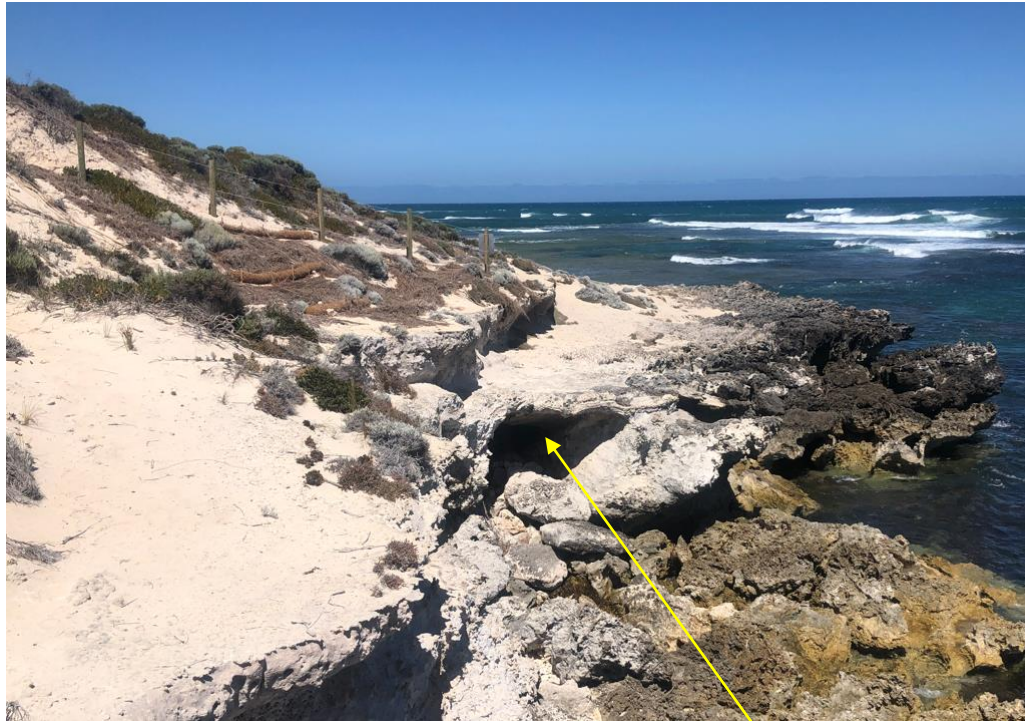
GN3-40 example
of undercut

Risk to Individual Most at Risk (R_{DI}) = 4.6×10^{-6} and 1.5×10^{-6} for GN3-40 and GN3-90 respectively. This is the same as Nov 2021.

It is noted however that ongoing erosion is likely to see these risk levels increase. Measures are urgently needed to a) prevent further erosion and b) to discourage public access to the ledge below the lookout.

People accessing this area cannot see if they are walking on an undercut ledge.

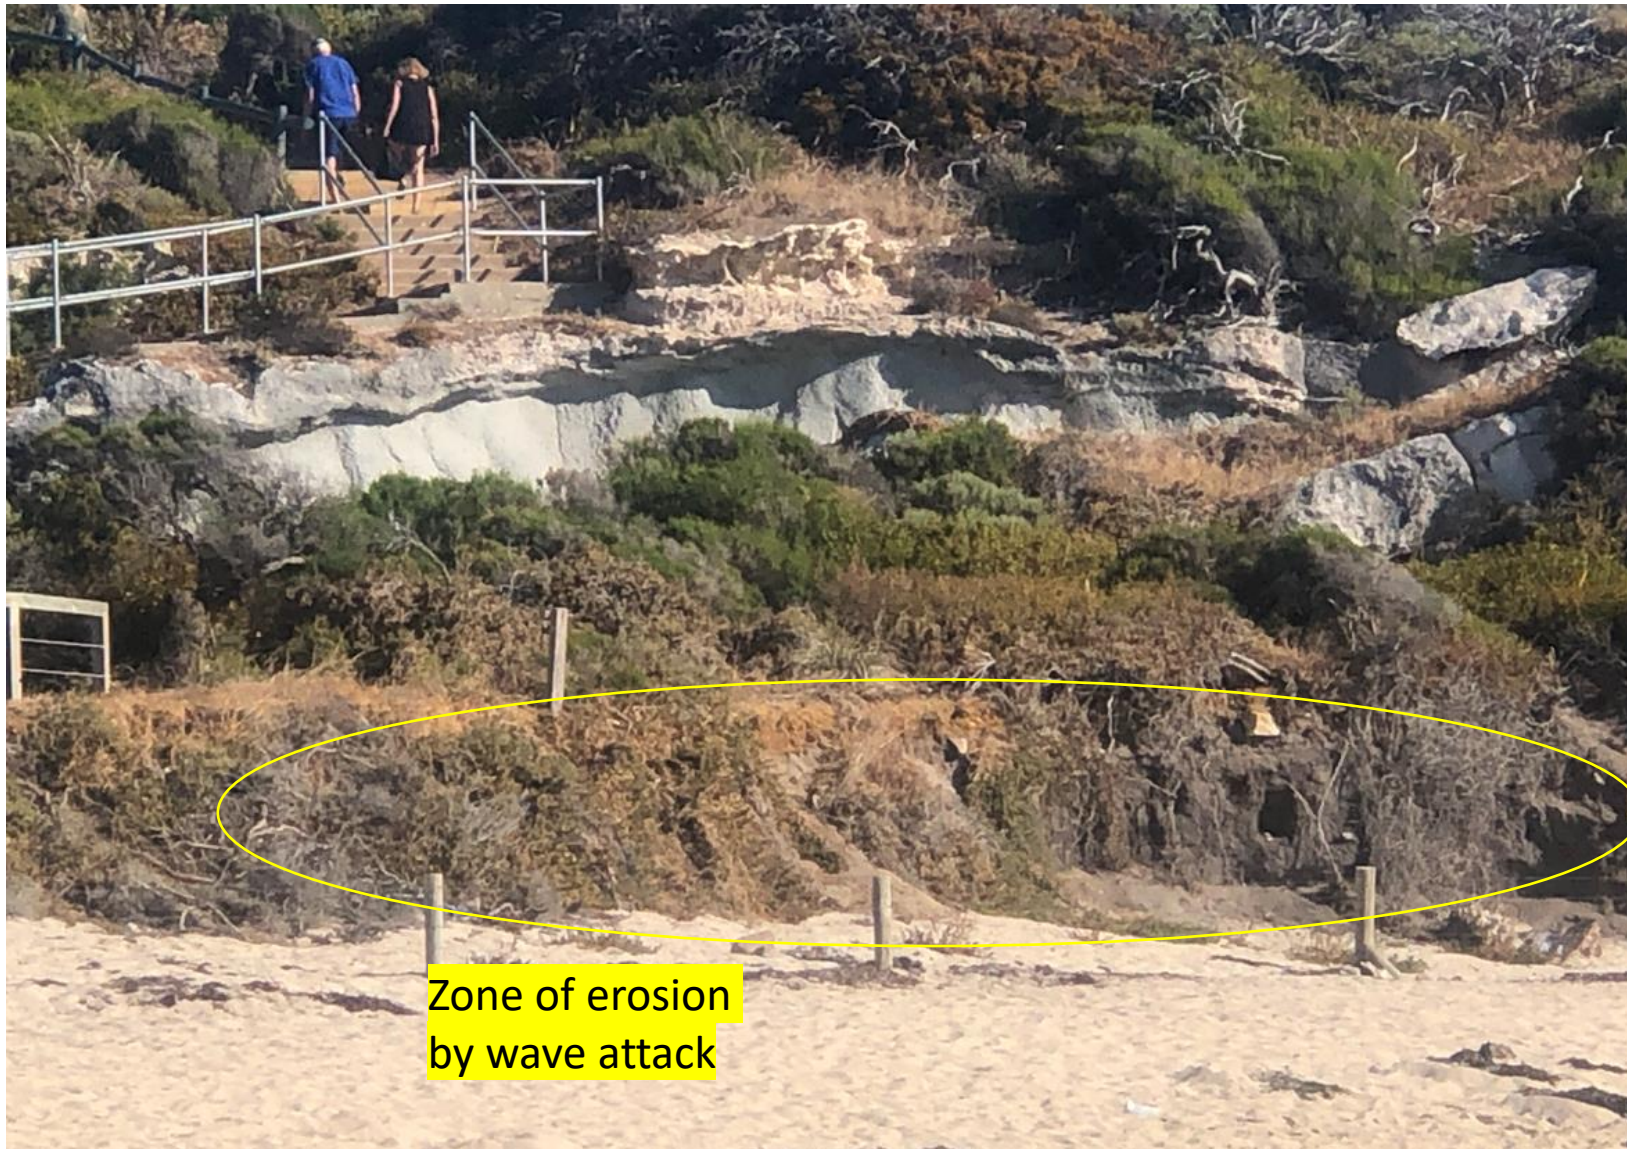
Zone of erosion
by wave attack

Erosion of the soil slope below and in front of the white elephant stairs has been occurring due to storm wave attack.

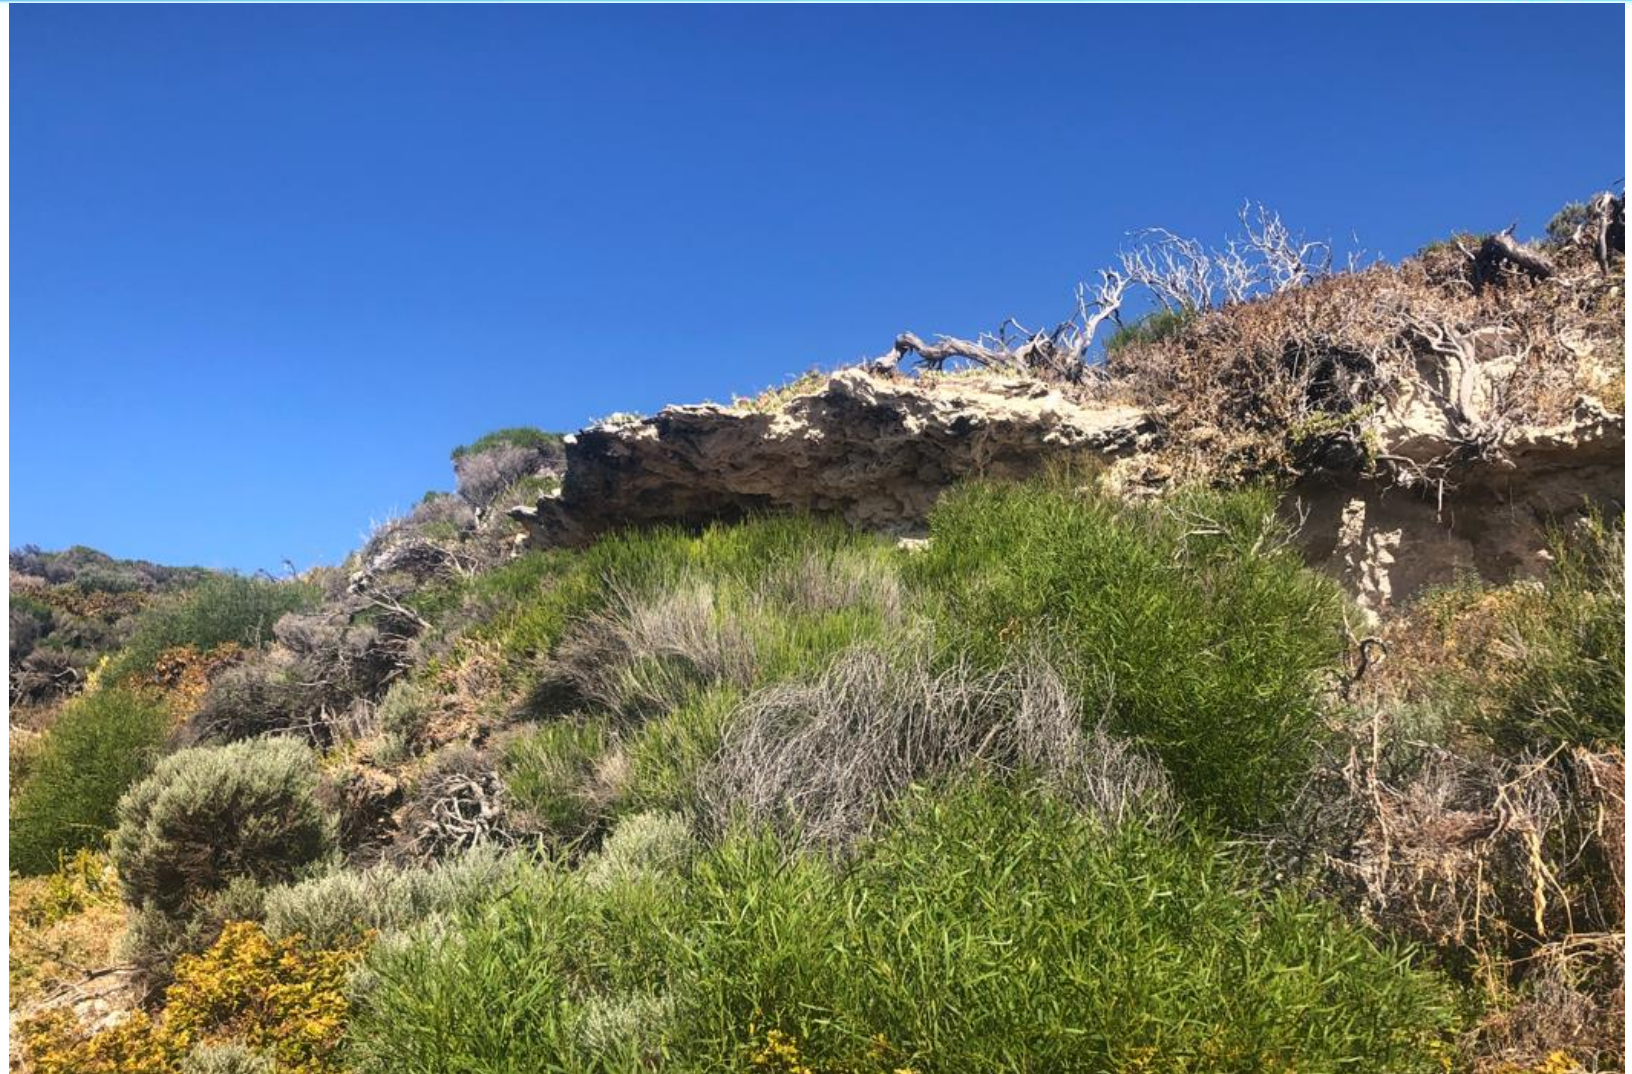
Note: There is currently minimal people traffic in this area and the grassed area below is not used by the Café for customers. **The level of risk would increase significantly if this area was used for seating.**

The level of risk to the Individual Most at Risk (R_{DI}) remains the same as November 2021 $R_{DI} = 7.6 \times 10^{-7}$

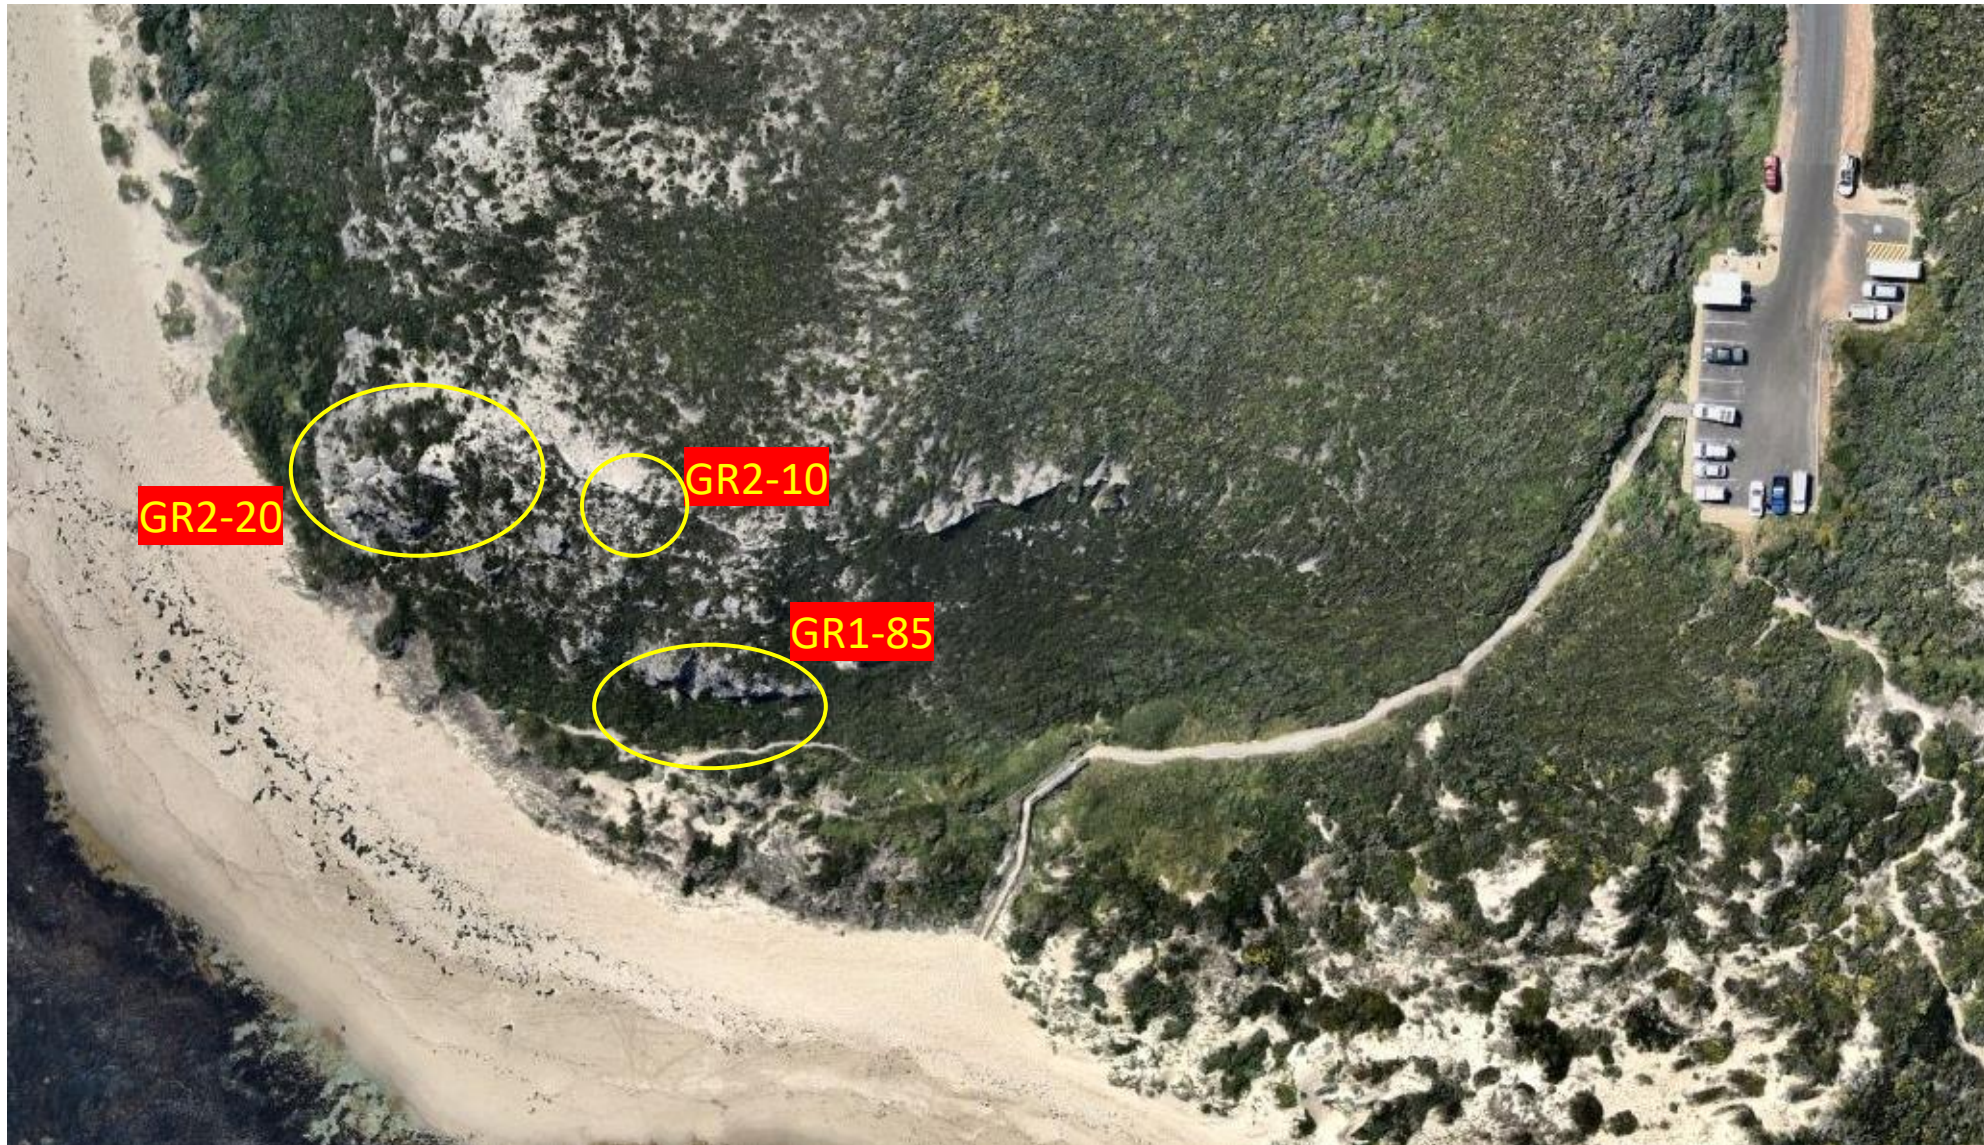
The level of Risk to the Individual Most at Risk (R_{DI}) remains the same as the 2021 assessment.

$R_{DI} = 7.8 \times 10^{-8}$
 Since 2021 inspection fence has been repaired and new sign installed.
