GRACETOWN, PREVELLY, GNARABUP, GRUNTERS, WESTERN
AUSTRALIA

LIMESTONE CLIFF RISK ASSESSMENT

Shire of Augusta Margaret River

Job No. PER2023-0291AB | Rev 1

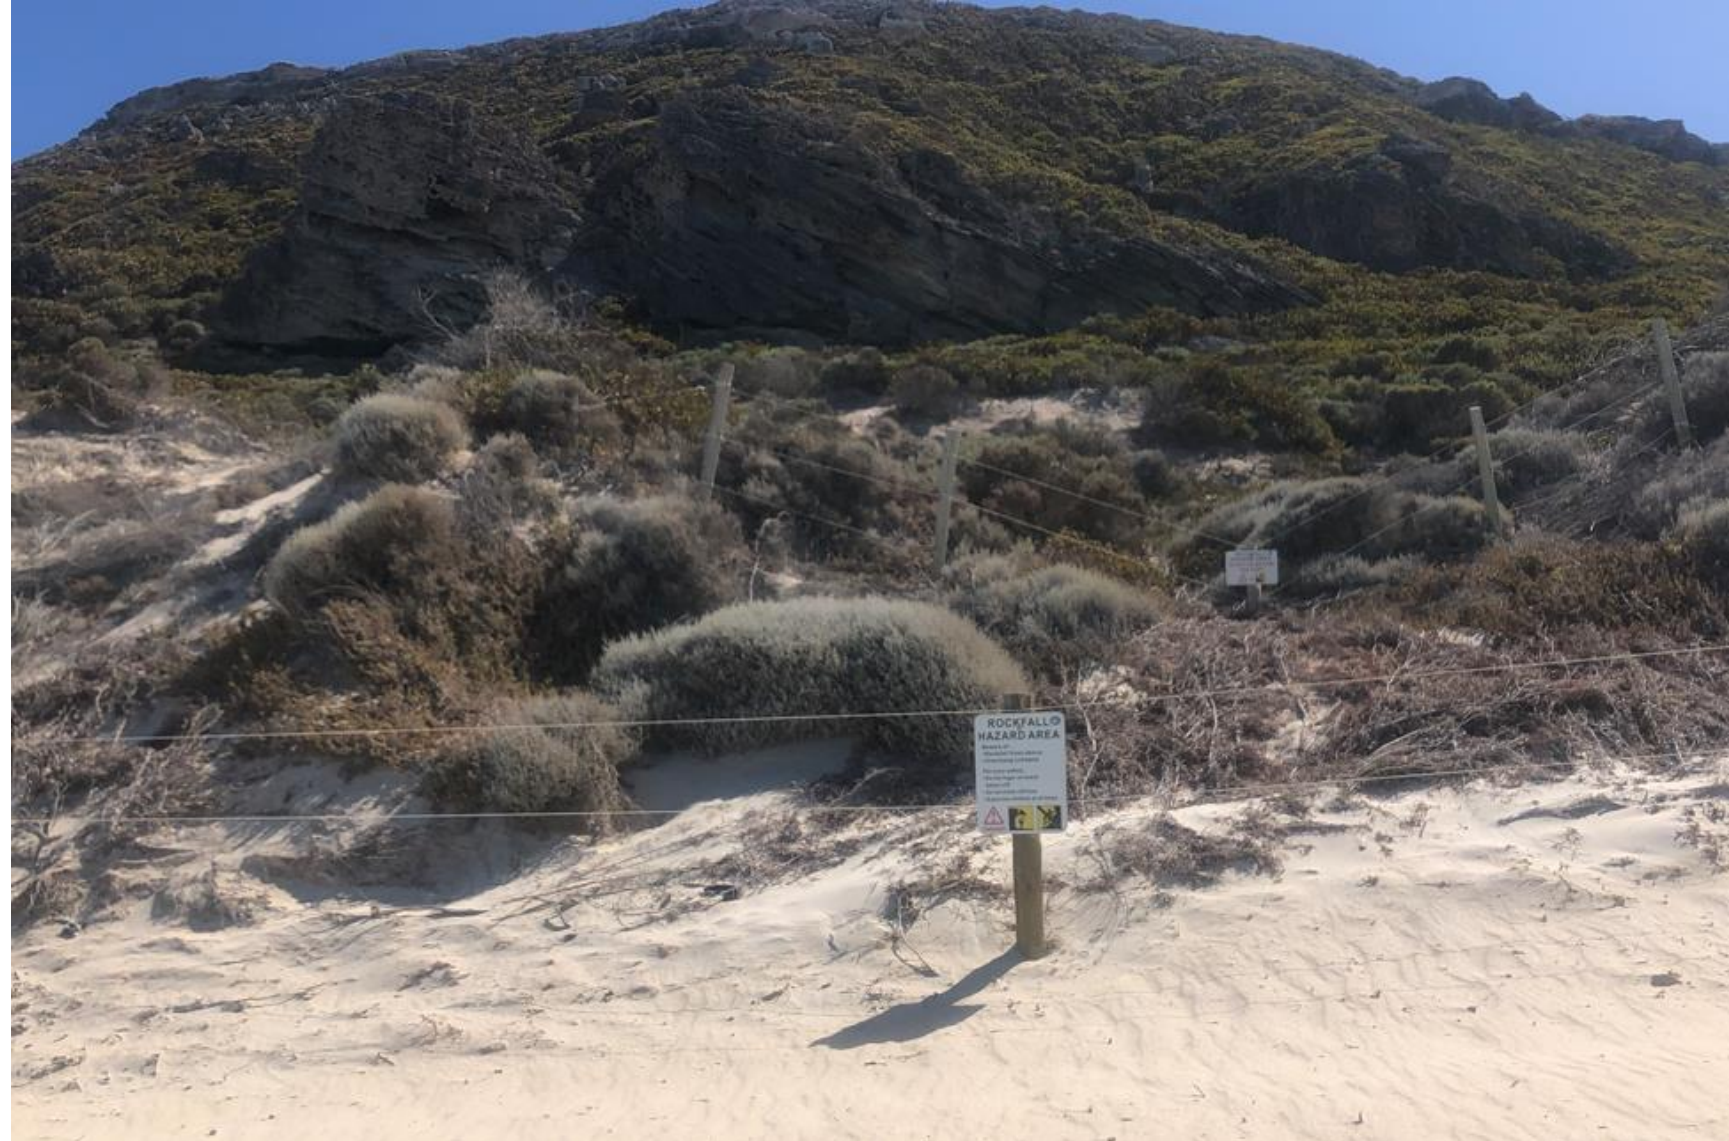
The level of Risk to the Individual Most at Risk (R_{DI}) remains the same as the 2021 assessment.

$$R_{DI} = 1.3 \times 10^{-7}$$

Rockfall hazard area sign on the beach recommended in March 2022 assessment report has been installed.

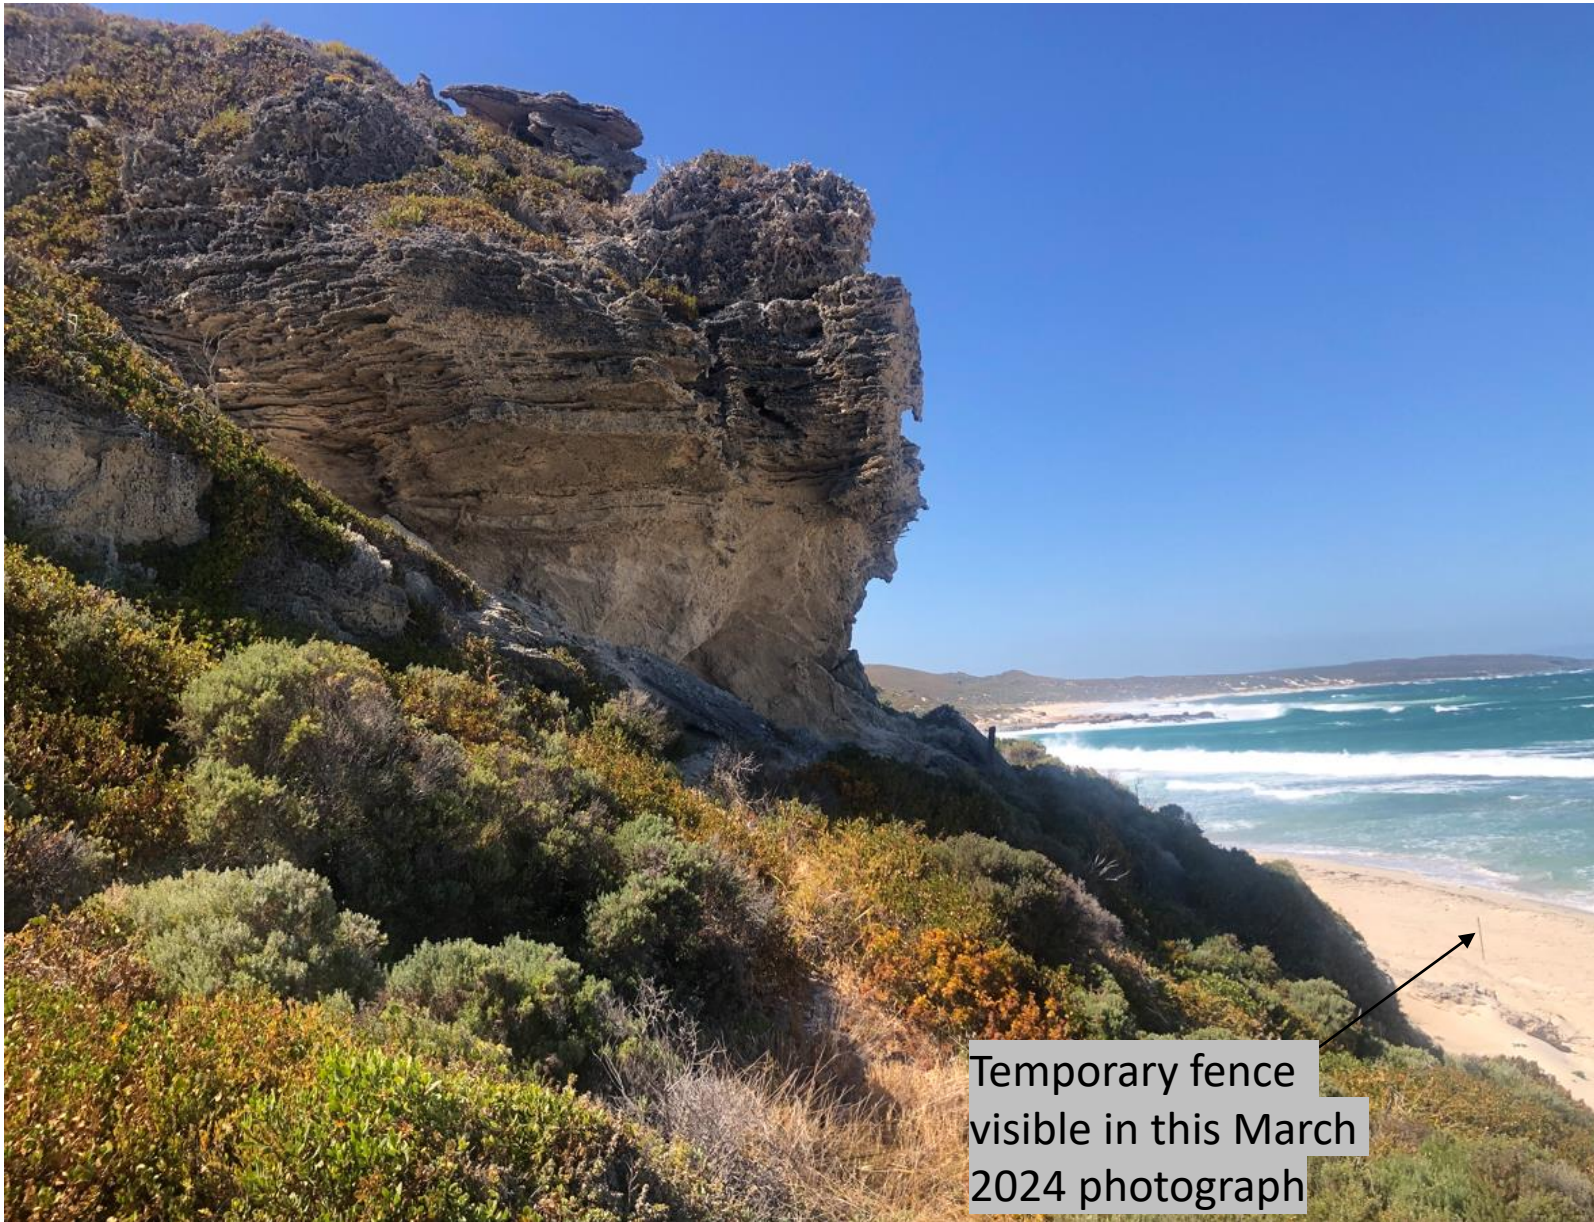
Temporary fence
visible in this March
2024 photograph

The level of Risk to the Individual Most at Risk (R_{DI}) reduced since the November 2021 inspection assessment due to the provision of a summer fence.

This level of risk however assumes that a fence (see following slide) continues to be installed at least 6 m from dune/beach interface for the months of Nov to April inclusive to keep people away from high-risk zone.

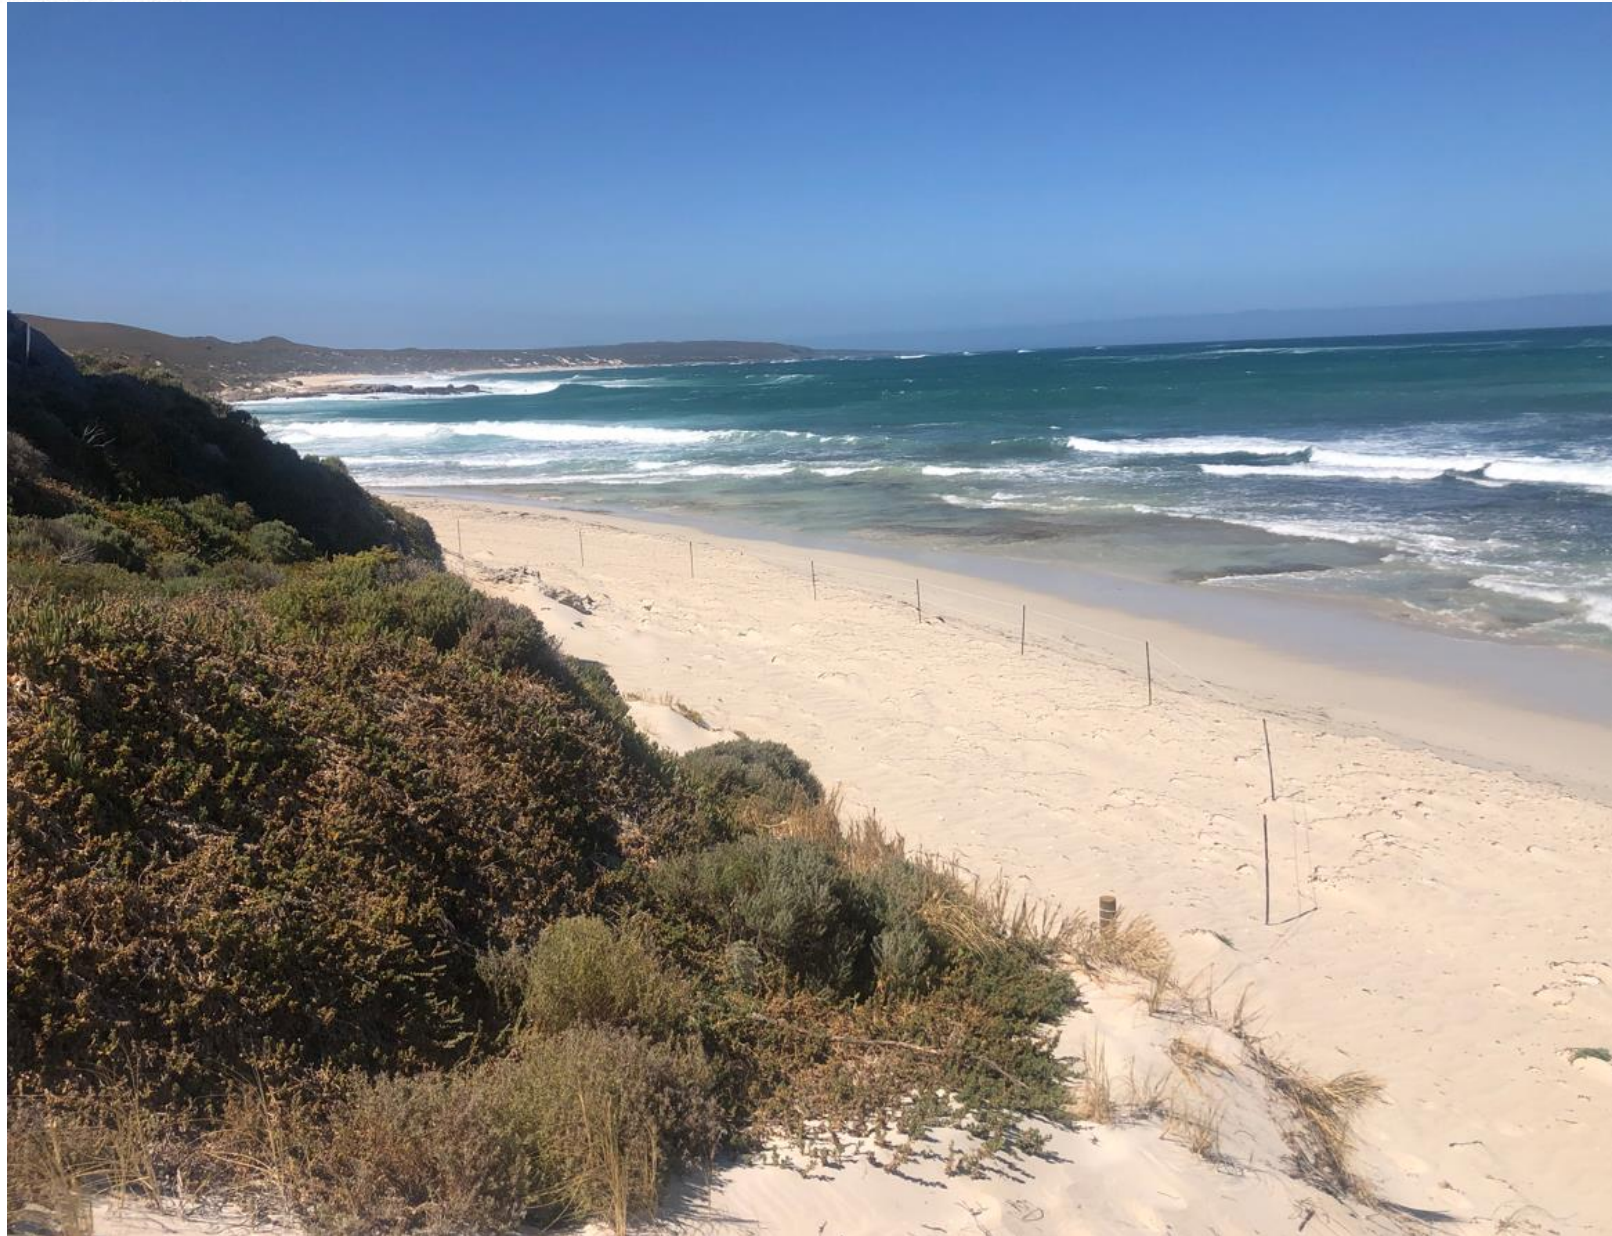
Temporary summer fence (Nov to April) to keep people away from the risk zone at the base of GR2-20.

This fence must be erected each summer.

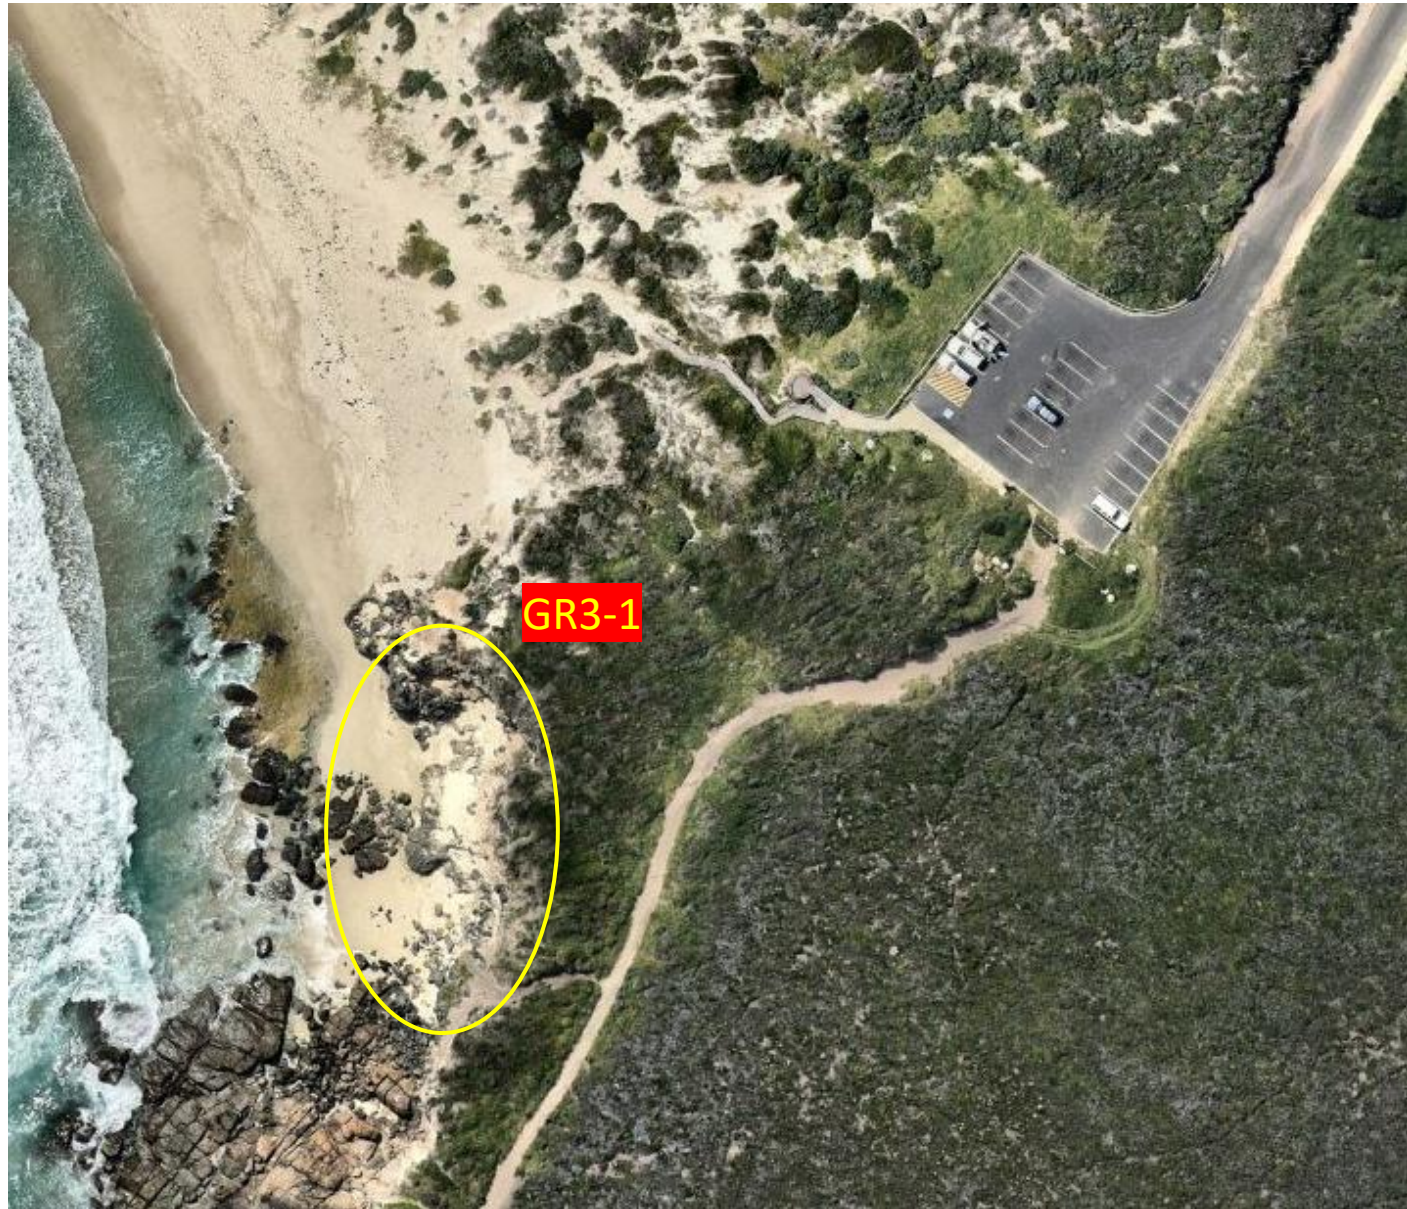
Approximately
3m overhang

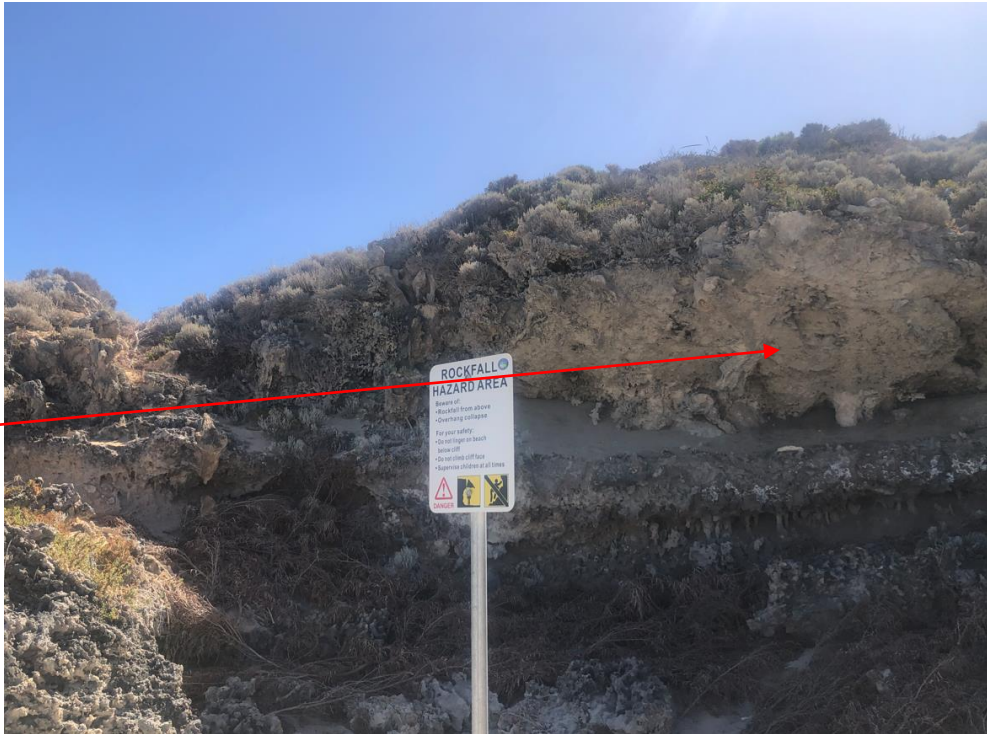
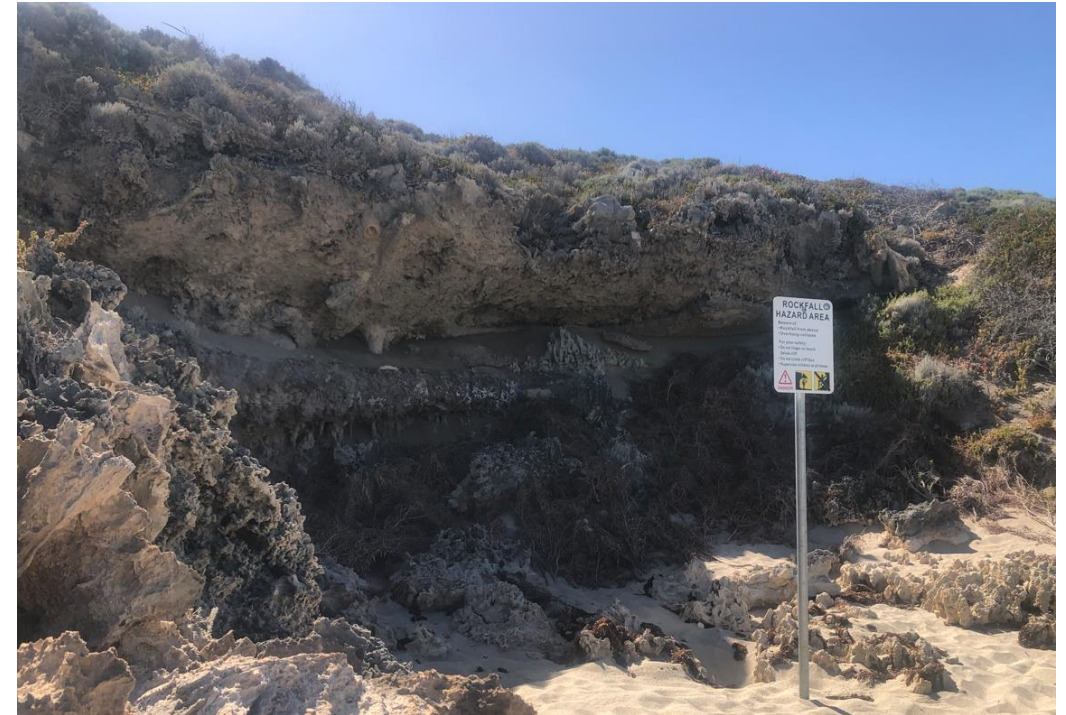
Area approximately 10m wide with a 2.5m overhang.

Rockfall risk sign recommended in March 2022 inspection report has been installed.
