LIMESTONE STABILTY ASSESSMENT

**GRACETOWN, PREVELLY, GNARABUP, WESTERN
AUSTRALIA**

**INSPECTION, RISK ASSESSMENT AND
REMEDIATION DESIGN REPORT**

PER2019-0229AA Rev 1

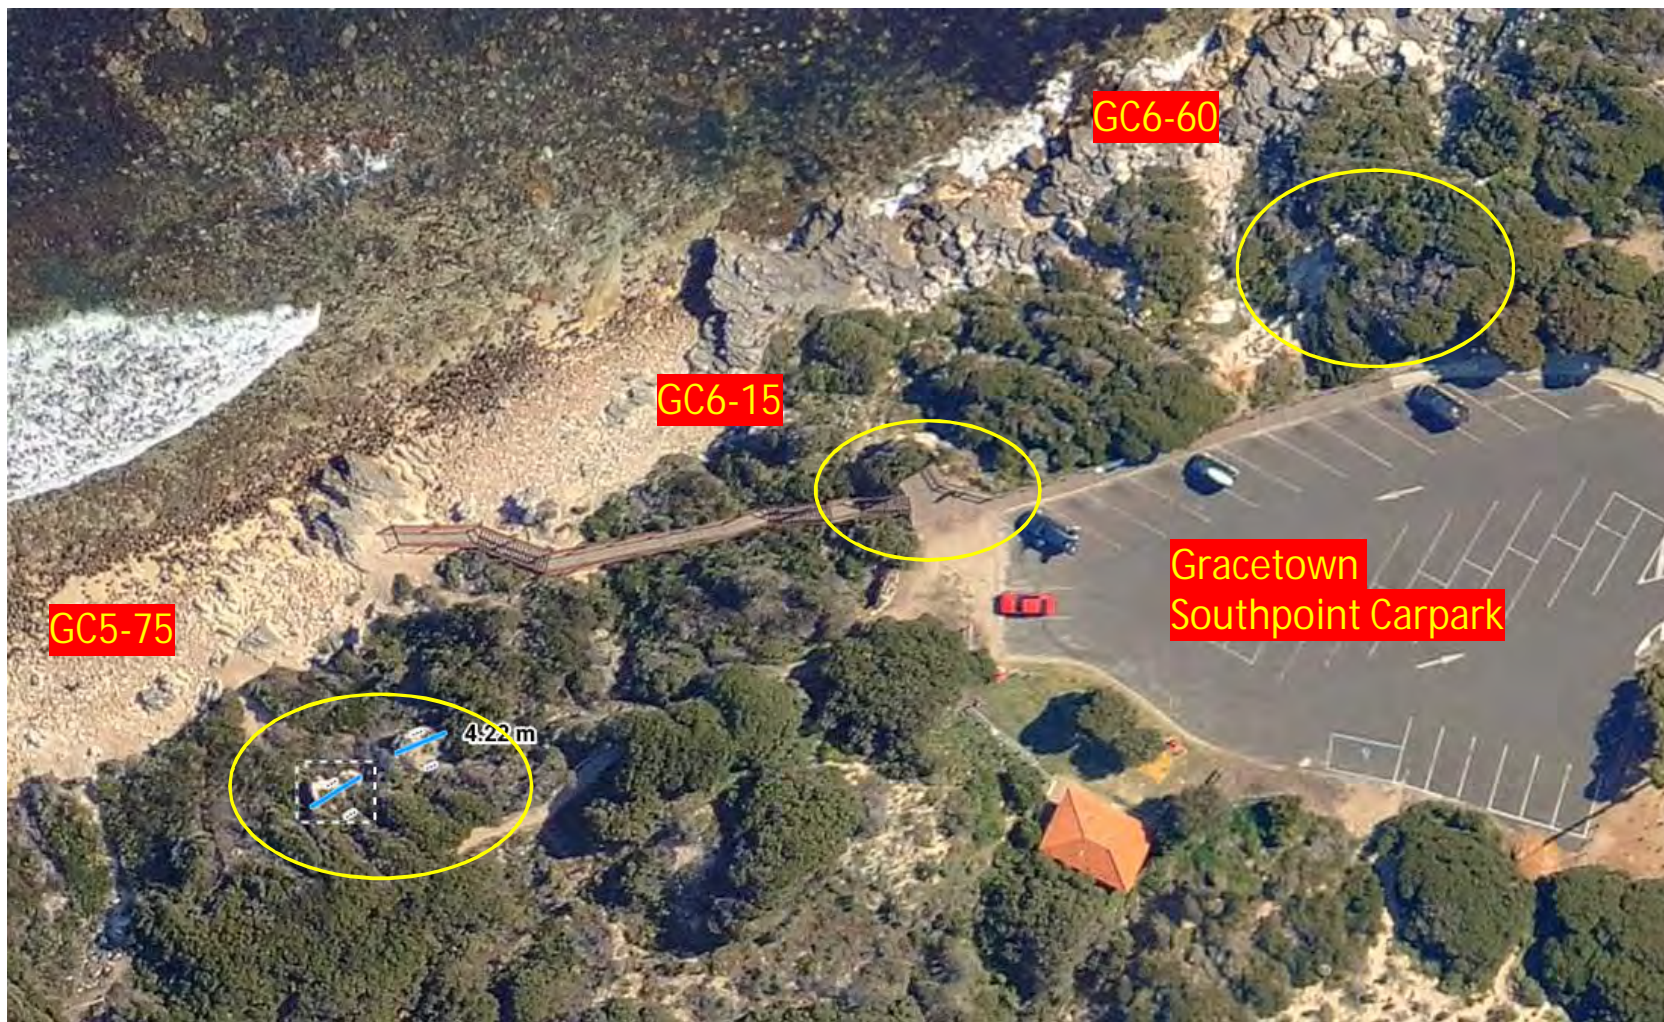
No retrogression of embayment to west of GC6-60 since 2017 is apparent. Healthy establishment of native vegetation has occurred (see photo on right)

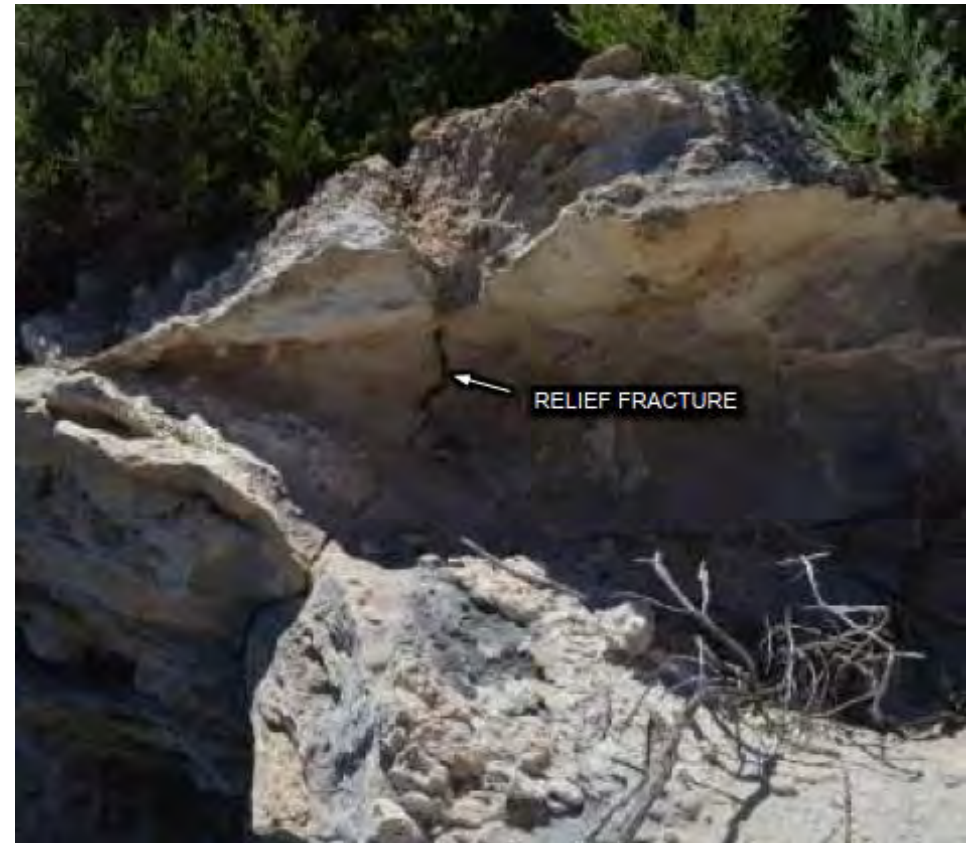
August 2019 inspection indicates little change from 2017

Fracture from Golder 2017 inspection

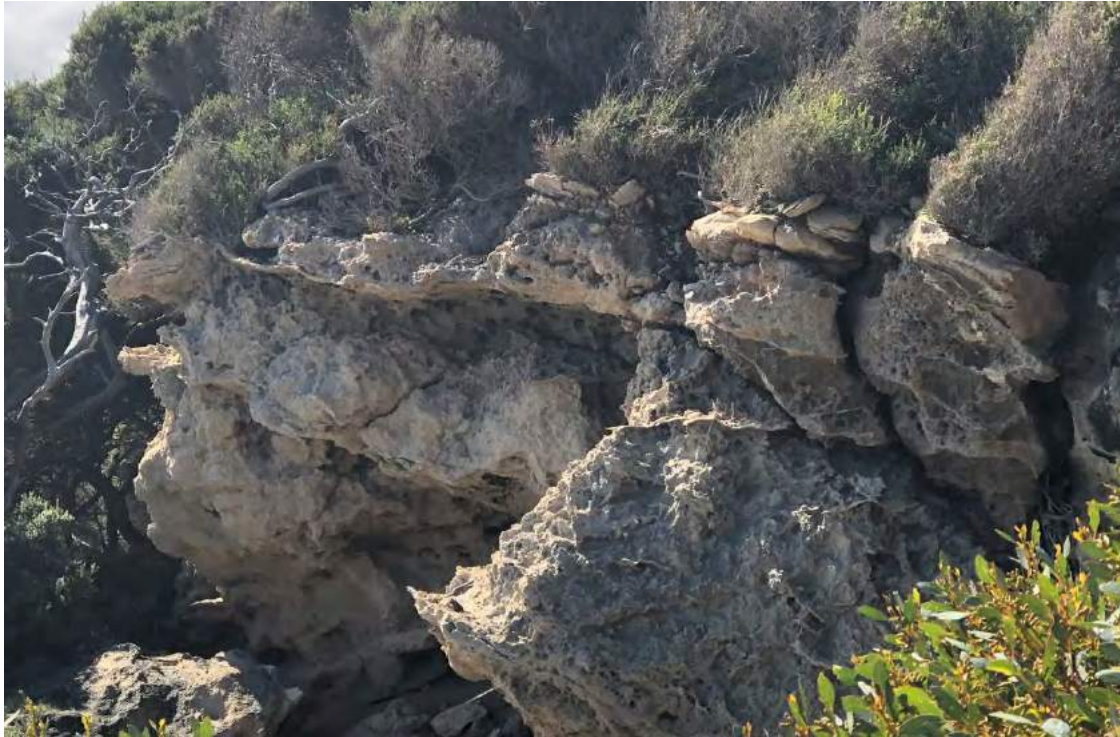
Photo from CMW August 2019 inspection little change noted from 2017

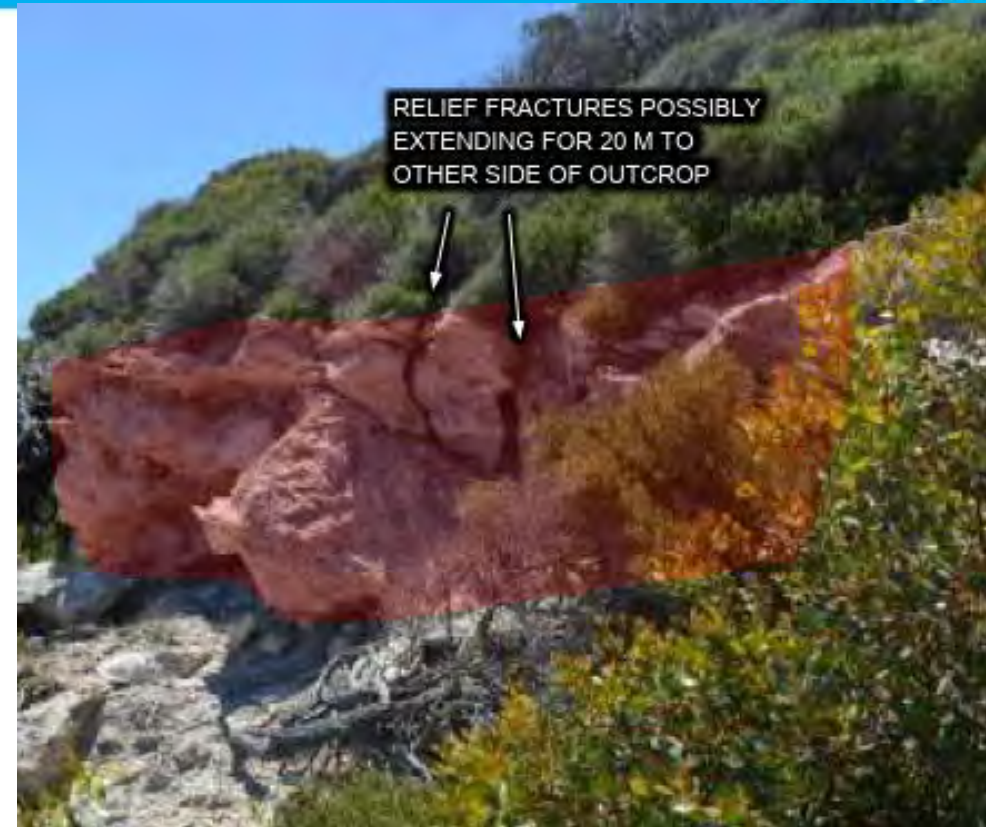
Photo from Golder 2017 inspection

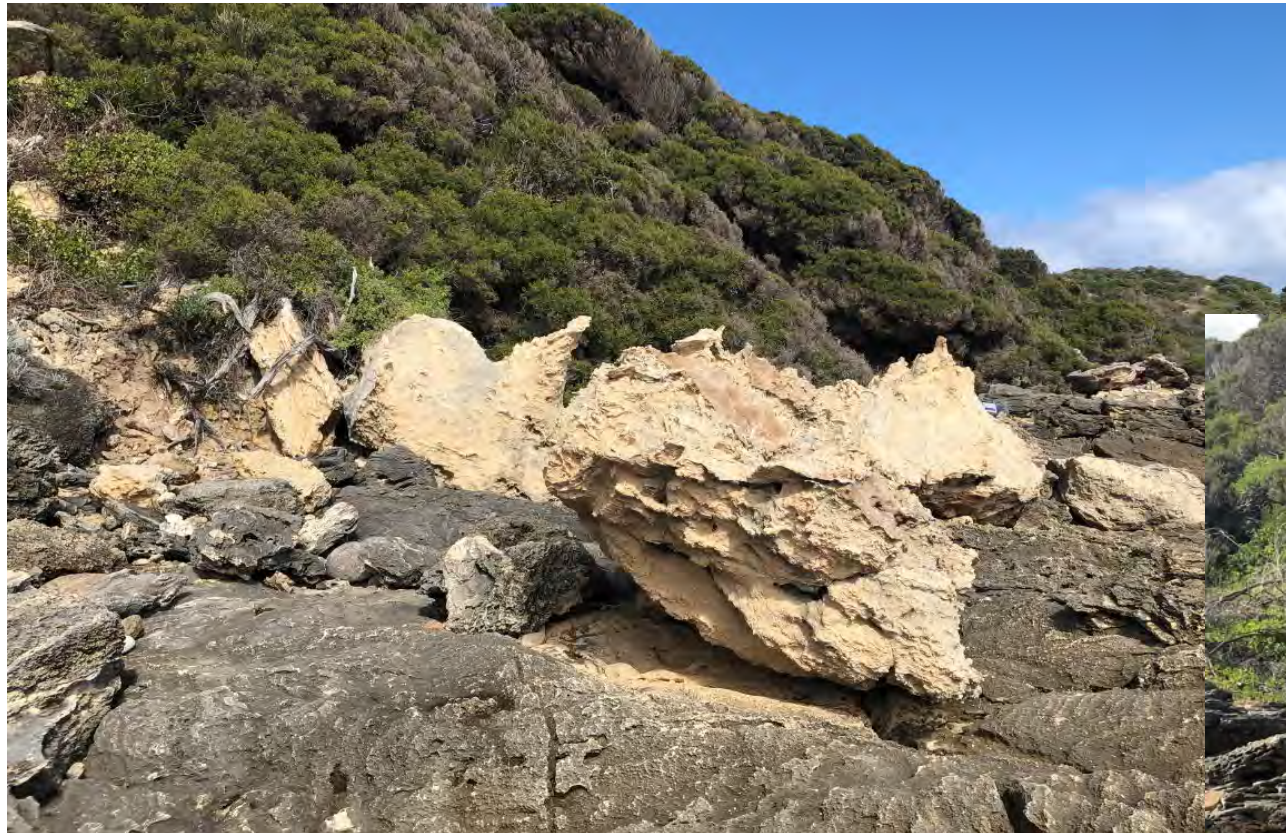
Rockfall debris still present
on wave cut platform similar
to 2017

Warning signs in place on
approaches to section of
foreshore affected by
rockfall

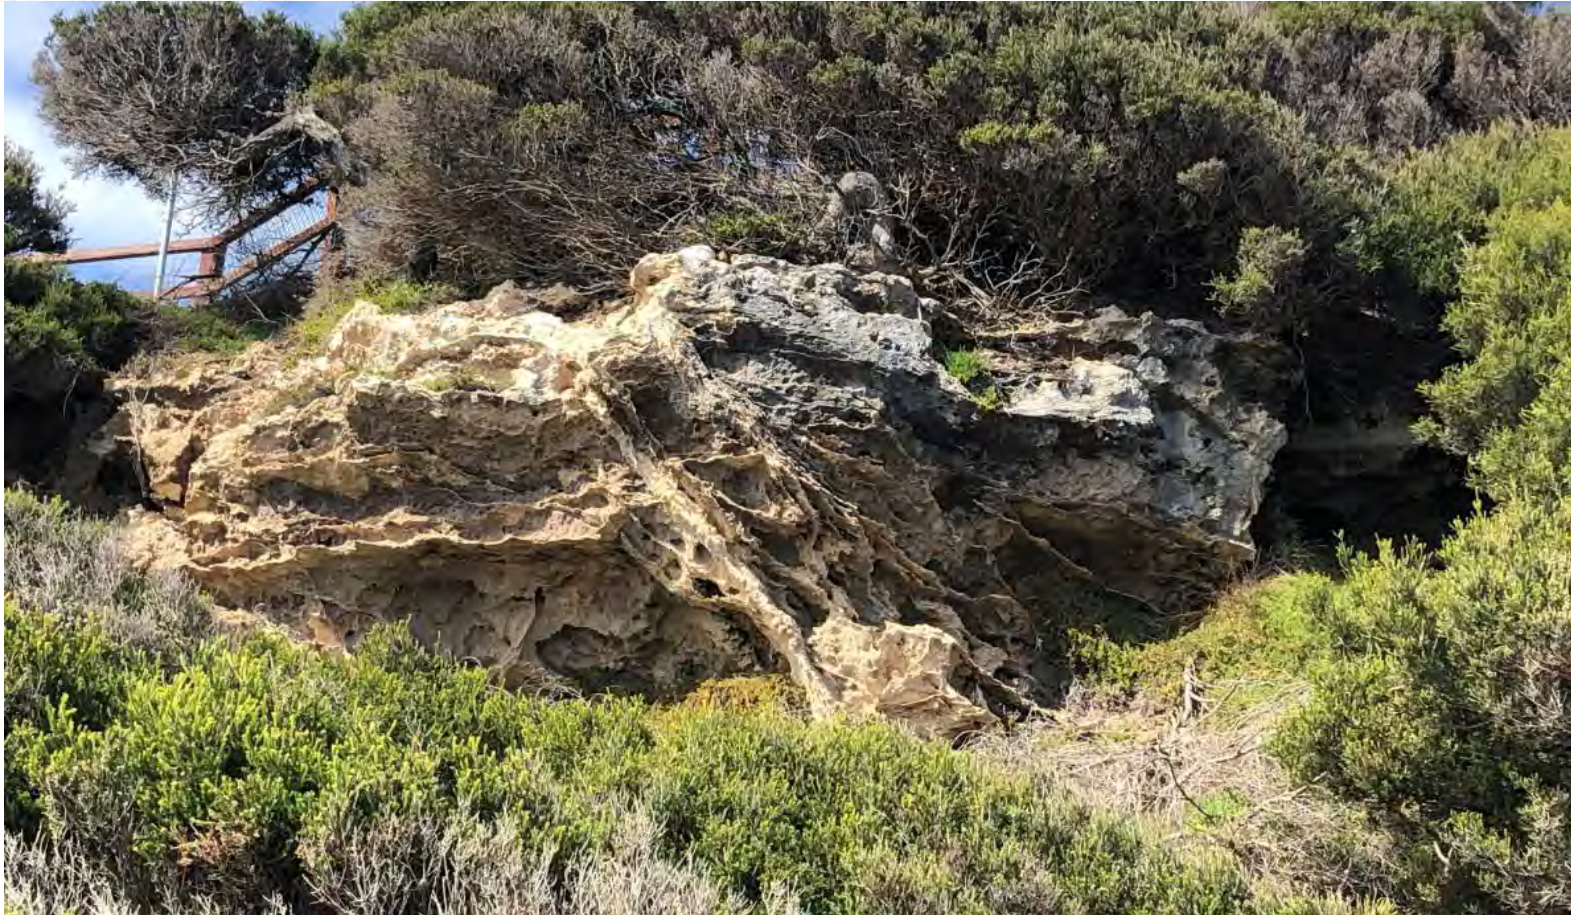
August 2019 – Undercut outcrop on which lookout formerly stood.

Following the recommendation of the 2017 report the lookout was removed.

Current (August 2019) inspection of stairs indicates the steps are not at imminent risk of catastrophic if rockfall was to occur below the steps but monitoring should still be undertaken to detect changing conditions and to maintain serviceability

At this stage it is however recommended that the stairs be visually assessed by Shire personnel every 3 months or following storm events or any reports of erosion affecting Gracetown. If individual supporting stanchions get undercut by storm and wave activity or small-scale landsliding, the stairs should be immediately closed to the public until the undercut stanchions has been underpinned and the structure levelled, if subsidence occurred as a result of the loss of support.

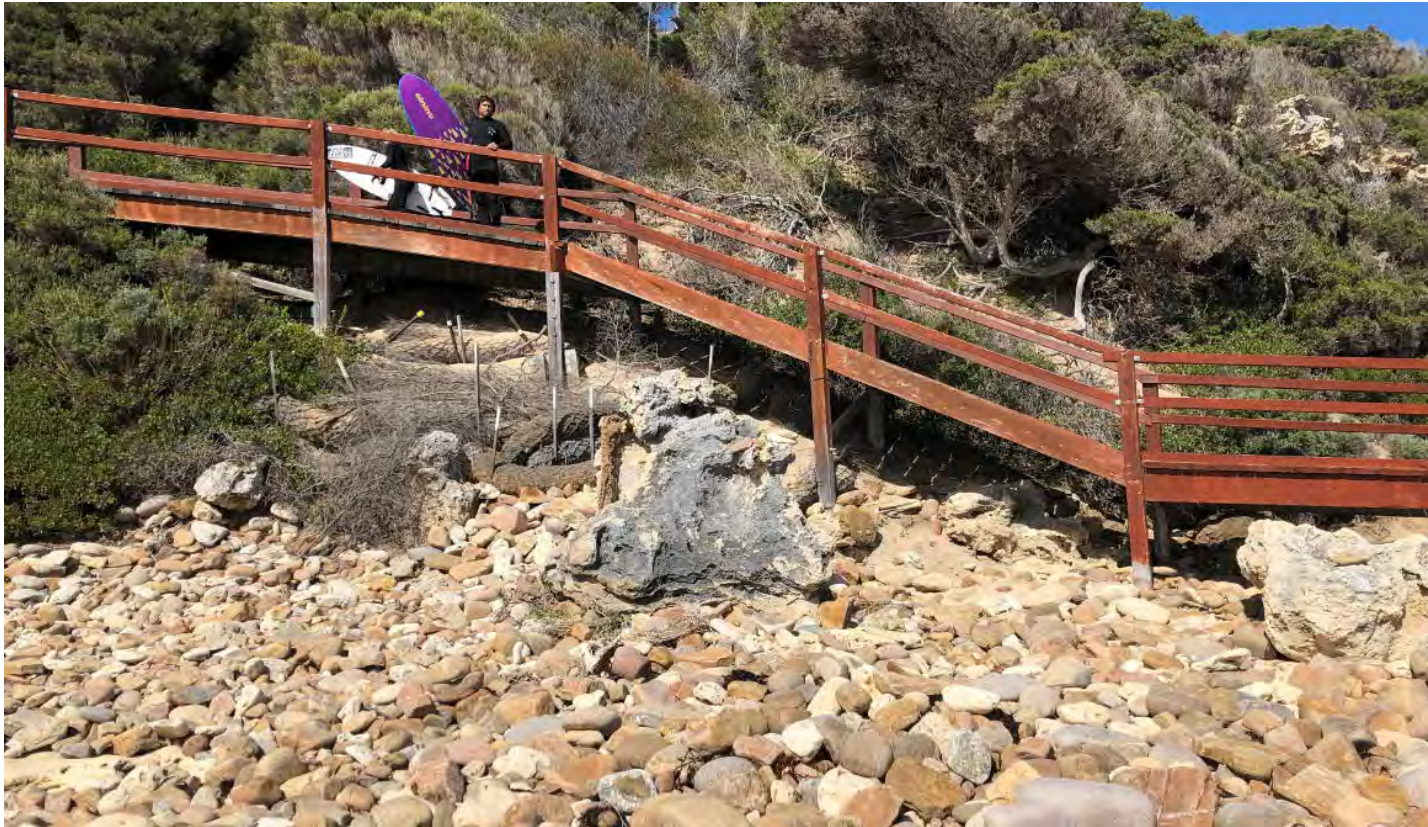
Coastal erosion undercutting some of the supporting stanchions on the lower part of Southpoint carpark stairs.

Integrity of structure requires regular monitoring to detect and act upon changing conditions to maintain serviceability.

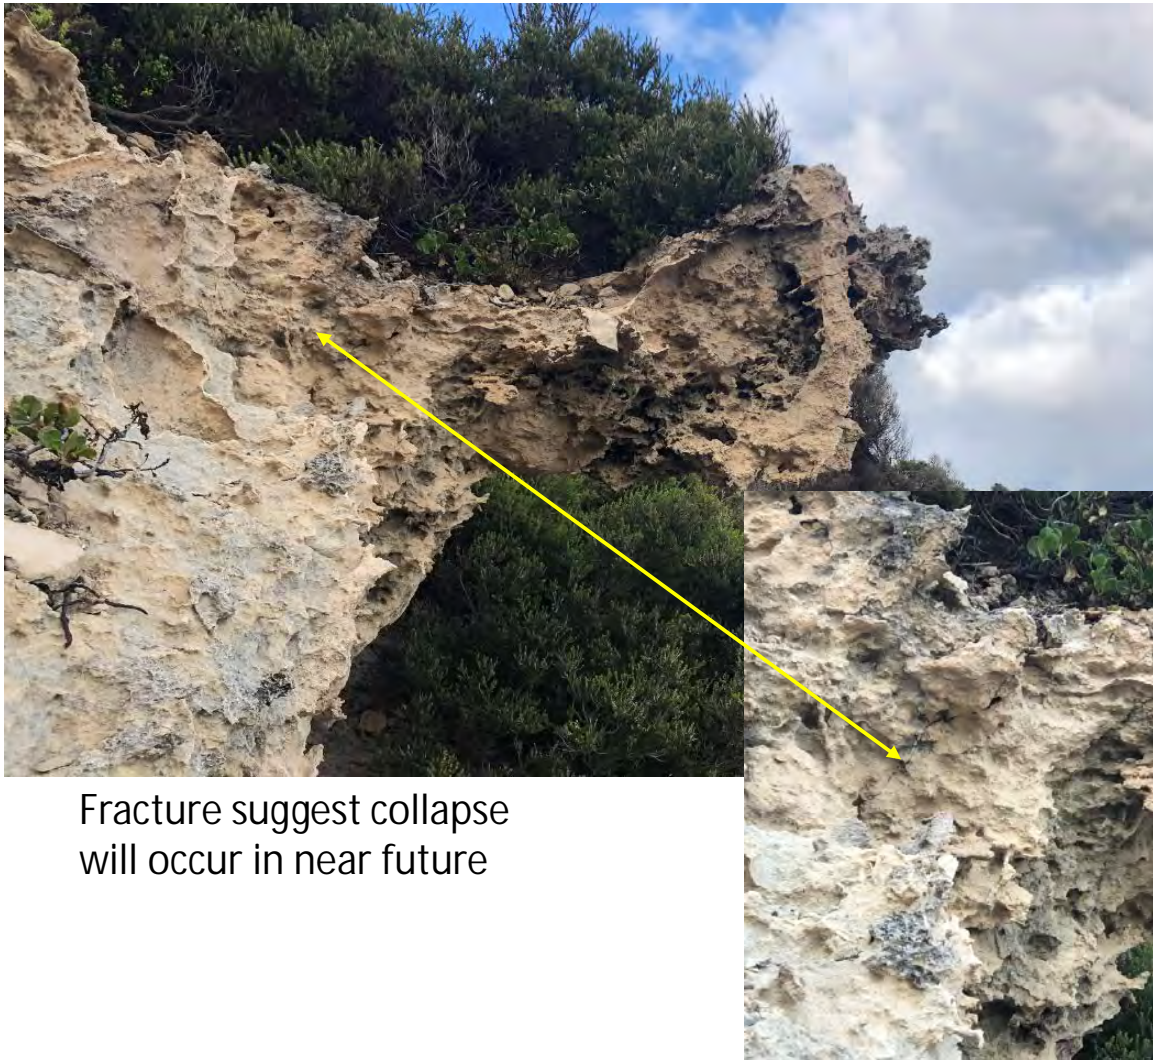
Fracture suggest collapse will occur in near future

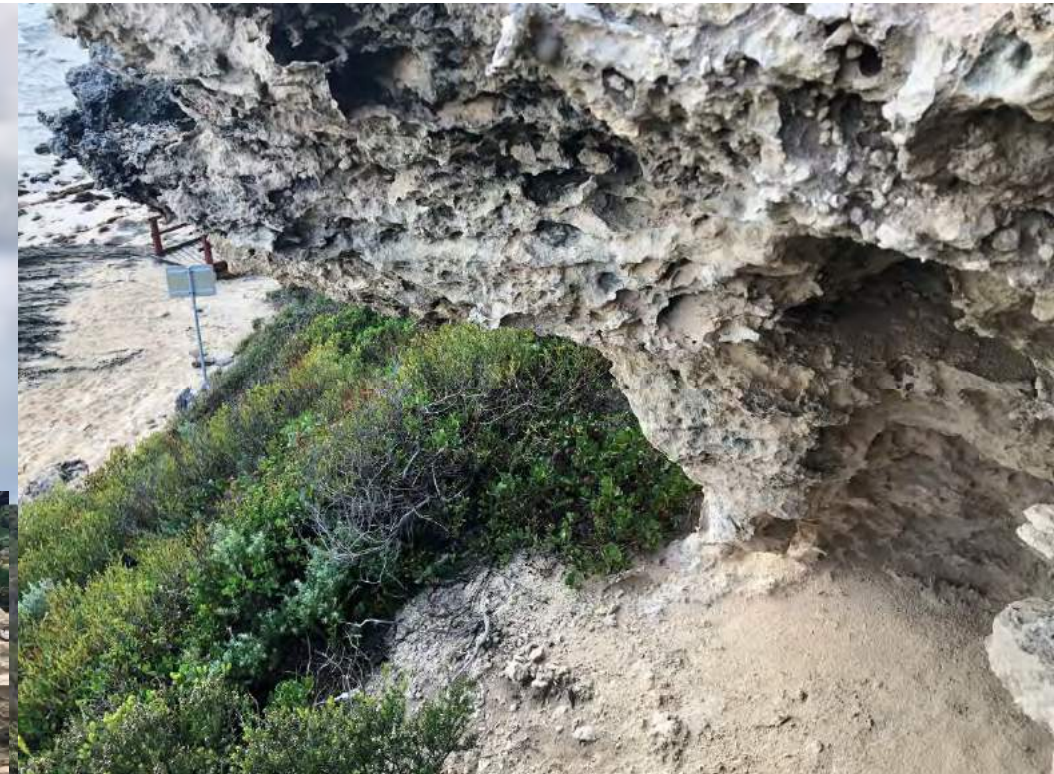
Overhang comprises two sections each approximately 5 m long and with an average overhang of about 1 m. Thickness of overhang varies from 1+m to approximately 300 mm

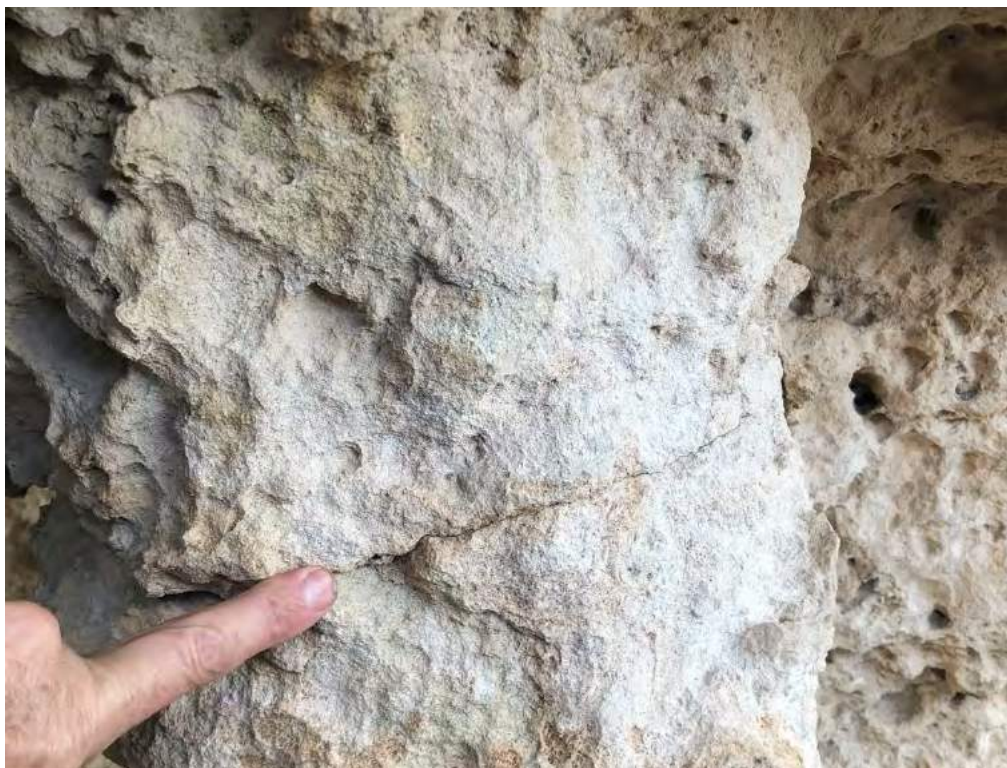
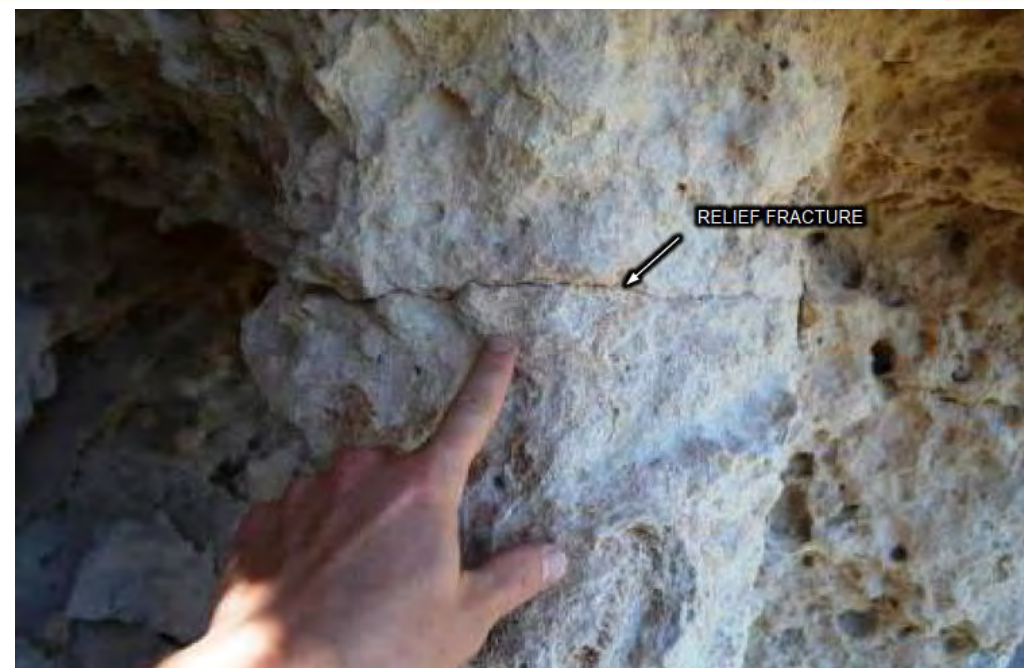
The cracks observed in Slide 9 (left image) has not substantially changed much since the Golder 2017 inspection (right image) however this could change rapidly following a storm event.

Same fracture viewed from slightly different angles Left - August 2019 Right - 2017

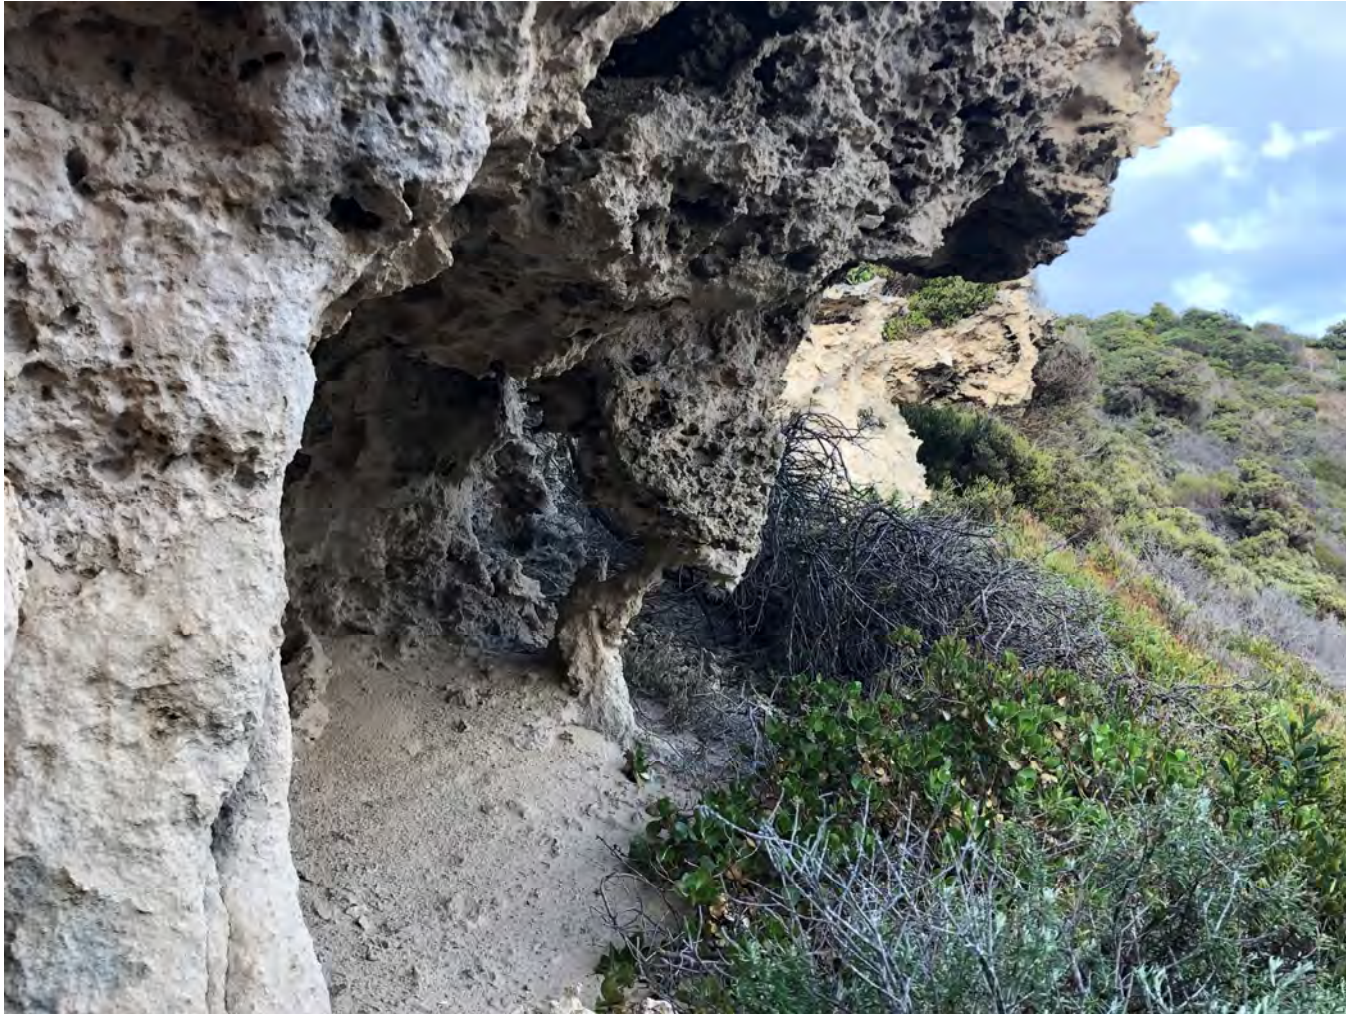
General nature of overhang which will require controlled collapse by needle drilling from above to define controlled breakaway line (approximately 10 metres (plan) require collapsing

- i) Once the upslope hazard has been collapsed, inspect debris to ensure it is secure and not likely to roll or be dislodged and become another hazard. If necessary, hand bar debris to base of slope.

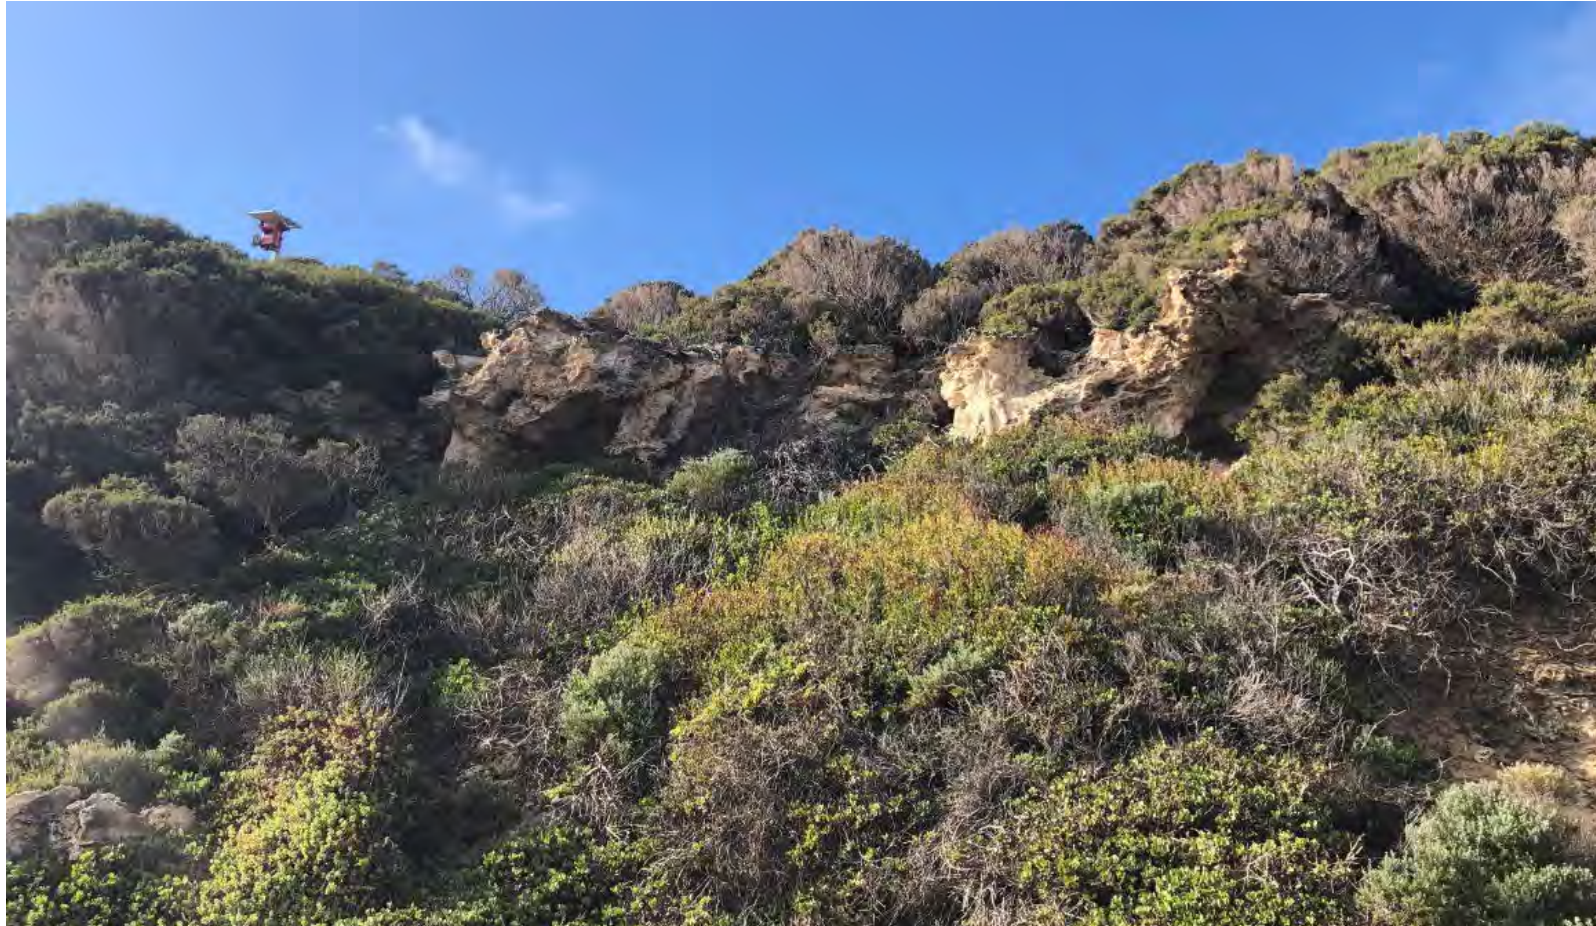
- Access to GC5-75 is difficult from below. Pedestrian access will be required however to
- a) survey overhang and establish points to needle drill and,
 - b) b) to fragment and bar down fallen rock that does not roll to base of slope

Access to top of overhang will be via footpath to South Point and will be pedestrian only. Some cutting of scrub between footpath and edge of overhang will be required. Anchor points for safety harness will need to be established and a line set out defining the overhang and no-go zone so no personnel stand or work in the no-go zone.

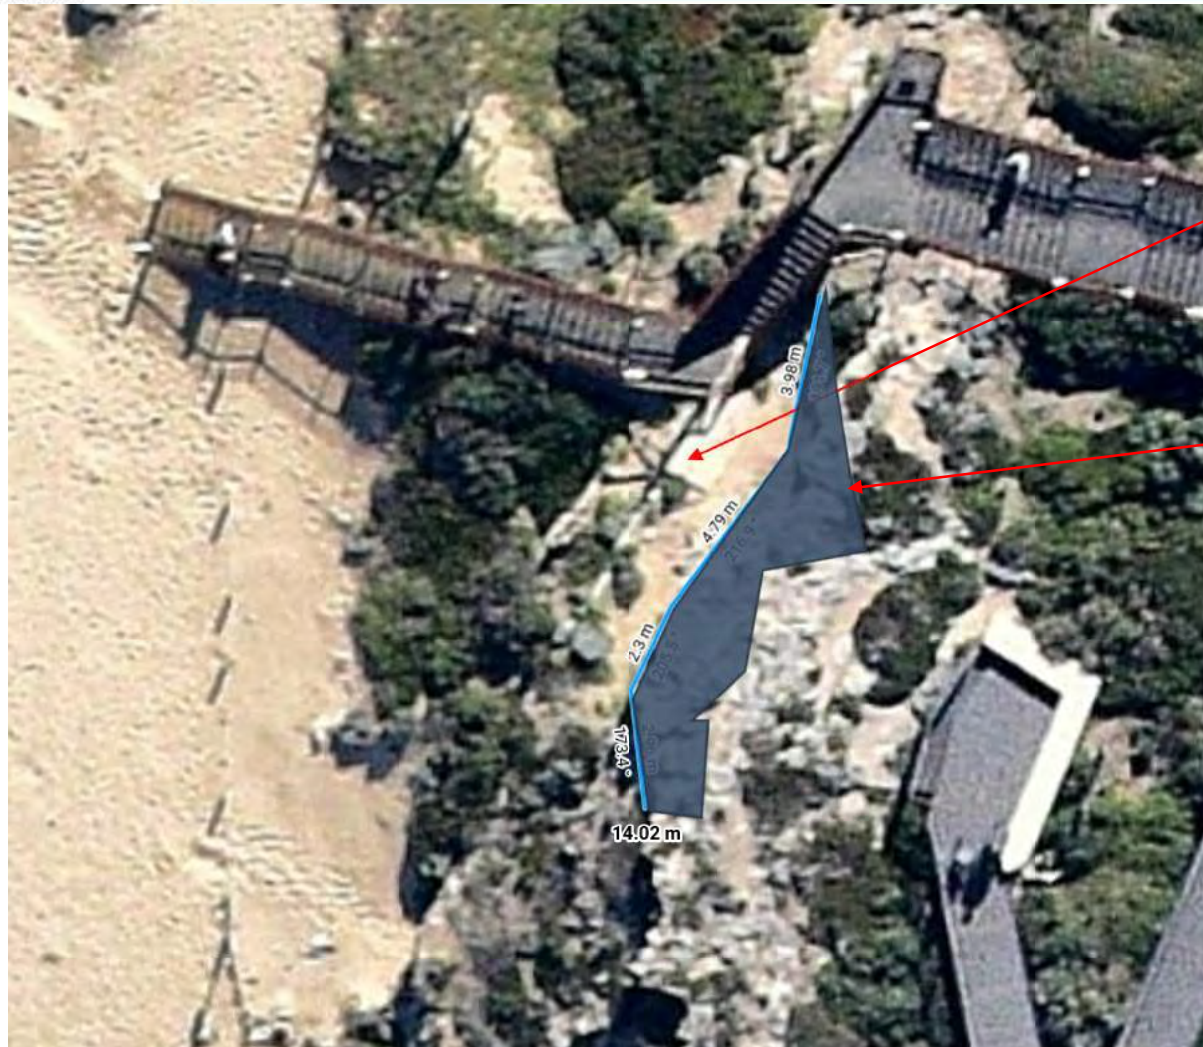
Lower lookout and bench removed since 2017

Approximate extent of undercut block caused by wind eroding out leached limestone/sand layer

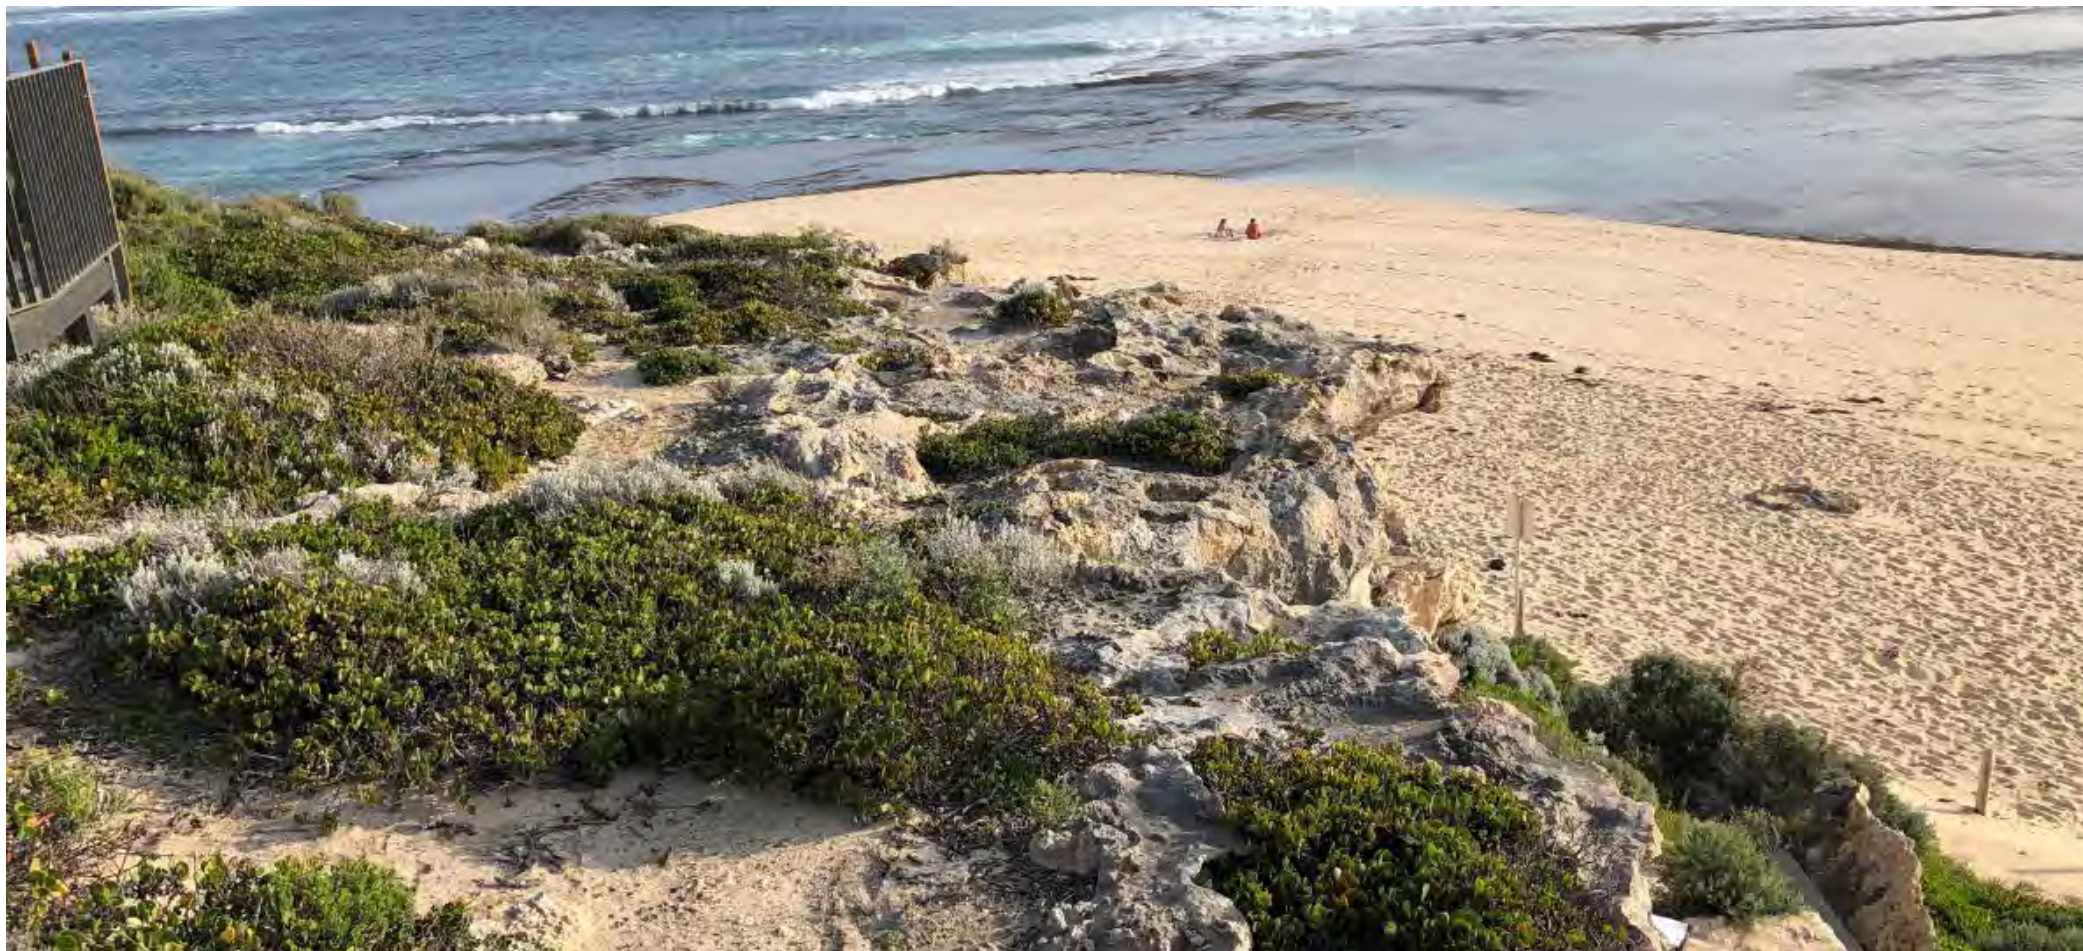
Flat area above overhang used unofficially by spectators and cameramen during surf events

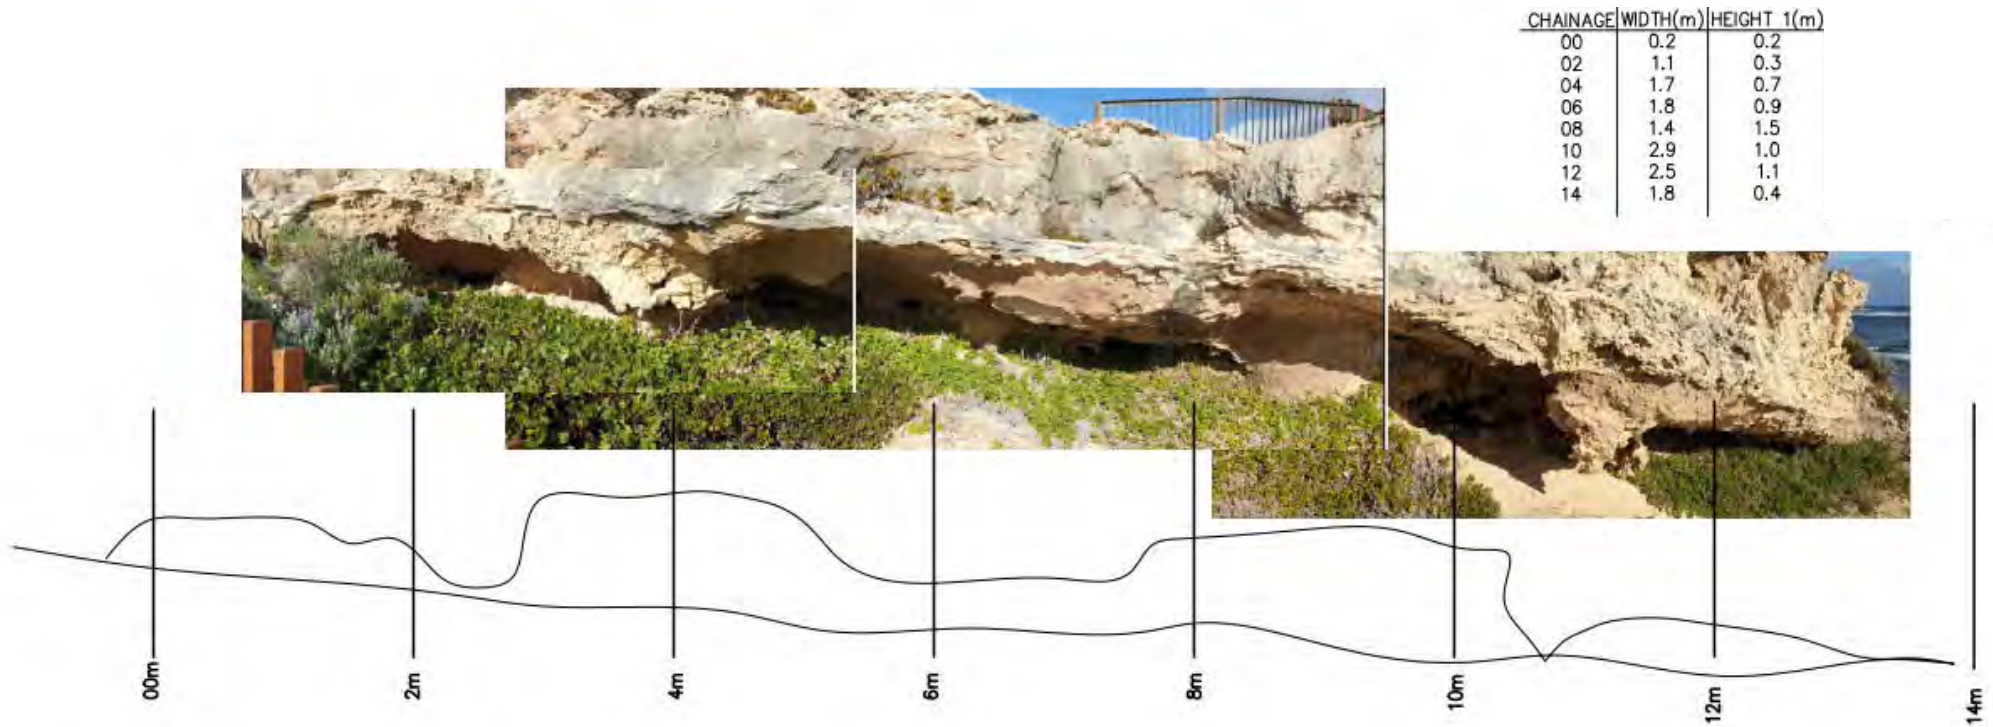
Overhang is approximately 14 m long, generally between 0.2 and 2.9 m wide (deep) (locally measured to be 3.5 m deep) with a height along outside face between 0.2 and 1.5 m tapering rapidly to a narrow slot a few centimetres high.

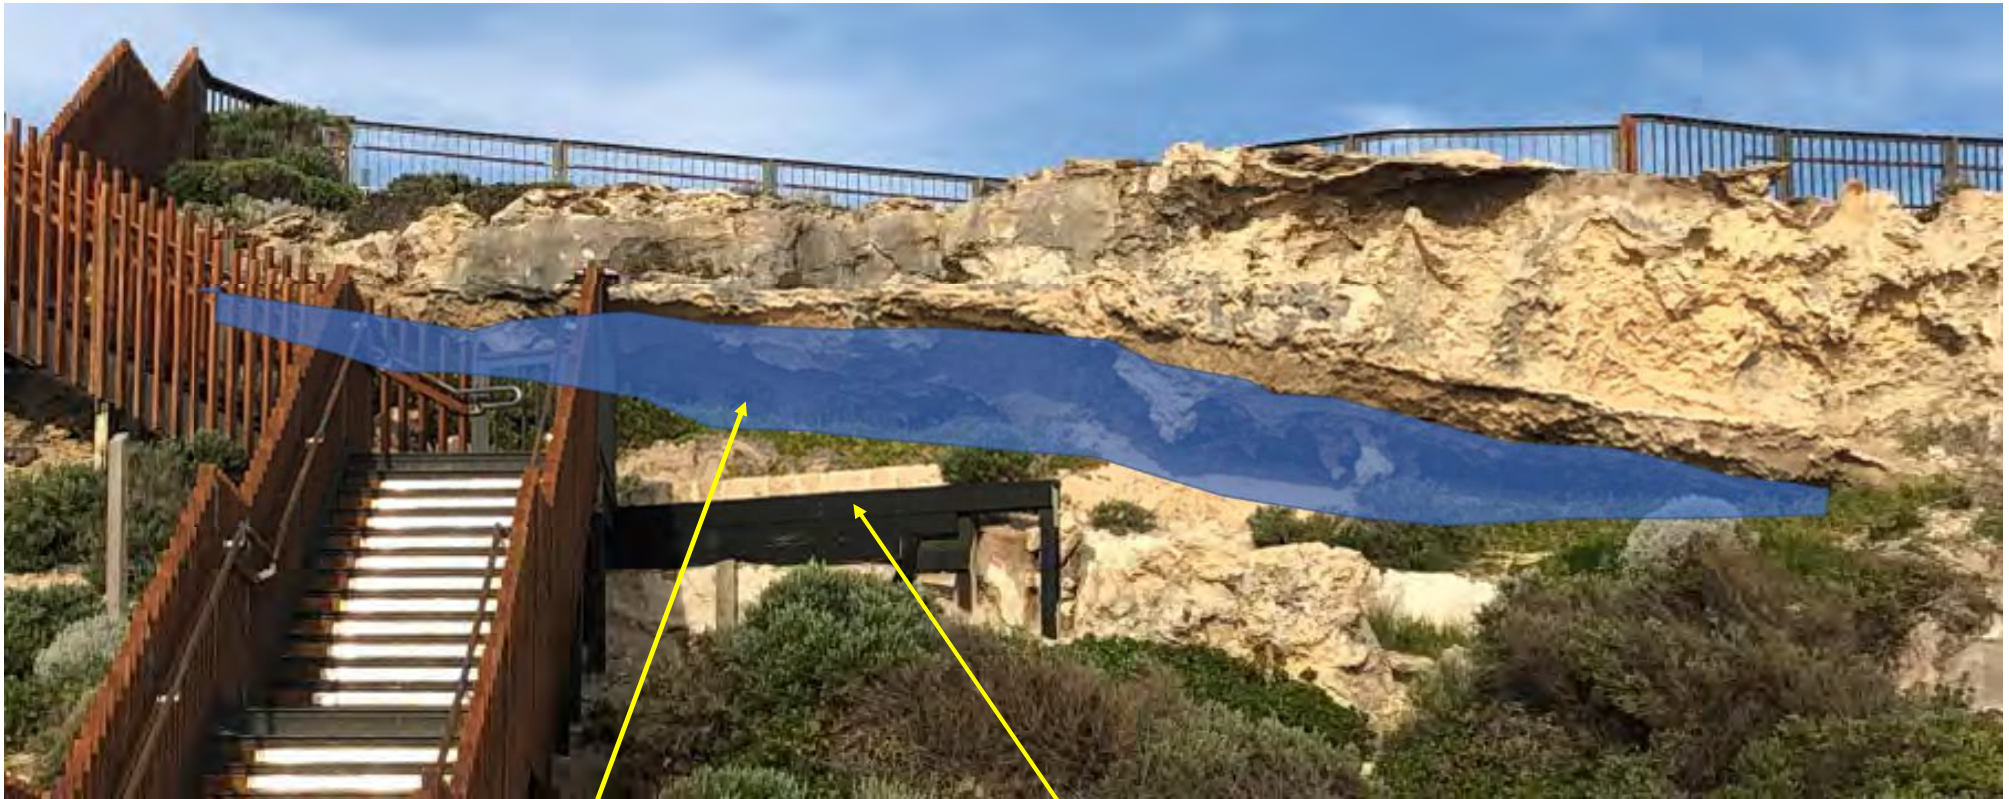
Remnant of former
lookout and bench
platform

Approximate extent of
underpinning with architecture
limestone blockwork facing

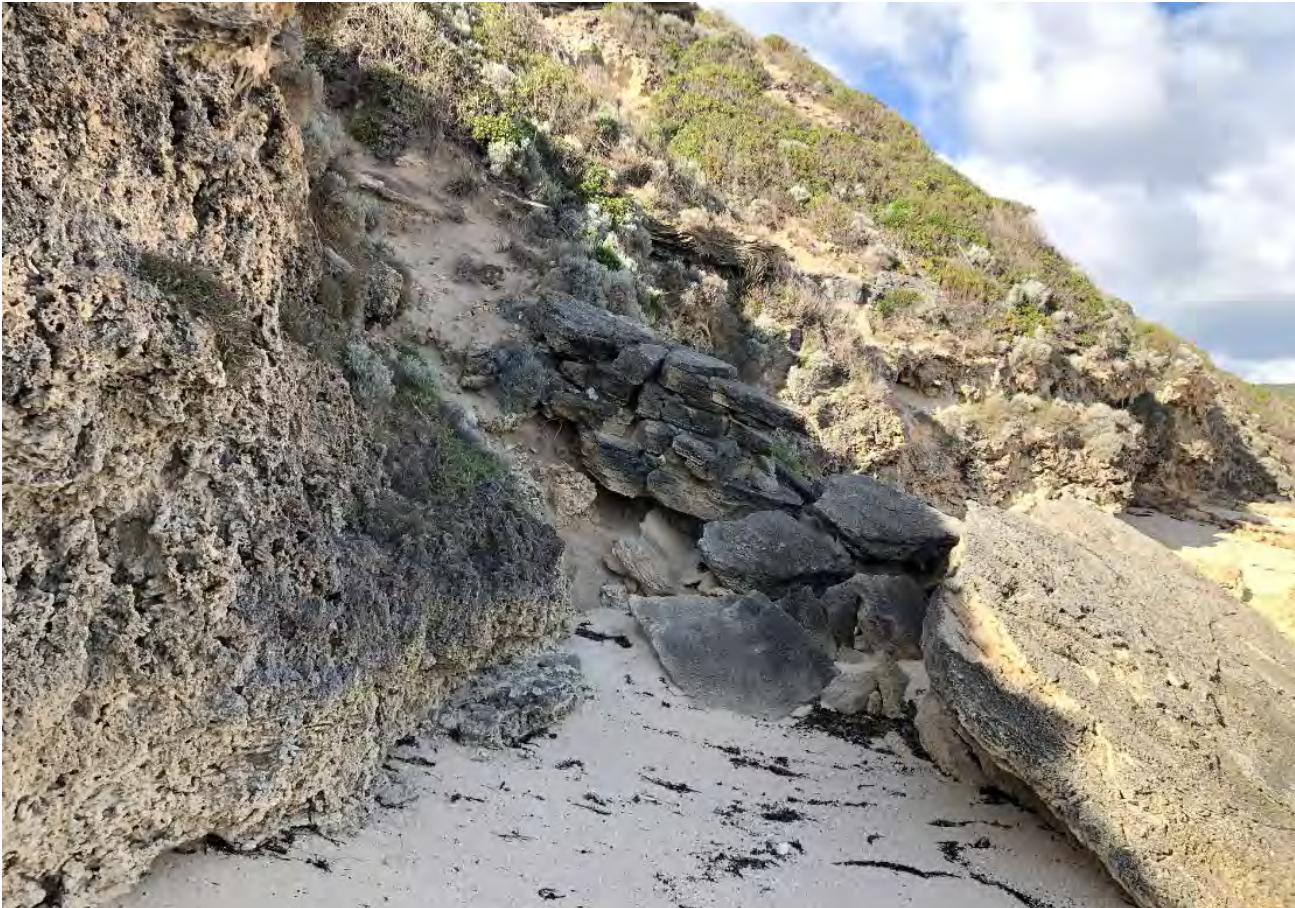
Although this rockfall was illustrated in the Baynes Geologic Report dated 2006 it serves to illustrate the large scale of rockfalls
