LIMESTONE STABILTY ASSESSMENT

**GRACETOWN, PREVELLY, GNARABUP, WESTERN
AUSTRALIA**

**INSPECTION, RISK ASSESSMENT AND
REMEDIATION DESIGN REPORT**

PER2019-0229AA Rev 1

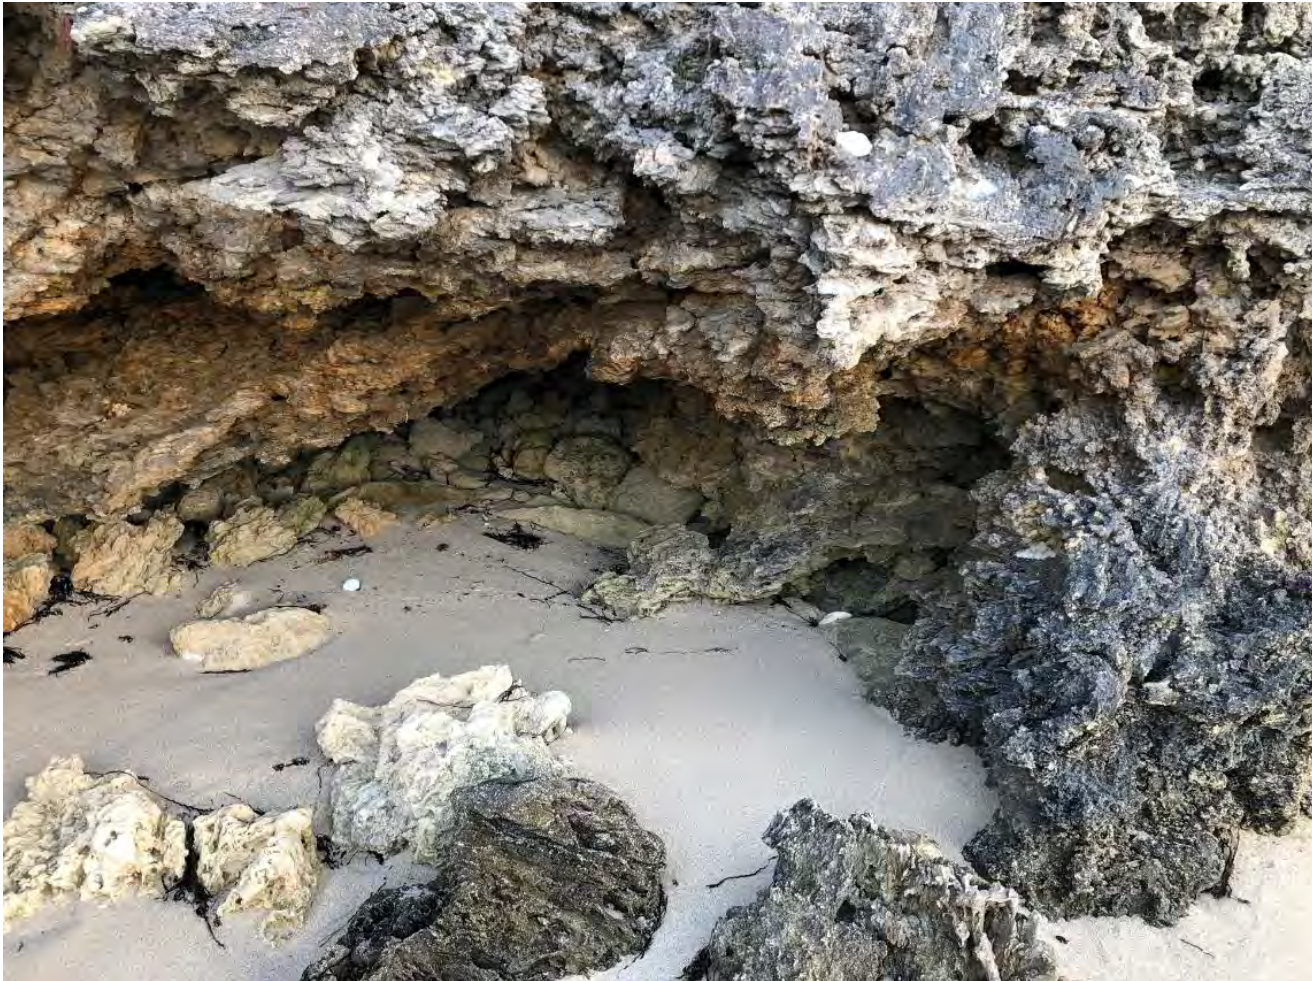
Several processes are occurring. The small cliff at the base of the slope is being undercut (refer Slide 23). Wind erosion is impacting the middle part and upper parts of the cliff/slope allowing more sandy horizons to be eroded and more resilient limestone horizons become undercut. From these undercut strata, blocks of limestone eventually topple and slide down to the beach running out onto the beach some 8 to 10 m. The block noted on Slide 21 and Slide 22 is an example. There is a block above the northern part of Riflebutts beach that is severely undercut and could topple and slide onto the beach (refer Slide 26). Slide 26 illustrates the mechanism and the potential run-out zone. With this degree of run-out it is not possible to simply isolate the upper part of the beach from the public. This because all of the beach at high tide and the majority of the beach at low tide would all within the impact/run-out zone.

Undercutting of cliffs on normal tides/conditions likely to result in collapse of several cubic metres in near future. White rock indicate recent falls

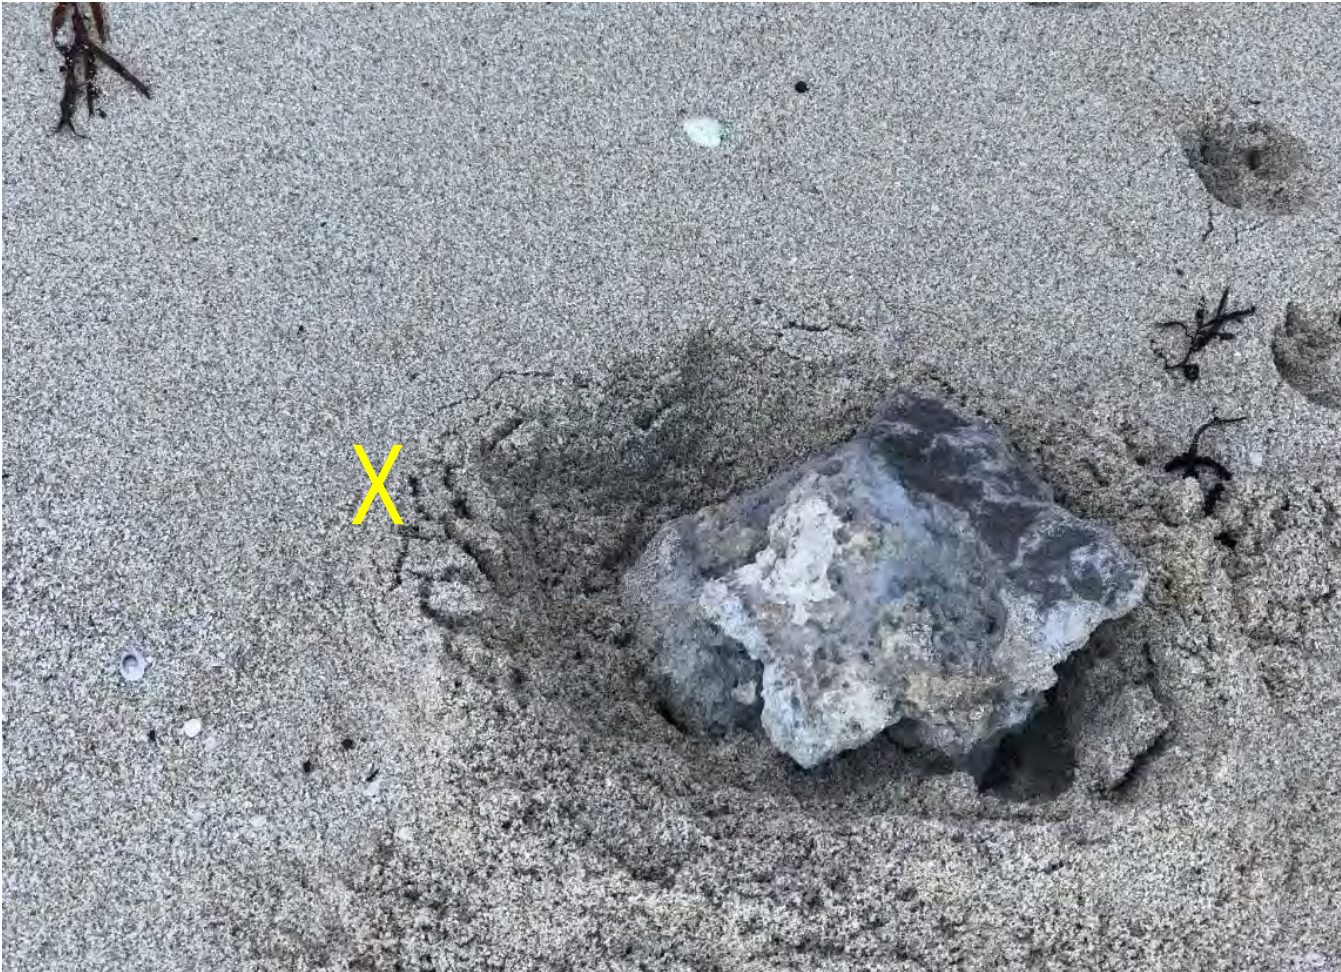
The exposure of this beach to rockfall can be noted by a 400 mm boulder (refer Slide 24) that evidence suggests fell only minutes prior to the joint CMW/SAMR inspection on Tuesday 20 August 2019, carried out to discuss options.

Very fresh impact crater from boulder size rockfall that occur a very short time before a joint CMW/SAMR inspection of the cliffs on 20 August. It clearly occurred since the tide went out however cracking in sand marked X is very fresh

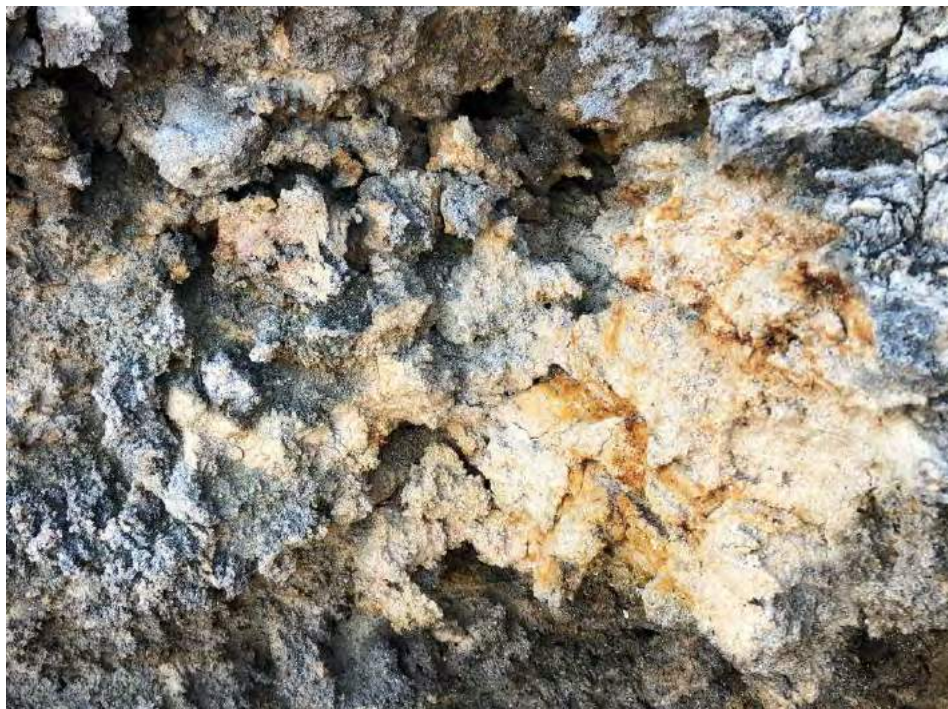
Highly leached and friable rock mass.
Yellow colouration indicates materials has recently broken away from cliff

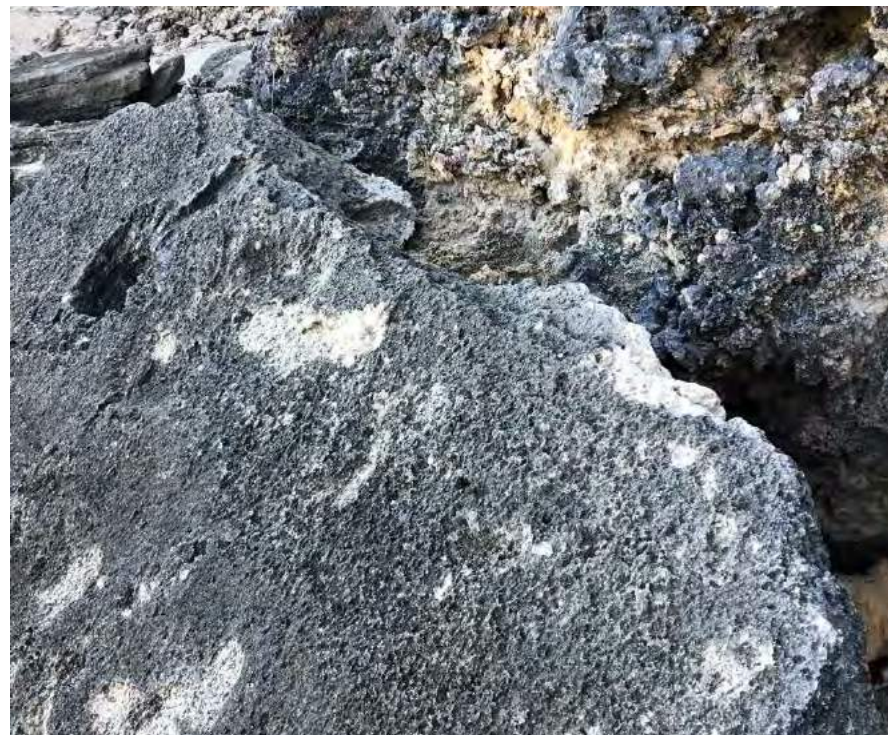
White scuff marks where cobbles and boulders have recently impacted a fallen block and ricocheted onto the beach

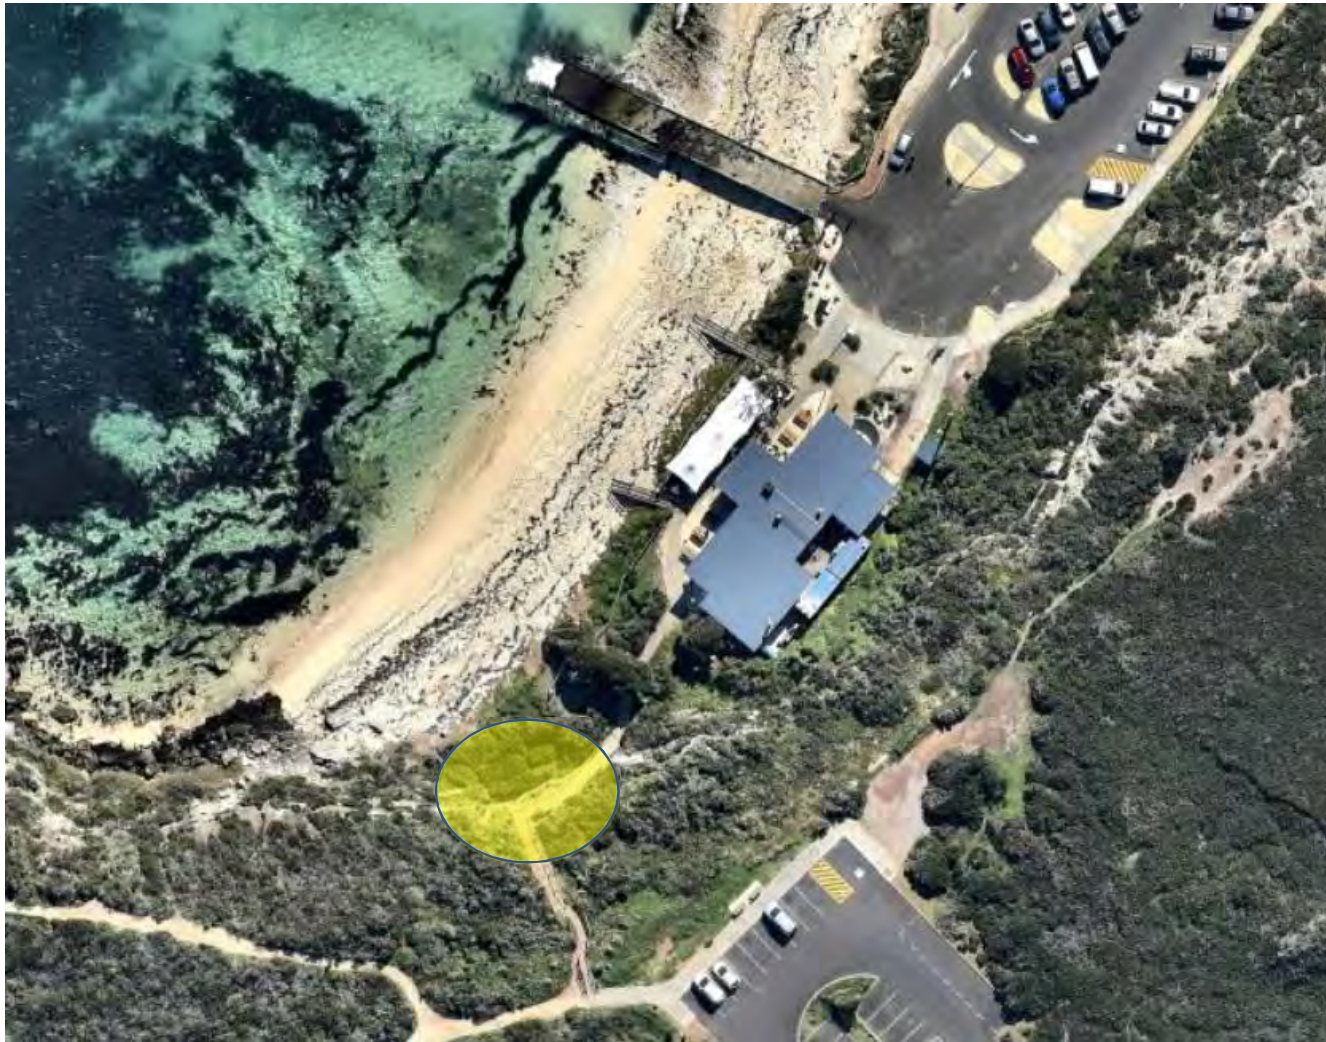
Undercut to steps leading down from carpark to White Elephant Café highlighted in this August 2019 Nearmap Image

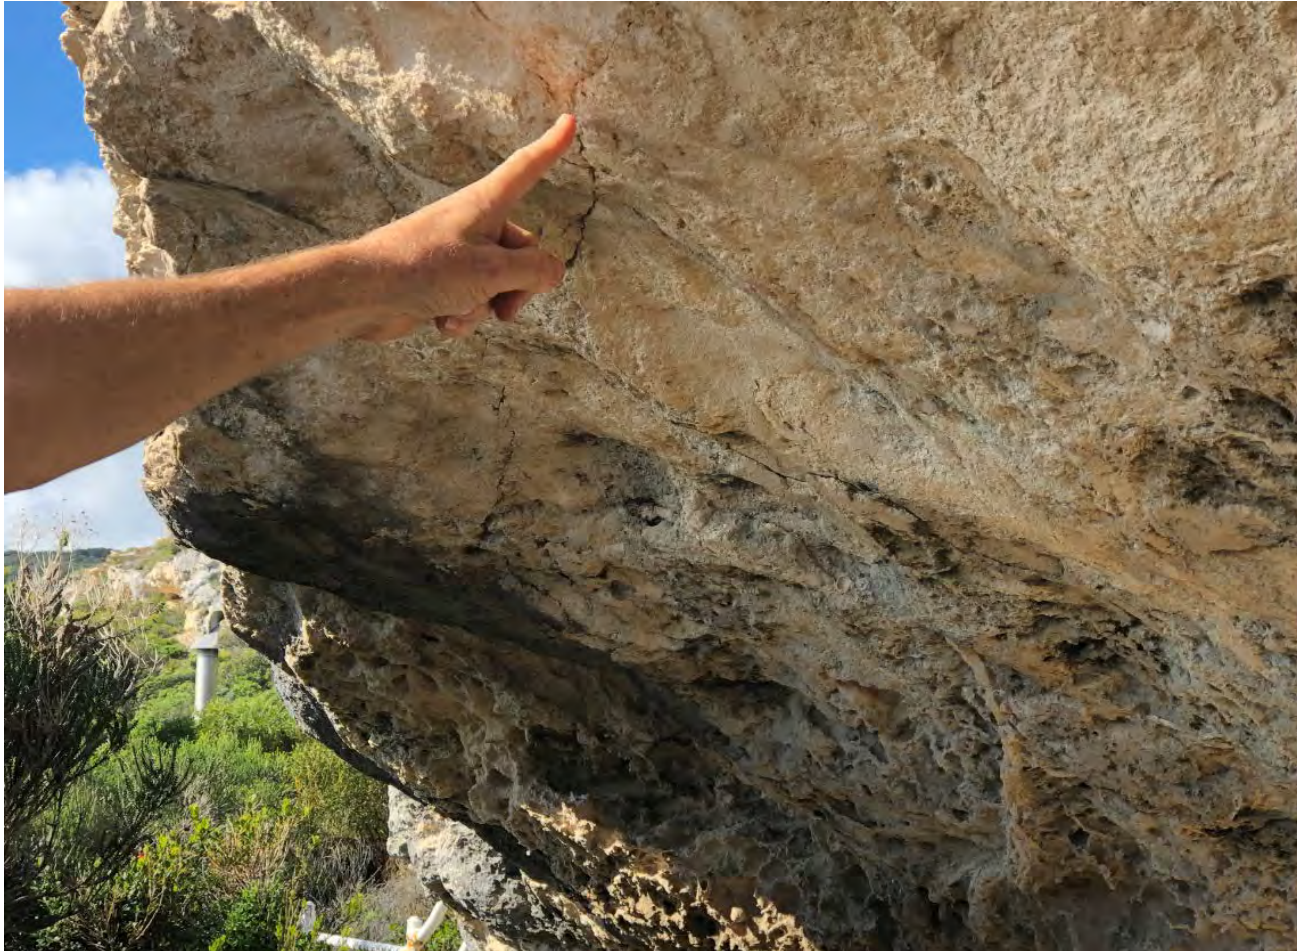
Crack could allow a small slab to breakaway from overhang

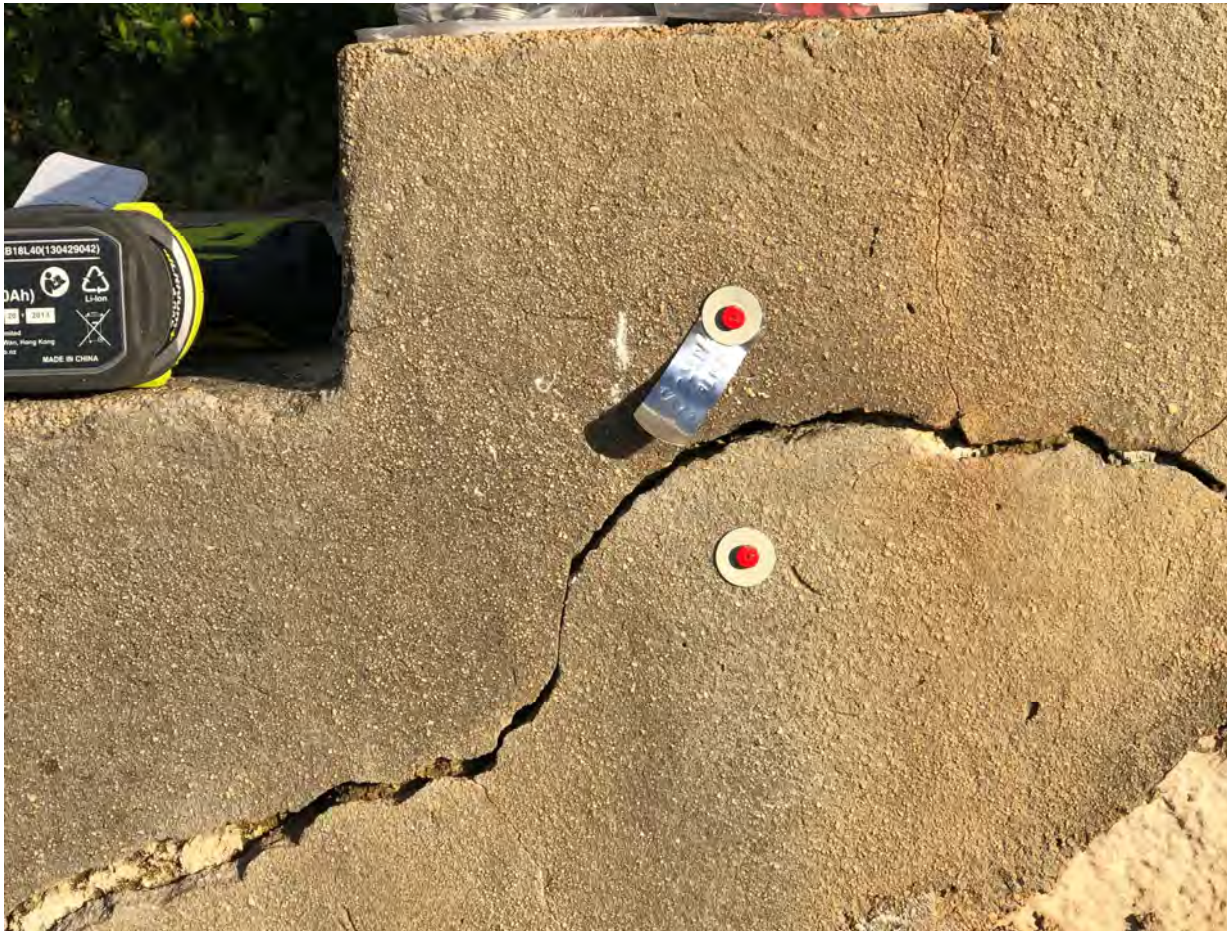
Survey nails at Site 2

Separation should be measured each survey. Separation (centre to centre) on 11 October 2019 was 101 mm and crack width at nails (6 mm) indicating 6 mm of subsidence to wall beneath stairs
