LIMESTONE CLIFF RISK ASSESSMENT

**GRACETOWN, PREVELLY, GNARABUP, GRUNTERS,
WESTERN AUSTRALIA**

INSPECTION AND RISK ASSESSMENT

PER2021-0300AB Rev0

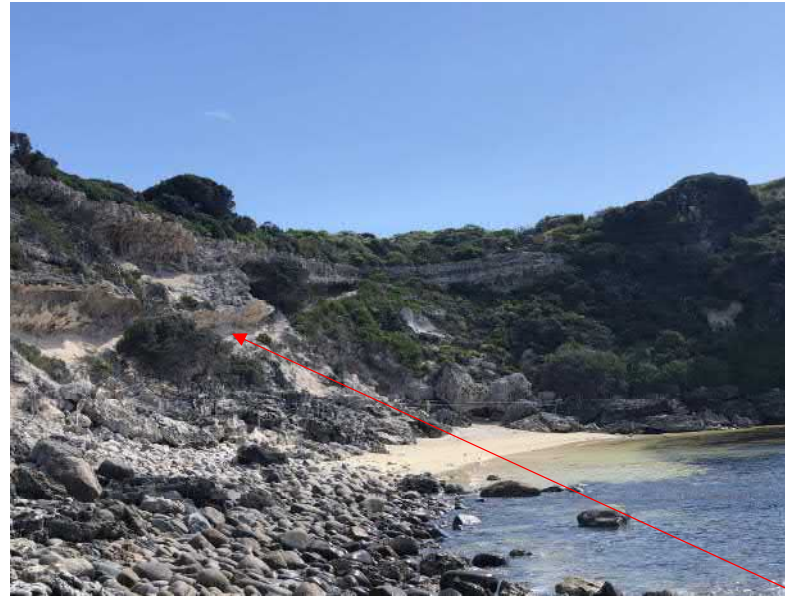
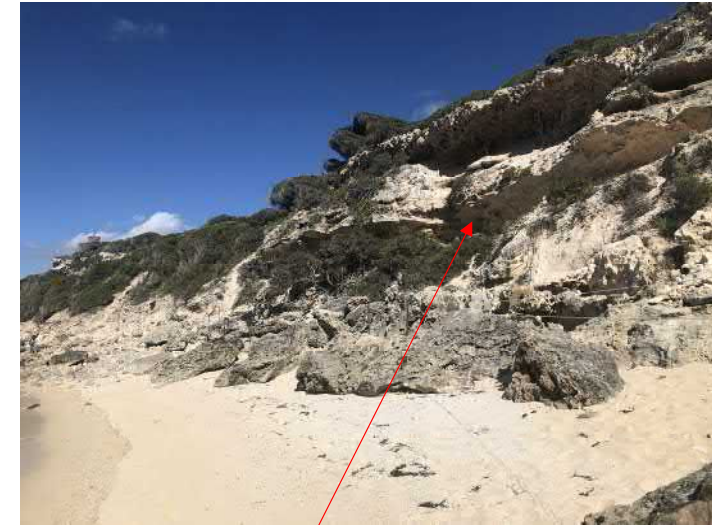
Cliff overhang – Level of Risk to Individual Most at Risk (R_{DI}) increased due to coastal erosion at east end of Huzzas Cliff
Nov 2021 $R_{DI} = 4.3 \times 10^{-6}$

Improve fencing including extending eastwards to prevent access to area of recent coastal erosion and moving further away from hazard (refer Slide 3). Add a 'Rockfall hazard sign' also include information signson approaches to Huzzas cliff from both directions (refer Slide 4 for approximate positions)

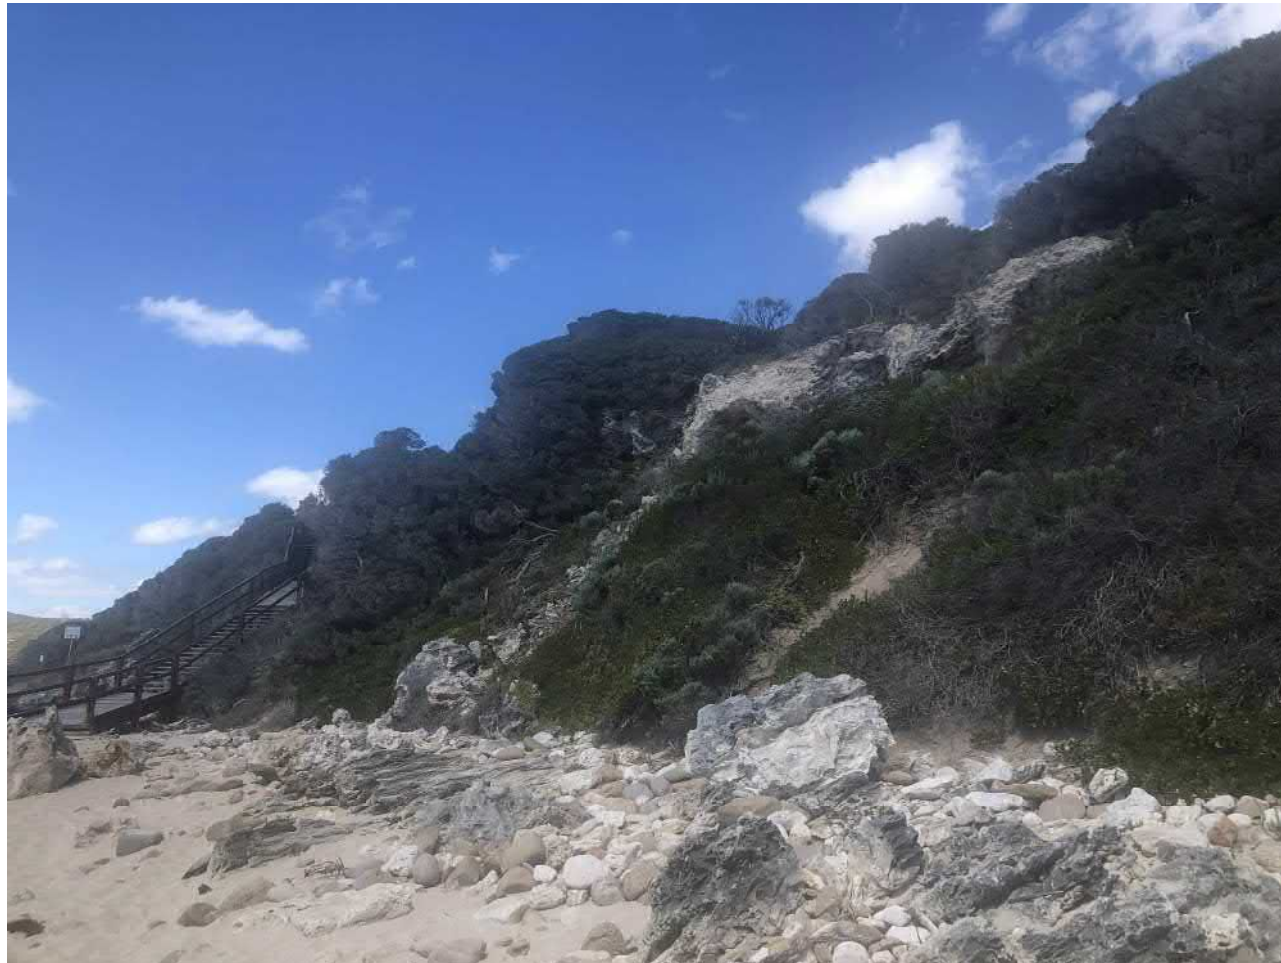
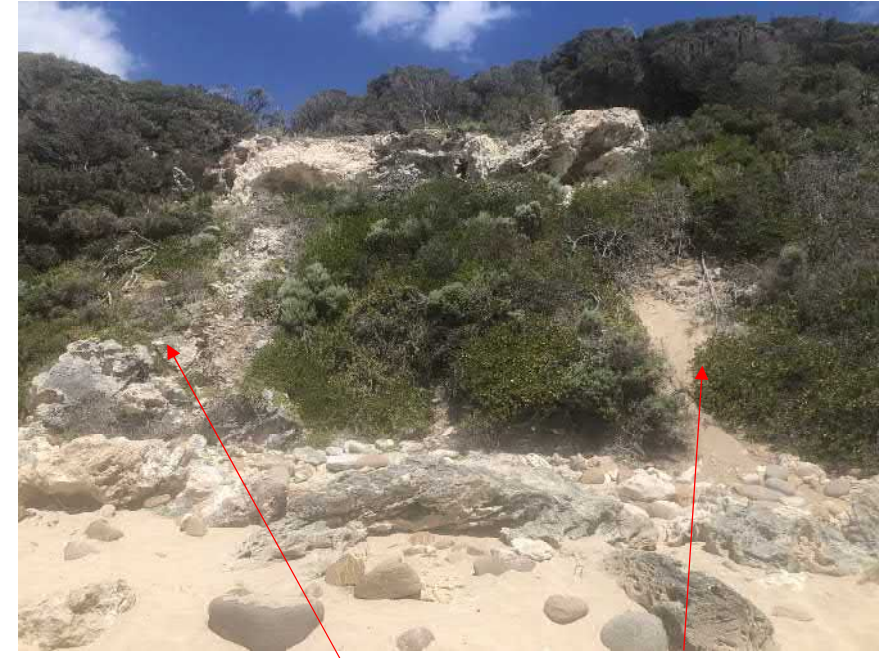
Remedial works (removal of overhang) occurred in May 2020, subsequently the Level of Risk to Individual Most at Risk (R_{DI}) has reduced to 1.2×10^{-7}

Recommend that brushwood is placed at these locations to encourage vegetation regrowth and discourage people climbing or descending the slope creating further erosion and putting themselves in the hazard area

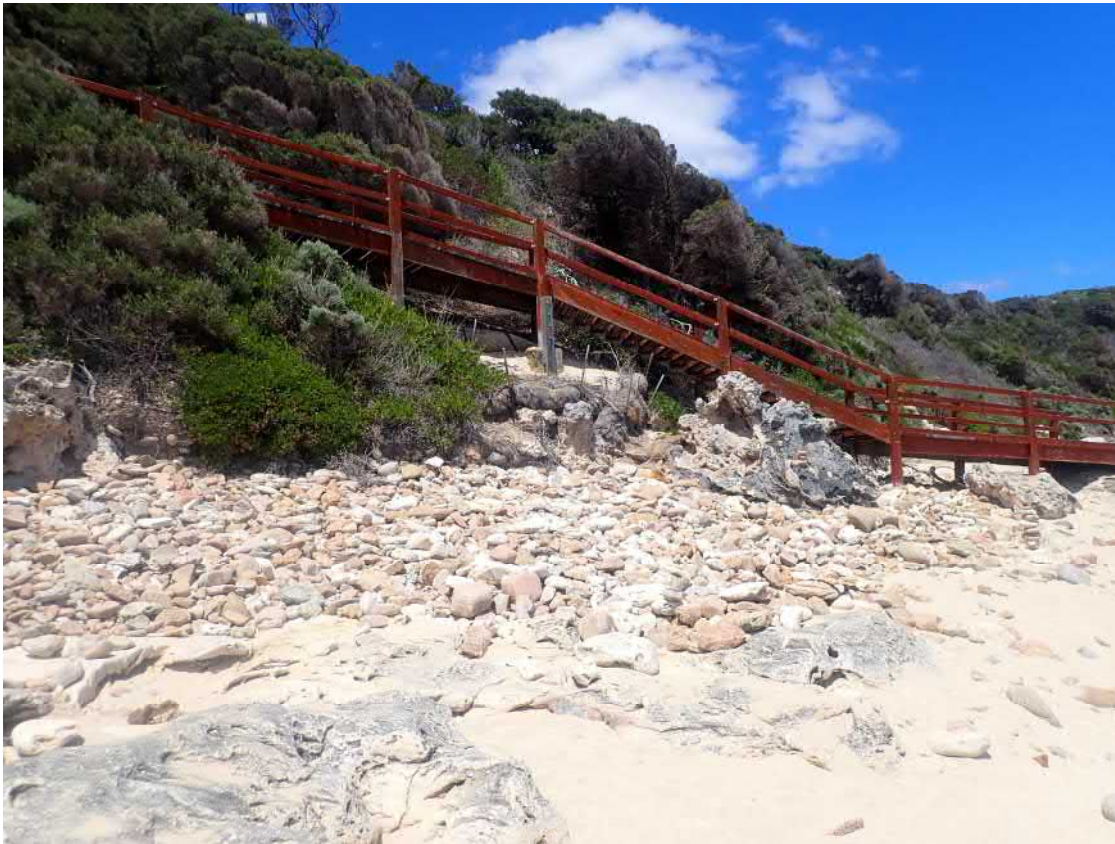
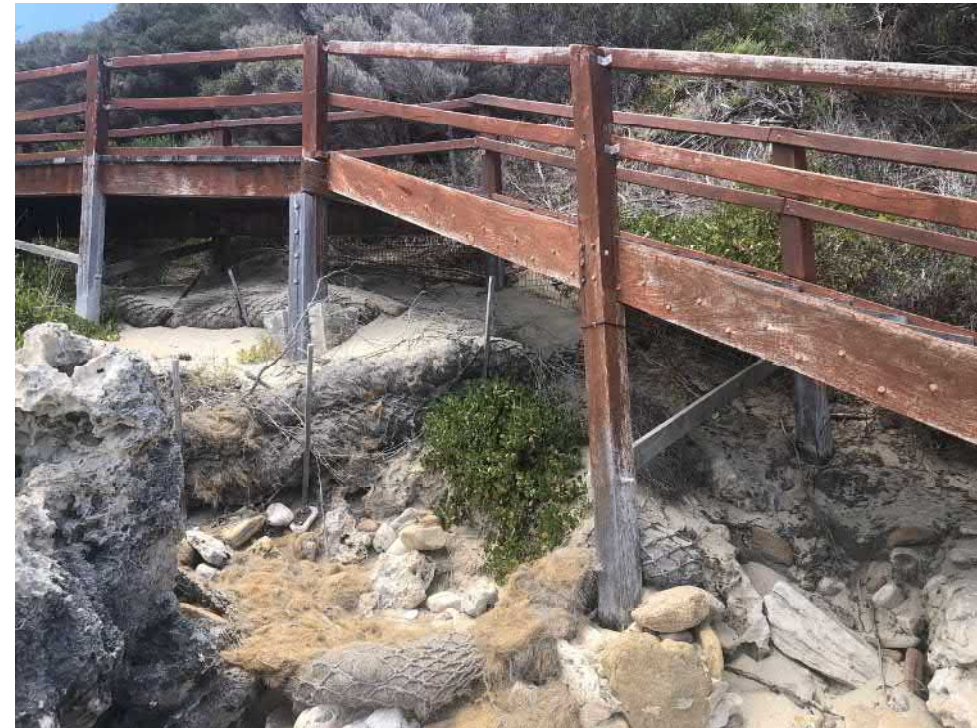
Minor coastal erosion occurring. Place brushwood on parts of slope where vegetation has been impacted. Monitor situation on beach, place riprap or other beach erosion control measures as and when required and extend stanchion to stairs if they become undercut.

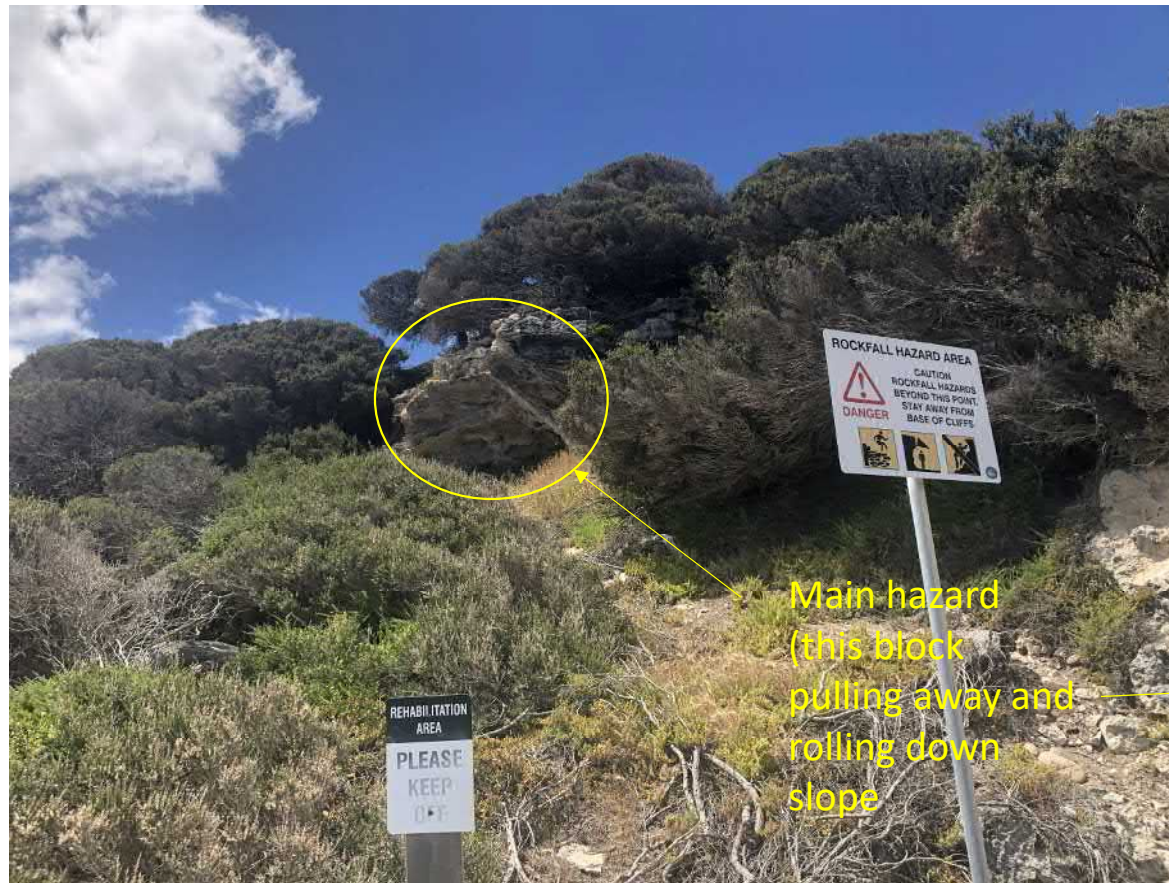
Note since 2017 Golder inspection the Lookout that sat onto of a potentially unstable block was removed. Steps are down sufficient distance back not to be impacted by this hazard

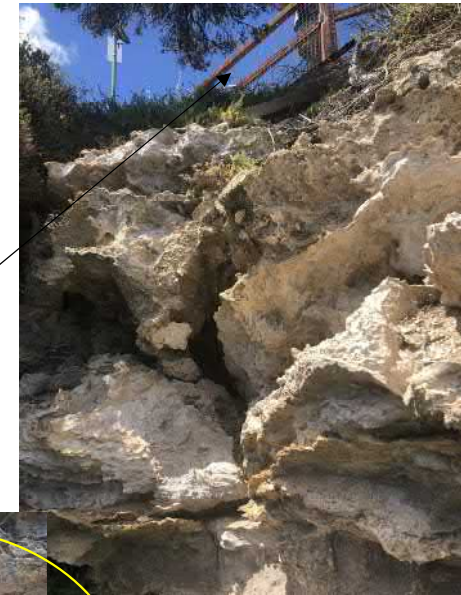
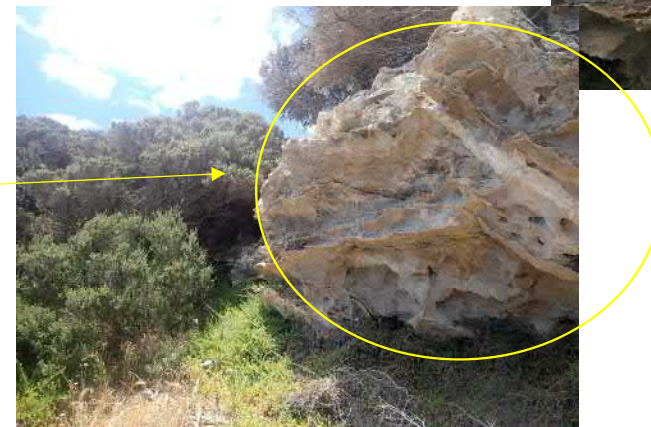
Level of Risk to Individual Most at Risk (R_{DI}) is now relates to a person traversing the rocky foreshore below the hazard rather than the steps above the hazard $R_{DI} = 2.9 \times 10^{-6}$

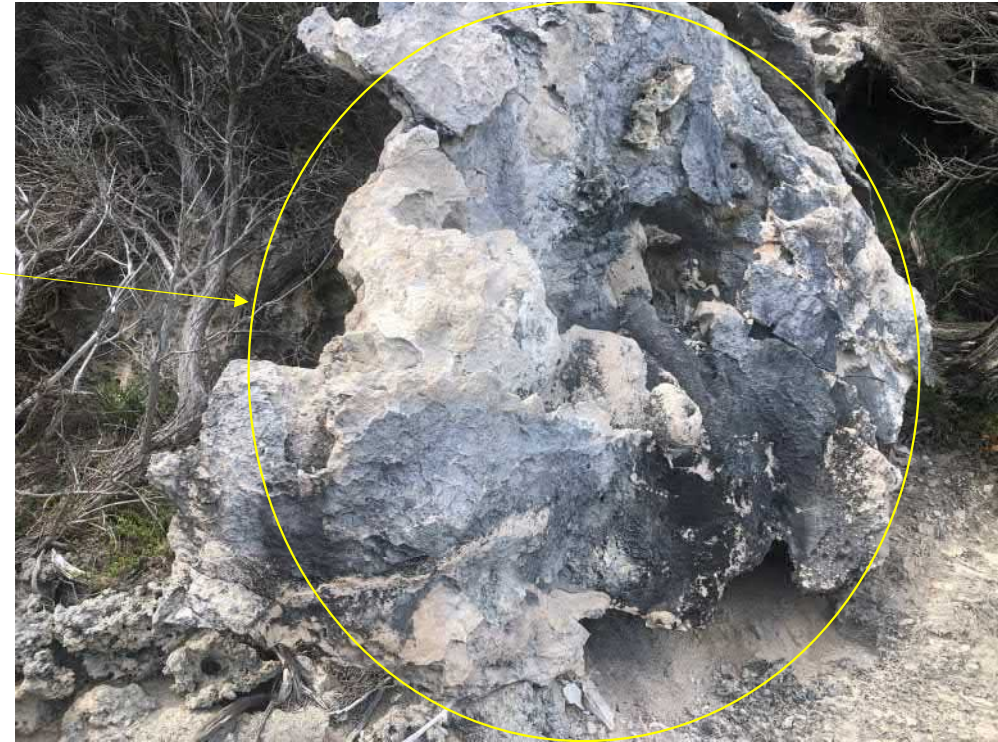
New location

If rockfall was to occur, it is not expected to reach the beach due to vegetation and other boulders breaking its fall. If it topples, it is likely to fragment into small pieces. Risk is assessed to be relatively low $R_{DI} = 8.6 \times 10^{-7}$
Recommend additional sign.

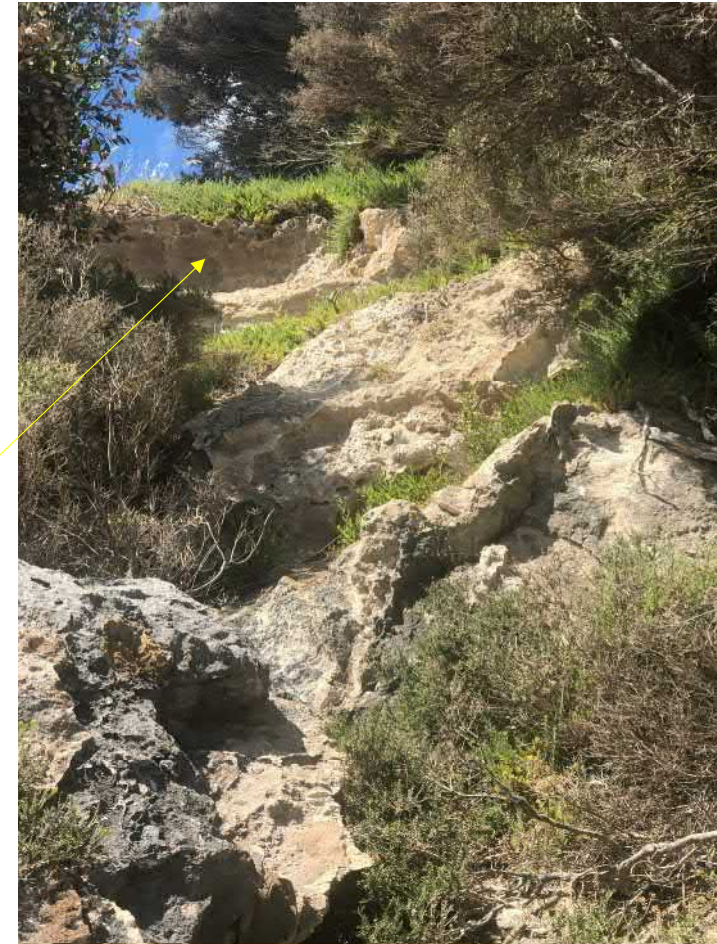
No apparent retrogression of embankment to west of GC6-60 since 2019. Further establishment of native vegetation has occurred which is helping to maintain status quo (see photo on right)

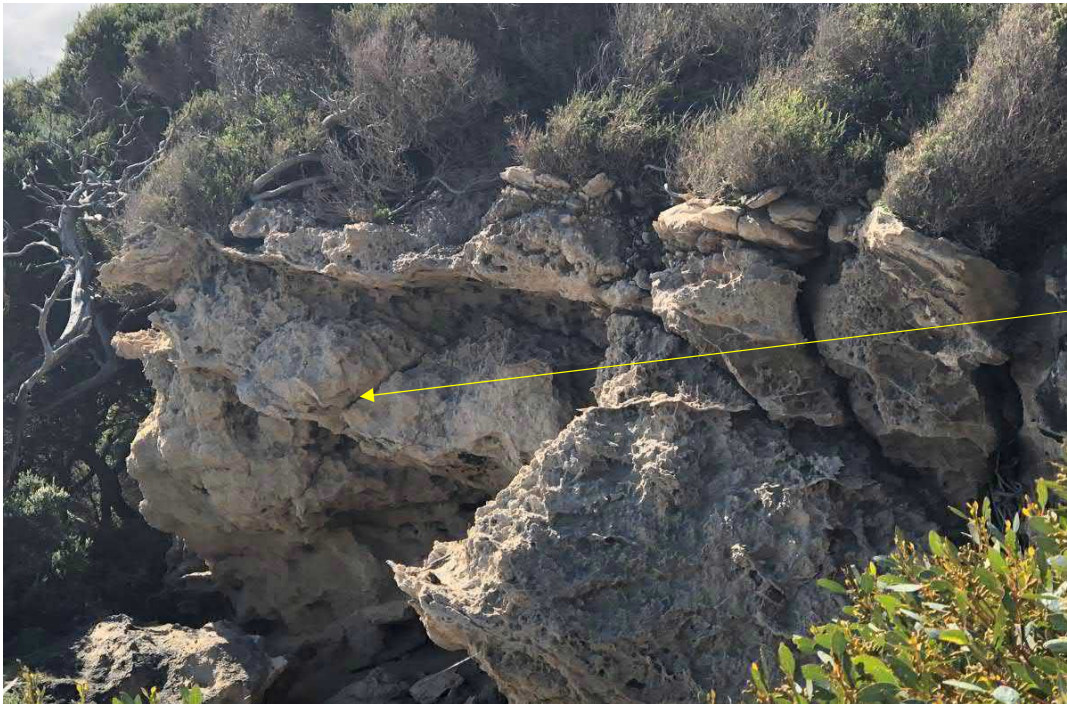
Fracture from August
2019

Level of Risk to Individual Most at
Risk (R_{DI}) Nov 2021 = 9.75×10^{-7}

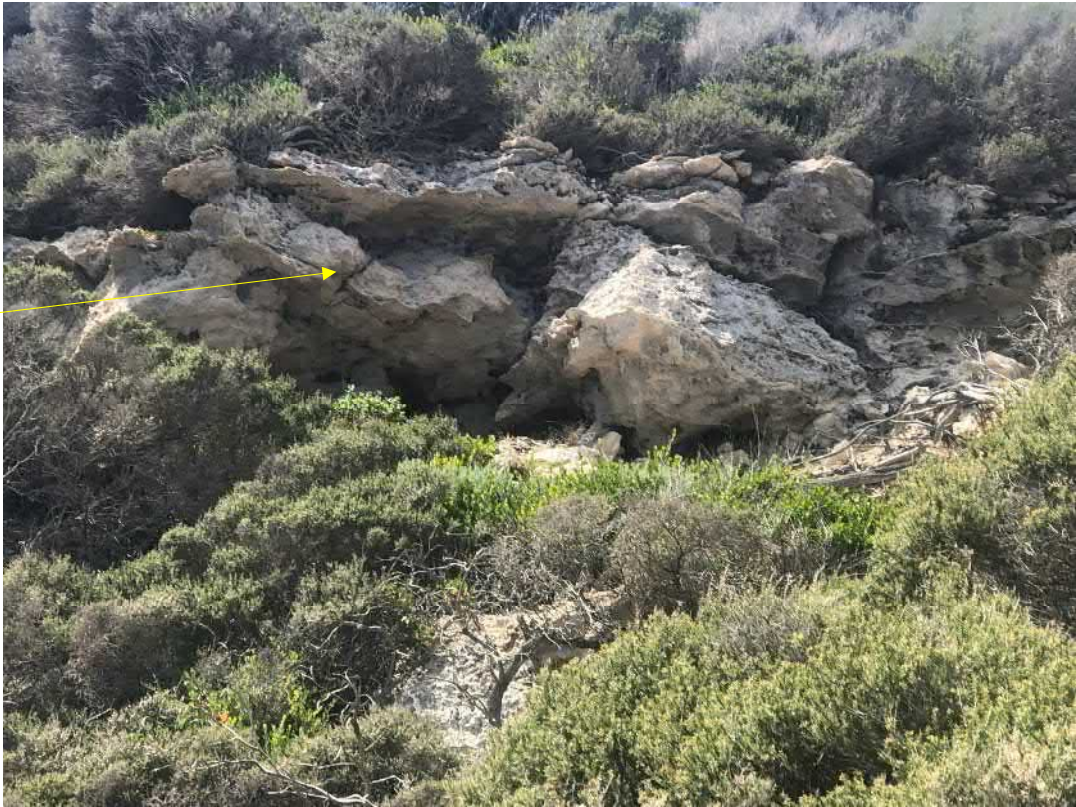
November 2021 inspection indicates
negligible change to tension crack from
2019

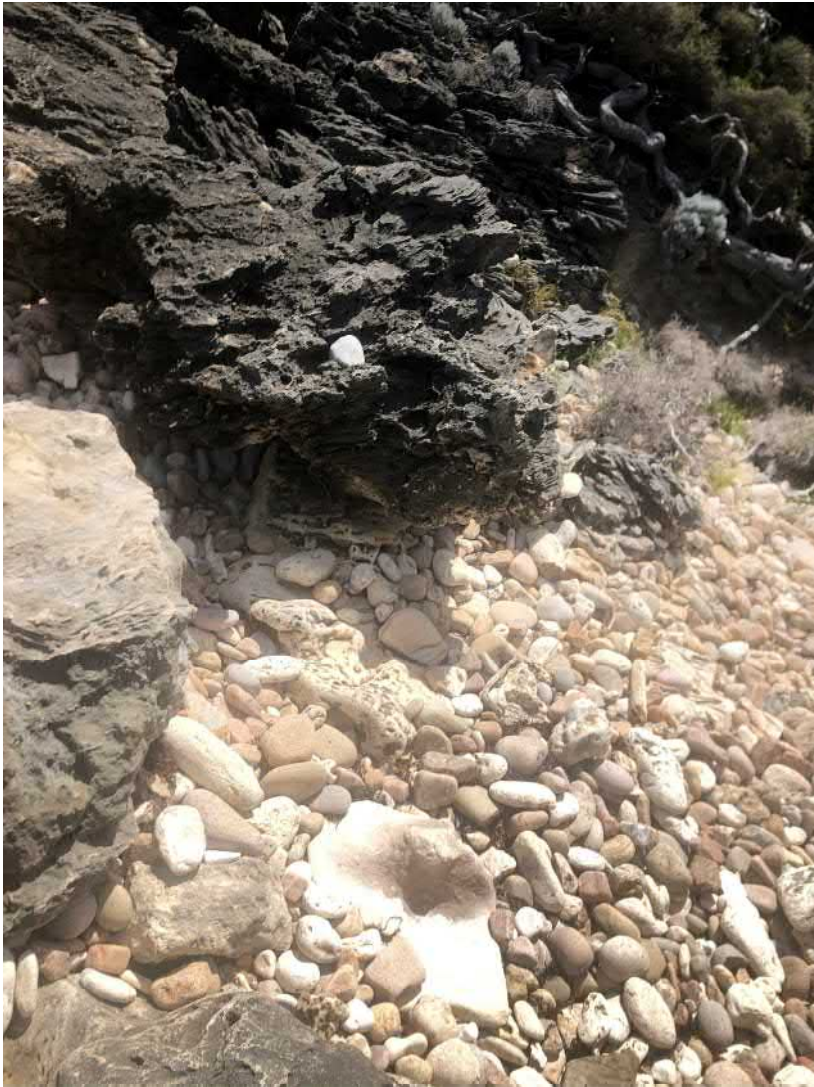
Rockfall debris still present on wave cut platform similar to 2019. Rounded boulders and cobbles indicative of high wave energy

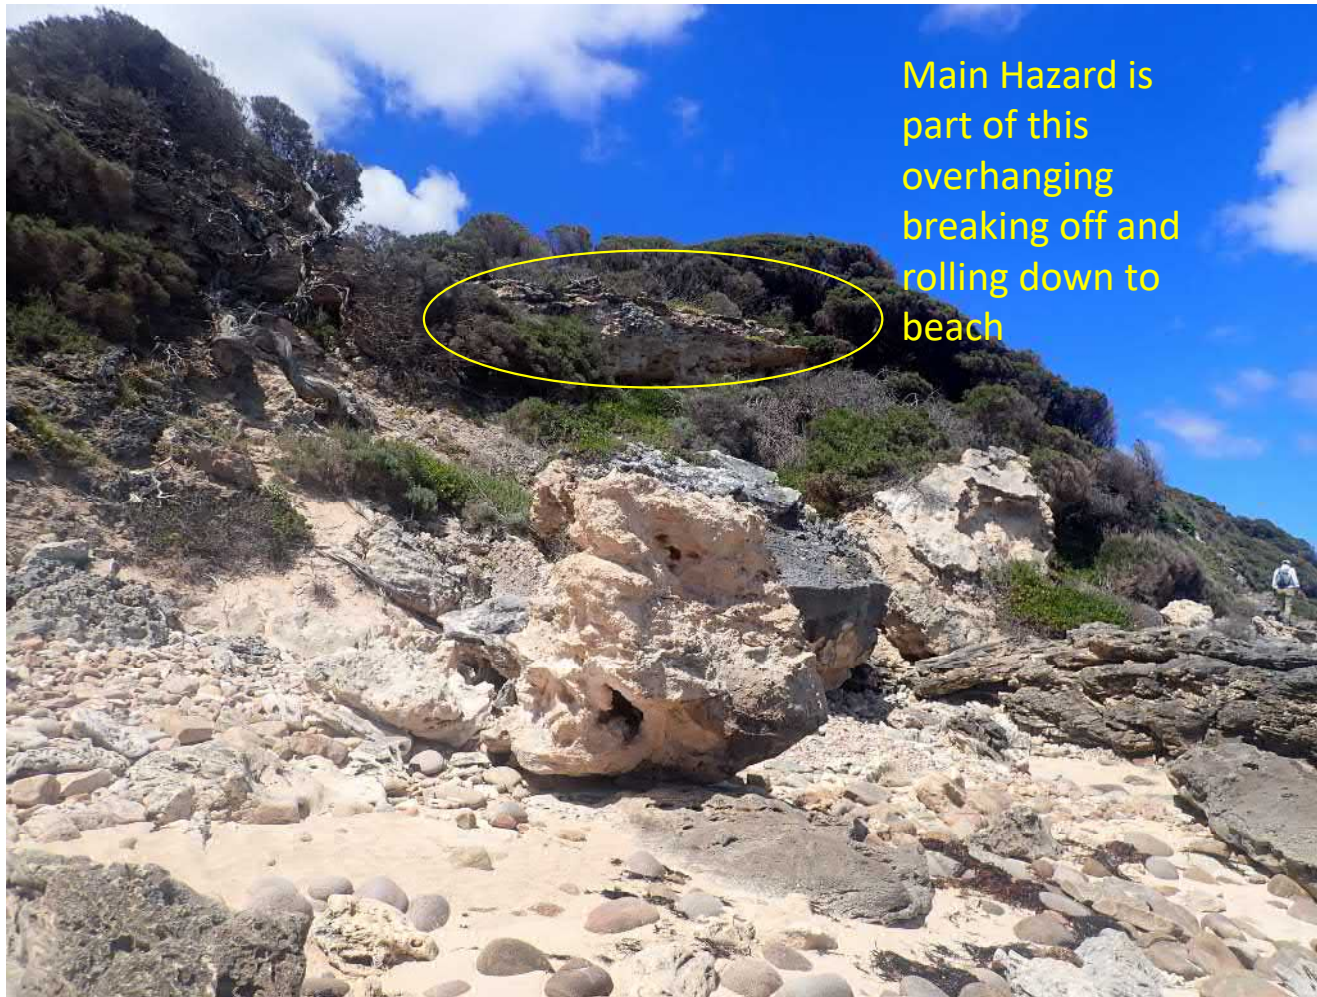
Main Hazard is
part of this
overhanging
breaking off and
rolling down to
beach

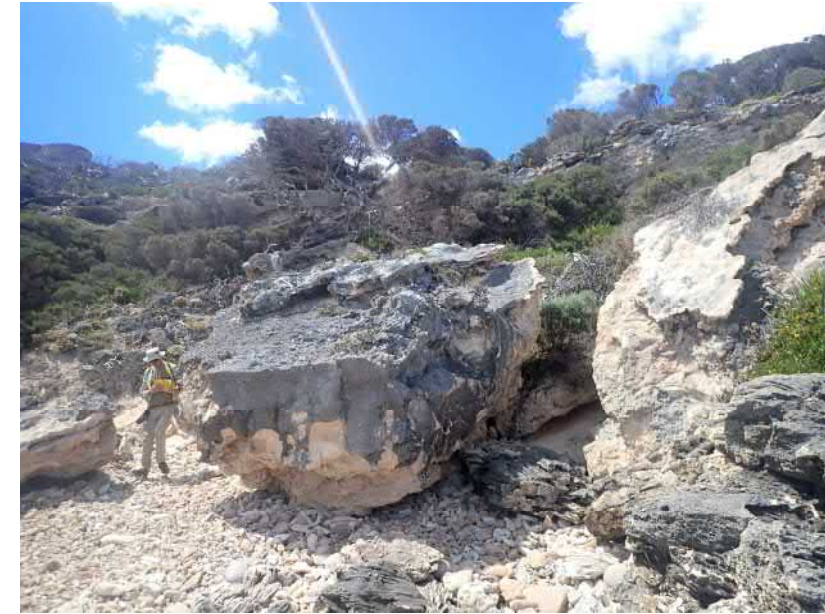
Level of Risk to Individual Most at
Risk (R_{DI}) not changed since
previous assessment – Nov 2021
 $R_{DI} = 8 \times 10^{-7}$

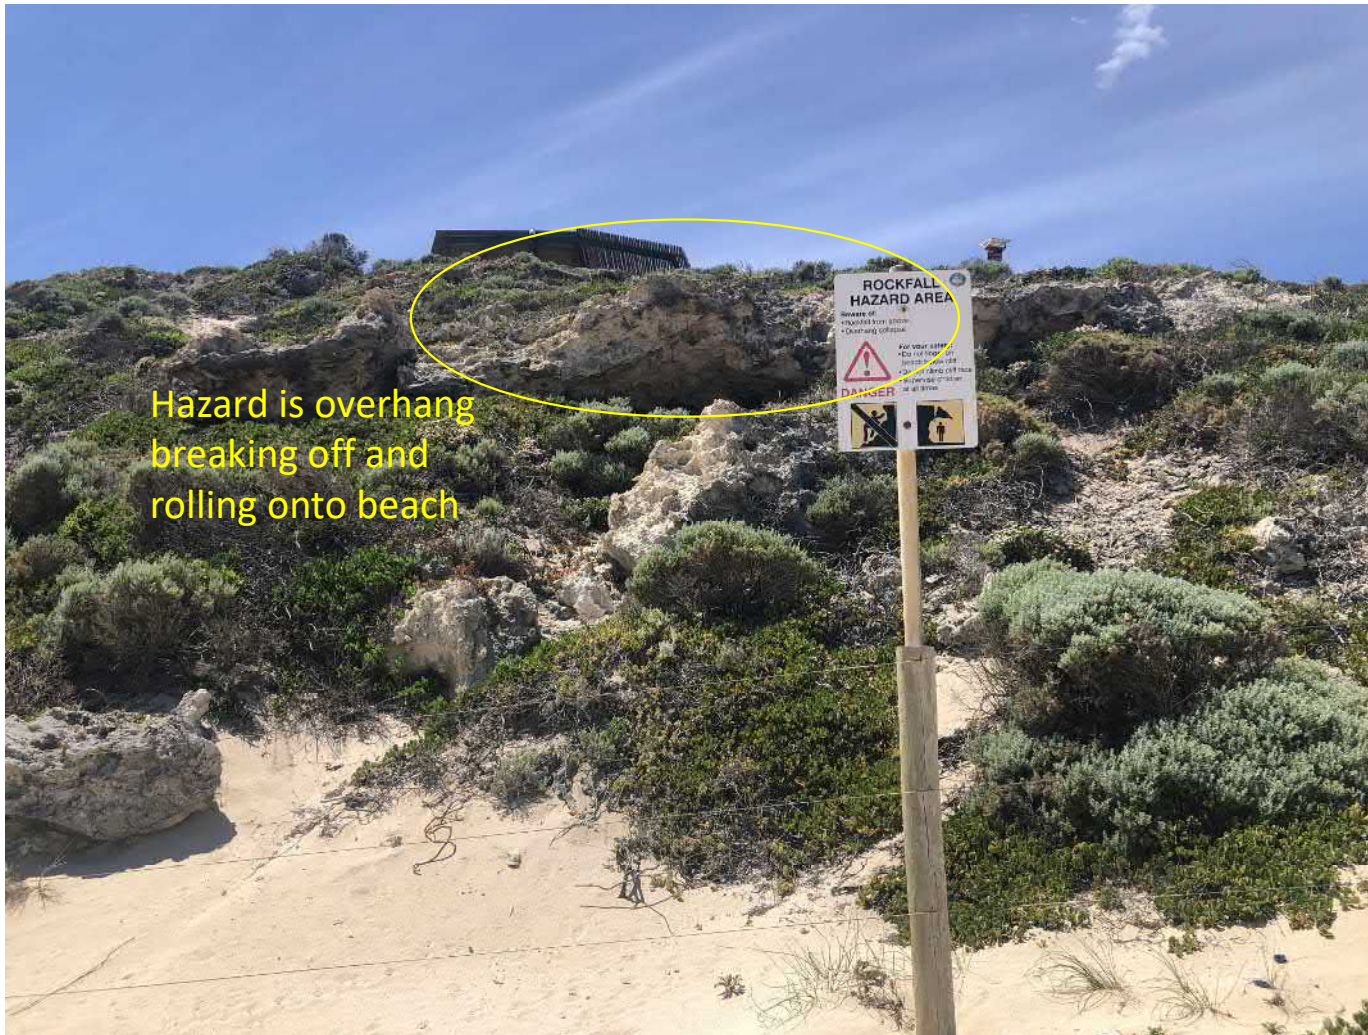
Hazard is overhang
breaking off and
rolling onto beach

Risk to Individual Most at
Risk (R_{DI}) not changed since
previous assessment (2017)
 $R_{DI} = 1.5 \times 10^{-6}$

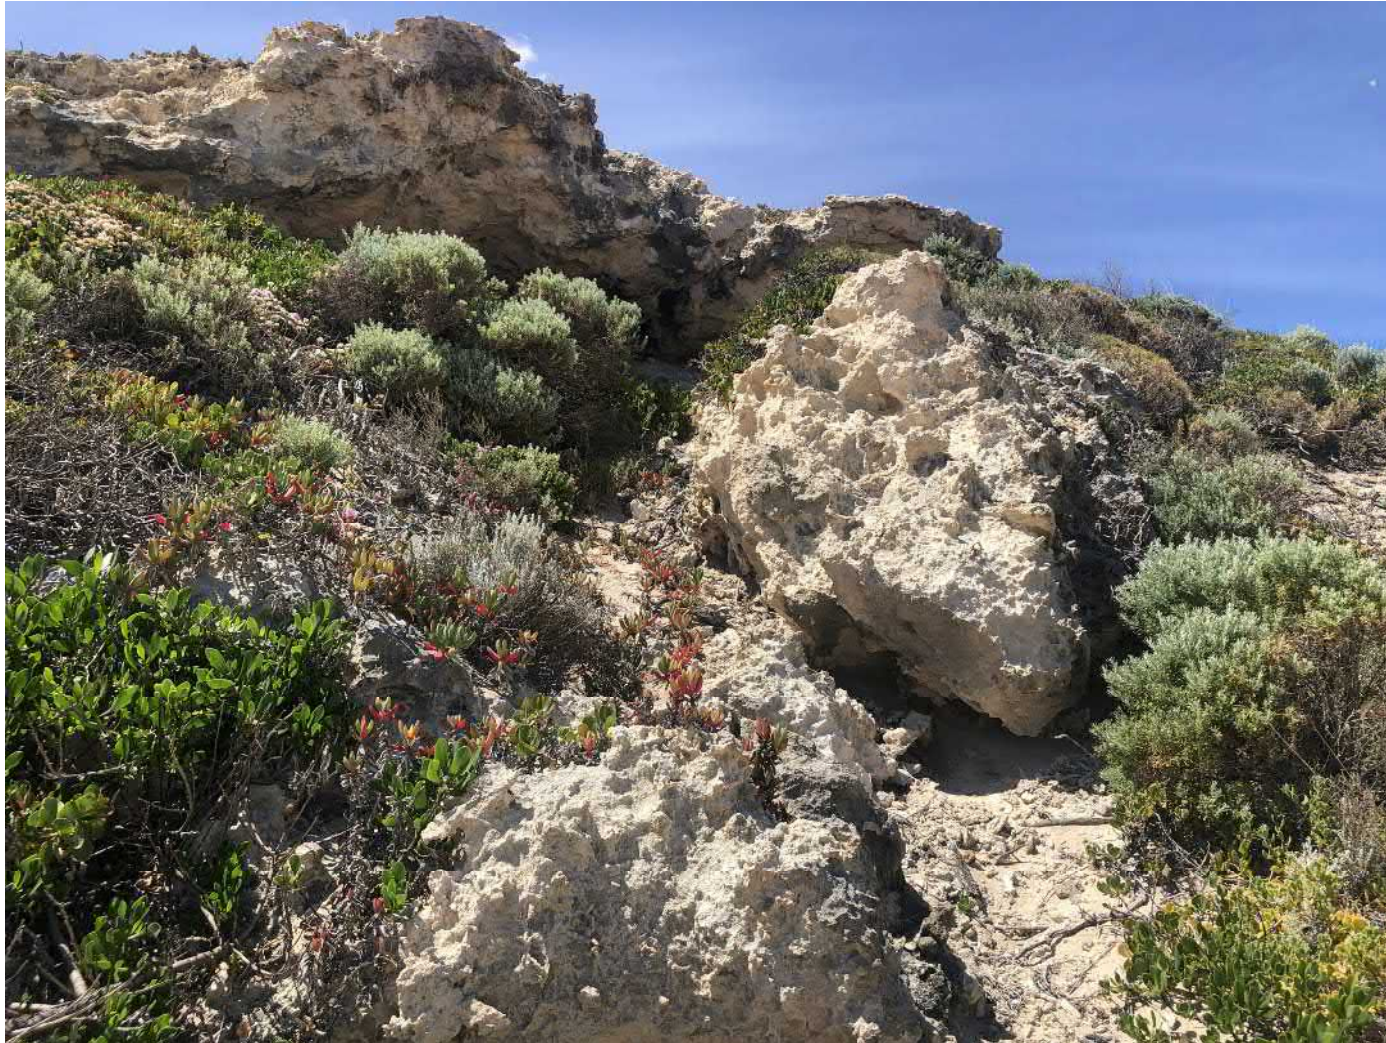
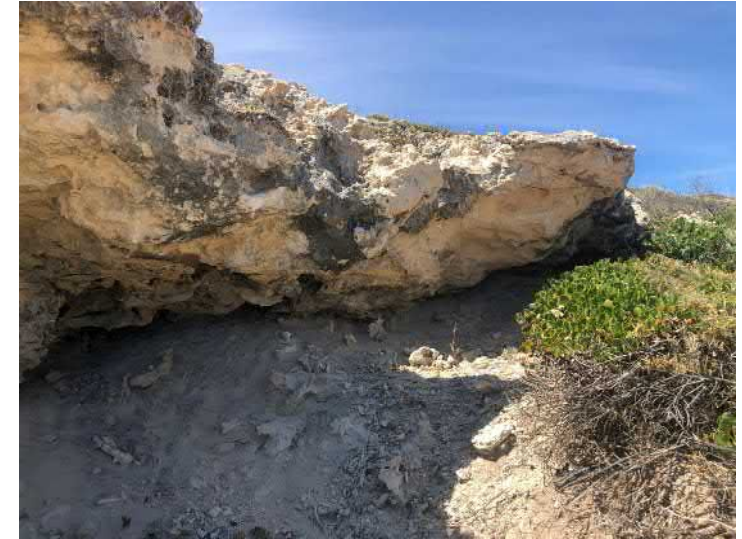
Overhang has not changed
since previous inspection

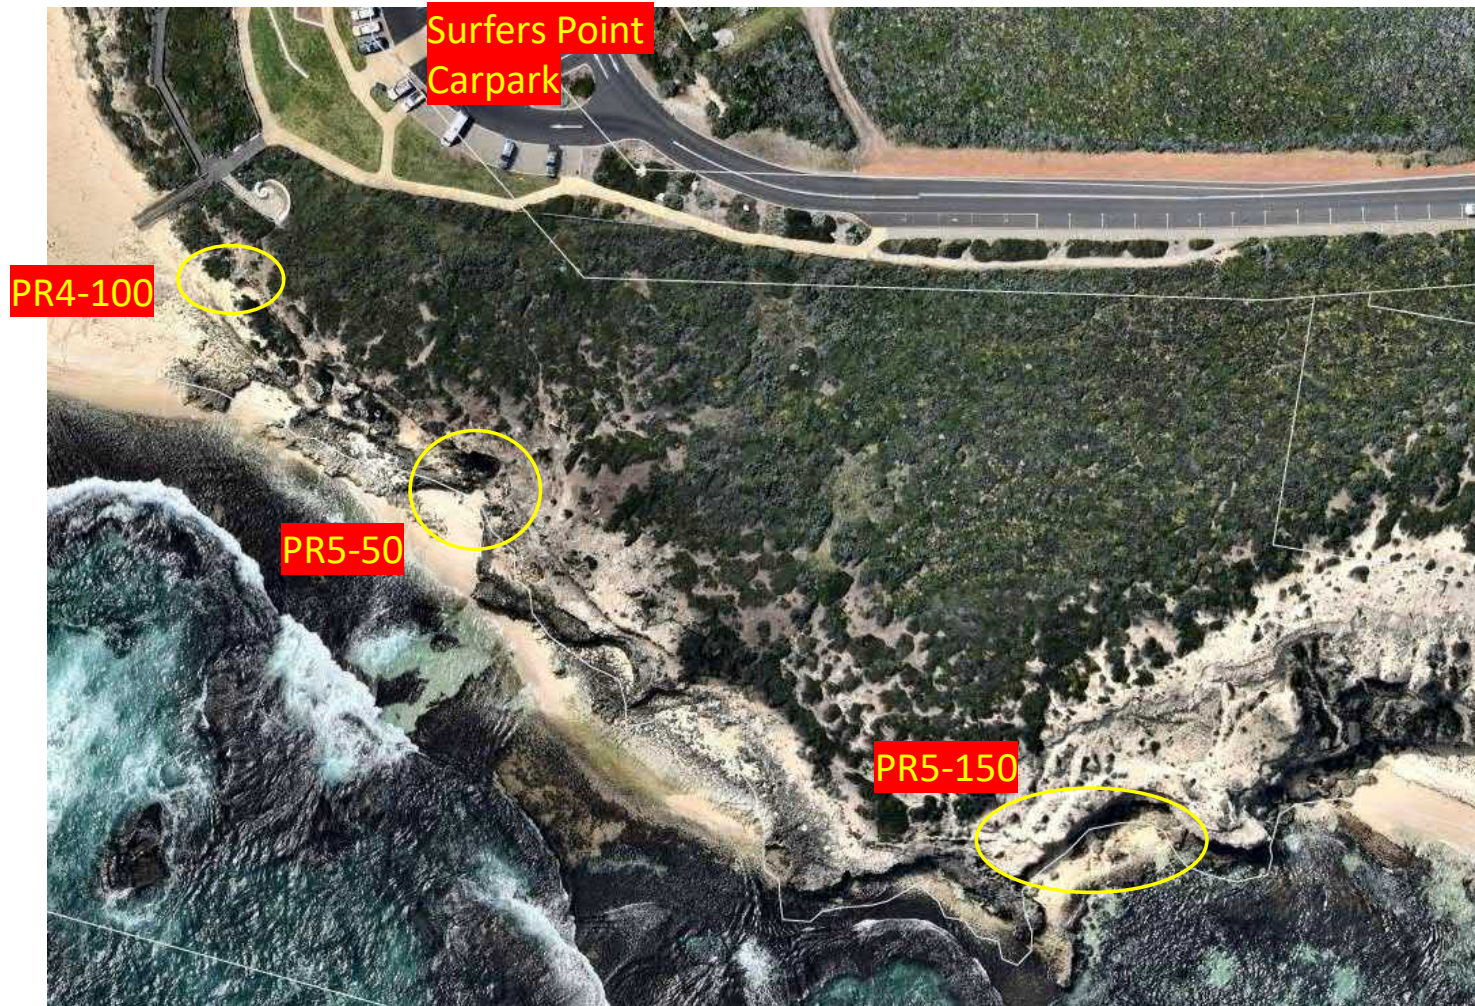
Risk to individual most at risk has been re-assessed and has increased.

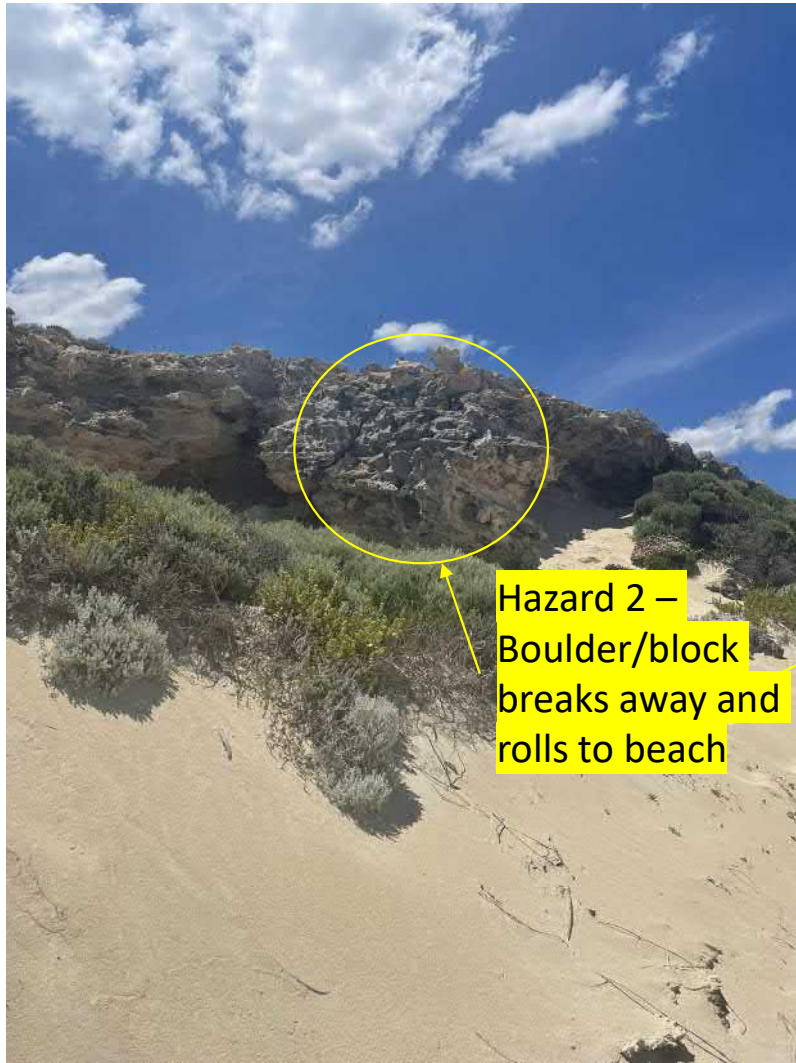
Hazard 2 –
Boulder/block
breaks away and
rolls to beach

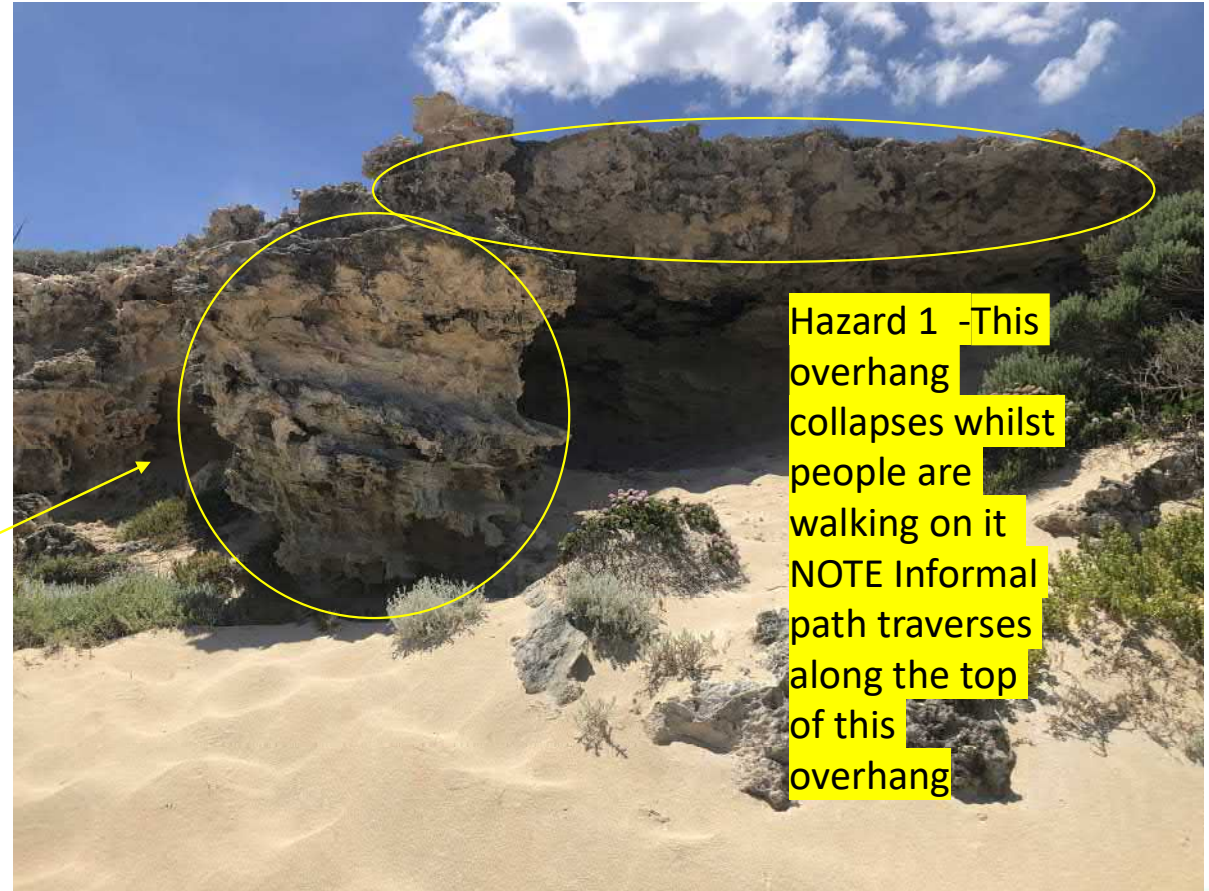
Hazard 1 -This
overhang
collapses whilst
people are
walking on it
NOTE Informal
path traverses
along the top
of this
overhang

Risk to Individual Most at Risk (R_{DI})
has increased since previous
assessment (2017) $R_{DI} = 4.8 \times 10^{-6}$
This is due to increased erosion and
pedestrian traffic in hazard zone

The risk in this area has increased due to the re-assessment of the hazard and impact zone. There is evidence of pedestrian traffic including on the overhang itself (refer Slide 25). To reduce the risk, it is recommended that pedestrian traffic be reduced and ideally stopped in this area through the use of 'Rockfall Hazard Area' signs (set at a suitable height for eye-level or angled similar to those used at PR4-30 and GN5-5) and to place brushwood to reduce traversing informal paths and to encourage vegetation growth. Fencing could be improved to further reduce entry into this area from the picnic area at Mainbreak (refer Slide 25).

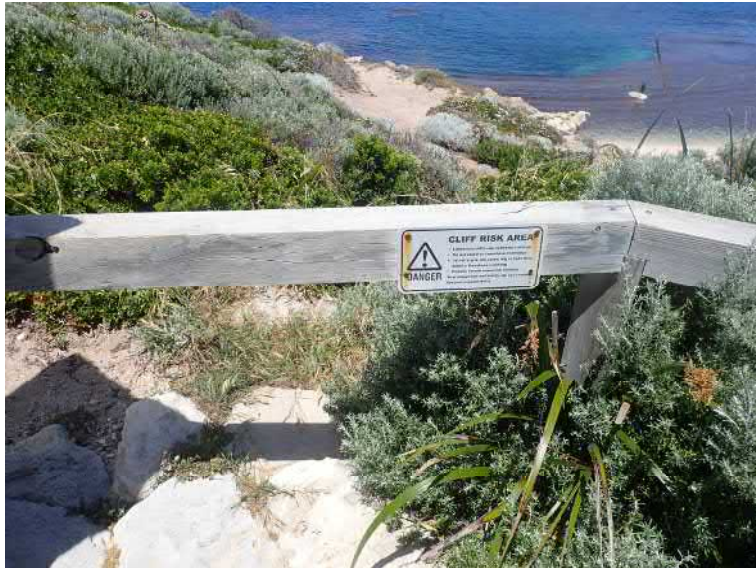
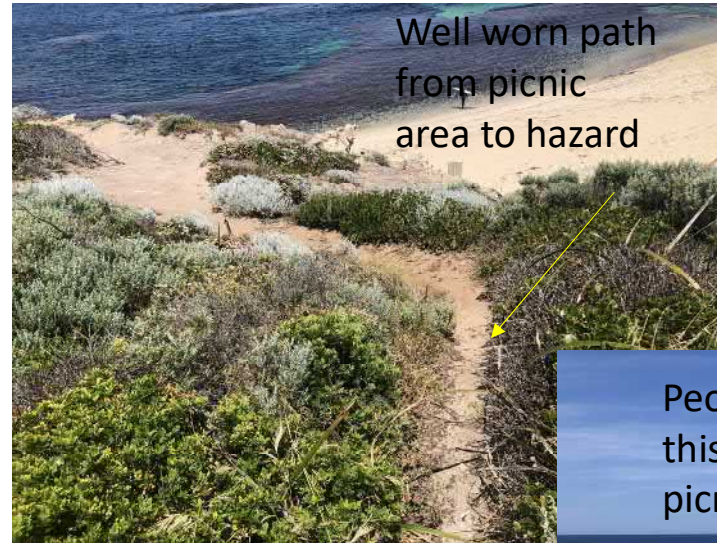
Well worn path
from picnic
area to hazard

People are entering
this area from the
picnic area

People are walking
along edge of
overhang

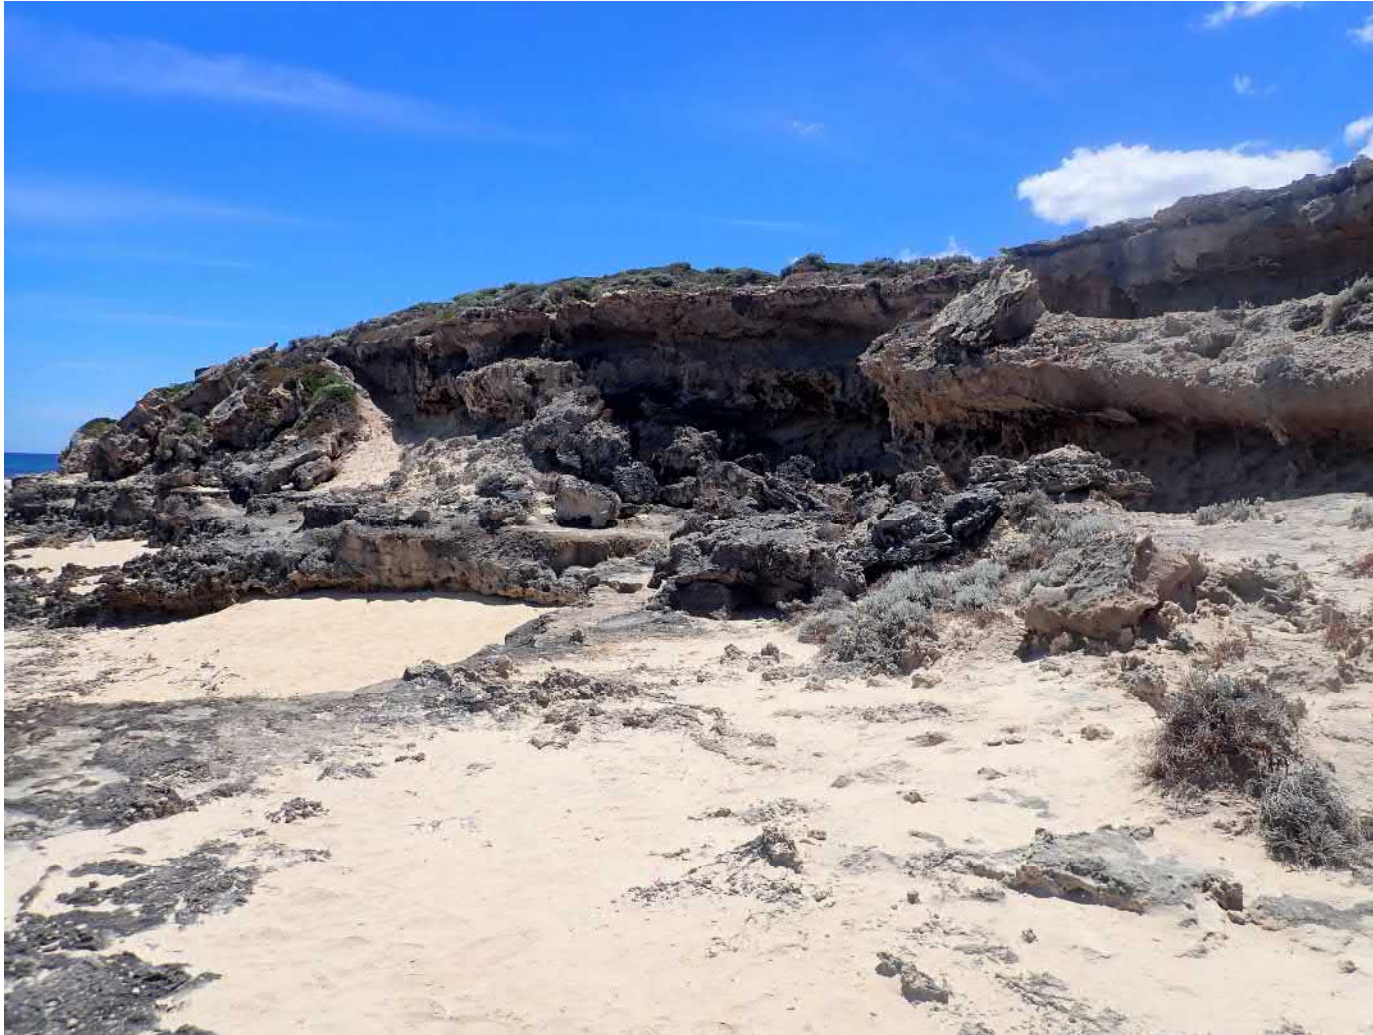
Site conditions similar to previous assessment.

Risk to Individual Most at Risk (R_{DI}) has not changed since previous assessment (2017)

$$R_{DI} = 1.8 \times 10^{-6}$$

Add rockfall hazard sign 5 m from hazard at edge of beach.

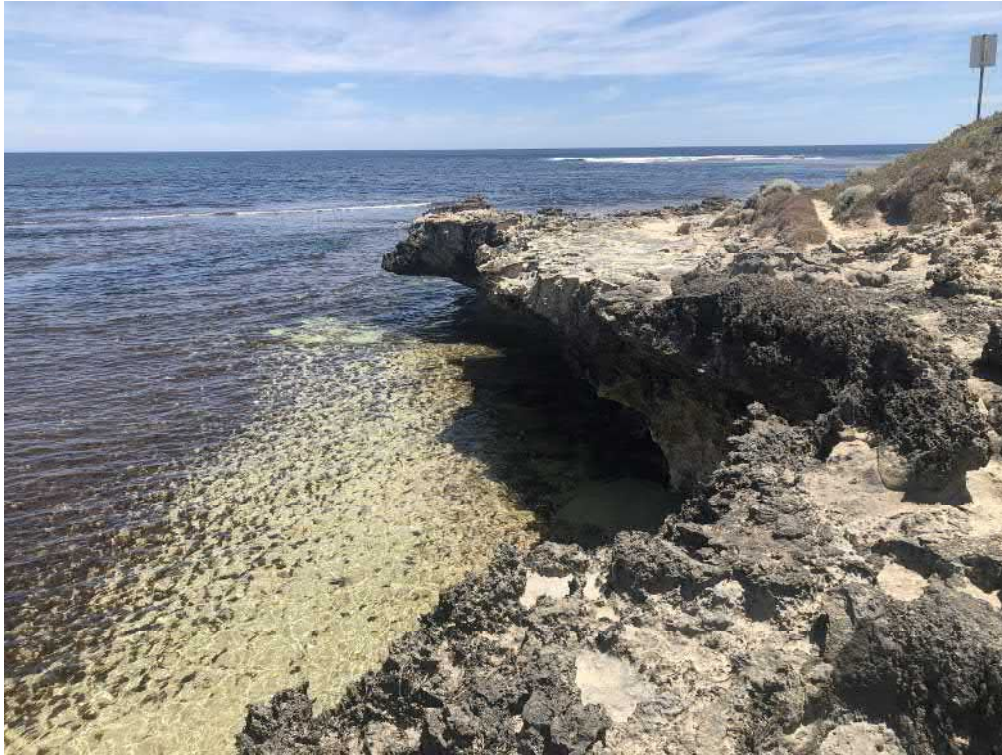
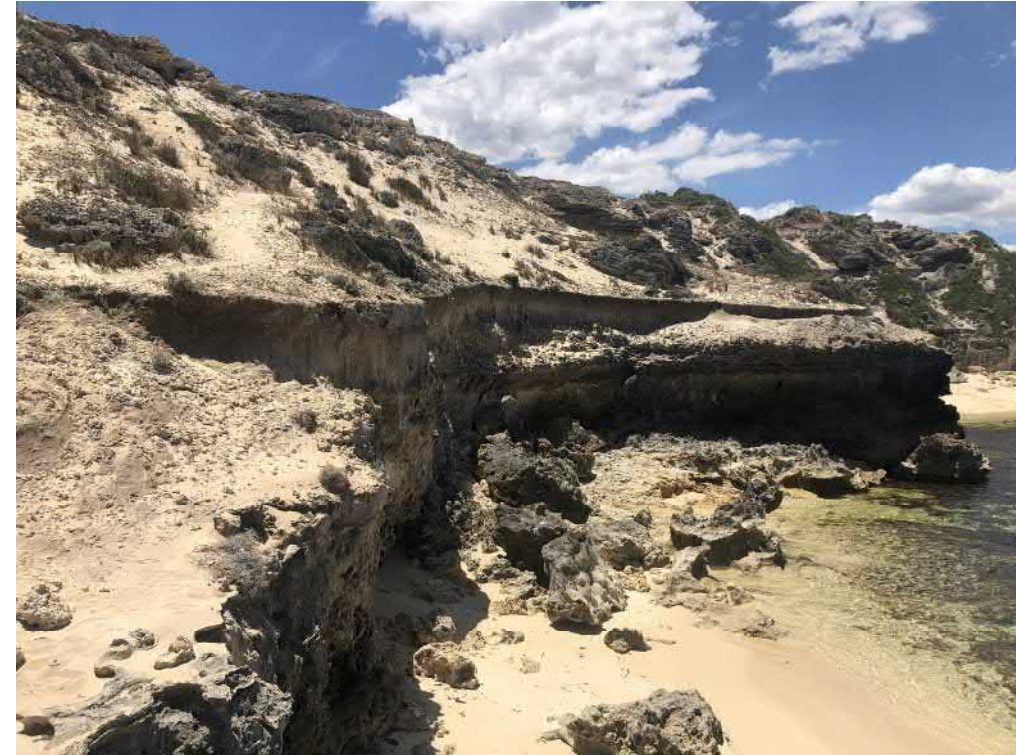
Site conditions similar to previous assessment. Risk to Individual Most at Risk (R_{DI}) has not changed since previous assessment (2017)

$$R_{DI} = 1.5 \times 10^{-6}$$
