LIMESTONE CLIFF RISK ASSESSMENT

**GRACETOWN, PREVELLY, GNARABUP, GRUNTERS,
WESTERN AUSTRALIA**

INSPECTION AND RISK ASSESSMENT

PER2021-0300AB Rev0

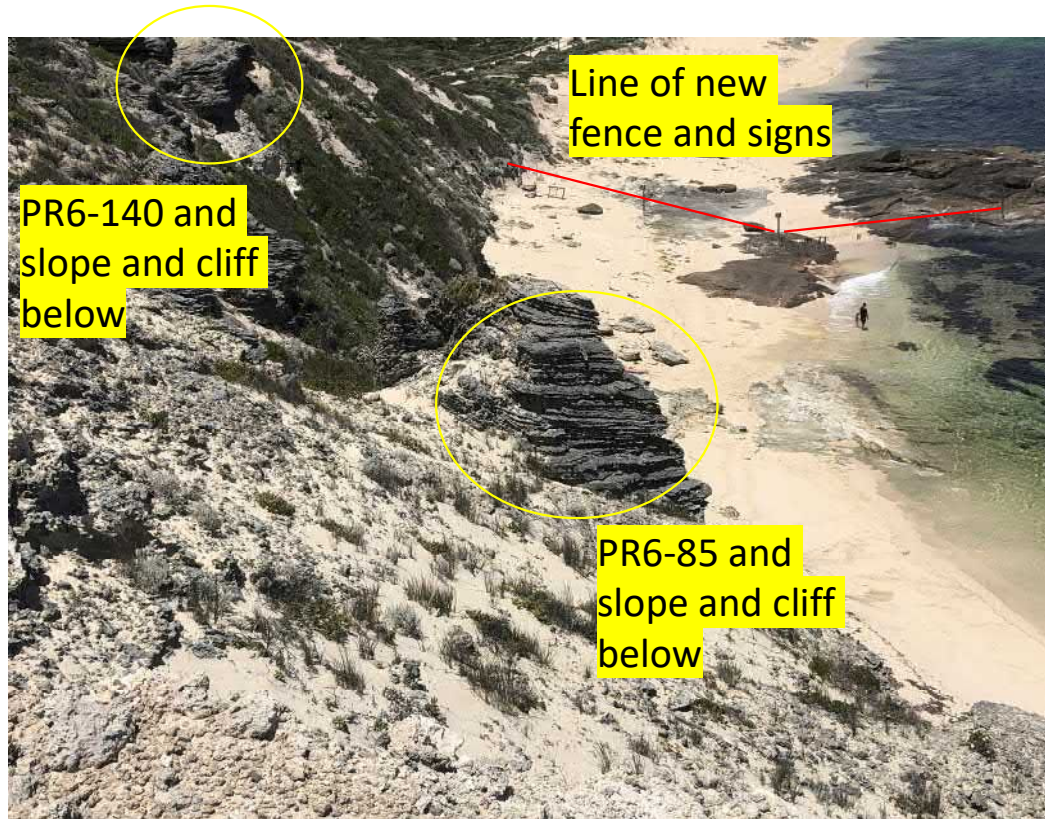
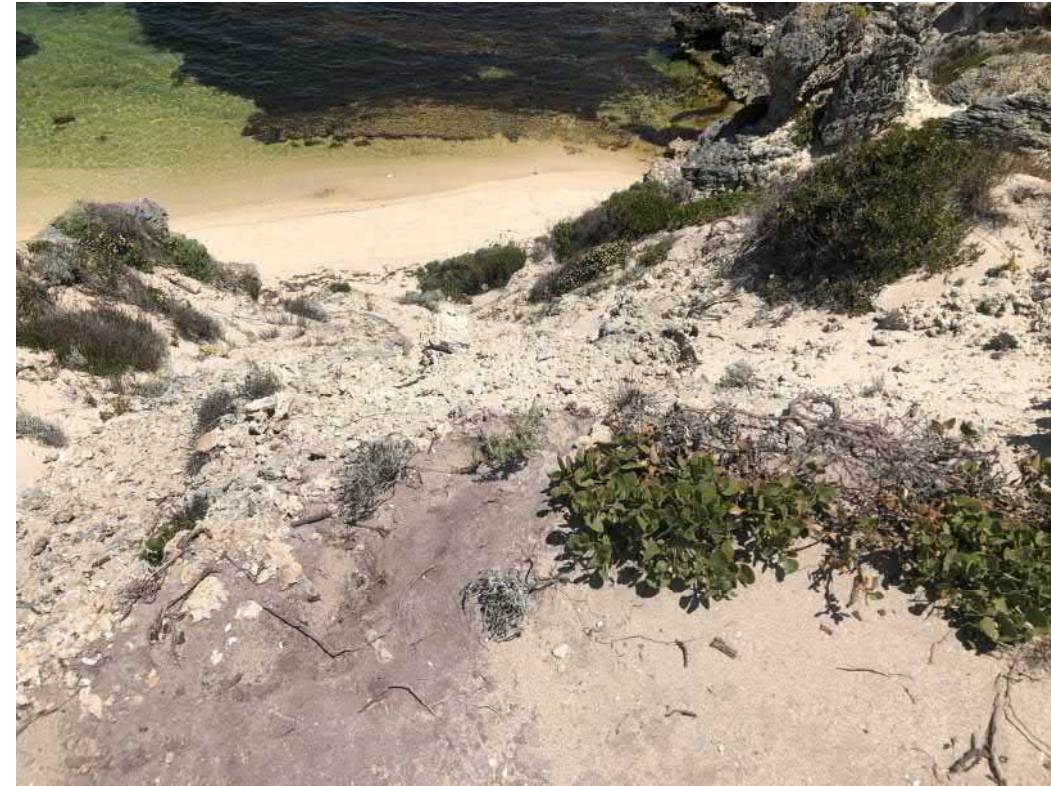
Conditions at top of PR6-85 and PR6-140.

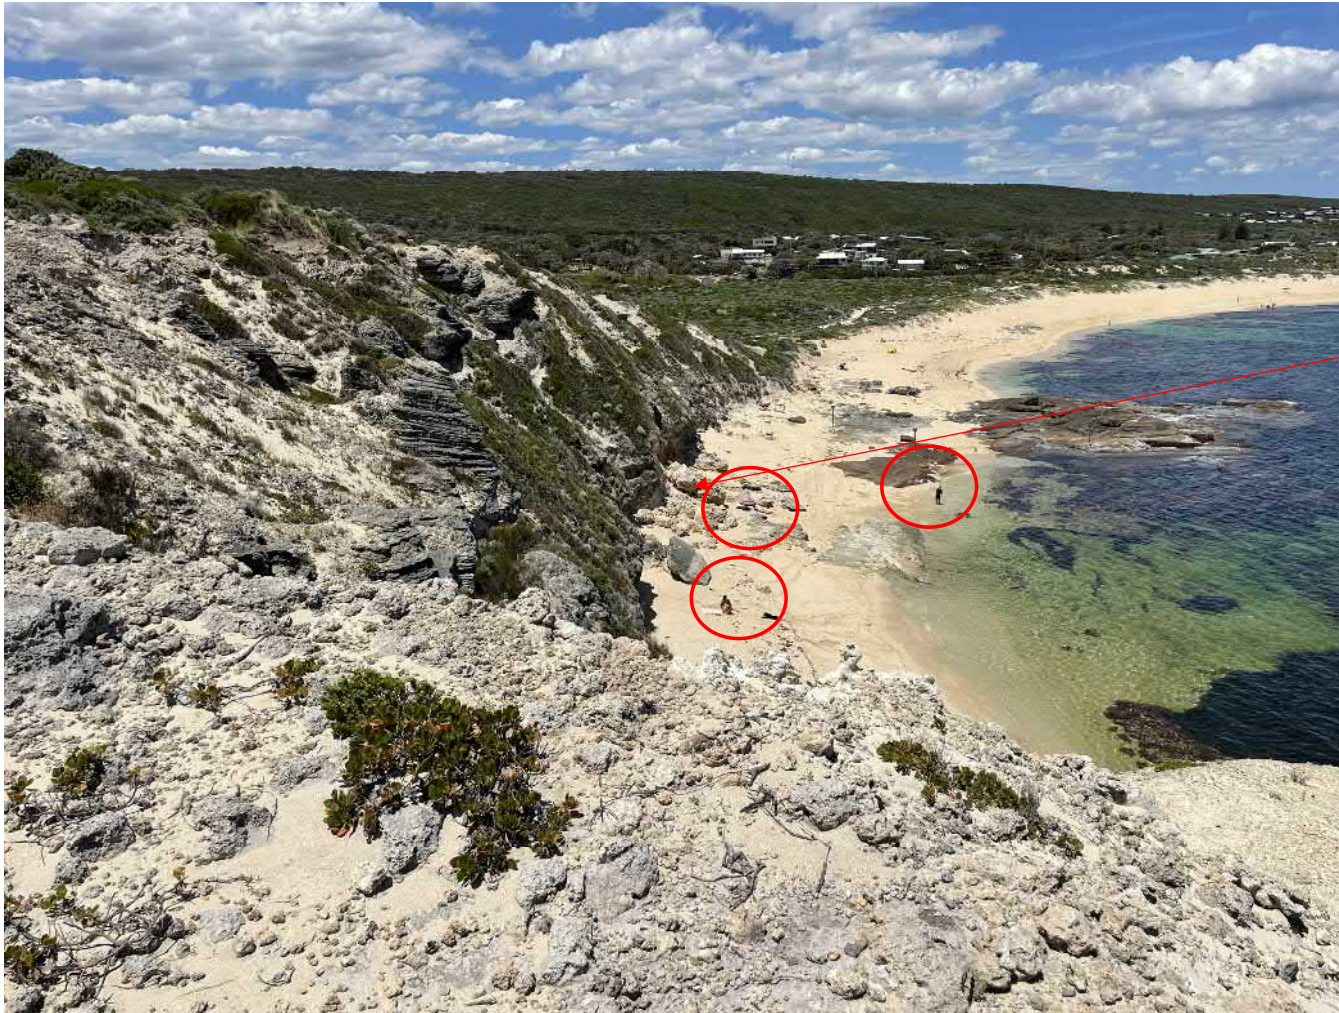
Three sets of recreational users (5 people) who have crossed the fence to access the beach.

Recent rockfall approx. 15 m³ (August 2021) with a recreational user sitting directly in front of the rockfall.

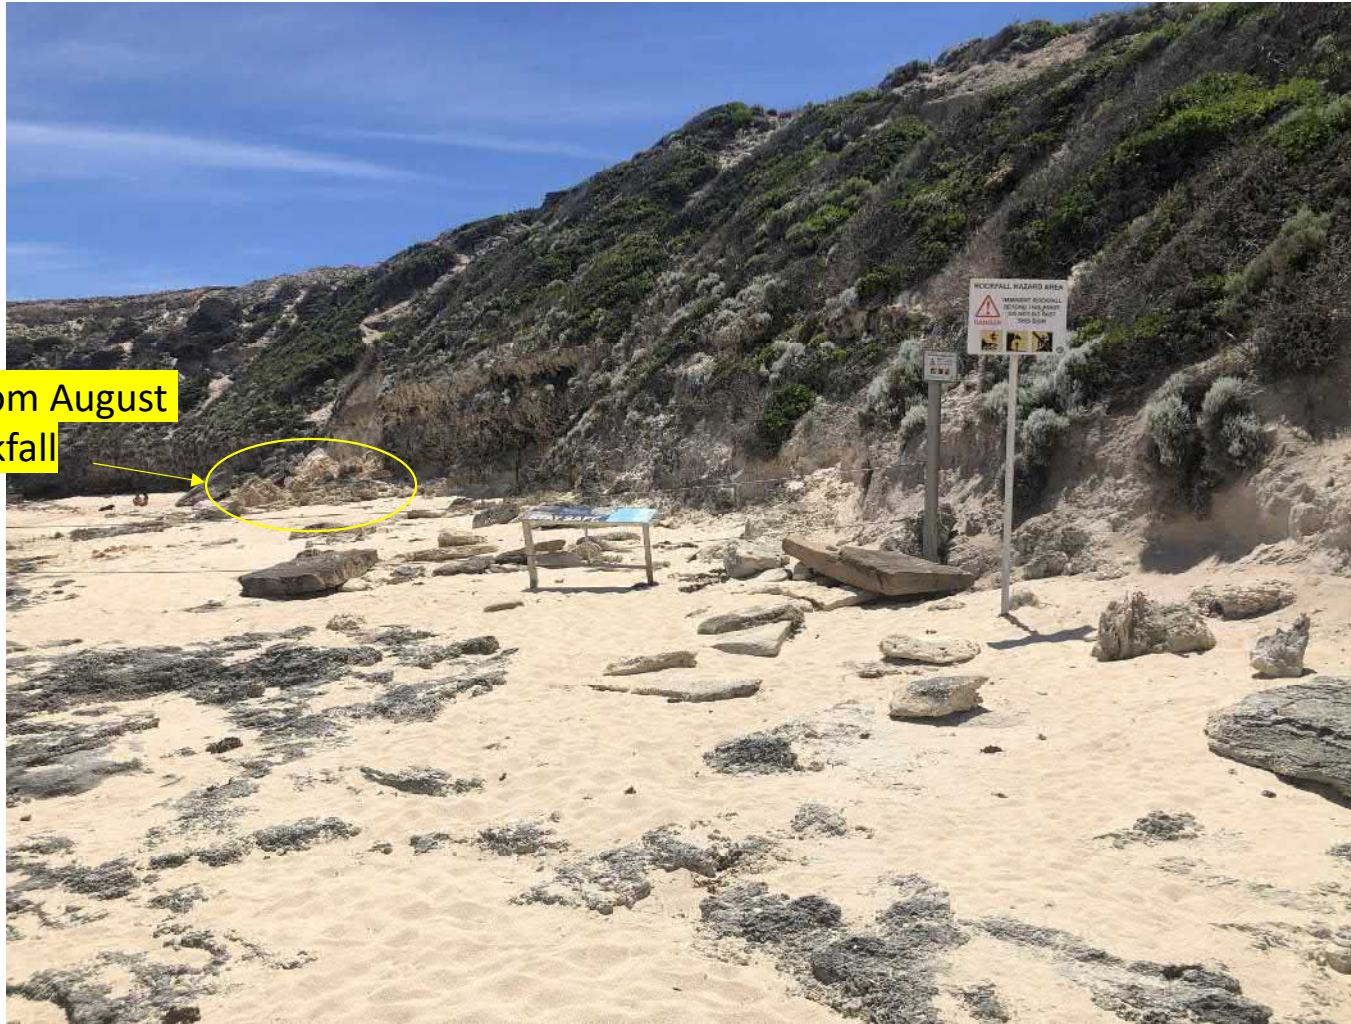
Appropriate signage warning of rockfall hazard in place and in good condition at southern end of Riflebutts Beach Hazard Zone.

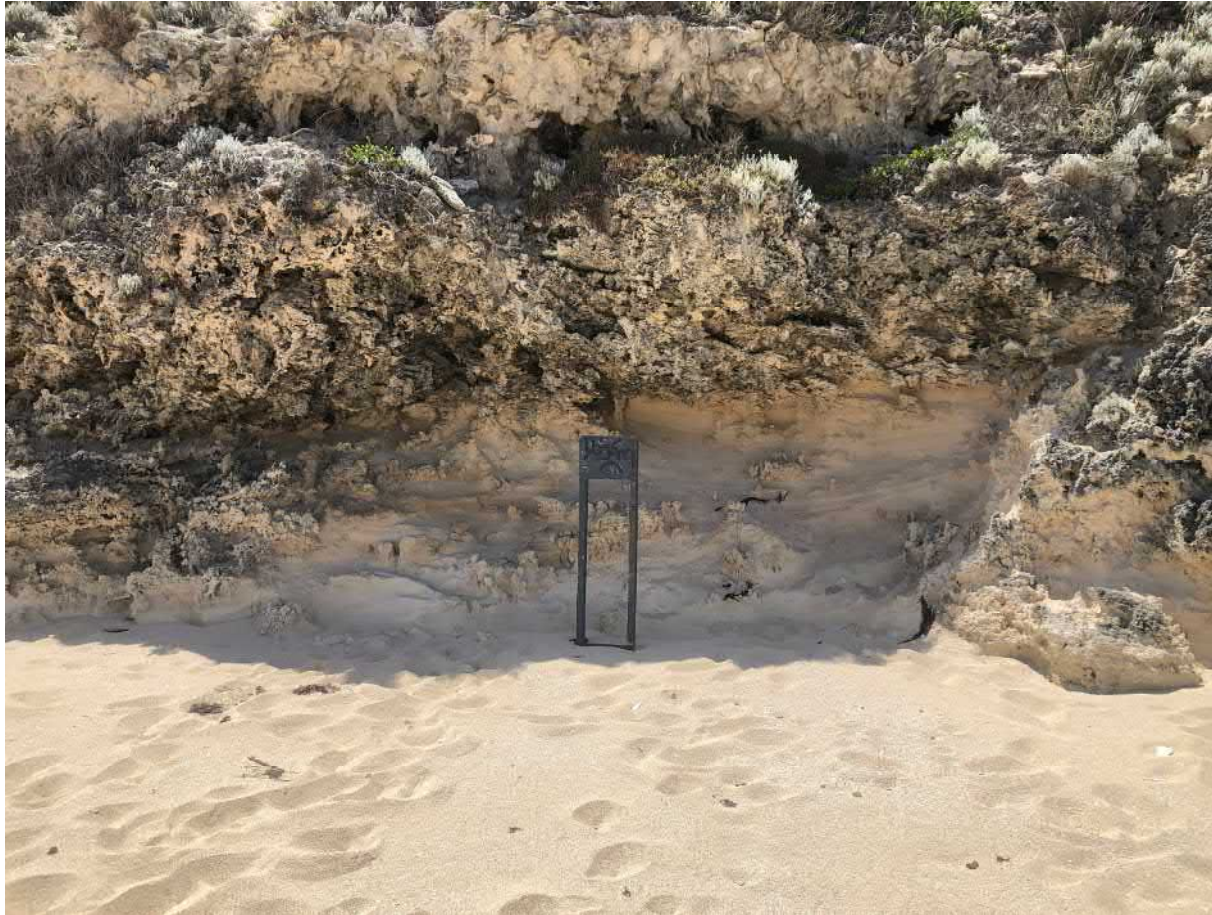
This sign is now
redundant and should
be removed

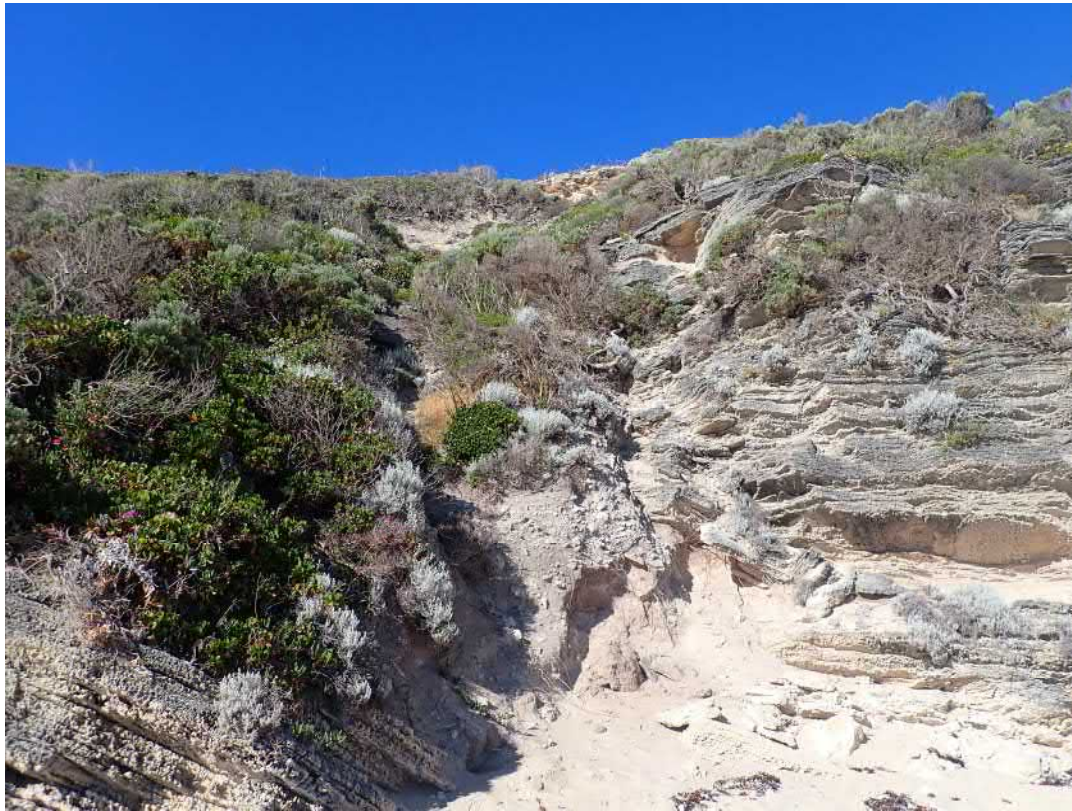
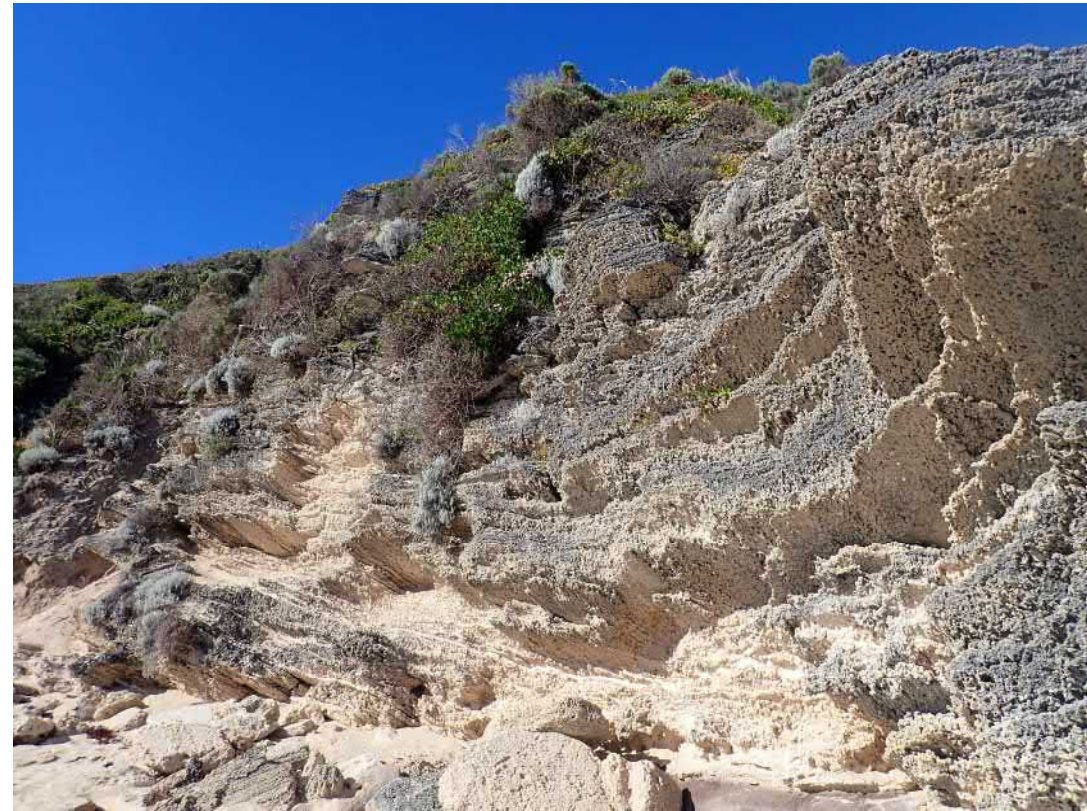
Risk to Individual Most at Risk (R_{DI}) has not changed since previous assessment (2017) $R_{DI} = 2.0 \times 10^{-7}$
Add rockfall hazard area signs be erected on beach to be viewed when approaching the hazard from both the north and the south..

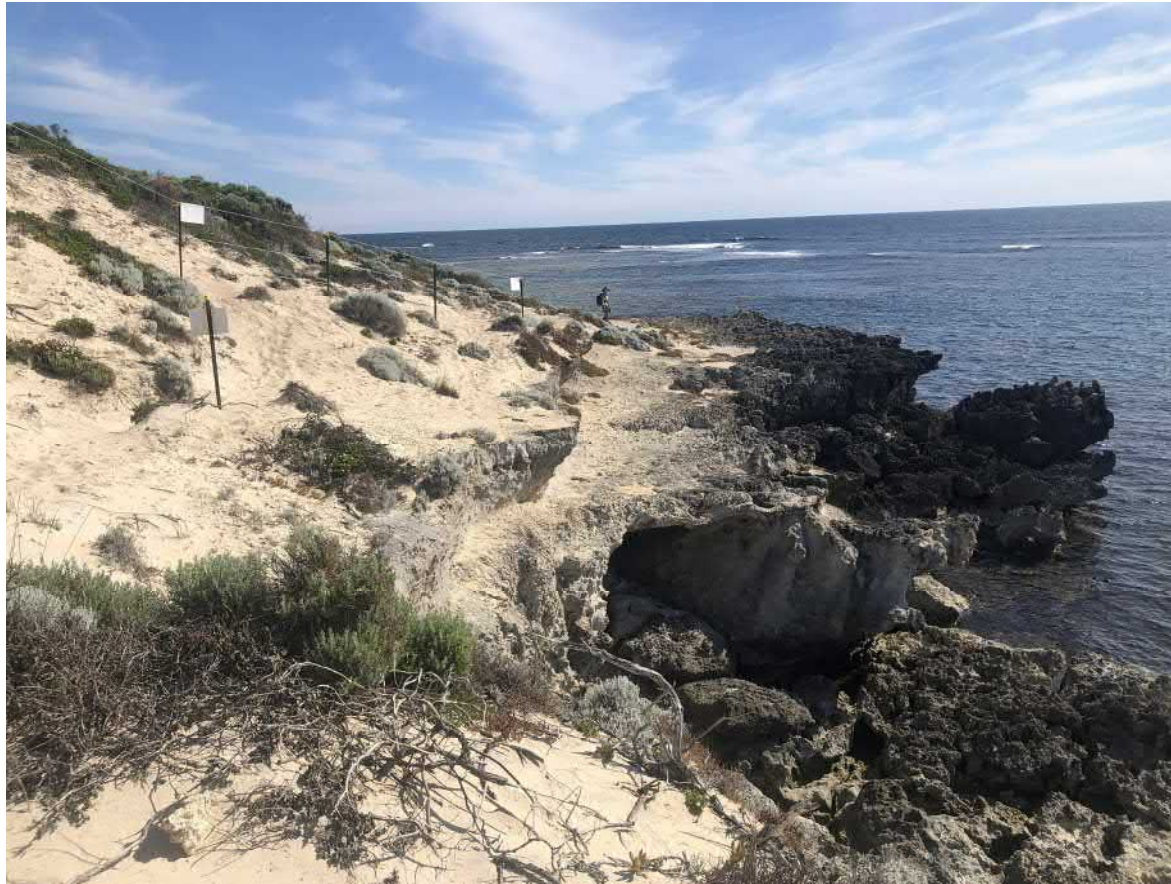
Improve temporary fencing and signing to permanent. Discourage pedestrian traffic. Some access appears to occur down the slope from the lookout. Other people access along the ledge from the south traffic.

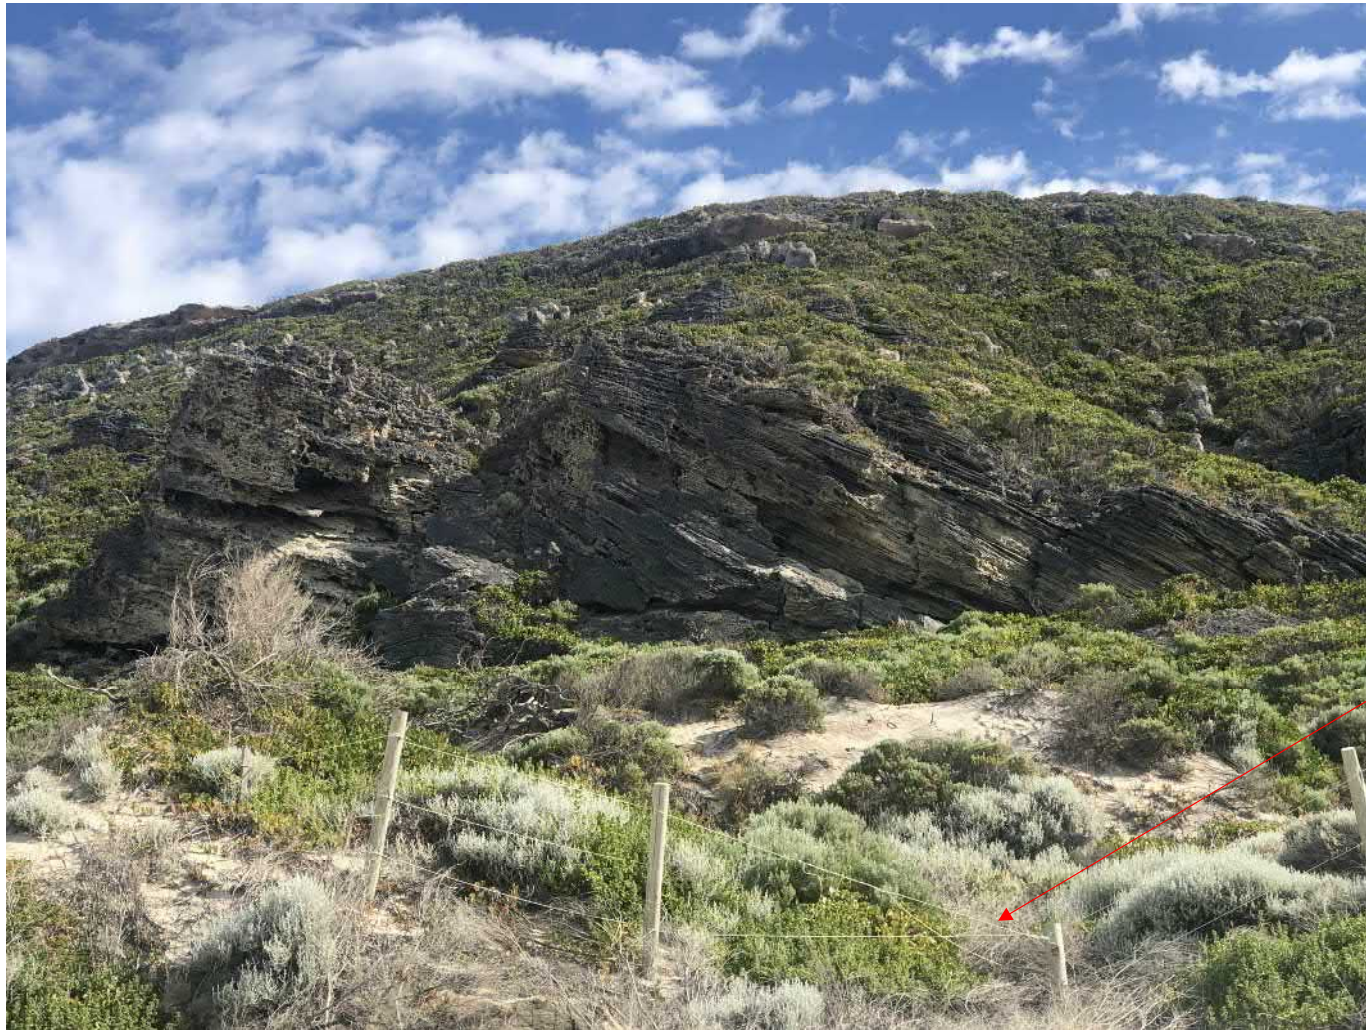
Broken fence.

$R_{DI} = 7.8 \times 10^{-8}$
Repair fence and install rockfall hazard area signage.

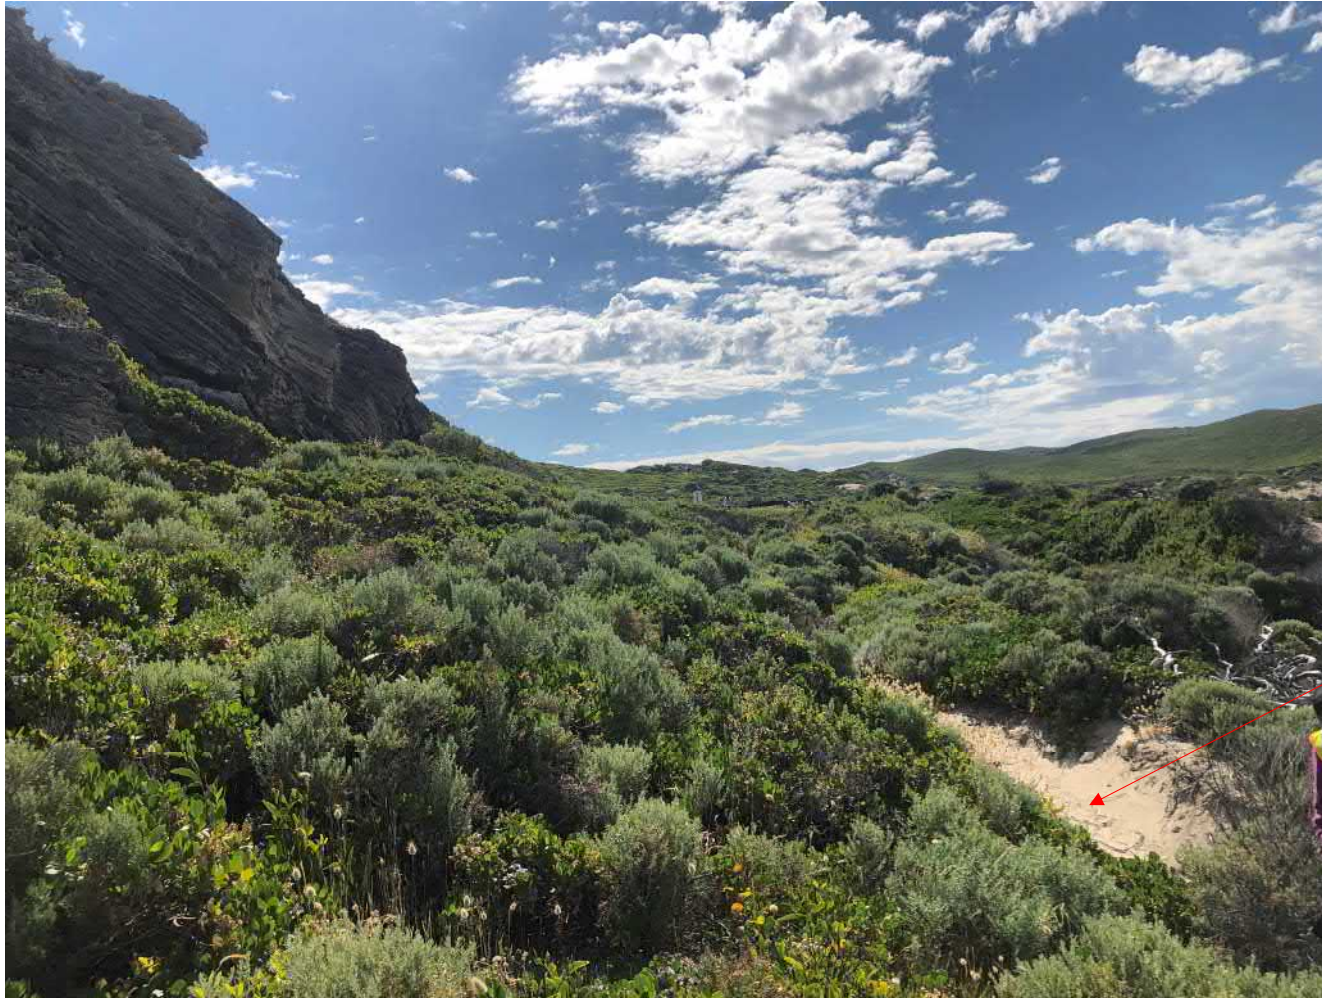
The level of Risk to the Individual Most at Risk (R_{DI}) remains the same as the 2017 assessment.

$$R_{DI} = 1.3 \times 10^{-7}$$

Re-vegetate or place brushwood matting across unofficial access track to discourage traffic.

Add 'rockfall hazard area' sign on the beach.

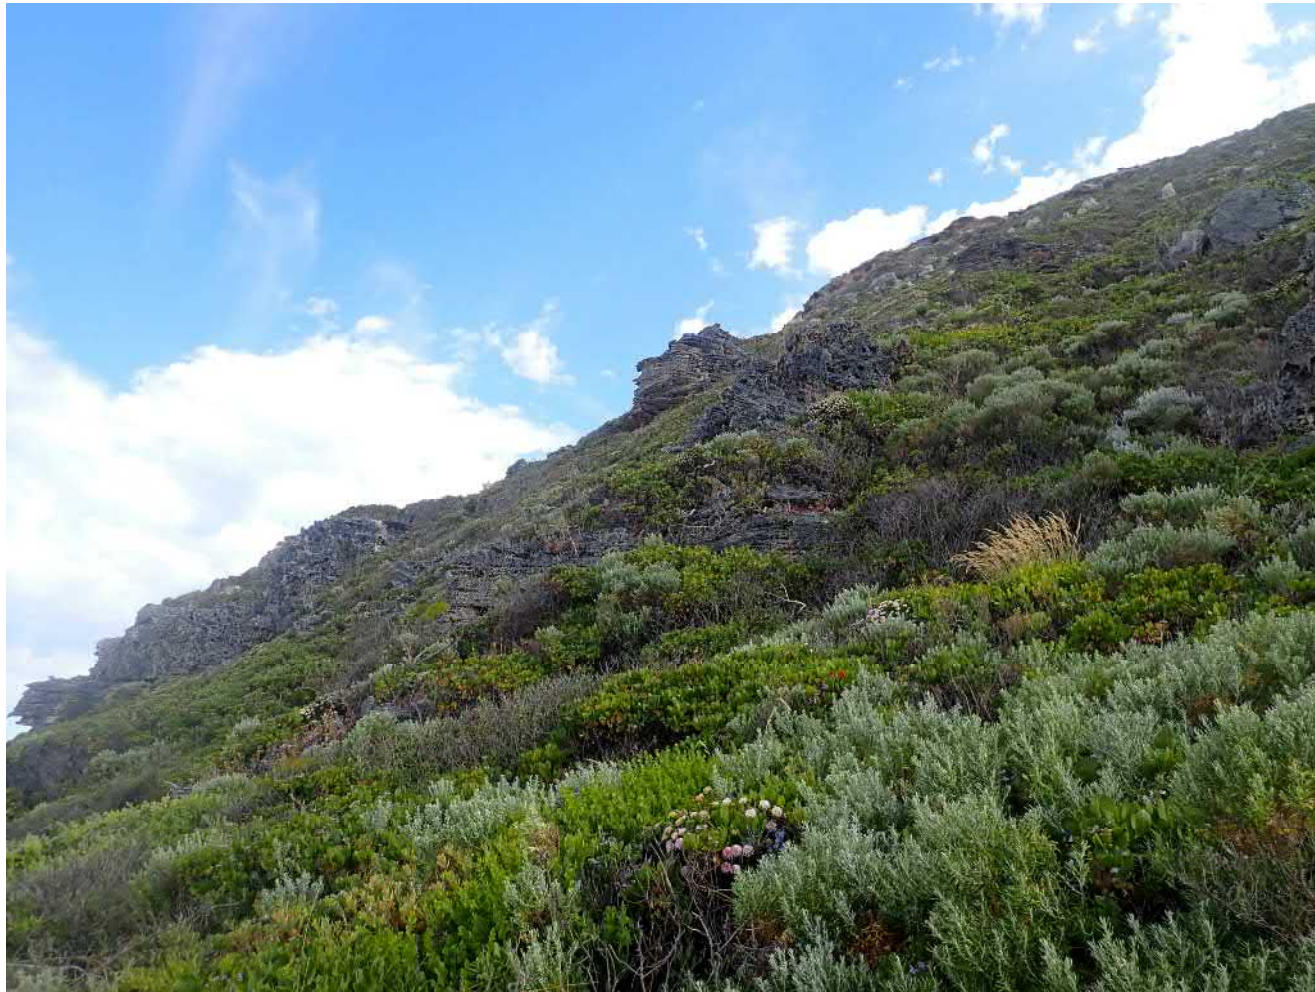
Approximately 3m
overhang

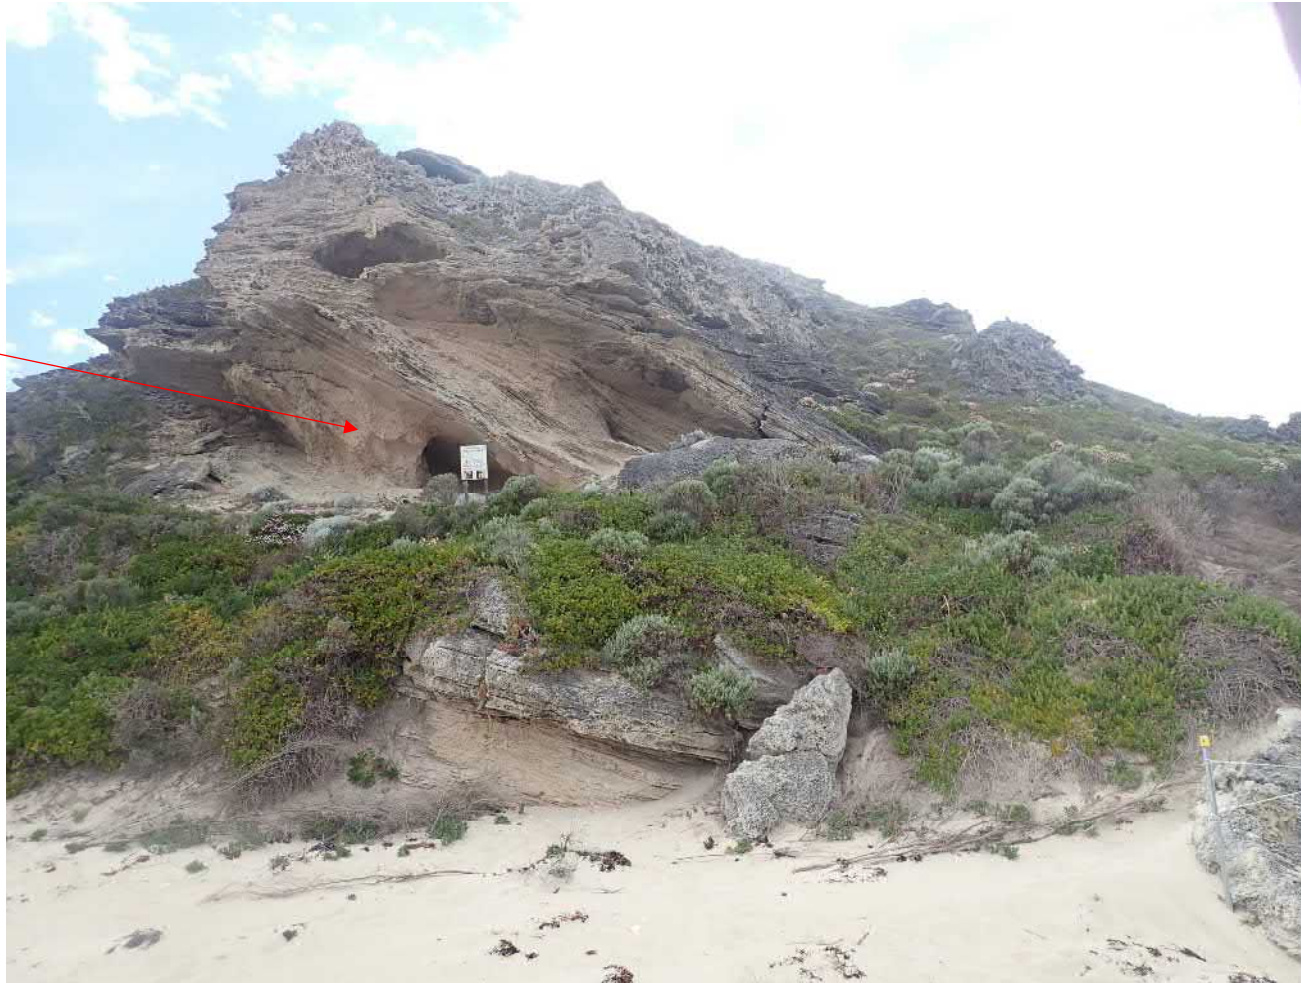
The level of Risk to the Individual Most at Risk (R_{DI}) remains the same as the 2017 assessment.

Add rockfall hazard sign on the beach as well as temporary fencing (Nov to April_ on beach 6 m from dune beach interface.

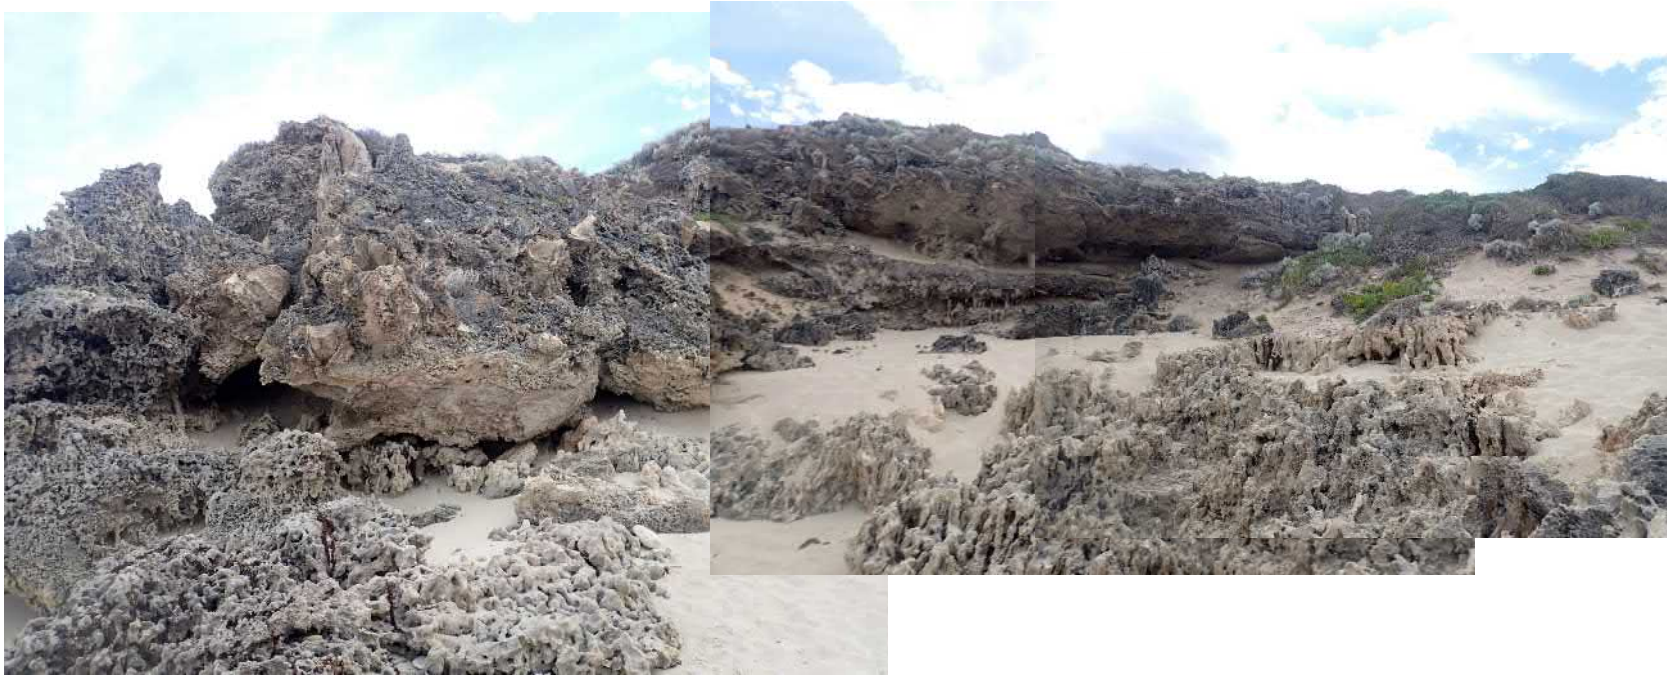
Area approximately 10m wide with a 2.5m overhang.

The level of Risk to the Individual Most at Risk (R_{DI}) = $R_{DI} = 6.2 \times 10^{-6}$

Recommend adding a rockfall risk sign at the base and re-vegetating informal pathway across rocks leading to this area to discourage pedestrian traffic.

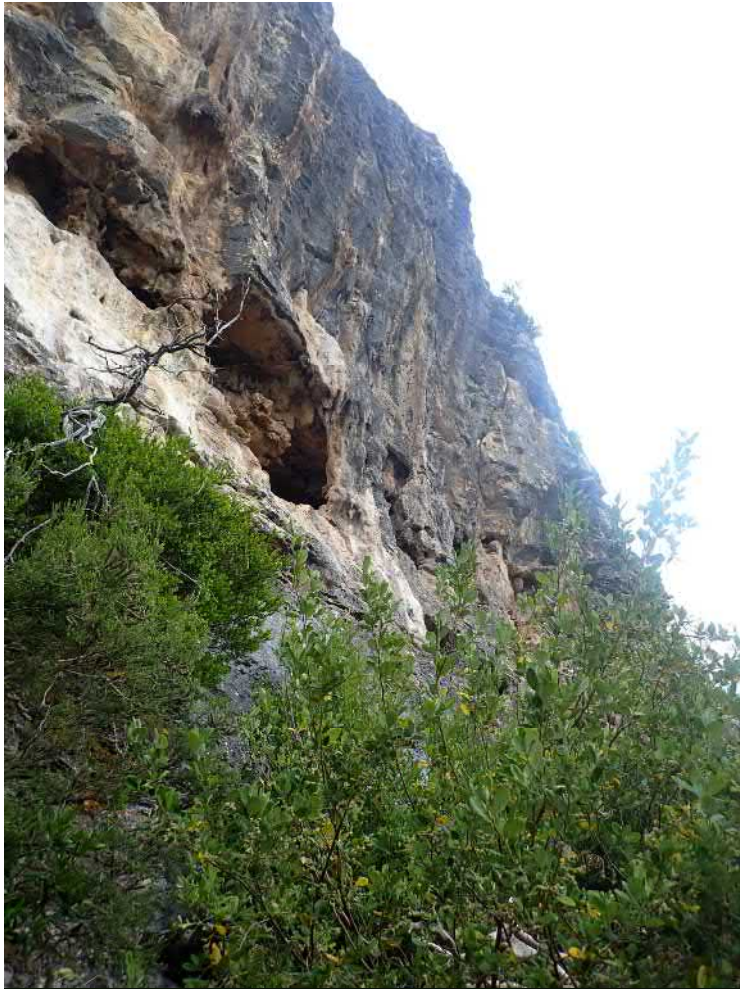
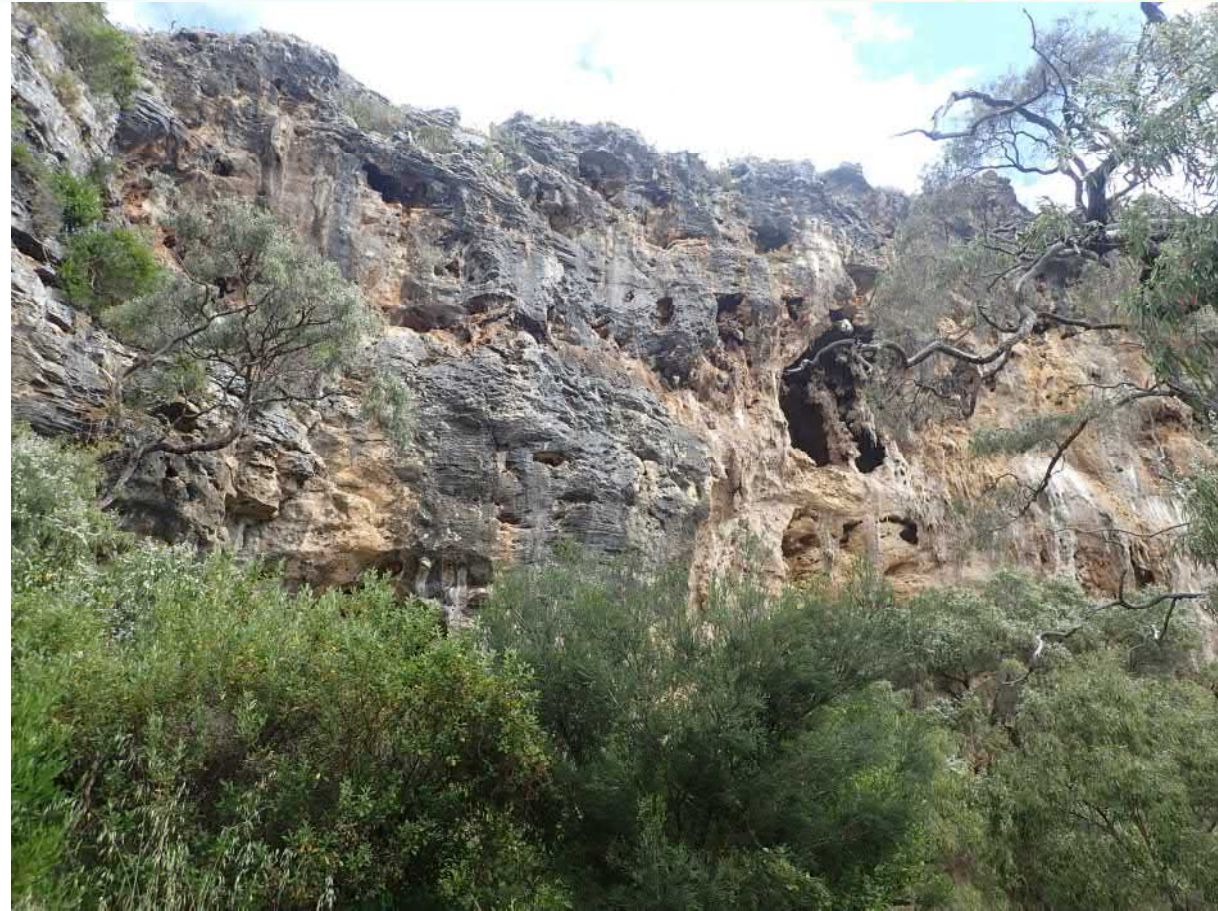
Caves within Wallcliffe cliff face - there are many wild bee hives within the cliff presenting hazard to contractor employer to remove climbing bolts

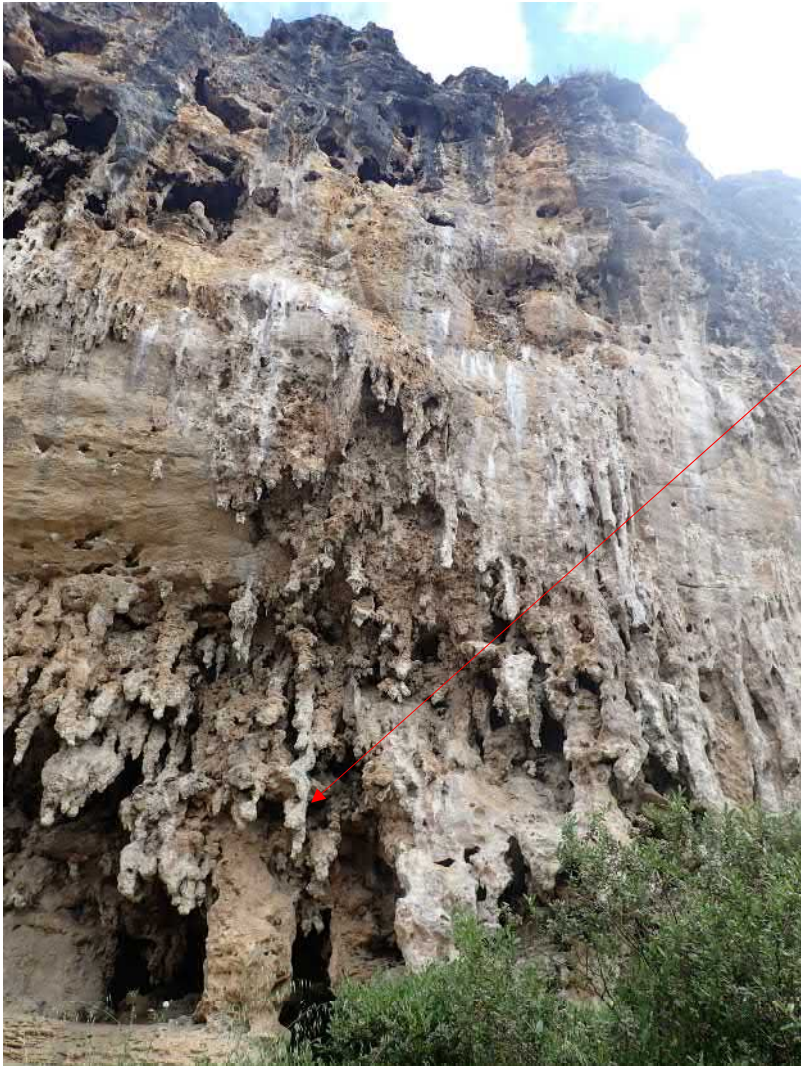
Stalactites potentially can drop process pf removing climbing Keeping people out of the potential drop zone will manage the safety risk but a methodology that avoids descending on ropes into this stalactite zone would help also preserve these features from damage as well as manage safety risk

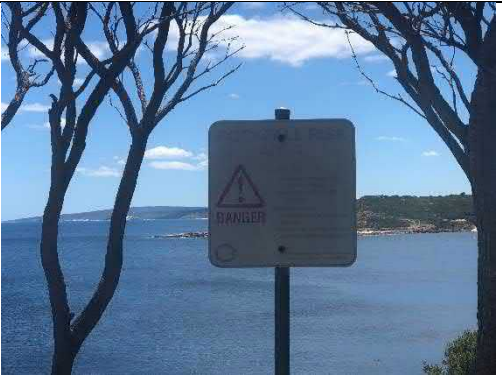
SR08	-	313342	6250918	Not on shire database. Remove sign as it is not directly applicable to the rockfall area.

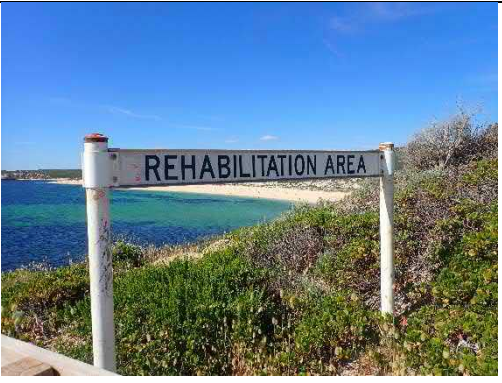
SR35	-	314336	6237021	Rehabilitation sign - good condition. Add "Rockfall Hazard Area" sign.

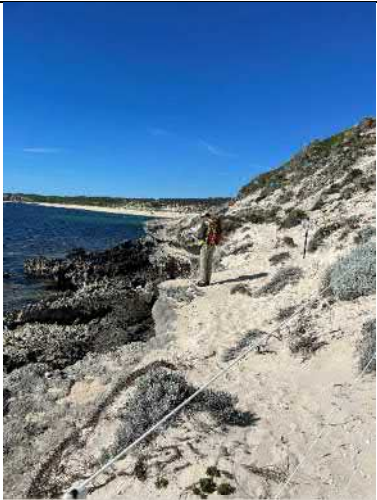
SR39	-	314299	6236987	Add permanent 'Imminent Rockfall Risk' same design/wording as the Riflebutts Cliff signs
