May 2017

# Limestone Cliff Stability Assessment

Report Number. 1666765-001-R-Rev0 Distribution:

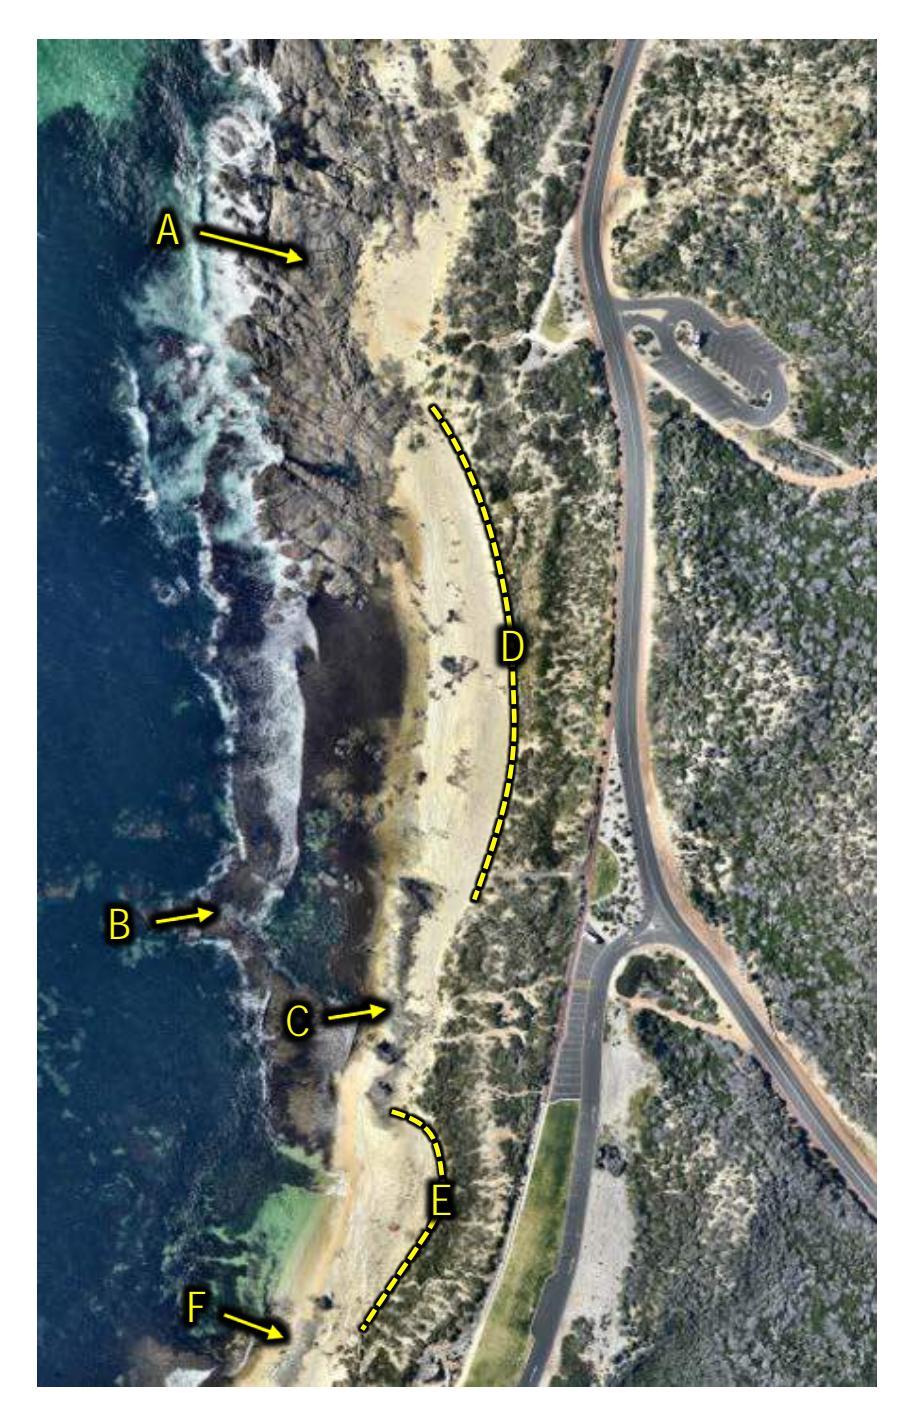
Sketch 3: Annotated aerial photograph showing effect of different types of shoreline protection on coastal geomorphology and cliff retreat

Notes: The lower edge of the existing slope leading up from the beach is marked by the start of vegetation. High strength granitic basement rock at A provides good shoreline protection. The presence of a small offshore reef at B, as well as beachrock and eolianite at C provide shoreline protection but both of these elements together are still not as effective as the granitic basement rock at point A. At D the only shoreline protection is beach sand and an occasional rock boulder. As a result wave erosion is greater and a small crescent shaped indentation in the shoreline has occurred. Likewise at E, the only shoreline protection present is beach sand and a smaller crescent shaped indentation in the shoreline has occurred between eolianite rock shoreline protection at C and F.

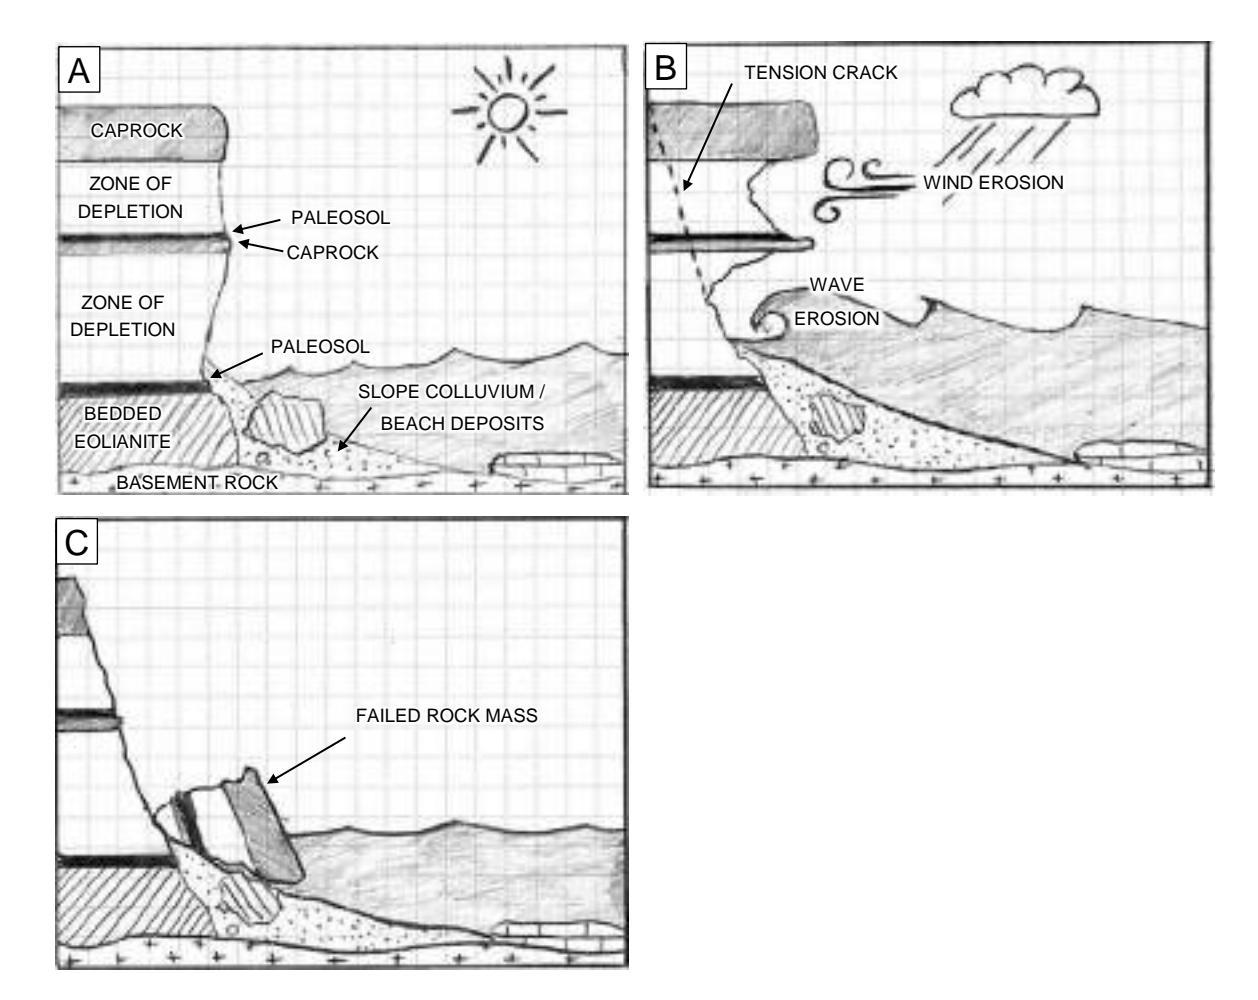
Sketch 4: Illustration of main rockfall mechanism

Notes: A) Showing cliff face and main geological layers. B) Wind and wave erosion leads to undercutting with erosion progressing faster in some layers, as rock layers become undercut relief fractures may form. A potential trigger event of heavy rainfall is shown. C) The slope after rockfall failure has occurred and with the relief fracture being the principal plane of release. The failed material now provides some temporary protection from wave erosion to the new slope.

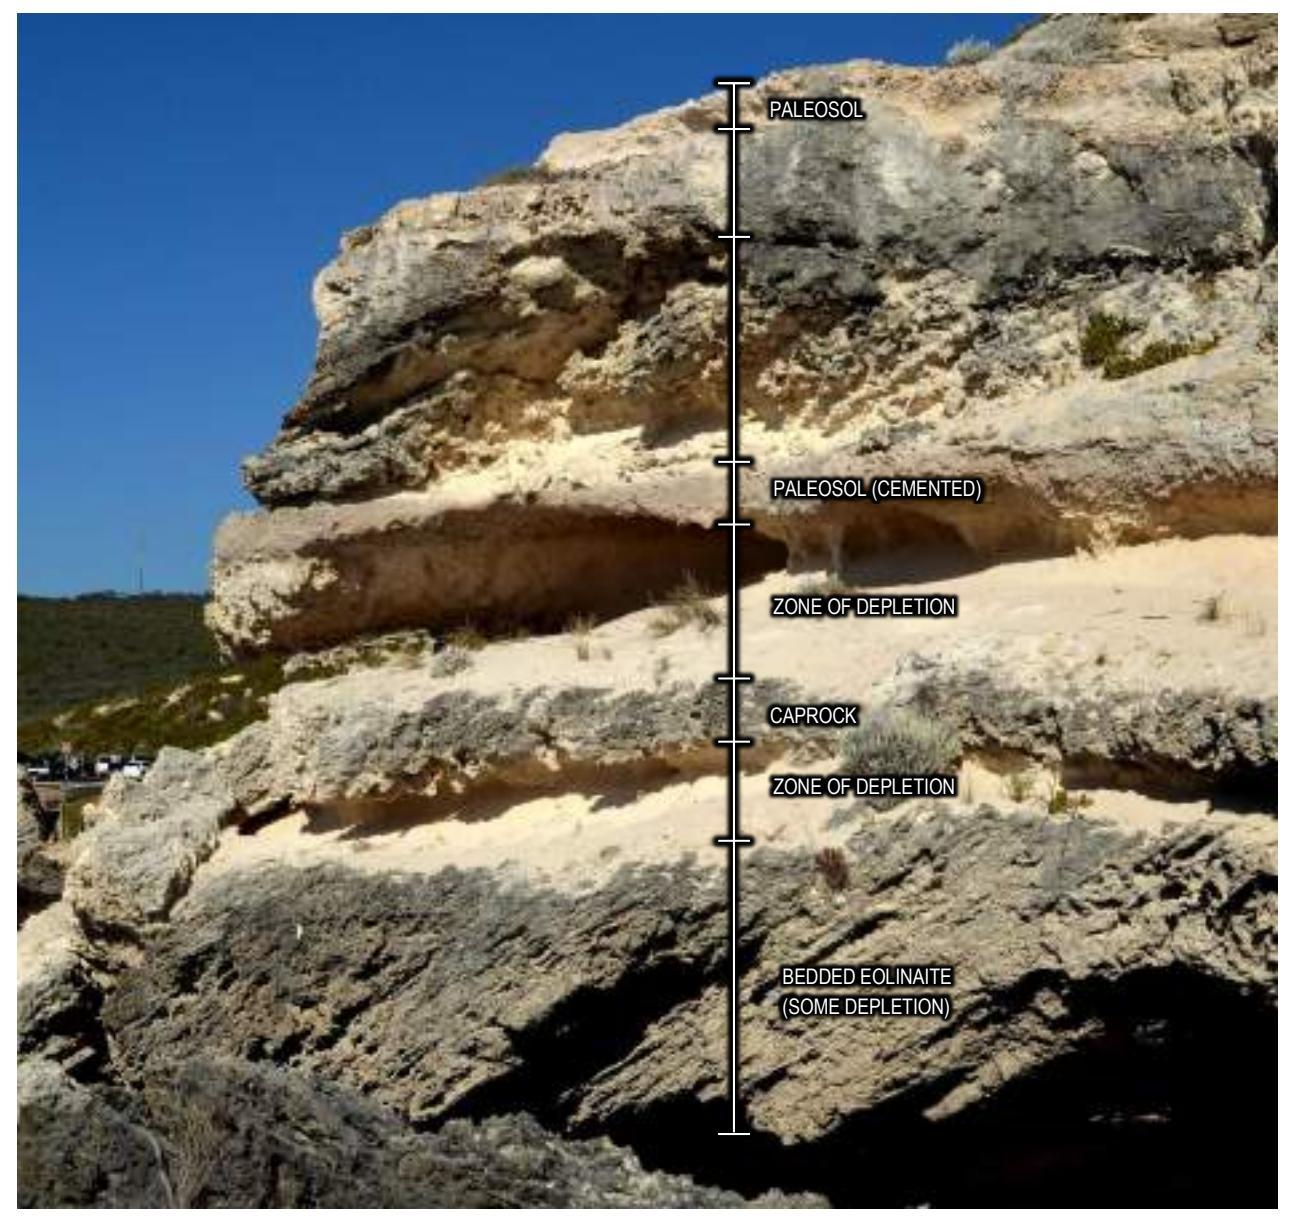
# **Gnarabup** Area

Photograph A8: Looking north-east at the cliffs below the Gnarabup Headland lookout (cars parked at the White Elephant Café parking lot are visible in the centre left of the photograph). The largest visible paleosols, zones of depletion and caprock layers are indicated. (Date of Photograph: 24 January 2017).

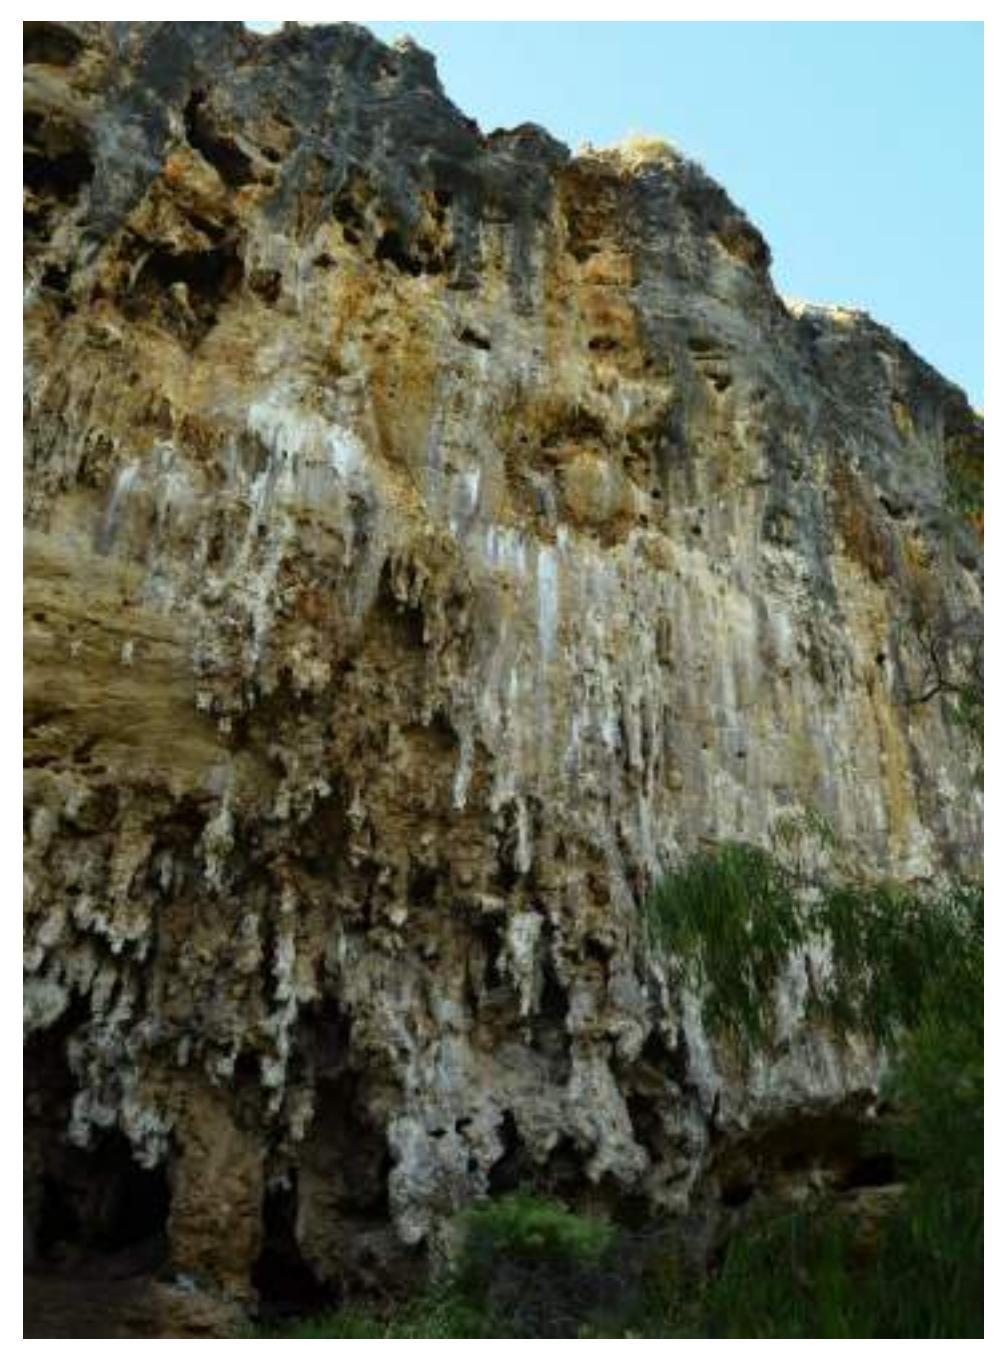
# Wallcliffe Location

Photograph A11: The main wall at the Wallcliffe site showing significant accumulation of flowstone calcrete on the cliff face and formation of stalactites (Date of Photograph: 25 January 2017).

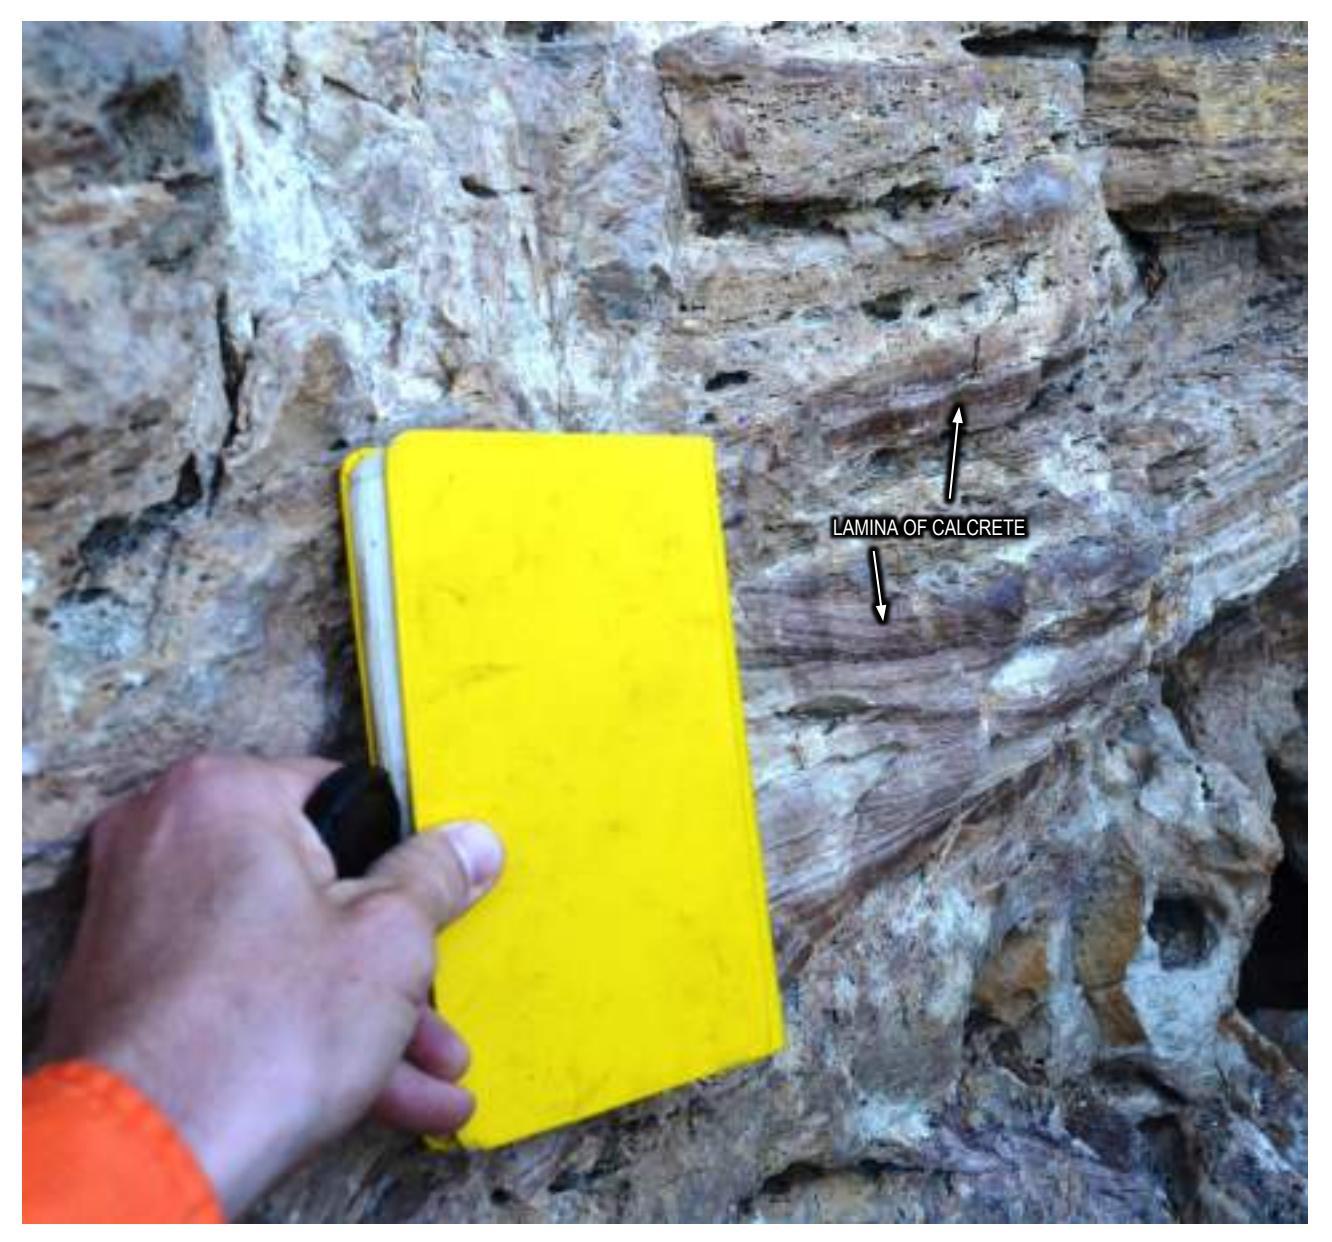
# Wallcliffe Location

Photograph A12: Thin layers (lamina) of calcrete precipitated in cracks on spaces in the older eolianite at the Wallcliffe site (Date of Photograph: 25 January 2017).

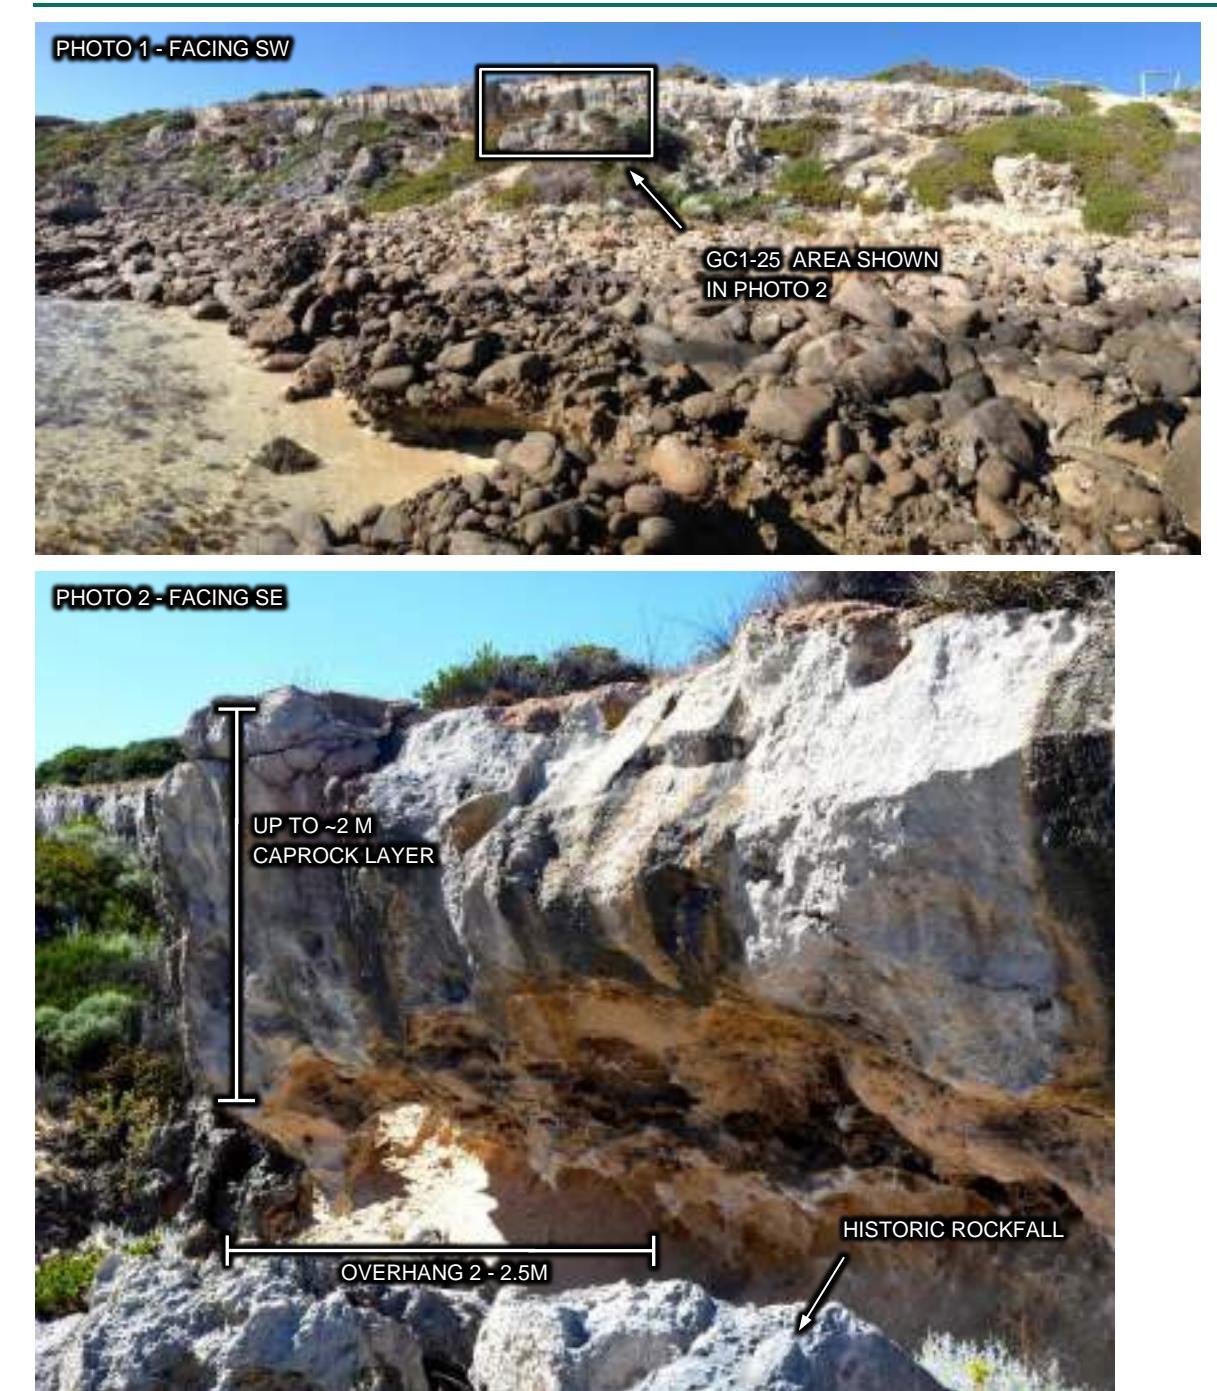
### GRACETOWN GC1 Hazard ID: GC1-50

<u>Description</u>: Overhang of up to 2.5 m with caprock layer up to 2 m thick overlying friable zone of depletion. Numerous rock blocks from historic rockfall on slope below rockfall hazard indicating rockfalls likely occur when overhang reaches between 3 m and 4 m.

- Continue to monitor every 3 years AND;
- Install rockfall hazard signs on fencing above and on exit from stairs onto beach.

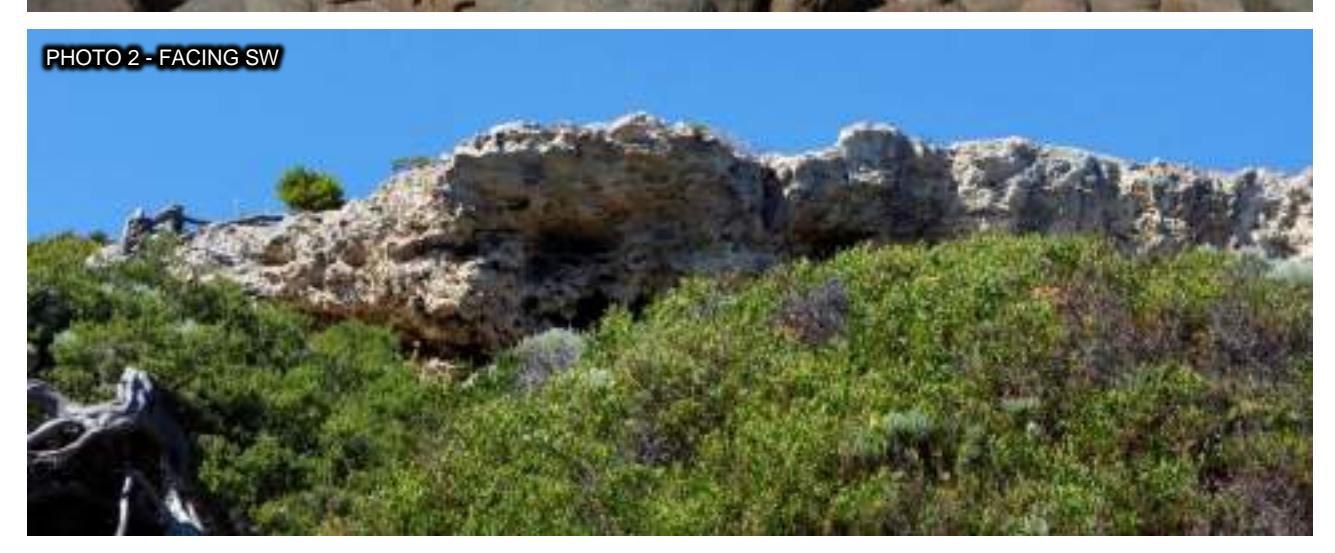
### **GRACETOWN GC2 Hazard ID: GC2-85**

<u>Description:</u> Layer of steeply dipping eolianite overlying more erodible paleosol leading to undercutting and relaxation of the layered eolianite out of the slope. Relief fractures visible due to relaxation.

- Continue monitoring every 3 years AND;
- Install large rockfall hazard signs on exits to the beach from access stairs.
