## 11.2.2 LIMESTONE CLIFF STABILITY ASSESSMENT

<b>LOCATION/ADDRESS</b>	Shire of Augusta Margaret River
<b>APPLICANT/LANDOWNER</b>	Shire of Augusta Margaret River
<b>FILE REFERENCE</b>	ENV/128
<b>REPORT AUTHOR</b>	Jared Drummond, Sustainability Planning Officer
<b>AUTHORISING OFFICER</b>	Dale Putland, Director Sustainable Development

Limestone Stability Assessment – Inspection, Risk Assessment and Remediation Design Report (2019)

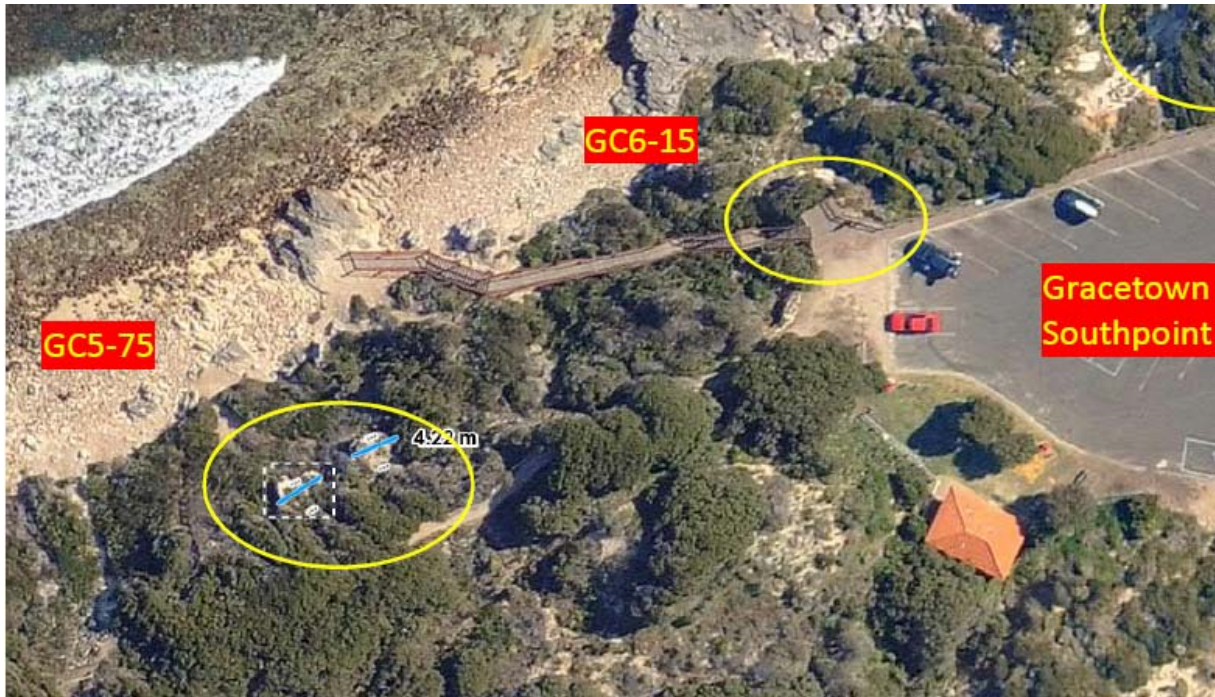
### **Site ID: GC5 – 75 (Gracetown – cliffs south of stairs)**

In 2017, the Shire removed the lookout at GC6 – 15 and this area is now considered to pose an acceptable risk. There are two 5 metre long sections of limestone overhang approximately 10 metres above the beach level (see image below). The site is subject to continuous wind erosion, which continues to further erode the limestone rock. The report notes a fracture associated with the overhang, with the report suggesting that the overhang may collapse in the near future, the risk of which may be exacerbated following a storm event.

It is a popular beach, with children occasionally exploring the overhangs and undercuts, particularly during surf events. The very action of scrambling around this area could be a trigger for a rockfall. The slope below the overhang is heavily vegetated and there is a chance of material hanging up on the slope once fallen from the overhang, reducing the risk of debris impacting people exiting the Southpoint carpark stairs as they traverse the beach towards Huzza beach. Nonetheless some material could reach the beach as noted in images in Attachment 1 depicting historic rockfall. The risk assessment for people traversing the beach resulted in relatively small risks. However, due to the large number of people traversing this beach each year to access the popular surf breaks, cumulative individual risks are considered relatively high.

Following an investigation of various options, the report recommends that the hazard is removed using needle drilling and hand barring to remove the rock on predetermined break lines. It is recommended that this action is implemented in 2020. The cost of implementing this action is \$25,000. There are funds available in the existing budget to implement this action. It is recommended this action be implemented following detailed project scoping and preliminaries, including community engagement.

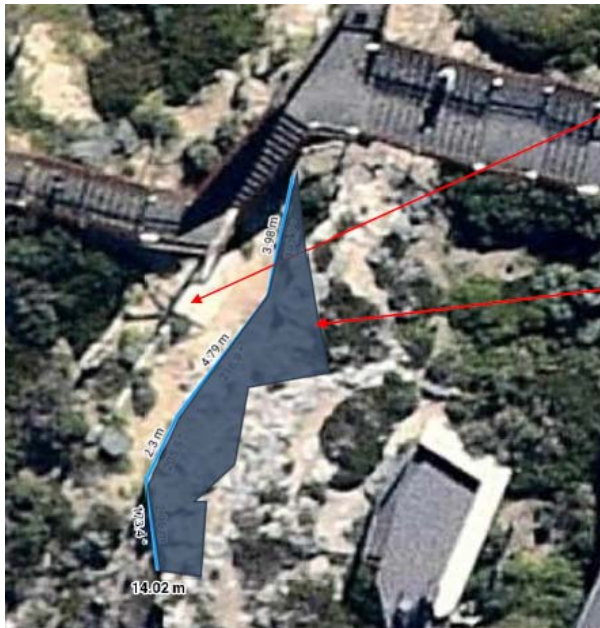
**Site ID: PR4 - 30 (Surfers Point)**

A cliff outcrop/overhang exists mid-way down the cliff face of Surfer's Point directly adjacent to the stairway. To reduce the risk from potential collapse of the overhang, the 2017 report recommended removing the viewing platform and beach midway down the stairway. The viewing platform was removed on this basis (see image below). The scope of works (for this study) required an analysis to be undertaken to determine the resultant risk to public from the overhang and response required (if any). The study also provides advice on the most suitable measure to address risk mitigation, should the Shire wish to re-install the platform in the future.

Removal of the bench and lower viewing platform resulted in the main risk now coming from people sitting on top of the outcrop during surf events or at other times, rather than a risk to people using the stairway. The recommended mitigation response in the report is to underpin the overhang using mass concrete and architectural block work. This not only supports the overhang from collapse but also protects the overhang from future wind erosion. The consultant advised that should this be undertaken it would be safe to re-instate the viewing platform in the future.

Lower lookout and bench removed since 2017

Approximate extent of undercut block caused by wind eroding out leached limestone/sand layer

Further risk mitigation works have commenced, with the first stage including installation of additional cliff safety signage, followed by extension of the balustrading. These works are intended to provide added protection to public and substantiate the exclusion zone. It should be noted that if the underpinning works do not proceed the risk of cliff collapse remains, which could result in retreat of the cliff face due to collapse and subsequent erosion.

In response to the above, it is recommended that the Shire manage this risk through preventive means (i.e. development approval conditions, signage, extended balustrading, inspections, monitoring during surf events etc.) rather than underpinning as recommended in the report. Underpinning may be required in the future if increased visitation is recorded at this site, but will be subject to ongoing monitoring. If required, underpinning could be implemented as part of future budget considerations.

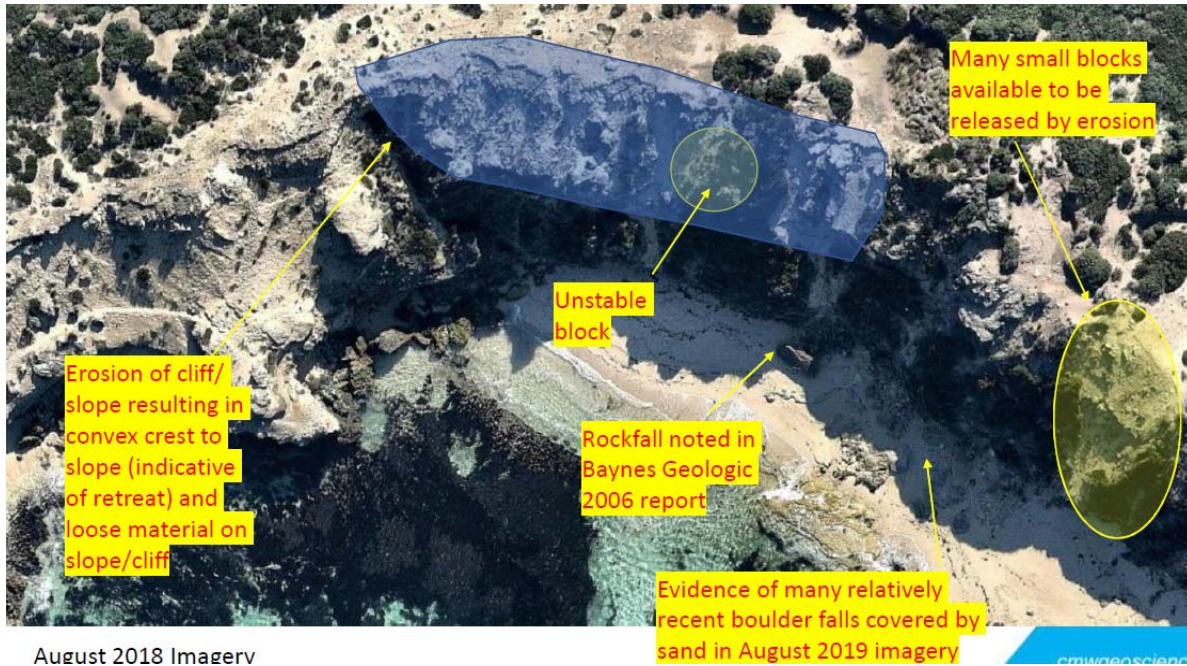
#### Site ID: PR6 - 85 (Cliffs at Riflebutts Beach)

The limestone report from 2017 referred to imminent rockfall risk in the next 1 – 10 years for this stretch of beach (see image below) and recommended closing the beach by way of signage. A large sign has been installed warning 'imminent rockfall beyond this point' but people continue to use this area. As part of the scope of works for the current study, the consultant was required to:

A risk scenario was developed based on the risk of rockfall occurring and the anticipated use of the site by sunbathers and walkers/ dog walkers accessing the hazard zone area. The calculated risk exceeds the tolerable thresholds set out in the AGS 2007 Guidelines (which recommends risk mitigation measures are undertaken to minimise the anticipated risk to public). The report investigated a number of risk mitigation options and included exploring installation of a fence at the base of the cliffs as referred to in the scope of works. This option was discounted due to practicality, primarily due to the significant distance the fence would need to be setback from the cliff base, resulting in it being affected by coastal processes. The report recommends installing a substantial fence (consisting of 4 X 125mm diameter steel posts 1.5 – 2m in height and high tensile wire strands) with *do not pass this point* signage across the full width of the beach, starting at the toe of the cliff and extending into the surf zone.

The cost of this option is estimated at \$25,000. This can be implemented using available funds in the 2019-20 budget. Prior to implementing works, there are a number of preliminary stages (consultation, design, procurement) that first must be undertaken.

An alternative option could be to install several additional signs in a line across the beach perpendicular to the cliff face (before the hazard area starts) warning people of the risks ahead. An educational sign, explaining the nature of the limestone risk ahead, and the importance of not entering this area could also be developed alongside the safety signage. Following installation of the signs, the subject area could be monitored over the summer period through an agreed approach to determine whether the exclusion zone is still being frequented. A risk rating could then be developed using the revised numbers recorded over the reporting period. The risk may be deemed low if members of the public have avoided this area. If following installation of signage visitation numbers to this area are still high, then a reasonable approach would be to install the proposed fence. At the briefing session it was advised that this could be a viable option should council wish to pursue it. As discussed in the report, existing signage has been ignored in the past, however a series of signs across the beach (inclusive of educational

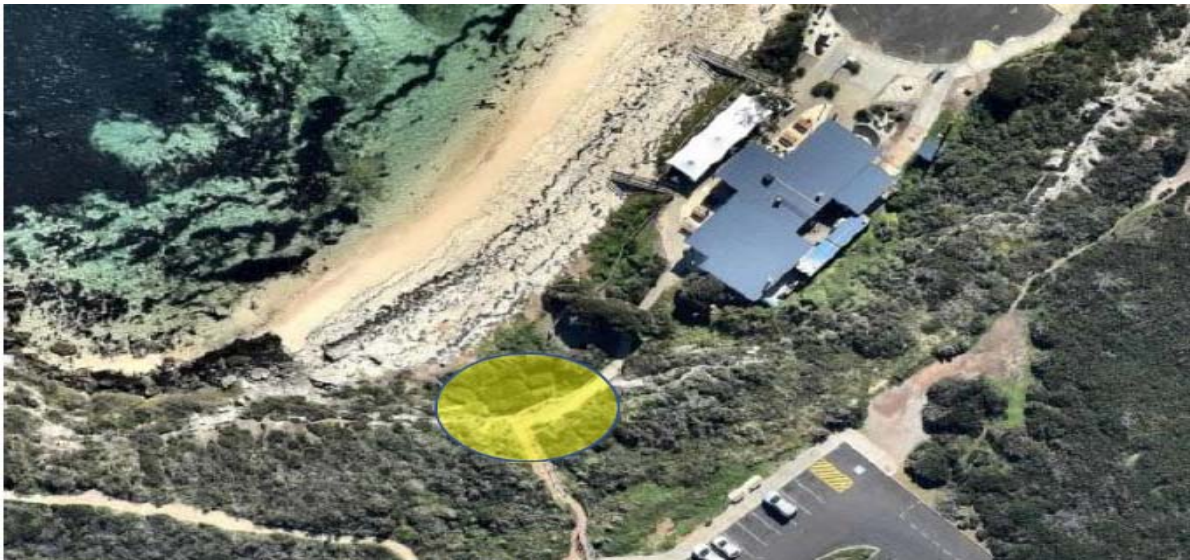
**Site ID: GN5 - 5 (Stairs leading to upper car park from White Elephant)**

Stairs leading down to the White Elephant Café from the upper car park area at Gnarabup are built directly on top of an overhang (see image below). The hazard at this location is largely associated with collapse of the overhang while recreational users are using the stairs. In response to the scope of works, the consultant has installed monitoring equipment and prepared detailed designs to underpin the overhang using concrete, similar to the approach presented for Surfers Point.

Underpinning will significantly reduce the risk of incident should the overhang collapse. The proposed underpinning seeks to improve the safety of the public in the long term, but may also provide a good foundation to replace stairs at the end of their life cycle (approximately 10 years from now). The proposed underpinning is likely to be screened by vegetation from most parts of the beach. It will however, still be visible from the shoreline, jetty and from the ocean. To minimise visual impacts, it is recommended that rockwork similar to the surrounding area (with a rough surface) be applied to the exterior of the concrete (similar to the approach for Surfer’s Point). At the briefing session, a query was raised as to whether the stairway could be relocated to another section of the cliff. The consultant has further considered this option and advised it is considered problematic to realign the stairway. This is mainly due to the existing rock fall hazards identified within the realignment area, the cost of removing rock fall hazards, and the cost of assessing the realignment. There would also be costs associated with removing the existing stairs, and undertaking erosion control in newly exposed areas. The estimated cost of implementing underpinning is \$100,000; however, with architectural rockwork it may cost up to \$150,000.
