Preliminary Acid Sulfate Soils and
Dewatering Management Plan

Proposed Wind Farm in Scott River

Synergy Renewable Energy Diversion

PTG/01489 | Rev E
10 September 2025

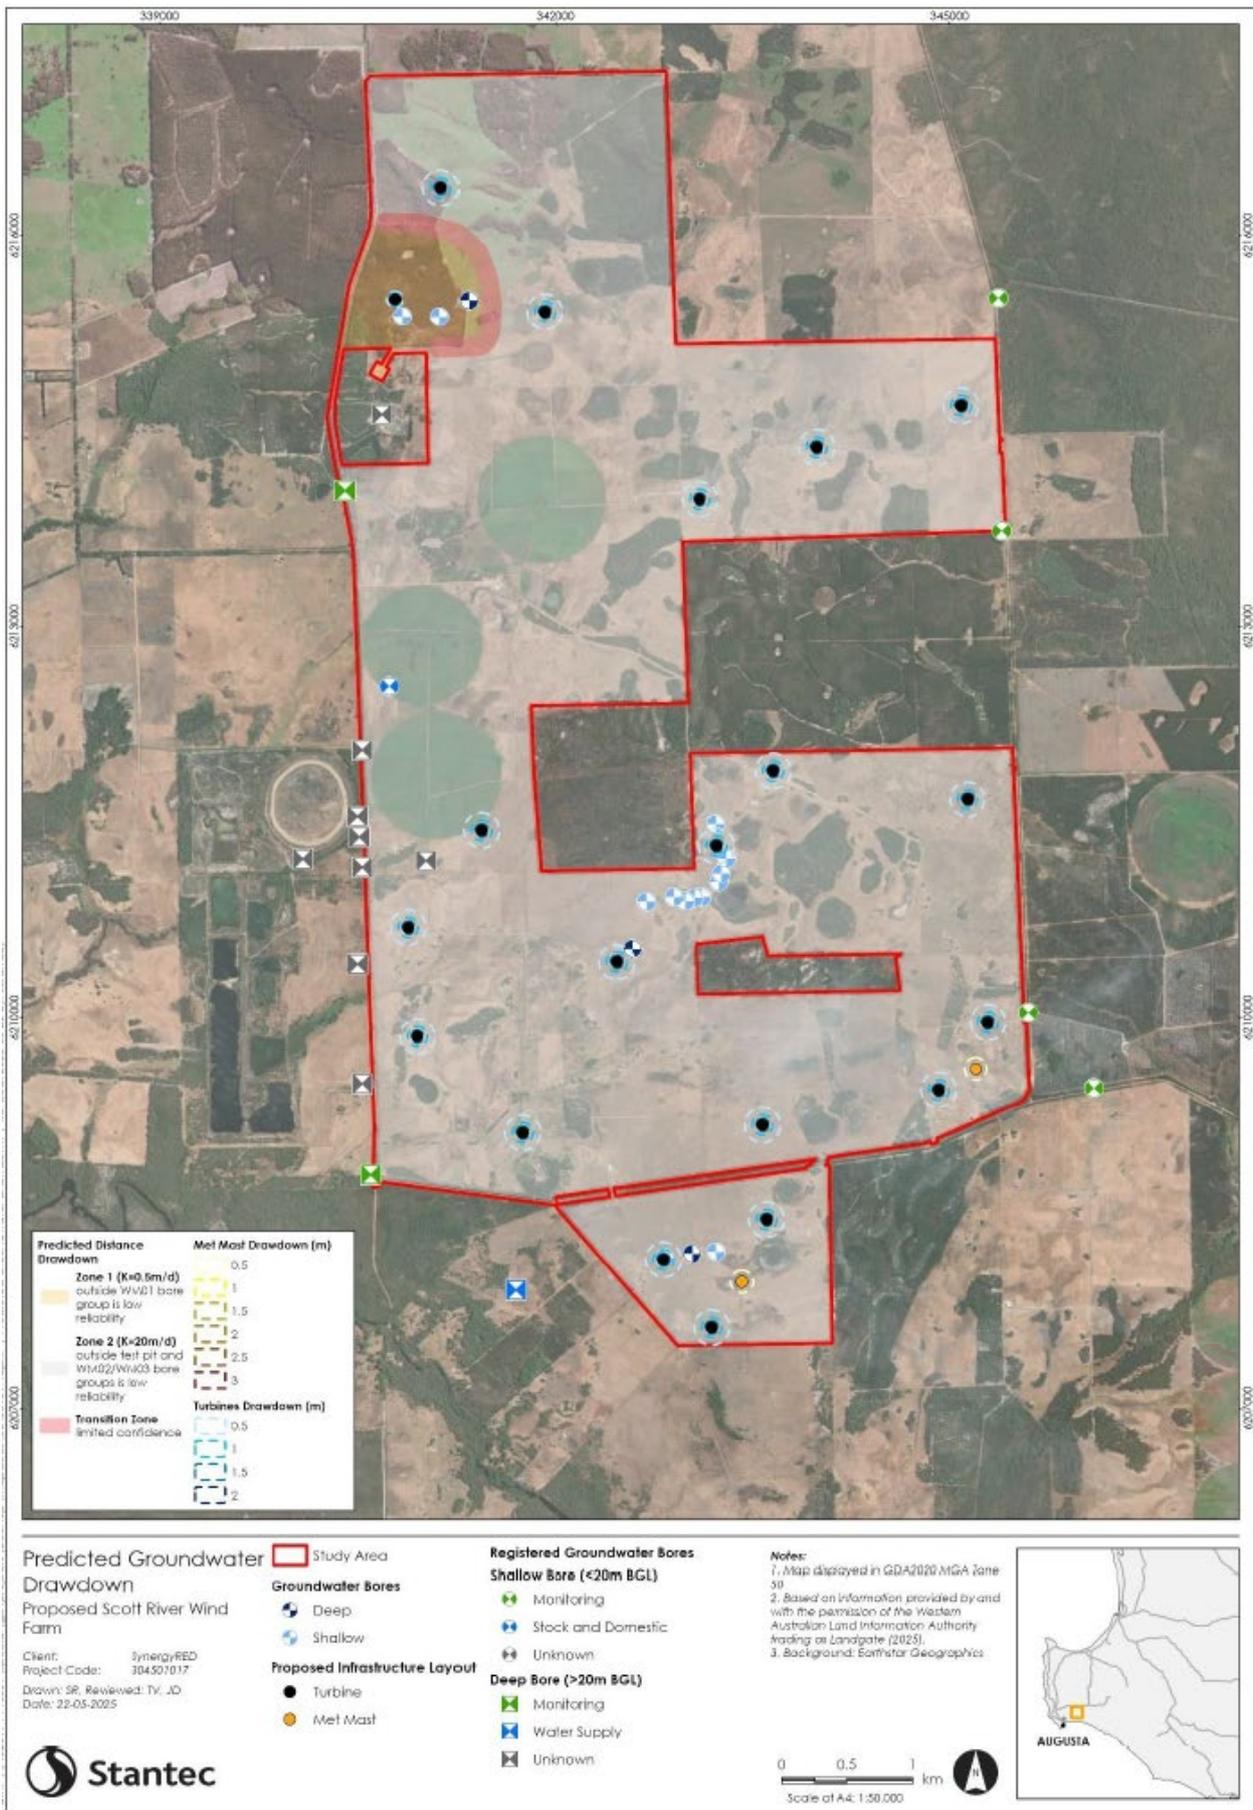
Figure 7-1: Predicted Groundwater Drawdown (Stantec, August 2025)

Groundwater time-varying drawdown extent has been based upon Cooper-Jacob equation (Kruseman and de Ridder, 1994), with the Dupuit-Thiem model used to evaluate distance-drawdown and Marinelli and Niccoli (2000) model used to evaluate inflows in steady state conditions.

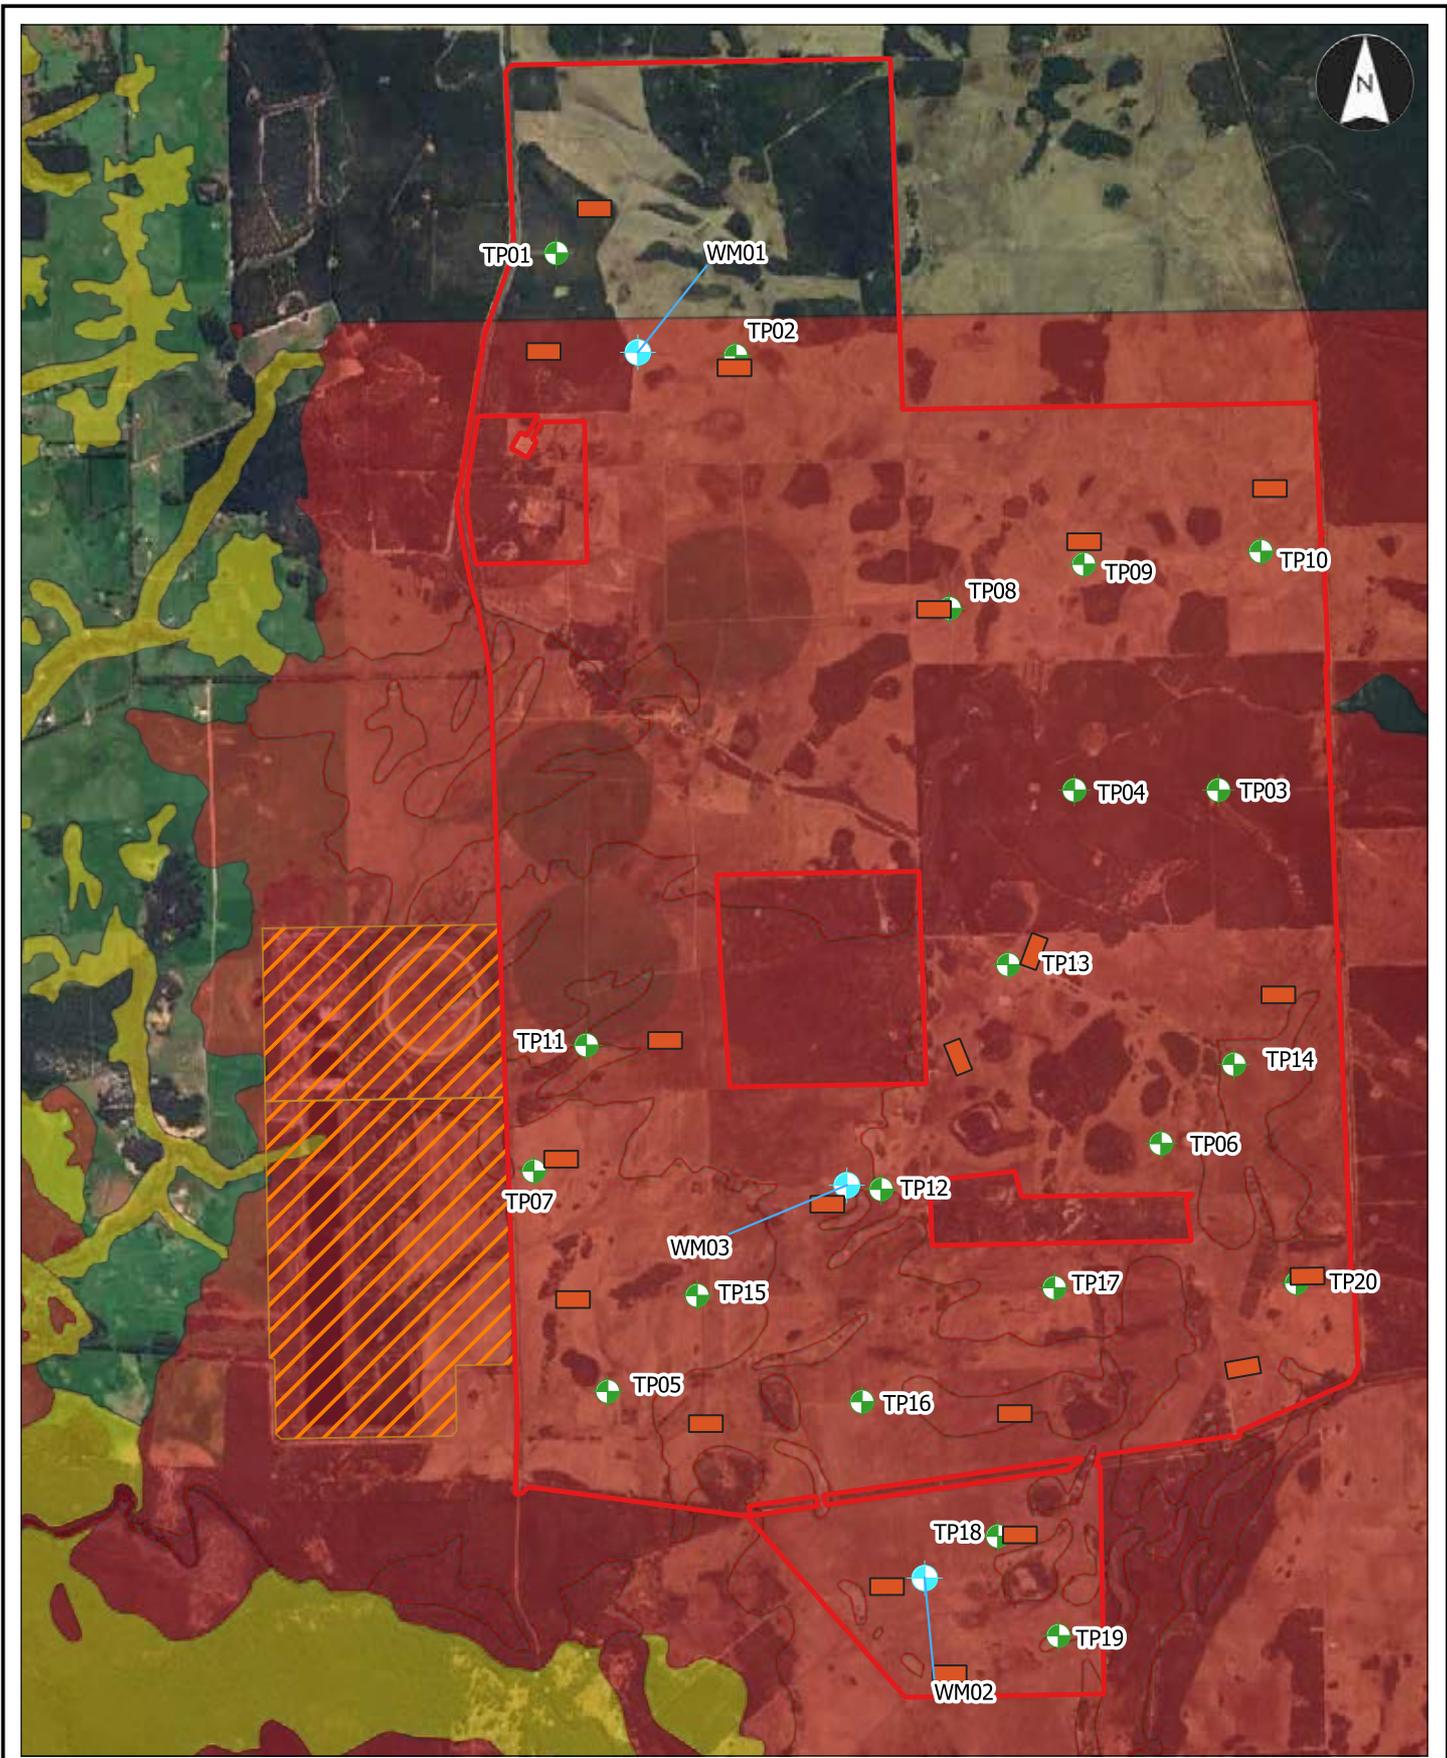
Acid Sulfate Risk and Soil Sampling Locations

<p>Acid Sulfate Soil Mapping and Conditions</p>	<p>Based on the DWER regional Acid Sulfate Soil (ASS) risk mapping (NationalMap, 2025a), the site is mapped “high risk of ASS occurring within 3 m of the natural soil surface” (Figure 3, Appendix A)¹.</p> <p>Investigations by BHP for the adjacent Beenup Mine identified grey/dark grey sands/silts as containing pyrite (only sulfide mineral present) and mainly present as very fine-grained framboidal form, from below ~18 mAHD. Total sulfur concentrations ranged between 0.15 to 6%, with ~70% of samples >1%S, with the majority in the top few metres of the grey/dark grey sands/silts. Minerals effective in neutralising any acidity generated were not present in the grey/dark grey sands/silts (Environmental Geochemistry International Pty Ltd, 1993).</p>
<p>Hydrology</p>	<p>The site intersects the Lower Blackwood, Beenup and Scott Surface Water Management Areas which are known to be influenced by natural groundwater flows, supporting environmental values (DoW, 2016).</p> <p>Key surface water features in the region consist of historically modified catchments with artificial drains to facilitate the agricultural and plantation activities. These drains have not been built in a coordinated way and intersect with roads and natural drainage lines, resulting in several areas of localised ponding due to catchment modification.</p> <p>The site has a poorly defined ridgeline that runs approximately through the centre of the site, segregating 11 Blackwood and Scott River headwater catchments that discharge from the site. Sheet flow occurs across cleared land areas, concentrating into more defined streamflow paths towards the site boundary.</p> <p>There are several areas of natural ponding following rainfall events in areas designated as wetlands and in depressions formed by historical anthropogenic activities. The roads on almost every boundary of the site act as an impediment to flow paths and cause localised upstream ponding, apart from the southernmost catchment which sheet flows across agricultural land (Stantec, November 2024).</p>

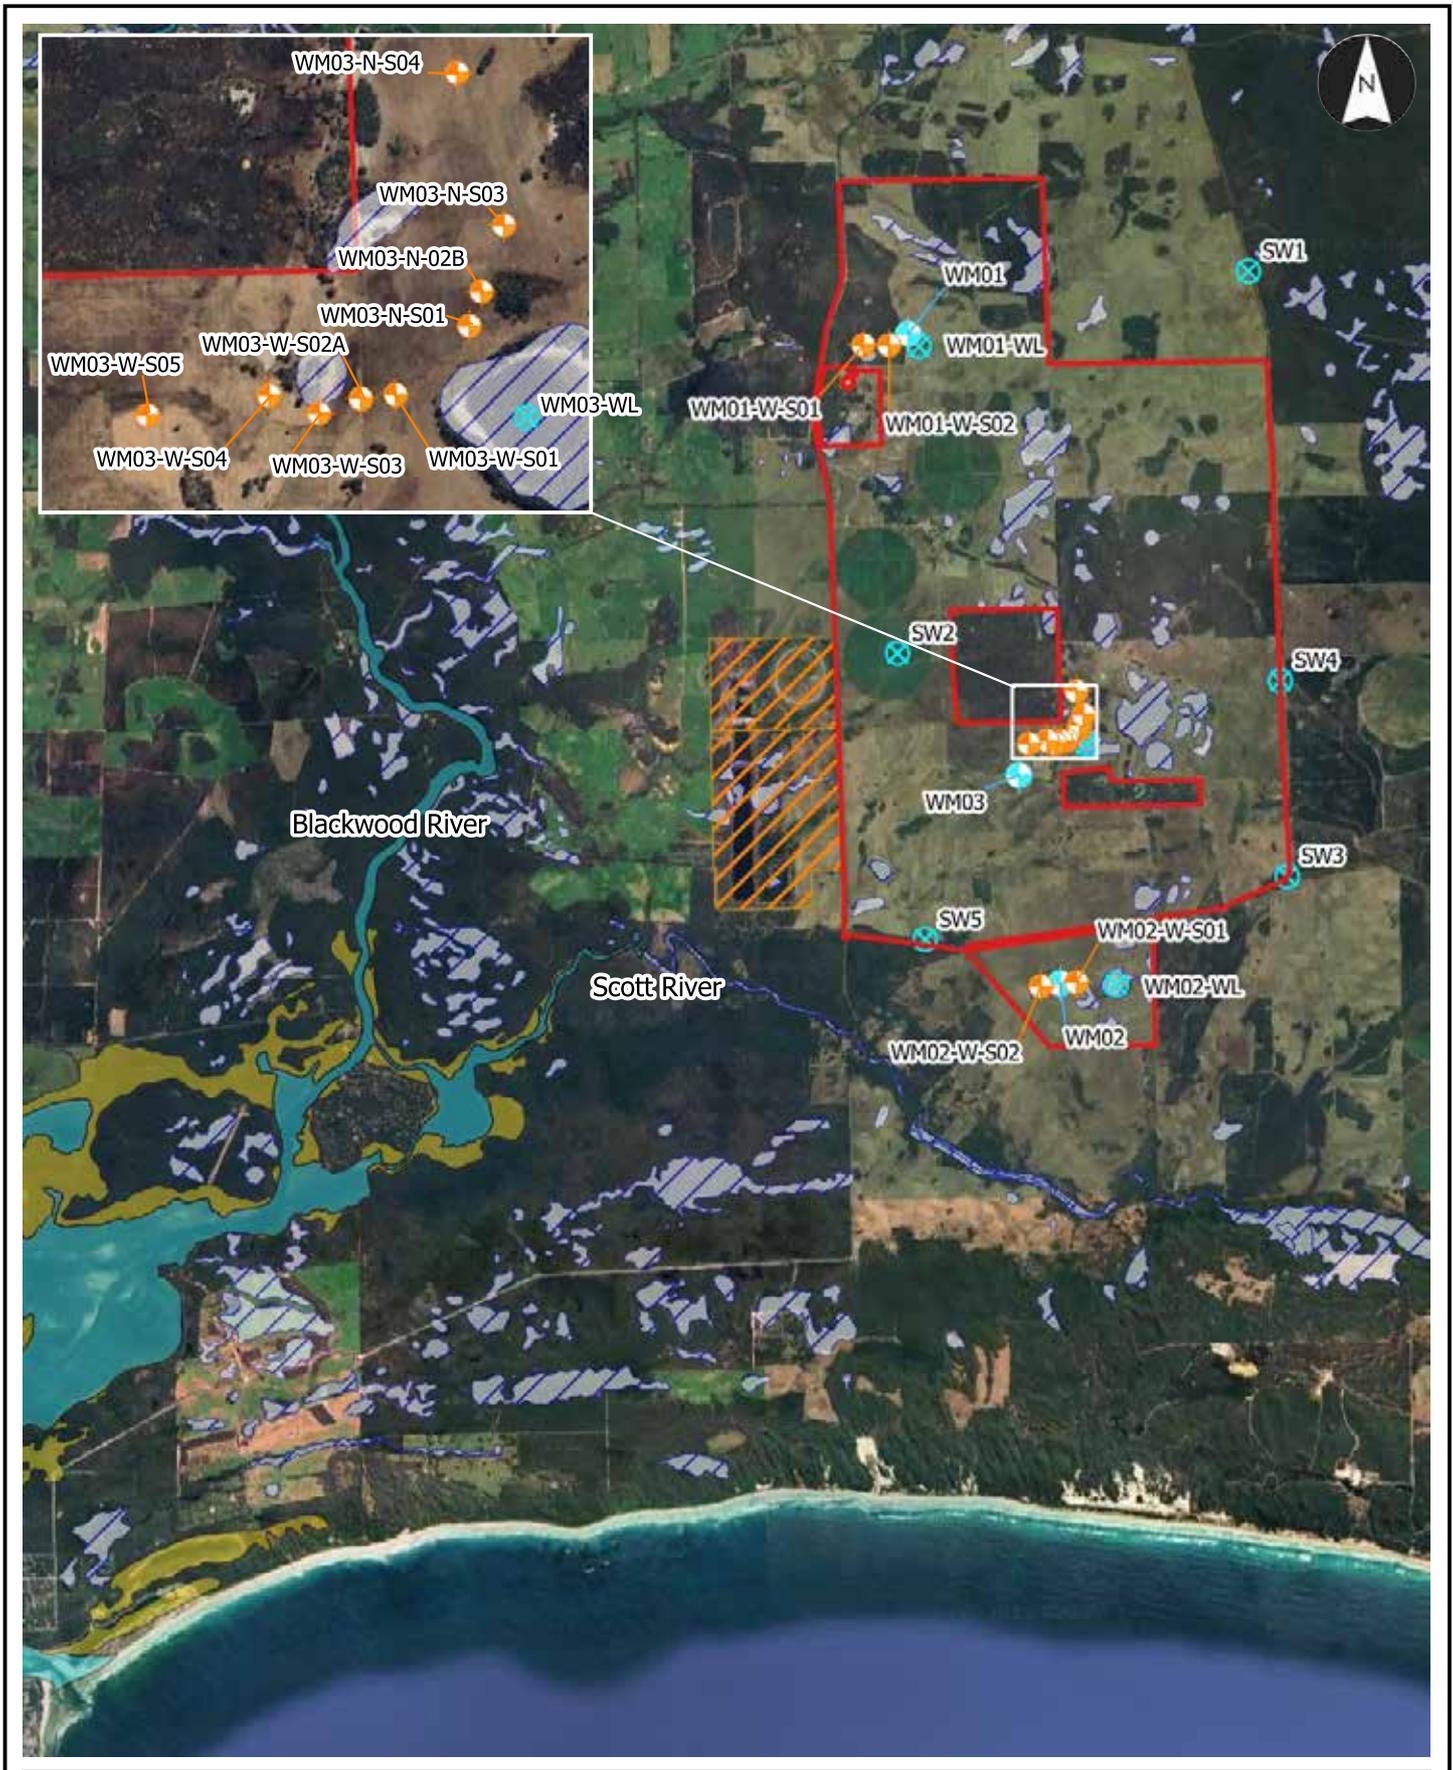
Groundwater, Waterways and Wetlands

Groundwater conditions were assessed from the nine groundwater monitoring bores sampled (Section 5.2.1), across the site (Figure 4). Groundwater results presented in Table B (Appendix D).

Surface water conditions were assessed from the nine surface water locations sampled (Section 5.2.1), across the site (Figure 4, Appendix A). Surface water results presented in Table C (Appendix D).

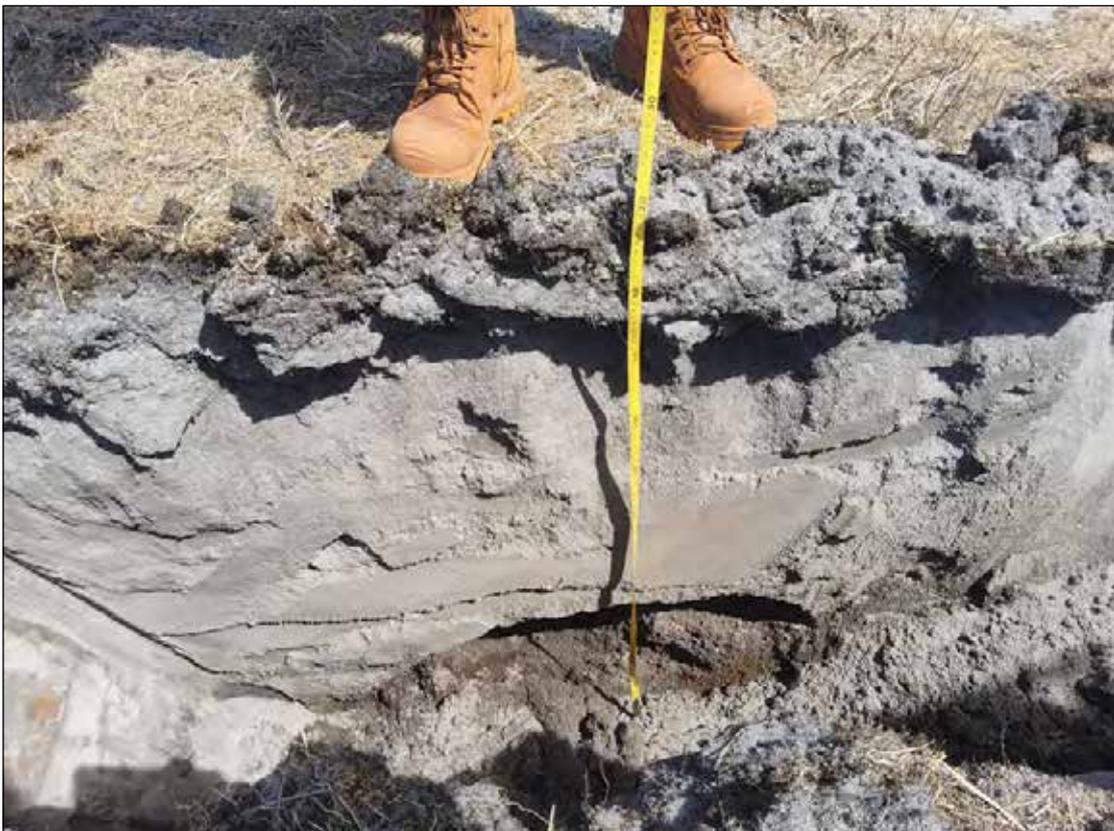
TP10: Downhole view

Excavation Method	Resistance	Stability	Water	Sampling & Testing		RL (m AHD)	Depth (m)	Geology	Graphic Log	SOIL TYPE, plasticity or particle characteristic, colour, secondary and minor components ROCK TYPE, grain size and type, colour, fabric & texture, strength, weathering, defects and structure	Moisture Condition	Cementation / Weathering	Consistency / Relative Density	STRUCTURE & Other Observations				
				Sample or Field Test	DCP TEST Blows													
BH VE Unstable Not Encountered				ES 0.00 m DUP 0.00 m TRIP 0.00 m	3 6 9 12	28.000	0.00	Quaternary Dune Deposits (QDD)	0.10m	TOPSOIL: SAND: fine to medium grained, sub-rounded to sub-angular; dark grey; trace fines. (Topsoil)	D	Uc	Ls to MD	0.00 m: PID - 0.3ppm 0.01 m: had to move to new location due to spraying				
				ES 0.25 m		27.75	0.25			SAND (SP): fine to coarse grained, sub-rounded to sub-angular, quartz with lithics; pale brown to brown. (aeolian)

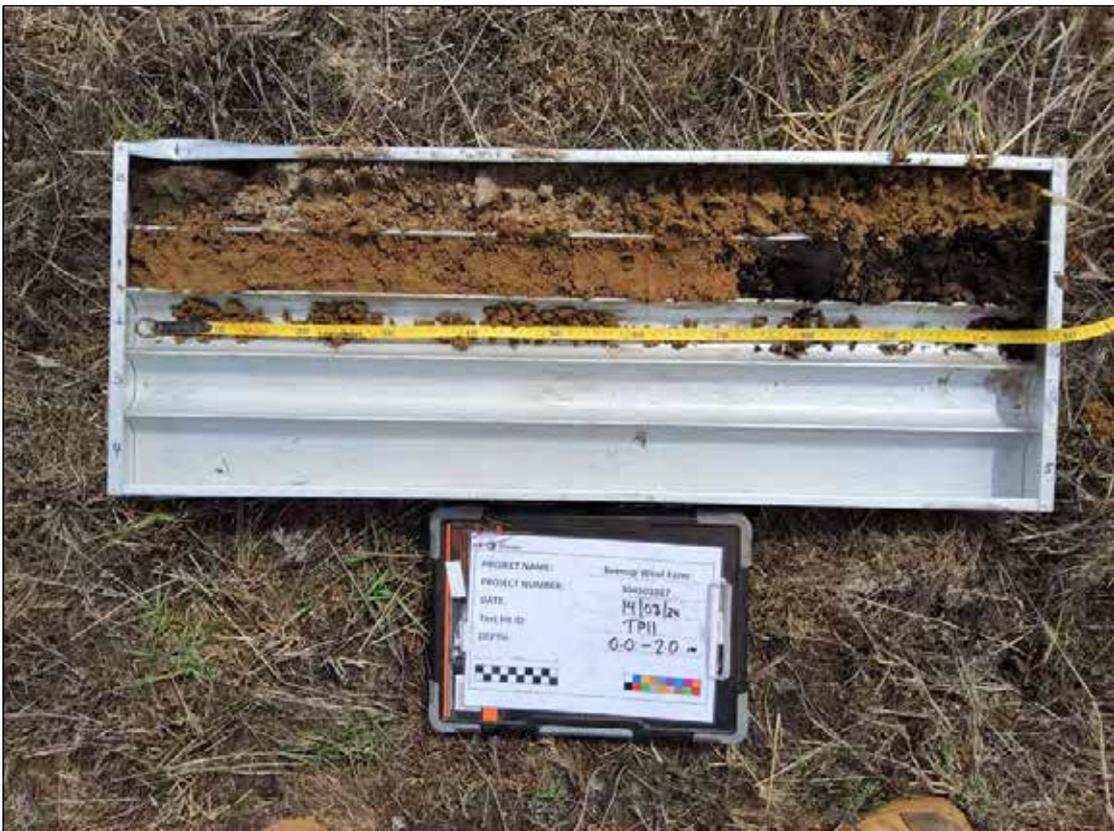
TP11: Coretray - 0.0 - 2.0m

Excavation				Sampling & Testing			Material Description							
Method	Resistance	Stability	Water	Sample or Field Test	DCP TEST Blows	RL (m AHD)	Depth (m)	Geology	Graphic Log	SOIL TYPE, plasticity or particle characteristic, colour, secondary and minor components ROCK TYPE, grain size and type, colour, fabric & texture, strength, weathering, defects and structure	Moisture Condition	Cementation / Weathering	Consistency / Relative Density	STRUCTURE & Other Observations
BH	VE	Stable	N.E	ES 0.00 m	3 6 9 12			TS		TOPSOIL: SAND: fine to medium grained, sub-rounded to sub-angular; dark grey; trace fines. (Topsoil)	D	Uc	Ls	0.00 m: PID - 3.4ppm
VH					Refusal			D		SAND (SP): fine to medium grained, rounded to angular, quartz; pale grey, mottled pale yellow-brown. (aeolian) FERRICRETE: fine grained; dark orange brown; massive; variably cemented comprising soil and rock strength fragments. (Dl duricrust).	We	M

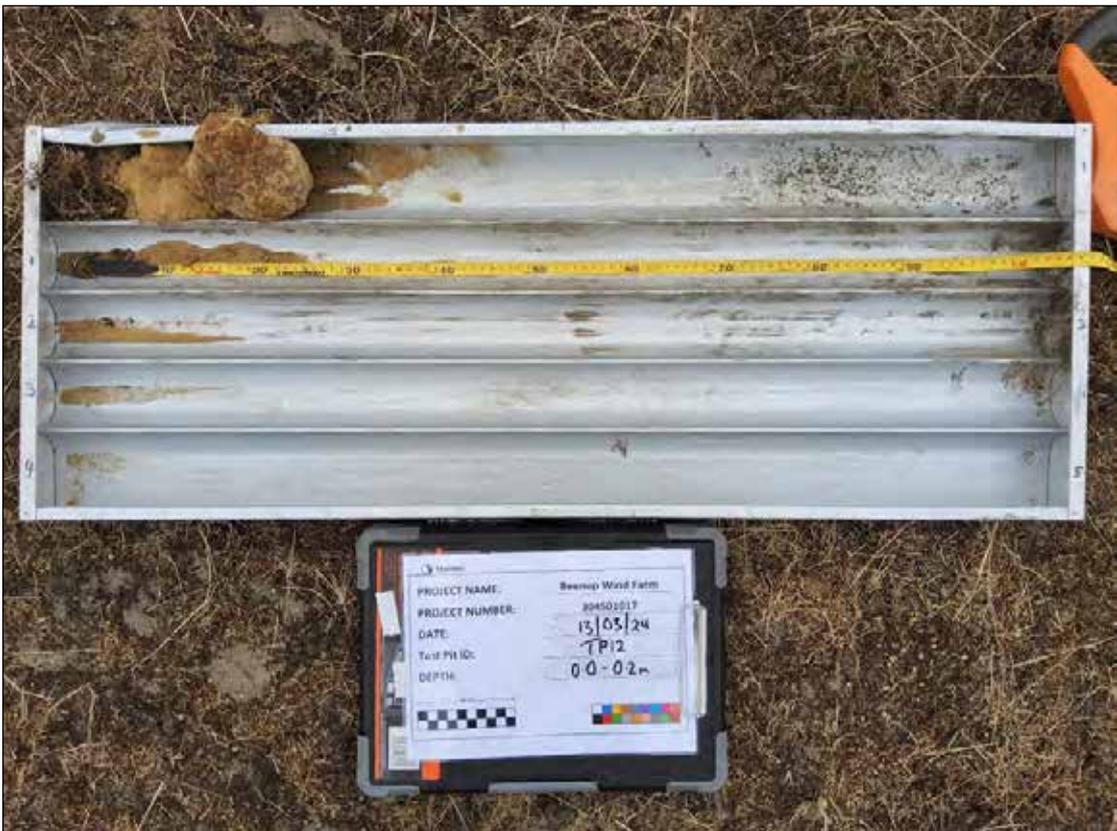
TP12: Coretray - 0.0 - 0.2m

Excavation			Sampling & Testing		Material Description									
Method	Resistance	Stability	Water	Sample or Field Test	DCP TEST Blows	RL (m AHD)	Depth (m)	Geology	Graphic Log	SOIL TYPE, plasticity or particle characteristic, colour, secondary and minor components ROCK TYPE, grain size and type, colour, fabric & texture, strength, weathering, defects and structure	Moisture Condition	Cementation / Weathering	Consistency / Relative Density	STRUCTURE & Other Observations
BH ↑ VE Unstable Not Encountered ↓				ES 0.00 m	3 6 9 12			TS	0.10m	TOPSOIL: SAND: fine to medium grained, sub-rounded to sub-angular; dark grey; trace fines. (Topsoil)	D	Uc	Ls to MD	0.00 m: PID - 0.7ppm
				ES 0.25 m	1			Quaternary Dune Deposits (QDD)		SAND (SP): fine to medium grained, rounded to angular, quartz; pale grey, mottled dark grey. (aeolian)				
				ES 0.50 m	2	38.5	0.5						MD	0.50 m: PID - 2.9ppm
				ES 0.75 m	3

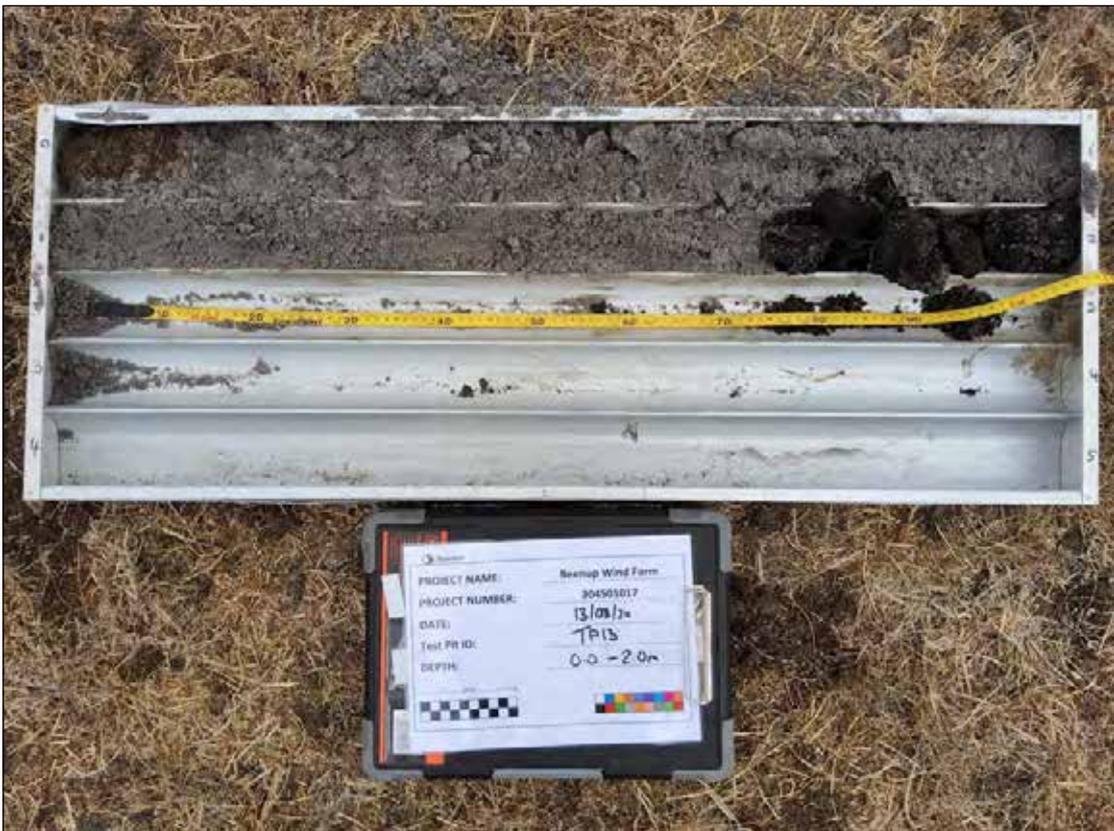
TP13: Corebox - 0.0 - 2.0

Excavation			Sampling & Testing			Material Description								
Method	Resistance	Stability	Water	Sample or Field Test	DCP TEST Blows	RL (m AHD)	Depth (m)	Geology	Graphic Log	SOIL TYPE, plasticity or particle characteristic, colour, secondary and minor components ROCK TYPE, grain size and type, colour, fabric & texture, strength, weathering, defects and structure	Moisture Condition	Cementation / Weathering	Consistency / Relative Density	STRUCTURE & Other Observations
BH	VE	Stable	Not Encountered	ASS 0.00 m	3 6 9 12			TS		TOPSOIL: SAND: fine to medium grained, sub-rounded to sub-angular; dark grey; trace fines. (Topsoil)	D	Uc	MD to D	0.00 m: PID - 2.5ppm
	VH			ES 0.25 m	Refusal			QDD		SAND (SP): fine to medium grained, rounded to angular, quartz; pale grey, mottled pale brown. (aeolian)

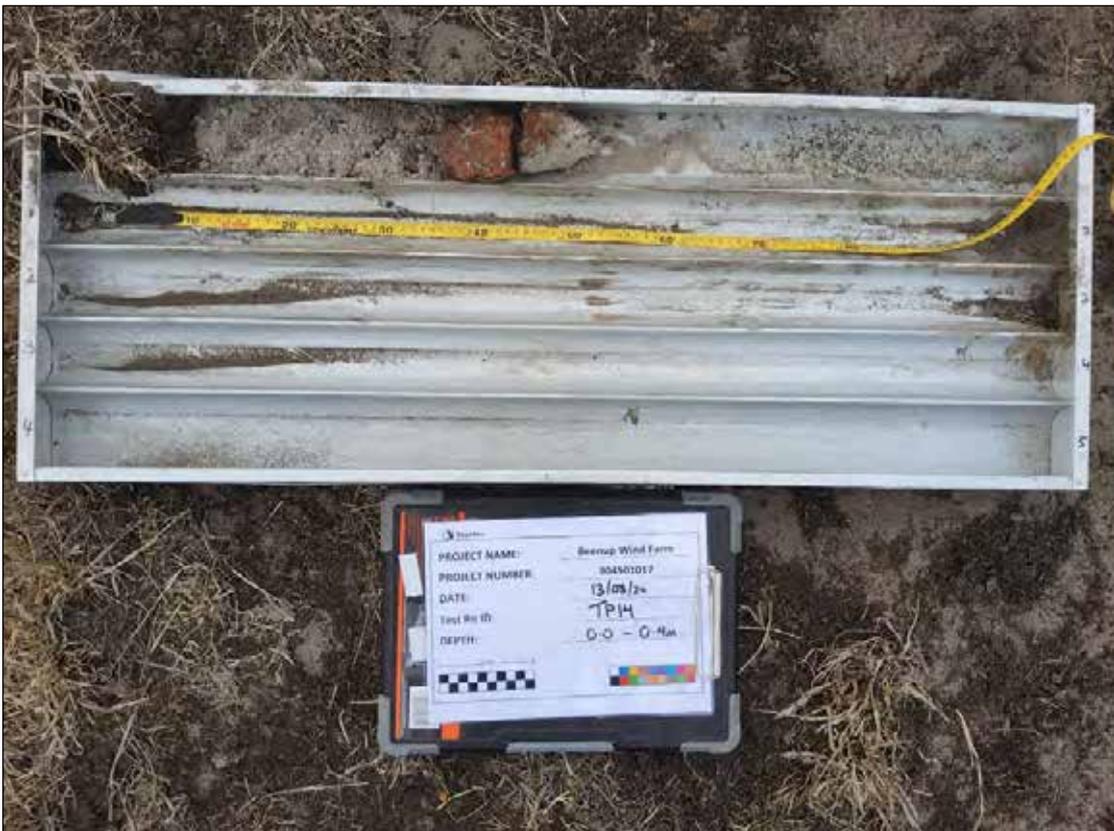
TP14: Corebox - 0.0 - 0.4

Excavation			Sampling & Testing		Material Description									
Method	Resistance	Stability	Water	Sample or Field Test	DCP TEST Blows	RL (m AHD)	Depth (m)	Geology	Graphic Log	SOIL TYPE, plasticity or particle characteristic, colour, secondary and minor components ROCK TYPE, grain size and type, colour, fabric & texture, strength, weathering, defects and structure	Moisture Condition	Cementation / Weathering	Consistency / Relative Density	STRUCTURE & Other Observations
BH ↑ ↓ VH	VE Stable	Not Encountered	Not Encountered	ES 0.00 m	3 6 9 12	27.5	0.5	Quaternary Dune Deposits (QDD)	0.10m	TOPSOIL: SAND: fine to medium grained, sub-rounded to sub-angular; dark grey; trace fines. (Topsoil)	D	Uc	Ls to MD to D	0.00 m: PID - 0.5ppm
				ES 0.25 m	3				SAND (SP): fine to coarse grained, sub-rounded to sub-angular, quartz and iron oxide; dark yellow, stained dark orange. (aeolian)	0.50 m: PID - 1.5ppm				
				ES 0.50 m	4

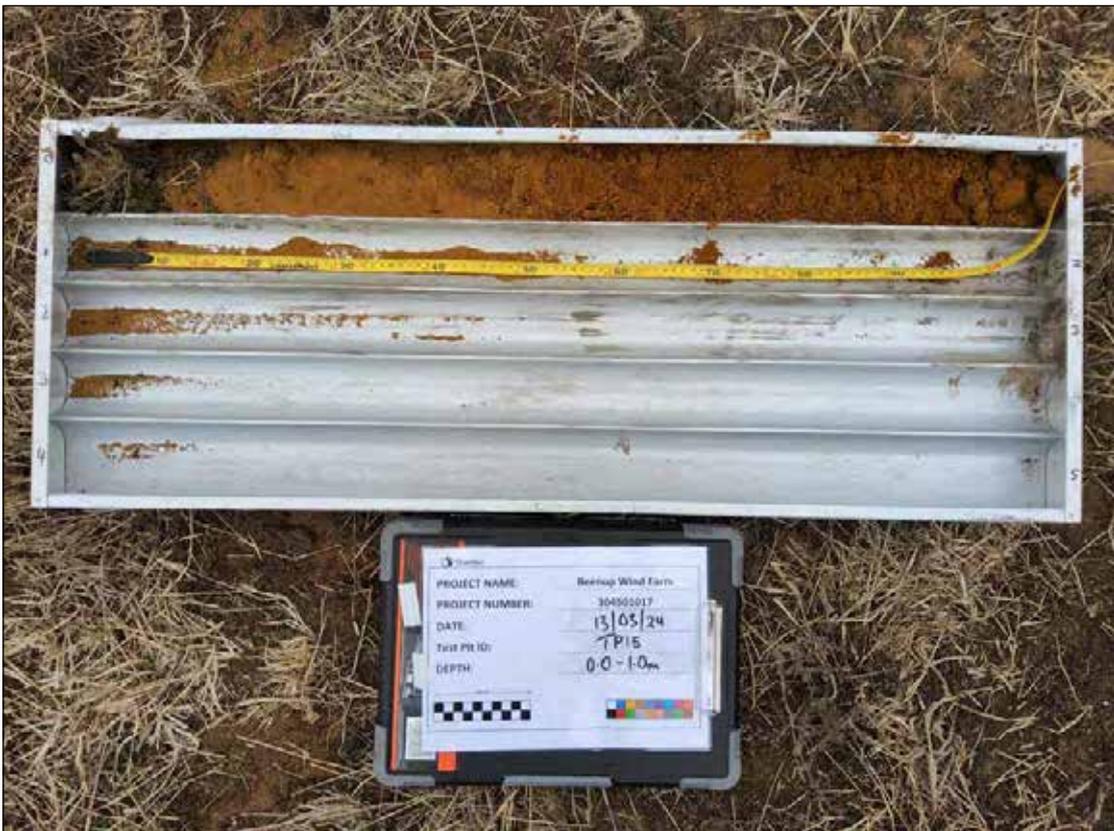
TP15: Coretray - 0.0 - 1.0m

Excavation				Sampling & Testing		Material Description								
Method	Resistance	Stability	Water	Sample or Field Test	DCP TEST Blows	RL (m AHD)	Depth (m)	Geology	Graphic Log	SOIL TYPE, plasticity or particle characteristic, colour, secondary and minor components ROCK TYPE, grain size and type, colour, fabric & texture, strength, weathering, defects and structure	Moisture Condition	Cementation / Weathering	Consistency / Relative Density	STRUCTURE & Other Observations
BH	VE	Stable	N.E	ES 0.00 m DUP 0.00 m TRIP 0.00 m	3 6 9 12					TOPSOIL: SAND: fine to medium grained, sub-rounded to sub-angular; dark grey; trace fines. (Topsoil)	D	Uc	VD	0.00 m: PID - 0.6ppm
	VH			Refusal on coffee rock						FERRICRETE: fine grained; dark orange brown; massive; variably cemented comprising soil and rock strength fragments. (DI duricrust). TERMINATED AT 0.15 m Refusal on rock		We	M

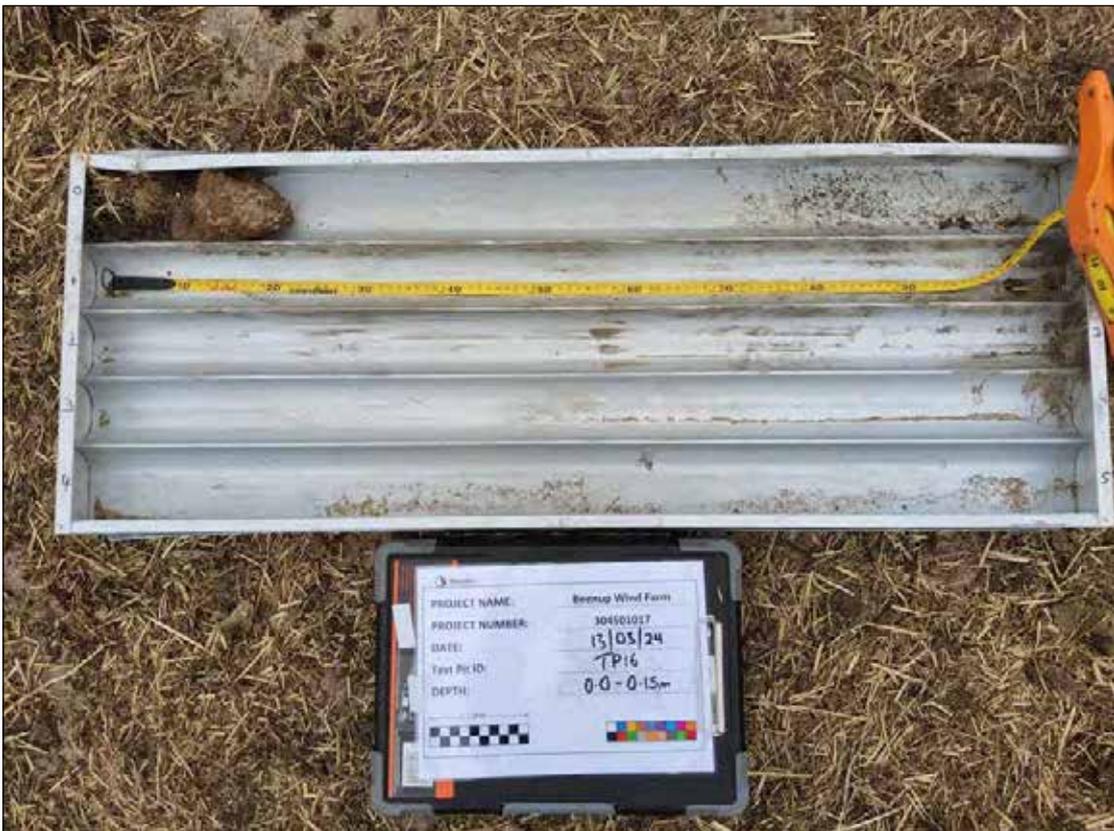
TP16: Coretray - 0.0 - 0.15m

Excavation			Sampling & Testing		Material Description									
Method	Resistance	Stability	Water	Sample or Field Test	DCP TEST Blows	RL (m AHD)	Depth (m)	Geology	Graphic Log	SOIL TYPE, plasticity or particle characteristic, colour, secondary and minor components ROCK TYPE, grain size and type, colour, fabric & texture, strength, weathering, defects and structure	Moisture Condition	Cementation / Weathering	Consistency / Relative Density	STRUCTURE & Other Observations
BH ↑ ↓ VE VH	Stable	Not Encountered	Not Encountered	ES 0.00 m	3 6 9 12			TS	0.10m	TOPSOIL: SAND: fine to medium grained, sub-rounded to sub-angular; dark grey; trace fines. (Topsoil)	D	Uc	Ls to MD	0.00 m: PID - 0.6ppm
				ES 0.25 m	Refusal			ODD	0.45m	SAND (SP): fine to medium grained, rounded to angular, quartz; pale grey, mottled dark grey. (aeolian)			VD	
				ES 0.50 m		36.5	0.5	D	0.50m	FERRICRETE: fine grained; dark orange brown; massive, variably cemented comprising soil and rock strength fragments. (Di duricrust). TERMINATED AT 0.50 m Refusal on rock	We		M	0.50 m: PID - 1.6ppm

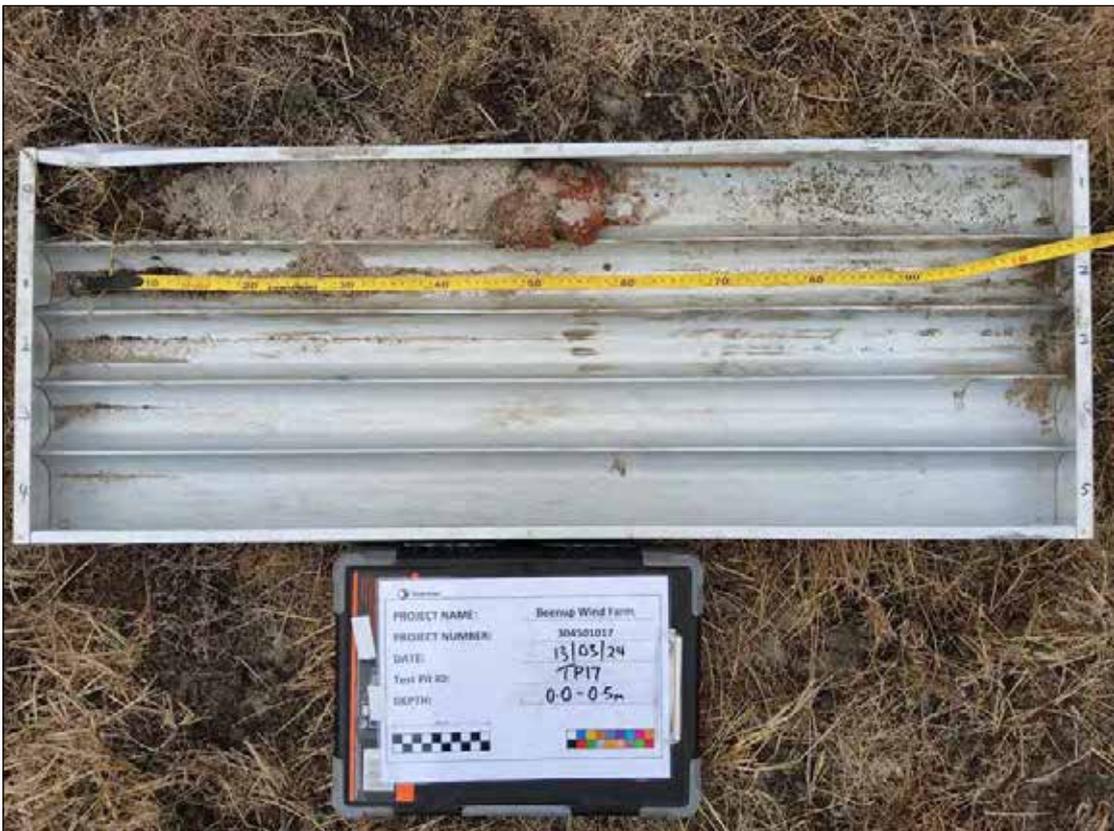
TP17: Coretray - 0.0. - 0.5m

Excavation				Sampling & Testing		Material Description								
Method	Resistance	Stability	Water	Sample or Field Test	DCP TEST Blows	RL (m AHD)	Depth (m)	Geology	Graphic Log	SOIL TYPE, plasticity or particle characteristic, colour, secondary and minor components ROCK TYPE, grain size and type, colour, fabric & texture, strength, weathering, defects and structure	Moisture Condition	Cementation / Weathering	Consistency / Relative Density	STRUCTURE & Other Observations
BH	VE	Stable	N.E	ES 0.00 m	3 6 9 12			TS		TOPSOIL: SAND: fine to medium grained, sub-rounded to sub-angular; dark grey; trace fines. (Topsoil)	D	Uc	VD	0.00 m: PID - 1.0ppm
VH				Refusal						FERRICRETE: fine grained; dark orange brown; massive; variably cemented comprising soil and rock strength fragments. (DI duricrust). TERMINATED AT 0.15 m Refusal on rock		We	M

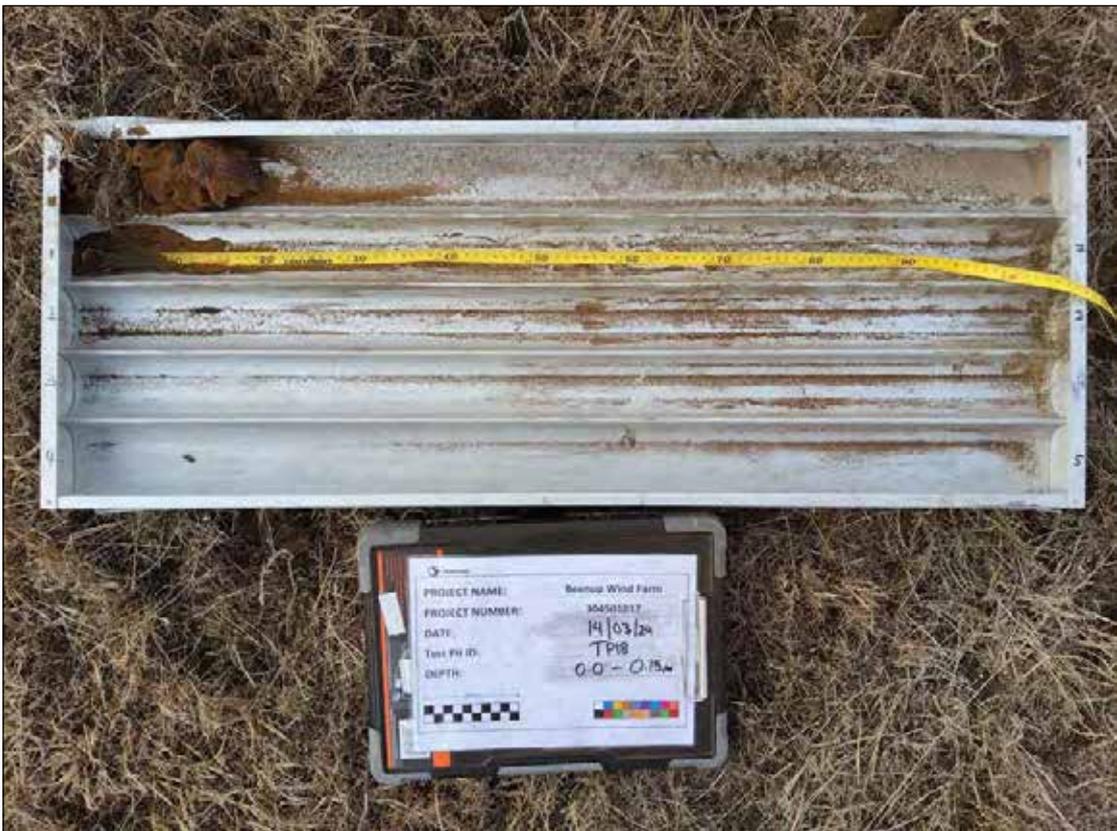
TP18: Coretray - 0.0 - 0.15m

Excavation			Sampling & Testing			Material Description									
Method	Resistance	Stability	Water	Sample or Field Test	DCP TEST Blows	RL (m AHD)	Depth (m)	Geology	Graphic Log	SOIL TYPE, plasticity or particle characteristic, colour, secondary and minor components ROCK TYPE, grain size and type, colour, fabric & texture, strength, weathering, defects and structure	Moisture Condition	Cementation / Weathering	Consistency / Relative Density	STRUCTURE & Other Observations	
BH ↑ VE Stable ↓ VH		Stable	Not Encountered	ES 0.00 m	3 6 9 12			Quaternary Dune Deposits (QDBDS)	0.10m	TOPSOIL: SAND: fine to medium grained, sub-rounded to sub-angular; dark grey; trace fines. (Topsoil)	D	Uc	D	0.00 m: PID - 0.7ppm	
				ES 0.25 m						0.55m	SAND (SP): fine to medium grained, rounded to angular; pale grey, mottled dark grey. (aeolian)	M			
				ES 0.50 m							0.60m	FERRICRETE: fine grained; dark orange brown; massive; variably cemented comprising soil and rock strength fragments. (DI duricrust). TERMINATED AT 0.60 m Refusal on rock	We	M	0.50 m: PID - 2.3ppm

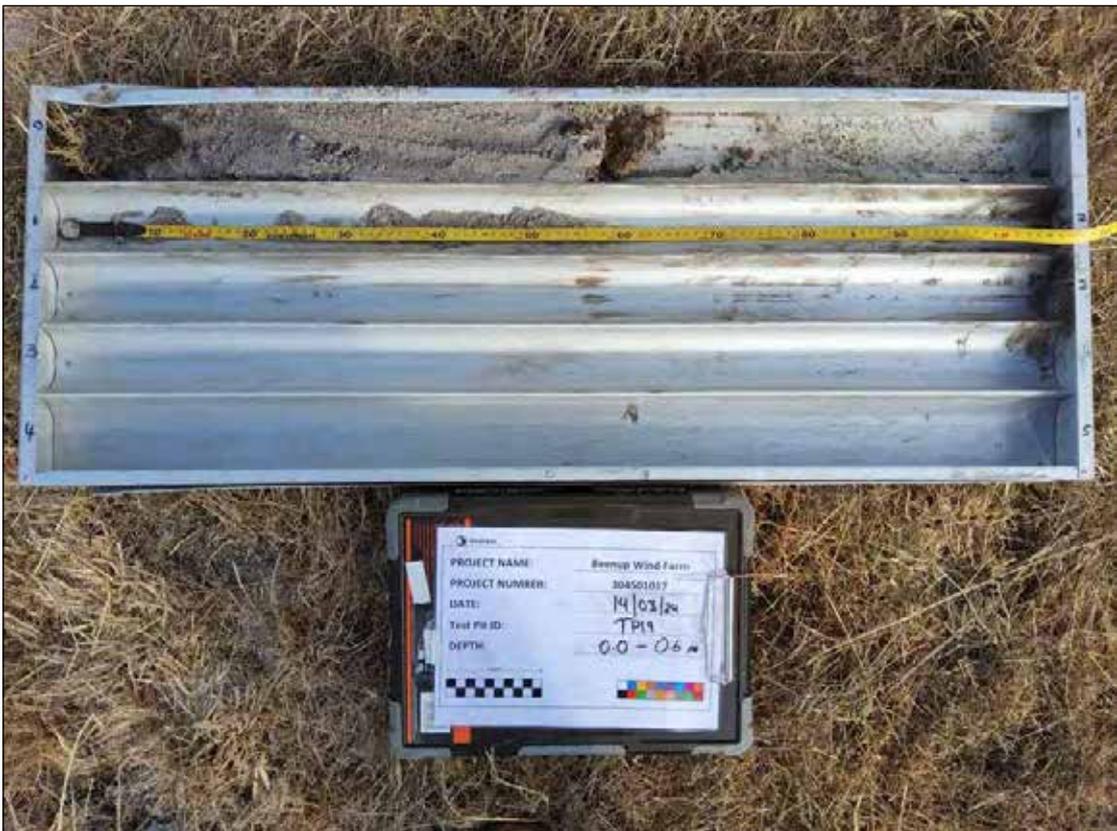
TP19: Coretray - 0.0 - 0.6m

Excavation Method	Resistance	Stability	Water	Sampling & Testing		RL (m AHD)	Depth (m)	Geology	Graphic Log	Material Description	Moisture Condition	Cementation / Weathering	Consistency / Relative Density	STRUCTURE & Other Observations	
				Sample or Field Test	DCP TEST Blows										
BH VE Stable Not Encountered VH				ES 0.00 m	3	32.5	0.5	TS		TOPSOIL: SAND: fine to medium grained, sub-rounded to sub-angular; dark grey; trace fines. (Topsoil)	D	Uc	Ls to MD	0.00 m: PID - 0.1ppm	
				DUP 0.00 m	6										
				TRIP 0.00 m	9										
					12										
				ES 0.25 m					SAND (SP): fine to coarse grained, sub-rounded to sub-angular, quartz; pale yellow stained orange-brown. (aeolian)						
				ES 0.50 m										0.50 m: PID - 1.7ppm	
				ES 0.75 m											
				ES 1.00 m						FERRICRETE: fine grained; dark orange brown; massive; variably cemented comprising soil and rock strength fragments. (Di duricrust). TERMINATED AT 0.90 m Refusal on rock	We	M

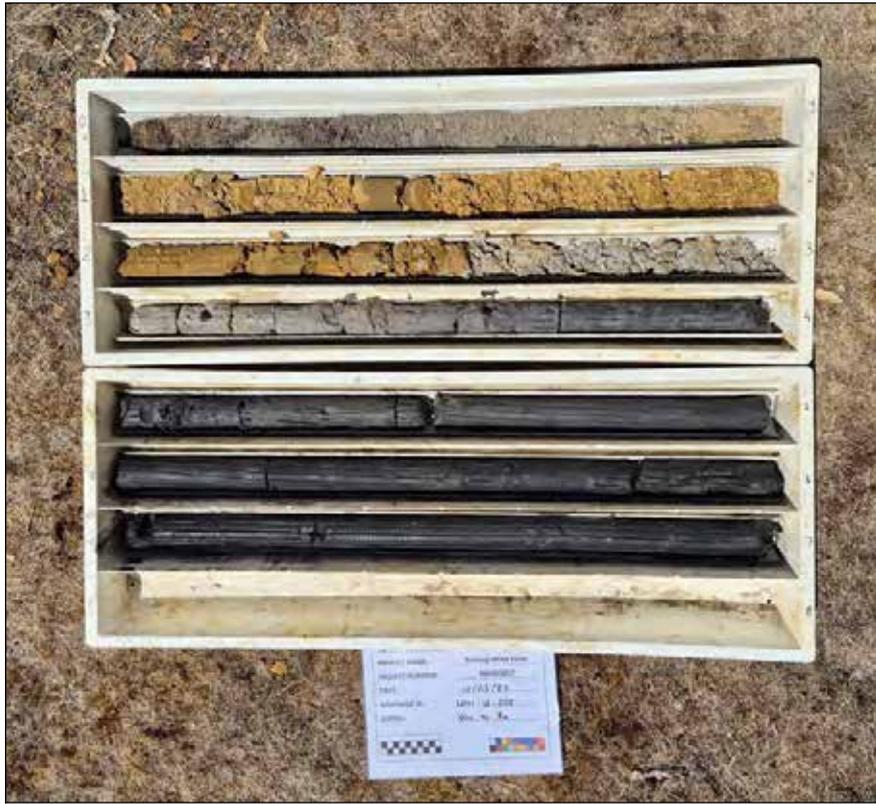
WM1-W-S01: 0 - 7m, Boxes 1

Drilling			Material Description						Defect Description						
Method	Casing	Core Run	RL (m AHD)	Depth (m)	Geology	Graphic Log	LITHOLOGY	Weathering / Cementation	Sample or Field Test	TCR (%)	RQD (%)	Average Natural Defect Spacing (mm)	Observations / Description of Defects	Water Level	Monitoring Well Details
				31.0			Organic CLAY (OH): high plasticity; black. (Residual)	Wk				20 60 200 600 2000			
				4.5											
				30.5											
				5.0											
				30.0											
				5.5											
				29.5											
				6.0											
				29.0											
				6.5											
				28.5											
				7.0			TERMINATED AT 7.00 m Target depth Soil Logging								
				28.0											
				7.5											
				27.5

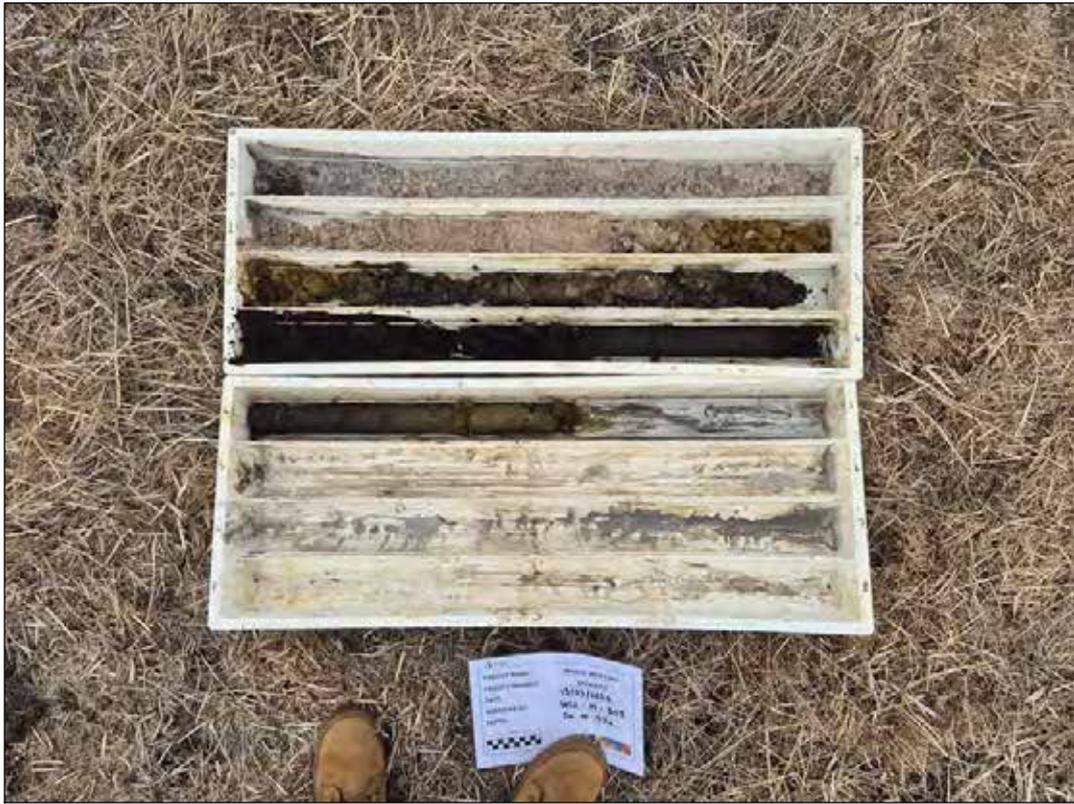
WM2-W-S01: 0 - 4.5m

Drilling		Material Description						Defect Description								
Method	Casing	Core Run	RL (m AHD)	Depth (m)	Geology	Graphic Log	LITHOLOGY	Weathering / Cementation	Strength / Density / Consistency	Sample or Field Test	TCR (%)	RQD (%)	Average Natural Defect Spacing (mm)	Observations / Description of Defects	Water Level	Monitoring Well Details
							Clayey SAND (SC): fine to coarse-grained; sub-rounded to sub-angular; quartz; grey; clay, low to medium-plasticity. (Residual) (continued) 4.20m Sandy CLAY (CI): medium plasticity; dark grey; sand, fine to coarse-grained, sub-rounded to angular, quartz & lithics. (Residual) 4.50m Clayey SAND (SC): fine to coarse-grained; sub-rounded to sub-angular; quartz & lithics; grey; clay, high-plasticity. (Residual)	Uc				20 60 200 600 2000				
						Leederville Formation										
							TERMINATED AT 7.00 m Target depth Soil Logging
