### 11.2.2 LIMESTONE CLIFF STABILITY ASSESSMENT

<b>LOCATION/ADDRESS</b>	Shire of Augusta Margaret River
<b>APPLICANT/LANDOWNER</b>	Shire of Augusta Margaret River
<b>FILE REFERENCE</b>	ENV/128
<b>REPORT AUTHOR</b>	Jared Drummond, Sustainability Planning Officer
<b>AUTHORISING OFFICER</b>	Dale Putland, Director Sustainable Development

Limestone Stability Assessment – Inspection, Risk Assessment and Remediation Design Report (2019)

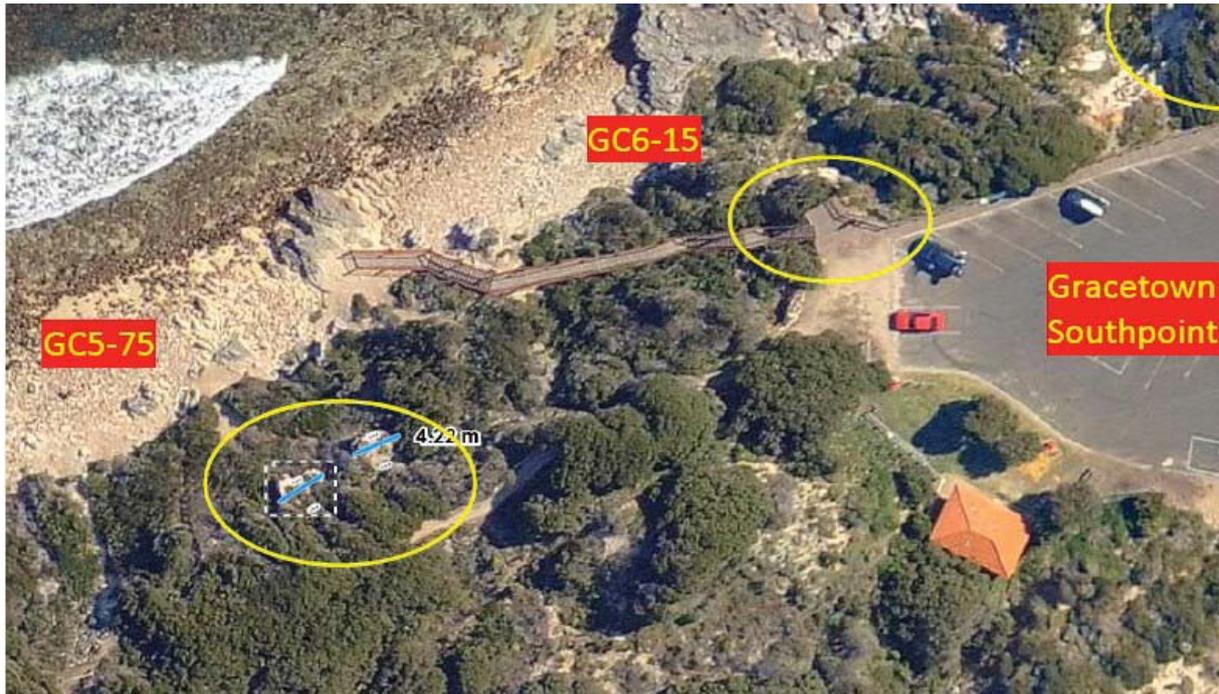
In 2017, the Shire removed the lookout at GC6 – 15 and this area is now considered to pose an acceptable risk. There are two 5 metre long sections of limestone overhang approximately 10 metres above the beach level (see image below). The site is subject to continuous wind erosion, which continues to further erode the limestone rock. The report notes a fracture associated with the overhang, with the report suggesting that the overhang may collapse in the near future, the risk of which may be exacerbated following a storm event.

It is a popular beach, with children occasionally exploring the overhangs and undercuts, particularly during surf events. The very action of scrambling around this area could be a trigger for a rockfall. The slope below the overhang is heavily vegetated and there is a chance of material hanging up on the slope once fallen from the overhang, reducing the risk of debris impacting people exiting the Southpoint carpark stairs as they traverse the beach towards Huzza beach. Nonetheless some material could reach the beach as noted in images in Attachment 1 depicting historic rockfall. The risk assessment for people traversing the beach resulted in relatively small risks. However, due to the large number of people traversing this beach each year to access the popular surf breaks, cumulative individual risks are considered relatively high.

Following an investigation of various options, the report recommends that the hazard is removed using needle drilling and hand barring to remove the rock on predetermined break lines. It is recommended that this action is implemented in 2020. The cost of implementing this action is \$25,000. There are funds available in the existing budget to implement this action. It is recommended this action be implemented following detailed project scoping and preliminaries, including community engagement.

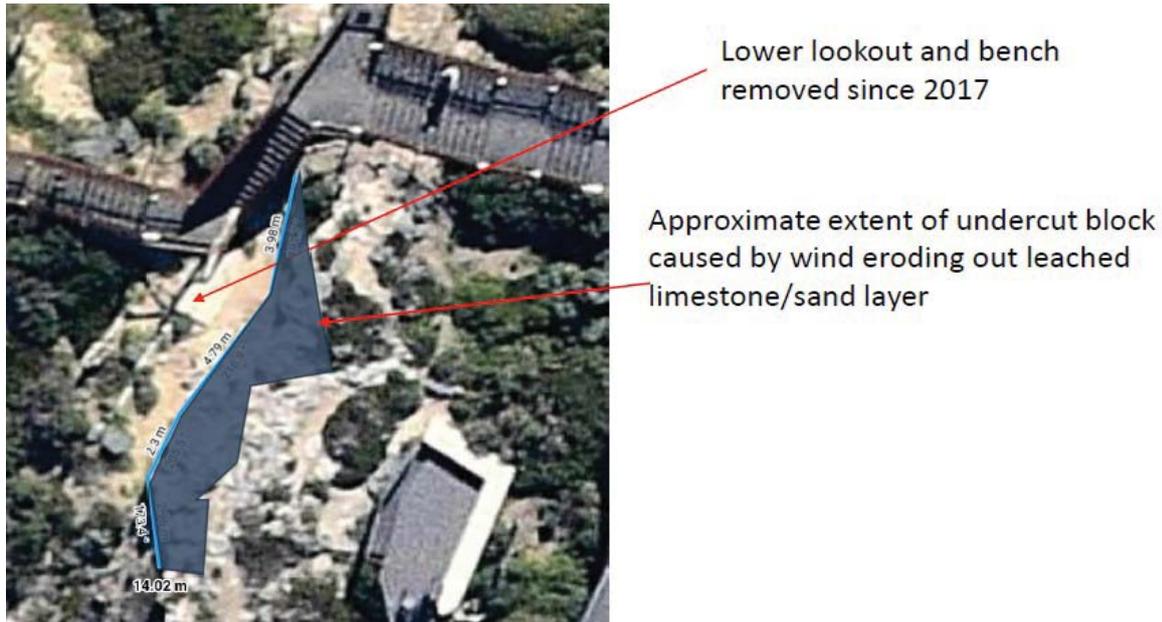
A cliff outcrop/overhang exists mid-way down the cliff face of Surfer's Point directly adjacent to the stairway. To reduce the risk from potential collapse of the overhang, the 2017 report recommended removing the viewing platform and beach midway down the stairway. The viewing platform was removed on this basis (see image below). The scope of works (for this study) required an analysis to be undertaken to determine the resultant risk to public from the overhang and response required (if any). The study also provides advice on the most suitable measure to address risk mitigation, should the Shire wish to re-install the platform in the future.

Removal of the bench and lower viewing platform resulted in the main risk now coming from people sitting on top of the outcrop during surf events or at other times, rather than a risk to people using the stairway. The recommended mitigation response in the report is to underpin the overhang using mass concrete and architectural block work. This not only supports the overhang from collapse but also protects the overhang from future wind erosion. The consultant advised that should this be undertaken it would be safe to re-instate the viewing platform in the future.

Further risk mitigation works have commenced, with the first stage including installation of additional cliff safety signage, followed by extension of the balustrading. These works are intended to provide added protection to public and substantiate the exclusion zone. It should be noted that if the underpinning works do not proceed the risk of cliff collapse remains, which could result in retreat of the cliff face due to collapse and subsequent erosion.

In response to the above, it is recommended that the Shire manage this risk through preventive means (i.e. development approval conditions, signage, extended balustrading, inspections, monitoring during surf events etc.) rather than underpinning as recommended in the report. Underpinning may be required in the future if increased visitation is recorded at this site, but will be subject to ongoing monitoring. If required, underpinning could be implemented as part of future budget considerations.

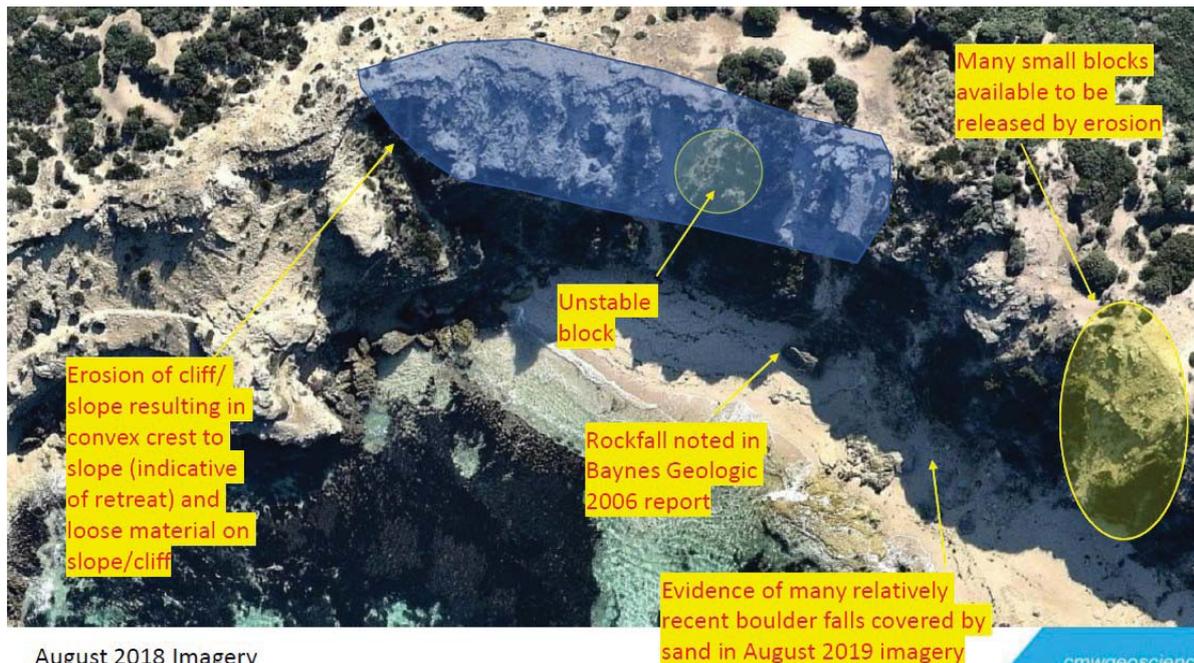
The limestone report from 2017 referred to imminent rockfall risk in the next 1 – 10 years for this stretch of beach (see image below) and recommended closing the beach by way of signage. A large sign has been installed warning 'imminent rockfall beyond this point' but people continue to use this area. As part of the scope of works for the current study, the consultant was required to:

A risk scenario was developed based on the risk of rockfall occurring and the anticipated use of the site by sunbathers and walkers/ dog walkers accessing the hazard zone area. The calculated risk exceeds the tolerable thresholds set out in the AGS 2007 Guidelines (which recommends risk mitigation measures are undertaken to minimise the anticipated risk to public). The report investigated a number of risk mitigation options and included exploring installation of a fence at the base of the cliffs as referred to in the scope of works. This option was discounted due to practicality, primarily due to the significant distance the fence would need to be setback from the cliff base, resulting in it being affected by coastal processes. The report recommends installing a substantial fence (consisting of 4 X 125mm diameter steel posts 1.5 – 2m in height and high tensile wire strands) with *do not pass this point* signage across the full width of the beach, starting at the toe of the cliff and extending into the surf zone.

Implementation of the fence will clearly signal to the public that the area beyond the fence is prohibited. Despite the anticipated effectiveness of the fence and improved safety standards, there are also a number of concerns, which are expressed below:

The cost of this option is estimated at \$25,000. This can be implemented using available funds in the 2019-20 budget. Prior to implementing works, there are a number of preliminary stages (consultation, design, procurement) that first must be undertaken.

An alternative option could be to install several additional signs in a line across the beach perpendicular to the cliff face (before the hazard area starts) warning people of the risks ahead. An educational sign, explaining the nature of the limestone risk ahead, and the importance of not entering this area could also be developed alongside the safety signage. Following installation of the signs, the subject area could be monitored over the summer period through an agreed approach to determine whether the exclusion zone is still being frequented. A risk rating could then be developed using the revised numbers recorded over the reporting period. The risk may be deemed low if members of the public have avoided this area. If following installation of signage visitation numbers to this area are still high, then a reasonable approach would be to install the proposed fence. At the briefing session it was advised that this could be a viable option should council wish to pursue it. As discussed in the report, existing signage has been ignored in the past, however a series of signs across the beach (inclusive of educational

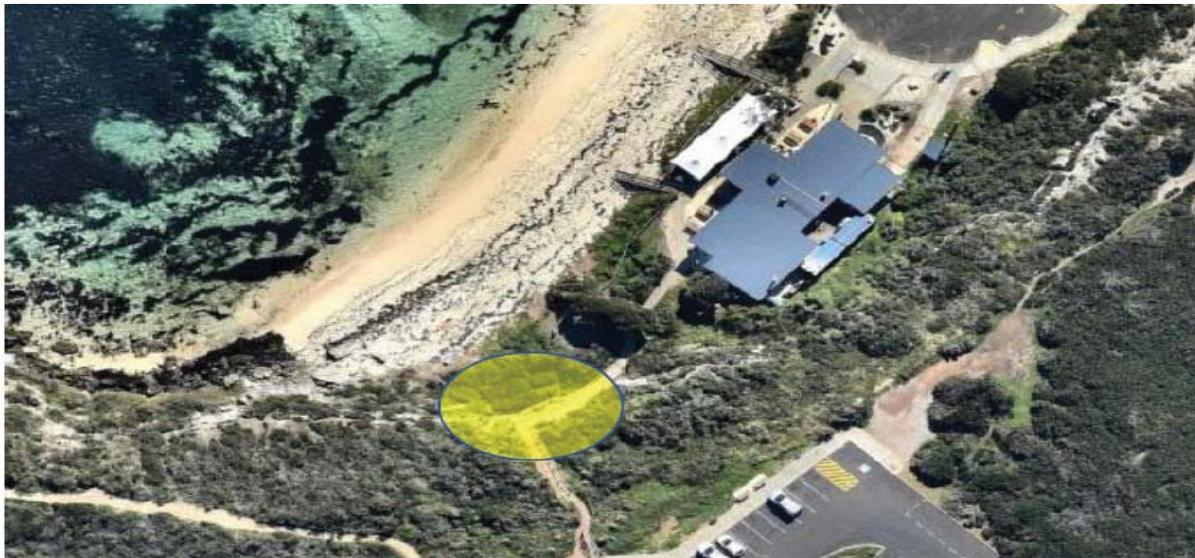
Stairs leading down to the White Elephant Café from the upper car park area at Gnarabup are built directly on top of an overhang (see image below). The hazard at this location is largely associated with collapse of the overhang while recreational users are using the stairs. In response to the scope of works, the consultant has installed monitoring equipment and prepared detailed designs to underpin the overhang using concrete, similar to the approach presented for Surfers Point.

Underpinning will significantly reduce the risk of incident should the overhang collapse. The proposed underpinning seeks to improve the safety of the public in the long term, but may also provide a good foundation to replace stairs at the end of their life cycle (approximately 10 years from now). The proposed underpinning is likely to be screened by vegetation from most parts of the beach. It will however, still be visible from the shoreline, jetty and from the ocean. To minimise visual impacts, it is recommended that rockwork similar to the surrounding area (with a rough surface) be applied to the exterior of the concrete (similar to the approach for Surfer’s Point). At the briefing session, a query was raised as to whether the stairway could be relocated to another section of the cliff. The consultant has further considered this option and advised it is considered problematic to realign the stairway. This is mainly due to the existing rock fall hazards identified within the realignment area, the cost of removing rock fall hazards, and the cost of assessing the realignment. There would also be costs associated with removing the existing stairs, and undertaking erosion control in newly exposed areas. The estimated cost of implementing underpinning is \$100,000; however, with architectural rockwork it may cost up to \$150,000.
