Shire of Augusta Margaret River

Coastal Hazard Risk Management and Adaptation Plan

for Shire of Augusta Margaret River November 2015 FINAL Report SCR1507

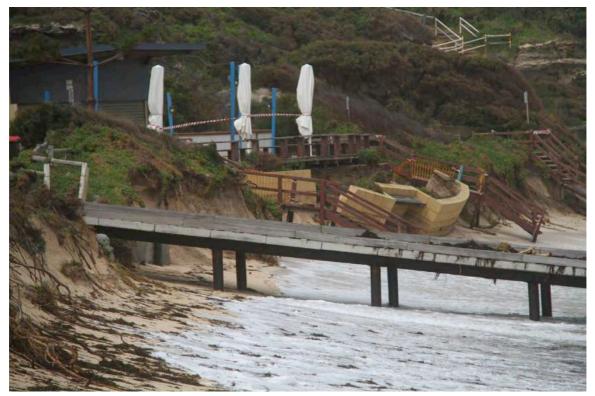
Figure 1.2 Coastal Erosion and Damage to Infrastructure in Gnarabup During September 2013 (Cristina Da Silva, DoT 2013)

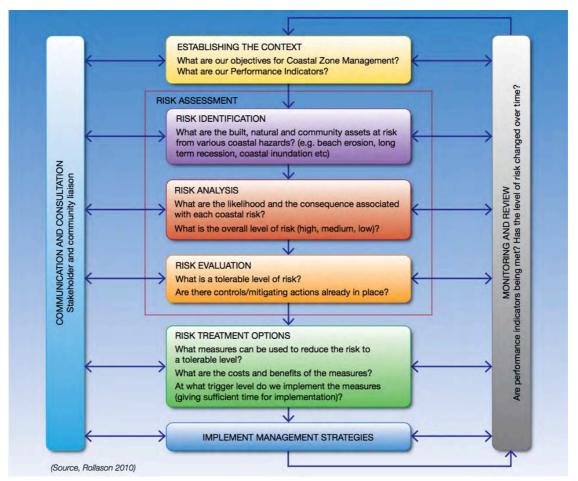
Figure 1.3 Coastal Hazard Risk Management and Adaptation Planning Process Diagram (WAPC, 2014)

Shore Coastal was commissioned in November 2014 to prepare a Coastal Hazard Risk Management and Adaptation Plan (CHRMAP) for the AMRSC based on the submitted proposal. This was for a targeted scope based on the Department of Planning's CHRMAP guidelines but necessarily limited by available data. This report has been structured to align with CHRMAP guidelines as shown in Figure 1.3.

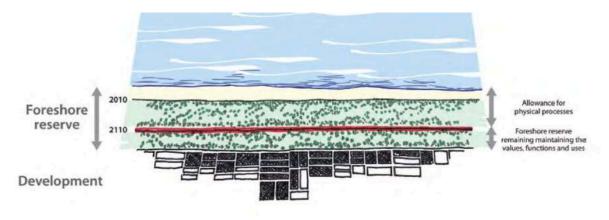
Figure 1.4 Coastal Foreshore reserve – Sandy Coast Example

- S1 Erosion: Allowance for the current risk of storm erosion
- S2 Erosion: Allowance for historic shoreline movement trends
- S3 Erosion: Allowance for erosion caused by future sea level rise.
- S4 Inundation: Allowance for the current risk of storm surge inundation.

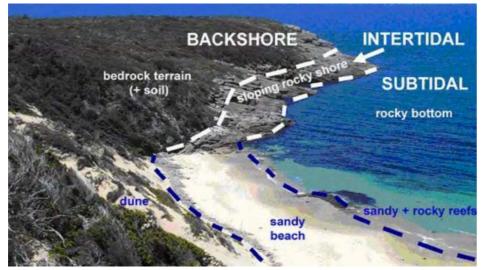
Figure 2.1 Landform Types in the Coastal Zone (Smartline database)

Coastal types have been assessed for the Shire using a publically available online database that provides preliminary coastal landform and landform stability mapping for the entire Australian. This is known as the Smartline database (University of Tasmania, 2009). Landform types for the Shire of Augusta Margaret River have been sourced from this database and imported into QGIS (Quantum GIS Development Team, 2015). This allowed coastal classification at study sites, which is a primary factor in identifying risk to coastal infrastructure.

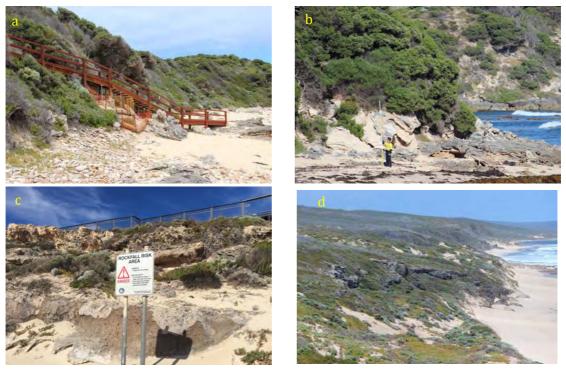
Figure 2.2 Examples of Weakly Lithified Sedimentary Rock Coast Type (a) South Point Carpark Access Stairs (Gracetown) (b) Southern end of Melaleuca Beach (Gracetown) (c) Base of the Cliffs at Surfers Point (Prevelly) (d) Beaches south of Gracetown.

Examples of the variety of coast types around the shire are presented in Figure 2.2 to Figure 2.4.

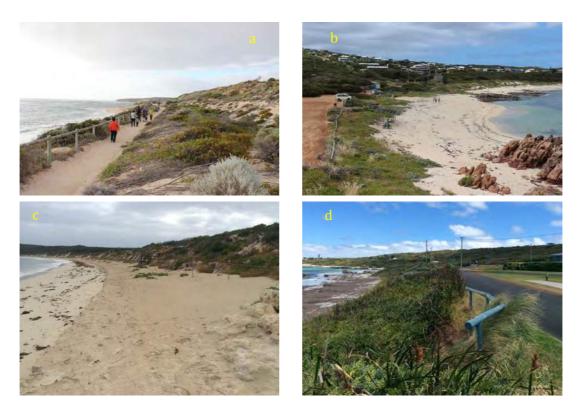
Figure 2.3 Examples of Sandy Coast Type

(a) Gnarabup Coastal Path (b) Cowaramup Bay Swimming Beach, Gracetown (c) Hamelin Bay Beach and (d) Albany Terrace, Augusta South.

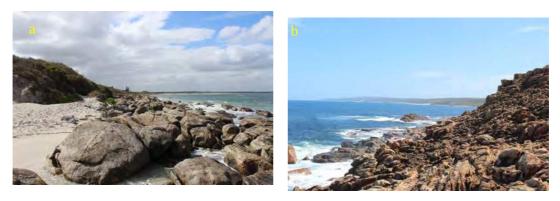
Figure 2.4 Examples of Hard Rock Coast Type (a) Flinders Bay Coastline, Augusta South (b) North Point, Gracetown.

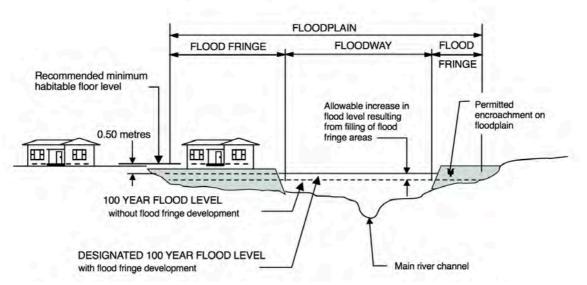
Figure 2.5 Typical Flood Plain Management Strategy (Water and Rivers Commission, 2000)

Both ocean conditions and runoff influence water levels within the lower Blackwood Estuary. Flood modelling has been undertaken for the lower Blackwood River estuary by the Department of Water (DoW, 2014). Figure 2.5 illustrates the typical flood plain management strategy and includes a representation of the key river flooding concepts and terminology.

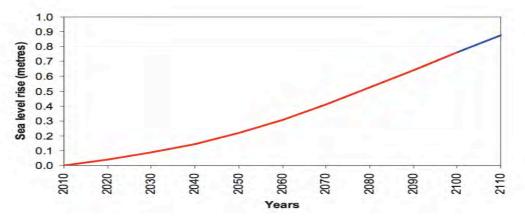
Figure 2.6 Recommended Allowance for Sea Level Rise in Coastal Planning for WA

Coastal adaptation planning requires consideration of the potential impact of Sea Level Rise on the coast. Figure 2.6 shows the recommended allowance when planning for Sea Level Rise in Western Australia based on the report on Sea Level Change in Western Australia -Application to Planning (DoT, 2010). SPP2.6 Schedule 1 Section 4.4.3 provides an horizontal allowance for Sea Level Rise (SLR) as a component of the coastal setbacks

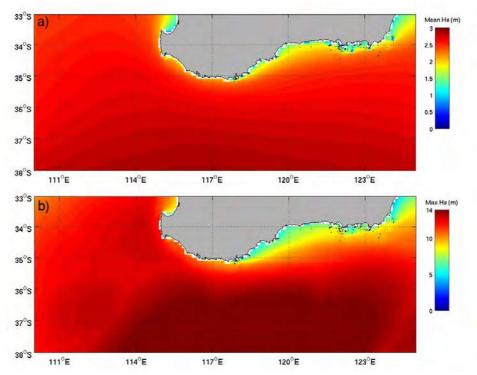
Figure 2.7 Map showing significant wave height for the SW region.

The regional wave climate has been described in Geoscience Australia Geomorphology and Sedimentology of the South Western Planning Area (Richardson, Mathews, & Heap, 2005). The Recherché Shelf is a high energy environment dominated by Southern Ocean swells (Figure 2.7) and storms.

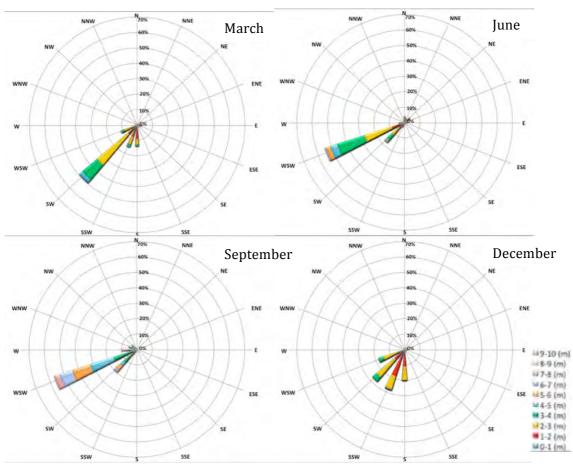
Figure 2.8 Seasonal variability in wave direction at the Cape Naturaliste offshore wave buoy.

Further analysis as part of this study of Cape Naturaliste wave data identified seasonal variability in wave height and direction (Figure 2.8),. Whilst increased wave heights during winter are evident, seasonal variability in offshore wave direction is also evident. For example, wave direction was predominantly from the southwest during summer period of 2013 (March 2013 and December 2013), while the winter period of 2013 (June and September 2013) had an increased prevalence of westerly waves. In addition there is greater range of wave directions during the summer period compared to the winter period.

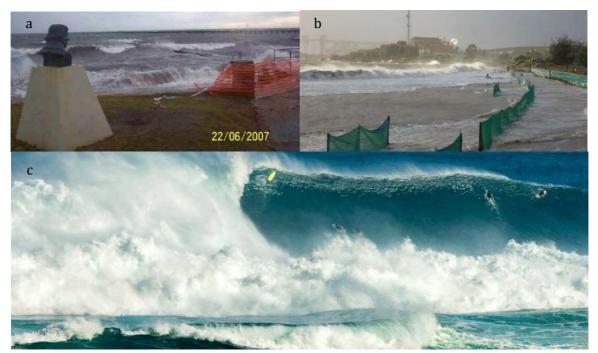
Figure 2.9 Types of Waves with Storm Seas at Busselton and Bunbury (a and b) and Large Swells at Gnarabup (c)

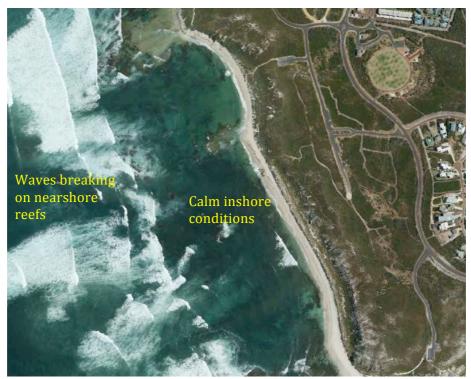
Figure 2.10 Aerial Image Illustrating Wave Breaking on Reefs and Platforms at Gnarabup Back Beach

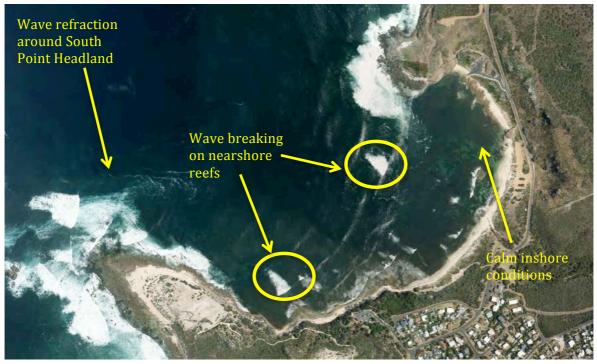
Figure 2.11 Aerial Image Illustrating Wave Refraction and Breaking at Gracetown.

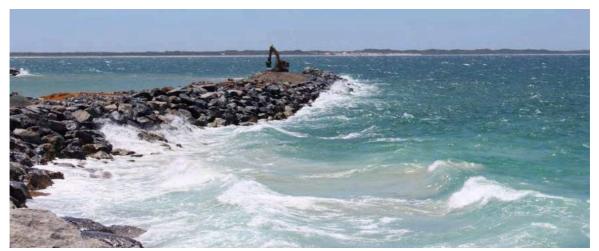
Figure 2.12 Wave Conditions Experienced within the Flinders Bay Area (South Augusta)

The coast south of Augusta experiences a different wave climate to that experienced along the west facing Leeuwin Naturaliste coast. Due to the coast's orientation it is largely sheltered from southwest swell and westerly storms that affect the southwest. Instead this coast is exposed to storms and swells from the south and east. It is also exposed to sea waves generated by the southerly sea breezes experienced in summer. Figure 2.12 shows the types of waves experienced along the east facing coast to the south of Augusta. Wave analysis within Flinders Bay has been undertaken by the Department of Transport for the Augusta Boat Harbour (DoT, 2012).

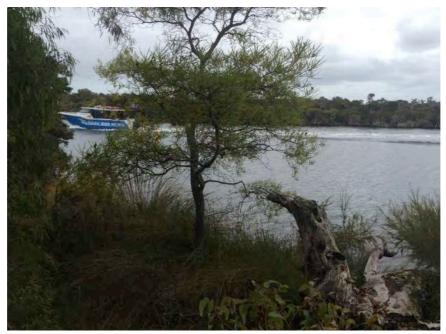
Figure 2.13 Boat Wake Wave Conditions Experienced at Molloy Island

Wave heights at Molloy Island within the Blackwood River are influenced by wind driven waves on the exposed southern shores and boat wakes on the higher vehicle traffic shores (see Figure 2.13). There are, however, no known records of local wave heights.

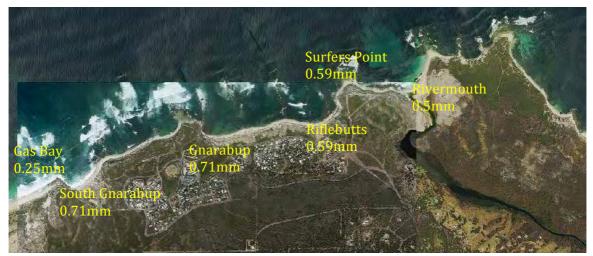
Figure 2.14 Distribution of Median Sediment Sizes from Gas Bay to the Prevelly Rivermouth

Sediment sampling in the Prevelly/Gnarabup area identified consistent medium/coarse sand with a high shell content from the Margaret River entrance to South Gnarabup. Visual analysis identified sediments south of Gas Bay as significantly finer with a lower observed shell content (see Figure 2.14). The nature of these sediments, and the capacity for beach material at Gnarabup to be transported around Gnarabup Headland and Surfers Point, requires consideration in understanding the potential recovery of the Gnarabup Beaches from storm erosion.

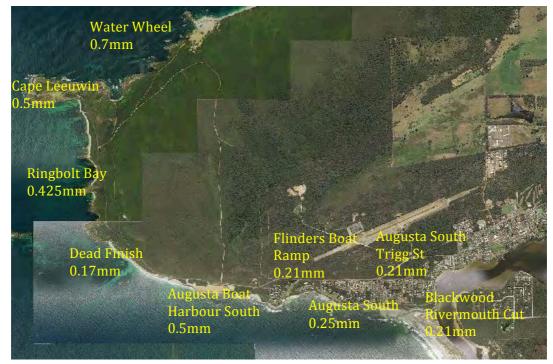
Figure 2.15 Distribution of Median Sediment Sizes from Cape Leeuwin to the Blackwood River Cut

Sediment sampling in Flinders Bay identified coarse material between the water wheel on the west coast and Ringbolt Bay within Flinders Bay. North of the granite headland at Ringbolt Bay the observed sediments are significantly finer (Figure 2.15). The distinct differences in sediment size between the beaches in Flinders Bay and those closer to Cape Leeuwin requires further consideration. In particular, it suggests material on the Flinders Bay beaches is at the southern end of a local sediment cell that includes the sandy beach north of the Blackwood River mouth. Future coastal monitoring and investigation of these beaches should consider the influence of this local sediment cell on observed beach erosion.

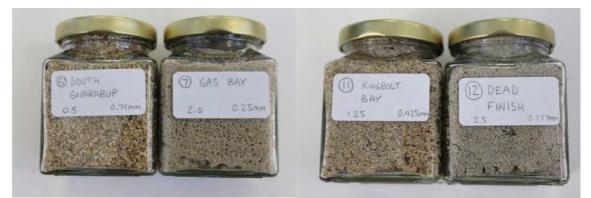
Figure 2.16 Sediment sampling showing sediment variability at adjacent sites (South Gnarabup/Gas Bay and Ringbolt Bay/Dead Finish).

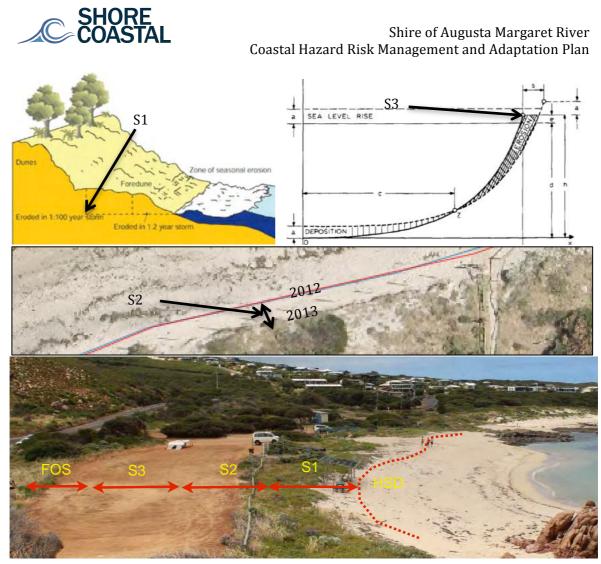
Figure 3.1 Representation of Allowance for Erosion on Sandy Coast Including HSD S1 + S2 + S3 + FOS Note: HSD – Horizontal Setback Datum, S1 – Allowance for Current Risk of Storm Erosion, S2 – Allowance for Historic Shoreline Movement Trends, S3 – Allowance for Erosion Caused by Future Sea Level Rise, FoS – Factor of Safety (Allowance for Uncertainty)

The method and assumed coastal processes allowances for sandy coasts (S1 + S2 + S3) for the 100 year planning period for each project sites are shown in Figure 3.1 and detailed below. These allowances are the basis for the risk analysis mapping in Attachment 3 Risk Analysis Drawings.

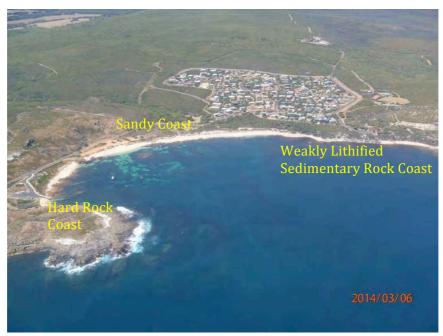
Figure 3.2 Gracetown Oblique Aerial (DoT, 2014)

Gracetown is a northwest facing embayment exposed to high energy waves. The shoreline position is controlled by a granite headland to the north (North Point) and a lower elongated granite headland, overlaid by sand dunes and weakly lithified sedimentary rock to the south (South Point). Within the bay there are numerous reefs that cause wave refraction and wave breaking, and along the shoreline there are rocky outcrops that provide a secondary control on shoreline position. A small creek drains to the beach along this section of coast. The coastal type includes sandy beaches backed by low dunes from the boat ramp to Melaleucas, weakly lithified sedimentary rock cliffs fronted by boulder beaches, limestone rock fall or narrow, thin perched sandy beaches. Development is associated with the Gracetown townsite and various beach and boating access nodes.

Three coastal types and five distinct sectors were identified and summarised in Table 3.2. For example whilst the coastal type at the Swimming Beach sector and Melaleucas sector are both sandy beaches, the observed historic erosion rates at these beaches have been different. Coastal erosion allowances have been assessed for each of these five sectors.

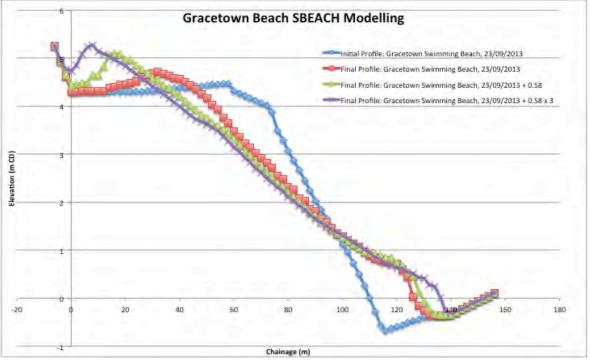
Figure 3.3 Gracetown SBEACH Modelling Output for 10 year, 20 year and 100 year Planning Period.

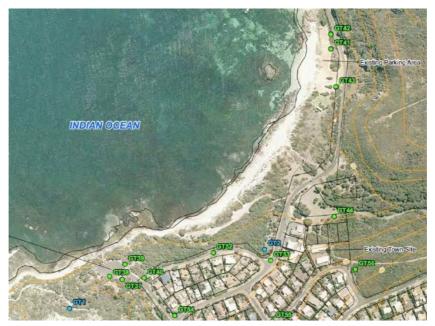
Figure 3.4 Borehole and Test Pit Locations used for Geotechnical Assessment in Gracetown (GHD, 2013)

Available geotechnical reports for Gracetown (Gordon 1997, Gordon 2002, Gordon 2005, GHD 2013) were reviewed to assess the geological structure of this coastal type and the allowance for storm erosion. There is limited information available and available logs show highly variable substrate of sand, soft rock and hard rock. Figure 3.4 shows the location of available borehole and test pit data for Gracetown.

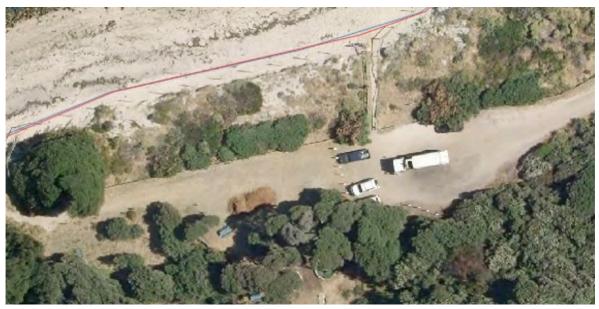
Figure 3.5 *Shoreline Movement Analysis for Gracetown Melaleuca Beach Area* Note: Figure shows the 2000 (red) and 2012 (blue) Vegetation Line on the 2013 Aerial Image

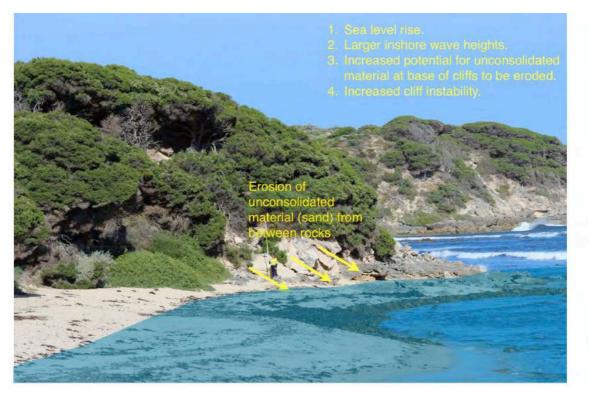
Figure 3.6 Concept for Weakly Lithified Sedimentary Rock Coast Response to Sea Level Rise

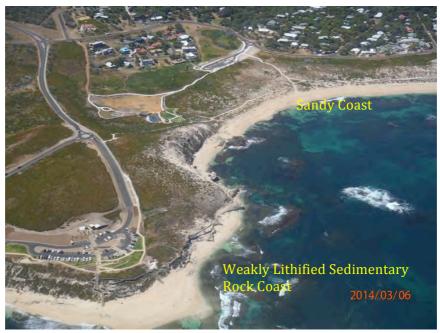
Figure 3.7 Prevelly Oblique Aerial (DoT, 2014)

Prevelly is a generally west facing coastline with inshore lagoons and offshore reefs exposed to high energy waves. Shoreline position is controlled by weakly lithified sedimentary headlands. Coastal types include the Margaret River mouth, weakly lithified sedimentary rock coast (Surfers Point) and sandy coast (Riflebutts). Thin, perched beaches overlaying rock are evident at Surfers Point whilst the beach at Riflebutts is relatively steep, high and narrow. There is evidence of recent erosion along the Riflebutts shoreline and at the Rivermouth. Development is associated with the Prevelly townsite and coastal nodes at Surfers Point and the rivermouth.

Two coastal types and four distinct sectors were identified and erosion allowances have been assessed for each of these sectors. The storm erosion allowance (S1) is based on a surveyed profile and bathymetry offshore of the northern beach access at Riflebutts. SBEACH modelling has been used to estimate S1 for the sandy coast. Grain size was based on a visual classification of beach sand in the swash zone.

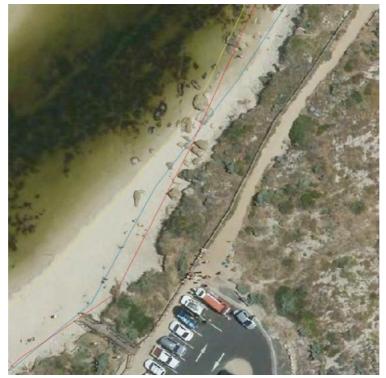
Figure 3.8 Shoreline Movement Analysis for Prevelly Rivermouth Area

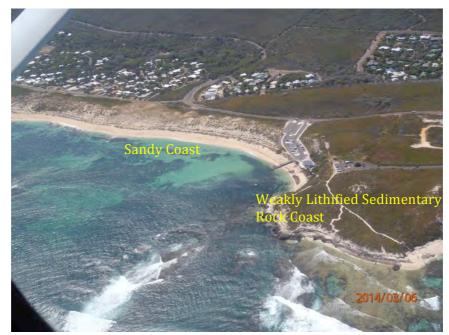
Figure 3.9 Gnarabup Oblique Aerial (DoT, 2014)

sedimentary rock coast and sandy coast. The hard rock at Gas Point is overlayed with sand dunes. Steep high sandy beaches with coarse sediments are backed by high dunes with intermittent limestone outcrops and cliffs from Gas Point to Gnarabup Point. There is a popular sheltered swimming beach north of the White Elephant café with recent evidence of erosion.

Three coastal types and six distinct sectors were identified and erosion allowances have been assessed for each of these sectors. In particular, the observed historic erosion rates vary significantly between sandy beaches. A storm erosion allowance (S1) was estimated based on a surveyed profile and bathymetry offshore of the beach access immediately north of the boat ramp. However, the SBEACH modelling showed an erosion response that was highly mitigated by offshore reefs at this location, which is not considered to be representative of the wider shoreline. The modelling undertaken at Riflebutts was adopted to sandy beaches in this sector, with the grain size based on a visual classification of beach sand in the swash zone.

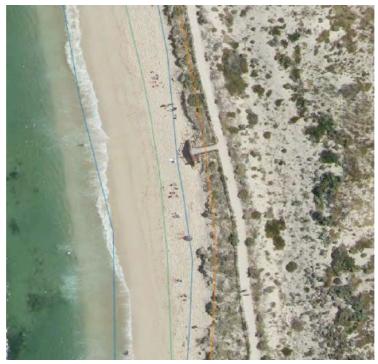
Figure 3.10 Shoreline Movement Analysis for Gnarabup Beach (North of the White Elephant Café)

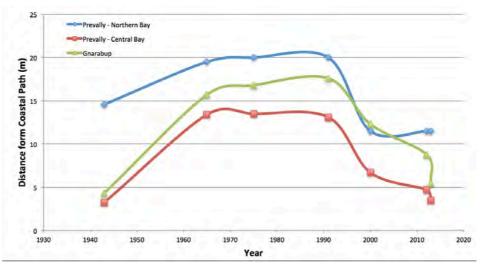
Figure 3.11 Shoreline Movement Assessment for Gnarabup Beach to Prevelly Beach

Further detail on how the vegetation line has changed since 1943 is shown in Figure 3.11. From this graph, it would appear that the beaches from Gnarabup to Prevelly accreted by approximately 10m between 1941 and 1965. Between 1965 and 1991 the beaches appear to have been relatively stable. Since 1991 the beaches from Gnarabup to Prevelly have eroded by approximately 10m. One interpretation from this analysis is that the beaches between Gnarabup and Prevelly are dynamically stable (the position of the vegetation line fluctuates about an average position over time).

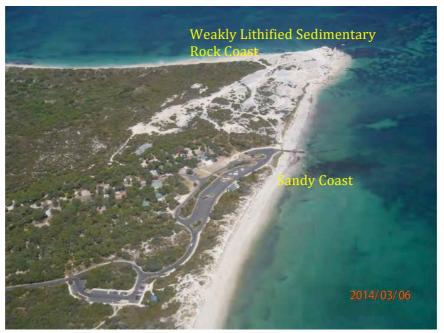
Figure 3.12 Hamelin Bay Oblique Aerial (DoT, 2014)

Two coastal types were identified and erosion allowances have been assessed for each of these types. A storm erosion allowance (S1) was estimated using SBEACH based on a surveyed profile and bathymetry offshore of the beach access immediately north of the boat ramp. There are limited geotechnical reports for the weakly lithified sedimentary rock coast in this area. Whilst a detailed geotechnical assessment has not been undertaken for the CHRMAP, and is outside the scope of the study, the assumption for S1 adopted in the CHRMAP for the weakly lithified sedimentary rock coasts is slumping to an angle of 26.5 degrees (2.0h:1.0v).

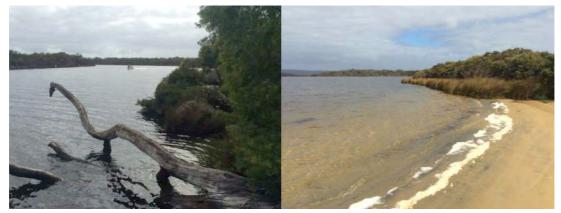
Figure 3.13 Molloy Island Foreshore (Shore Coastal, 2015)

Molloy Island is a small estuarine island within the tidal reaches of the Blackwood River about 10km from the entrance. This shoreline is reasonably unique in Western Australia and the island accommodates around 276 residential blocks, roads and public boating infrastructure managed by the Residents Association. There is a vegetated foreshore reserve surrounding most areas of the island where boat ramps, public and private jetties are evident (see Figure 3.13). Access to the island is via a cabled vehicle ferry. The shoreline is

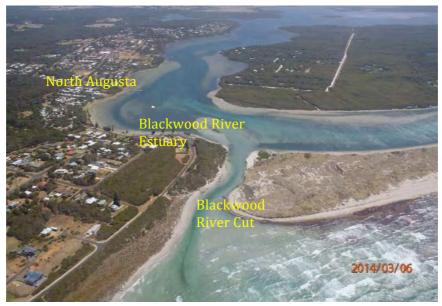
Figure 3.14 Augusta North Oblique Aerial (DoT, 2014)

The Augusta north project site includes the Blackwood River shoreline of the Augusta townsite. This is an east facing estuarine shoreline within the tidal reaches of the Blackwood River. There is a mixed sand/rock shoreline although sediments include fine estuarine silts. In recent years a second river entrance was cut about 2,000m south of the main entrance channel and has maintained tidal exchange. This has resulted in shoreline change associated with the development and establishment of ebb and tidal deltas for this new entrance. Public infrastructure is located along low lying areas of the shoreline with both low lying and elevated residences. The Turner Caravan Park is a large foreshore landholding managed by the Shire in a relatively low lying area of the foreshore (between 1m AHD and 3m AHD).

Preliminary investigations indicate the main coastal risk at Augusta North is inundation under either elevated ocean tides coming up the river, or riverine floods coming down the river. The DoW has modelled the 100yr ARI floodway and fringe line for the Augusta townsite, which is the best available information for identifying risk to infrastructure. Topographical data held by the Shire is available at 1 metre intervals and a nominal allowances of 10m has been allowed for foreshore erosion to allow for risk evaluation and adaptation on a 10 year planning timeframe.

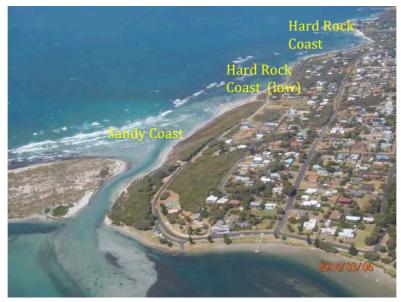
Figure 3.16 Augusta South Oblique Aerial (DoT, 2014)

The Augusta South project site includes the Flinders Bay shoreline of the Augusta townsite and the Flinders Bay settlement. This is an east facing embayment sheltered from high energy Indian Ocean waves but with significant exposure to the south east. Coastal types include hard rock coast and sandy coast. The development and establishment of ebb and tidal deltas for the new Blackwood River entrance influence shoreline change. Public infrastructure and a coastal road are located along modest dunes with narrow setbacks. There are a number of thin perched sandy beaches controlled by granite outcrops in the Flinders Bay area. The newly constructed Augusta Boat Harbour, along the rocky coastline south of Flinders Bay, marks the southern extent of this project site.

Two coastal types and four distinct sectors were identified and erosion allowances have been assessed for each of these sectors. A storm erosion allowance (S1) was estimated based on a surveyed profile and bathymetry offshore of Albany Terrace. SBEACH modelling has been used to estimate S1 for the sandy coasts based on a moderated storm wave height to account for sheltering from Cape Leeuwin. Grain size was based on a visual classification of beach sand in the swash zone. The extent of storm erosion is averaged across the profile (Figure 1).

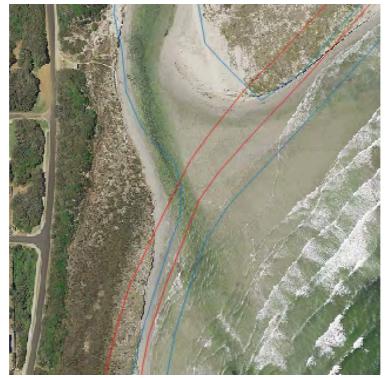
Figure 3.17 Shoreline Movement Analysis for Augusta South, Albany Terrace – Blackwood River Cut Area

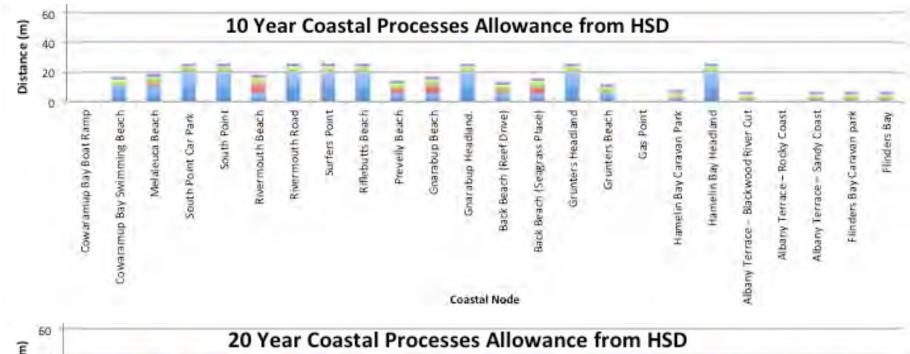
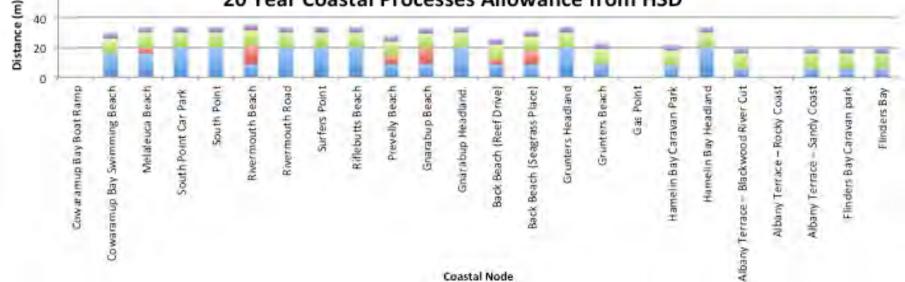
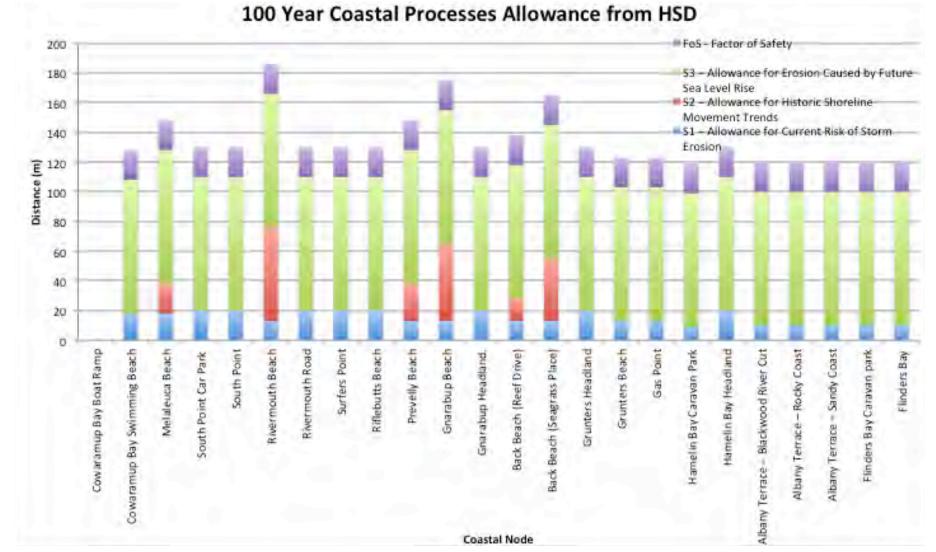
Figure 3.18 Summary of 10, 20 and 100 Year Coastal Processes Allowances

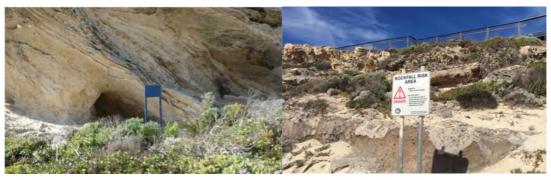
Figure 5.2 Blank Safety Sign Observed at Grunters Beach (left) and Safety Signage at South Point (right)

Geotechnical inspections of the limestone cliff stability are recommended as an immediate priority. Inspections must examine all trafficked areas including stairs, lookouts and South Point Car Park. Inspections should also be made of other limestone cliffs and an audit undertaken of safety signage. Blank safety signs (wording had worn off) adjacent to limestone caves in popular beach areas (Grunters) were observed during inspection (see Figure 5.2). This is recommended to take place immediately.
