GRACETOWN, PREVELLY, GNARABUP, GRUNTERS, WESTERN
AUSTRALIA

LIMESTONE CLIFF RISK ASSESSMENT

Shire of Augusta Margaret River

Job No. PER2023-0291AB | Rev 1

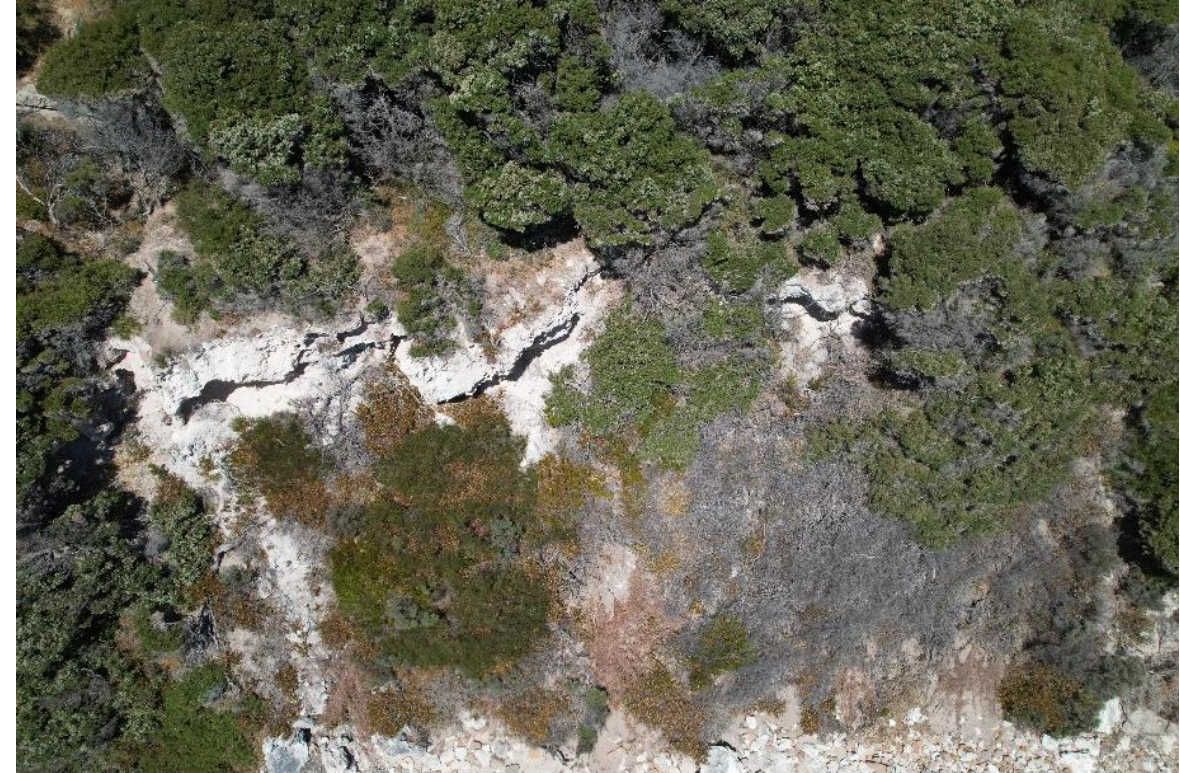
Aerial view of overhangs at GC4-60.

Level of Risk to Individual Most at
Risk (R_{DI}) remains the same as
previous assessment – i.e March
2024 $R_{DI} = 6.1 \times 10^{-7}$.

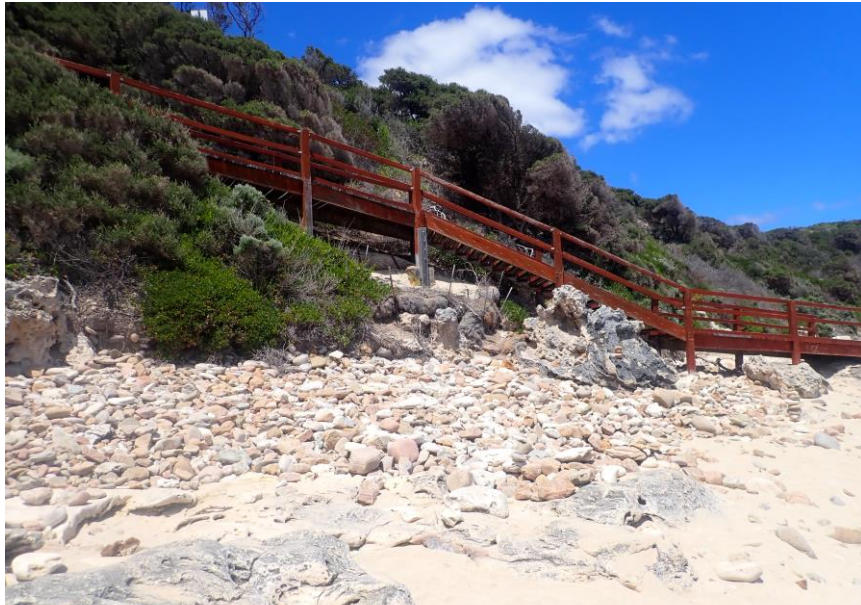
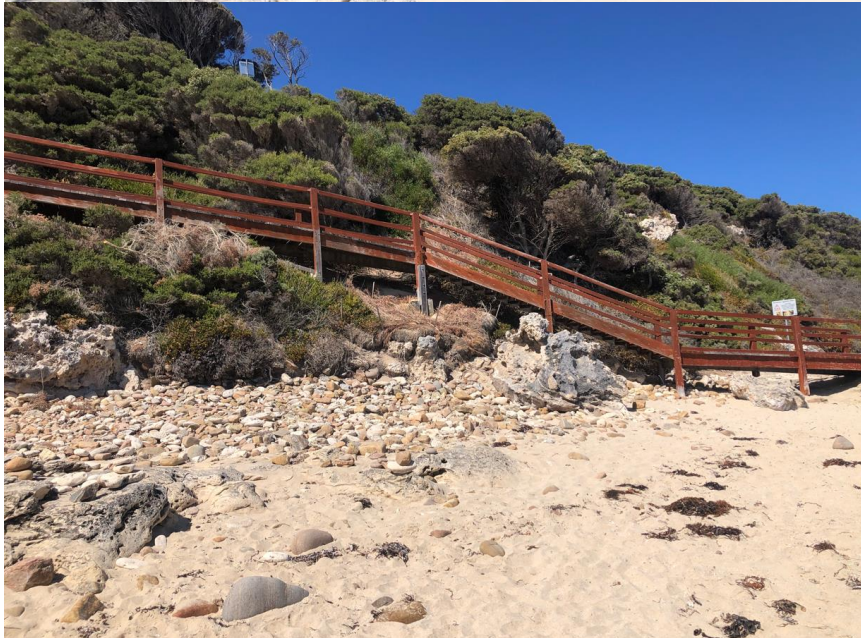
Stanchion supporting lower part of stairs is being undercut and requires extending.

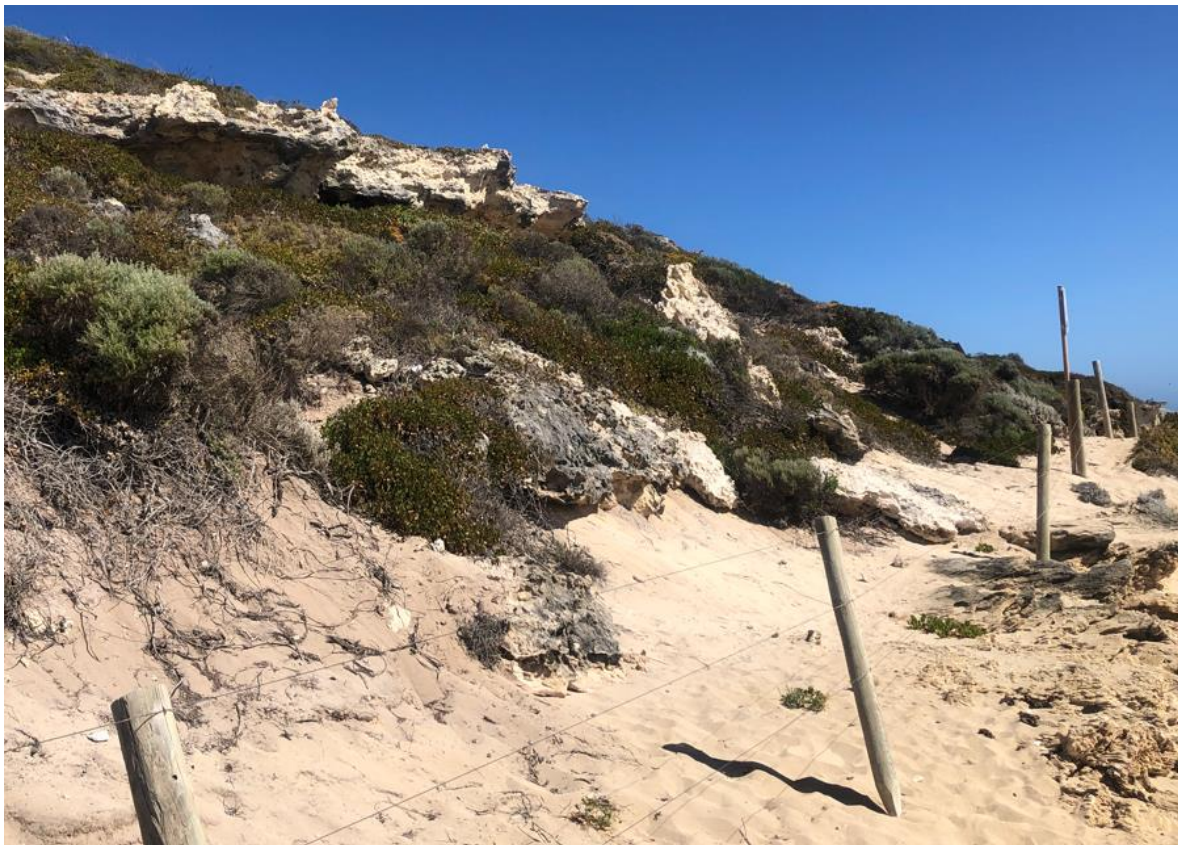
Coastal erosion undercutting fence south of PR3-165.

Carry out maintenance to fence to keep people off slope and away from limestone ledges - place brushwood across informal path and close gap in fence at picnic area.

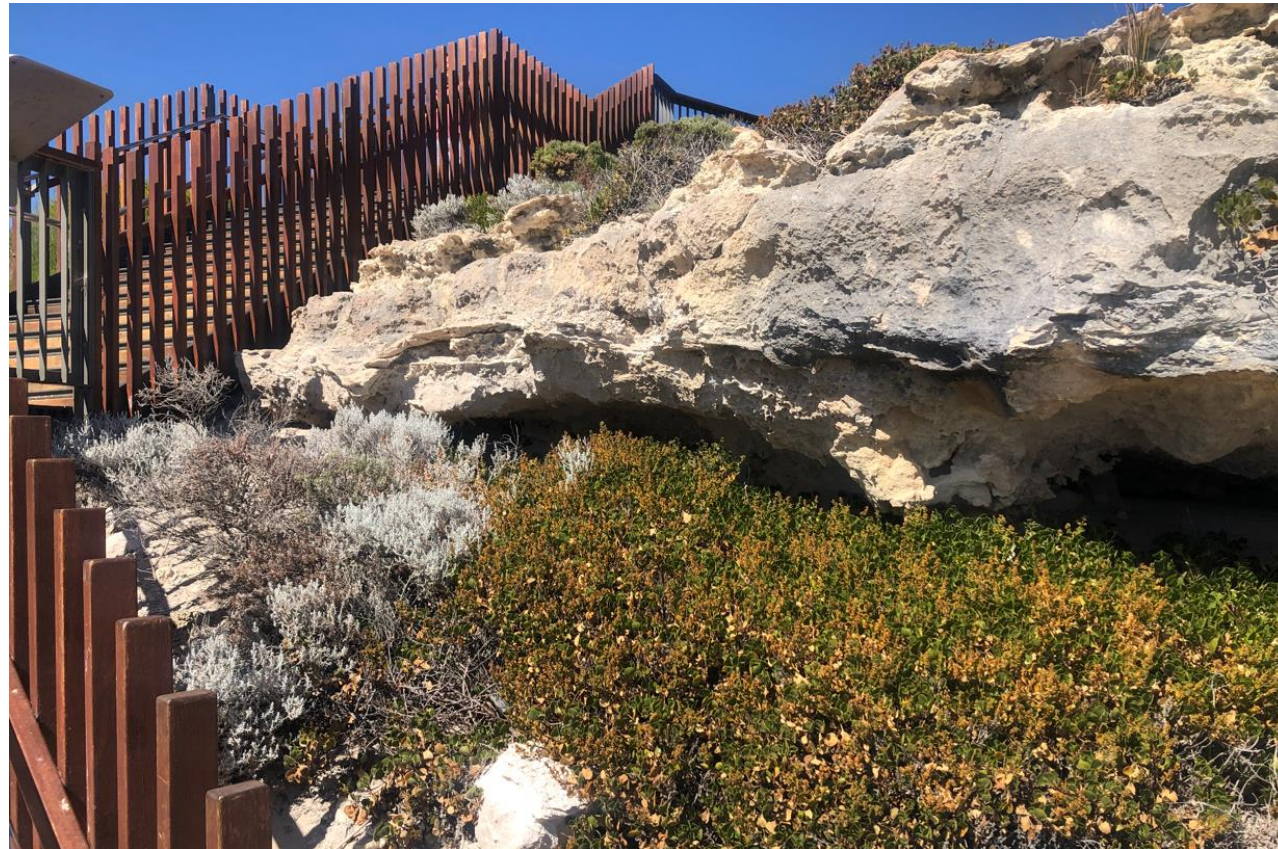
Vegetation cover in front of rock ledge and protecting the ledge from wind erosion is similar to the previous (2021) inspection.

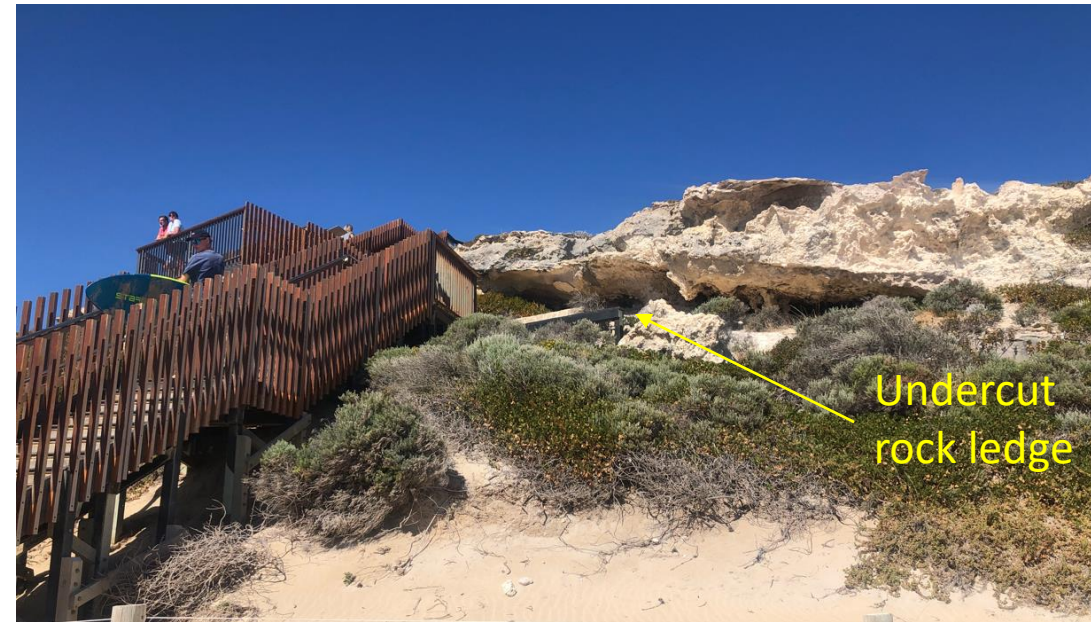
Main risk is to people sitting on top of this rock ledge if it was collapse – however signage and general healthy growth of vegetation suggests few people are accessing the rock ledge.

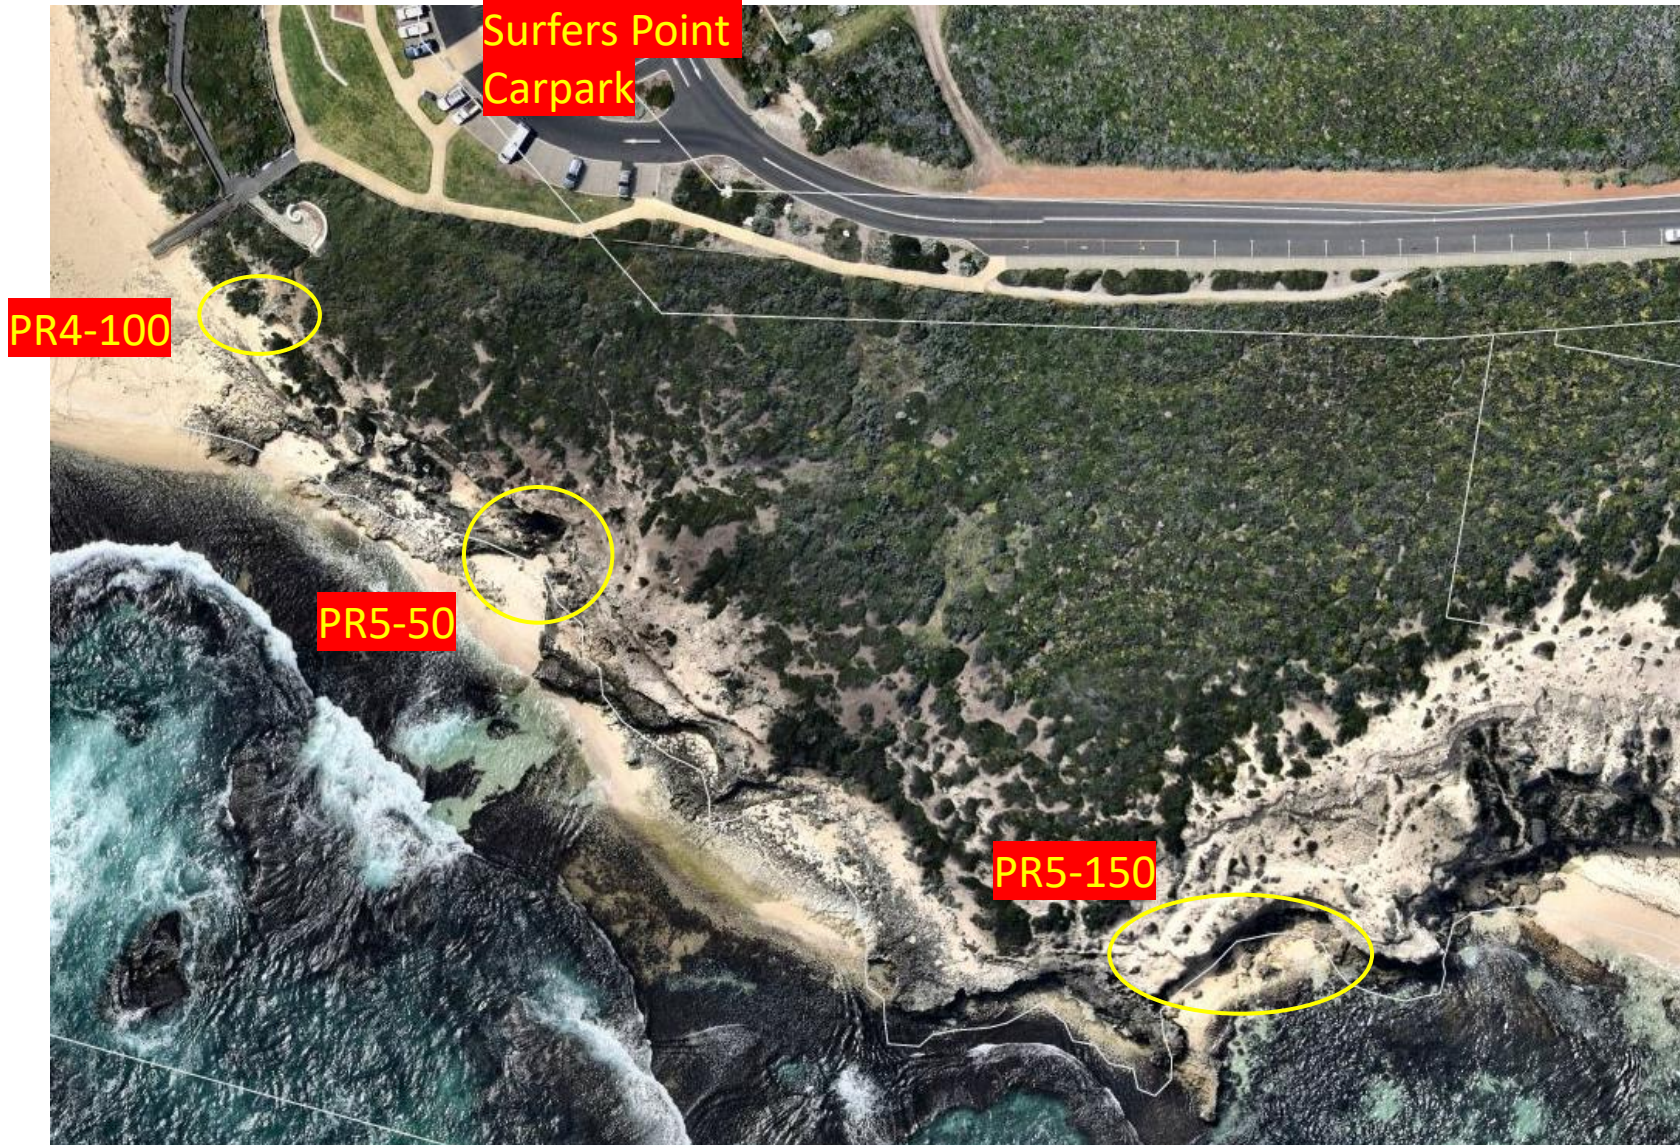
Hazard 1 -This overhang collapses whilst people are walking on it.
Note: Informal path traverses along the top of this overhang.

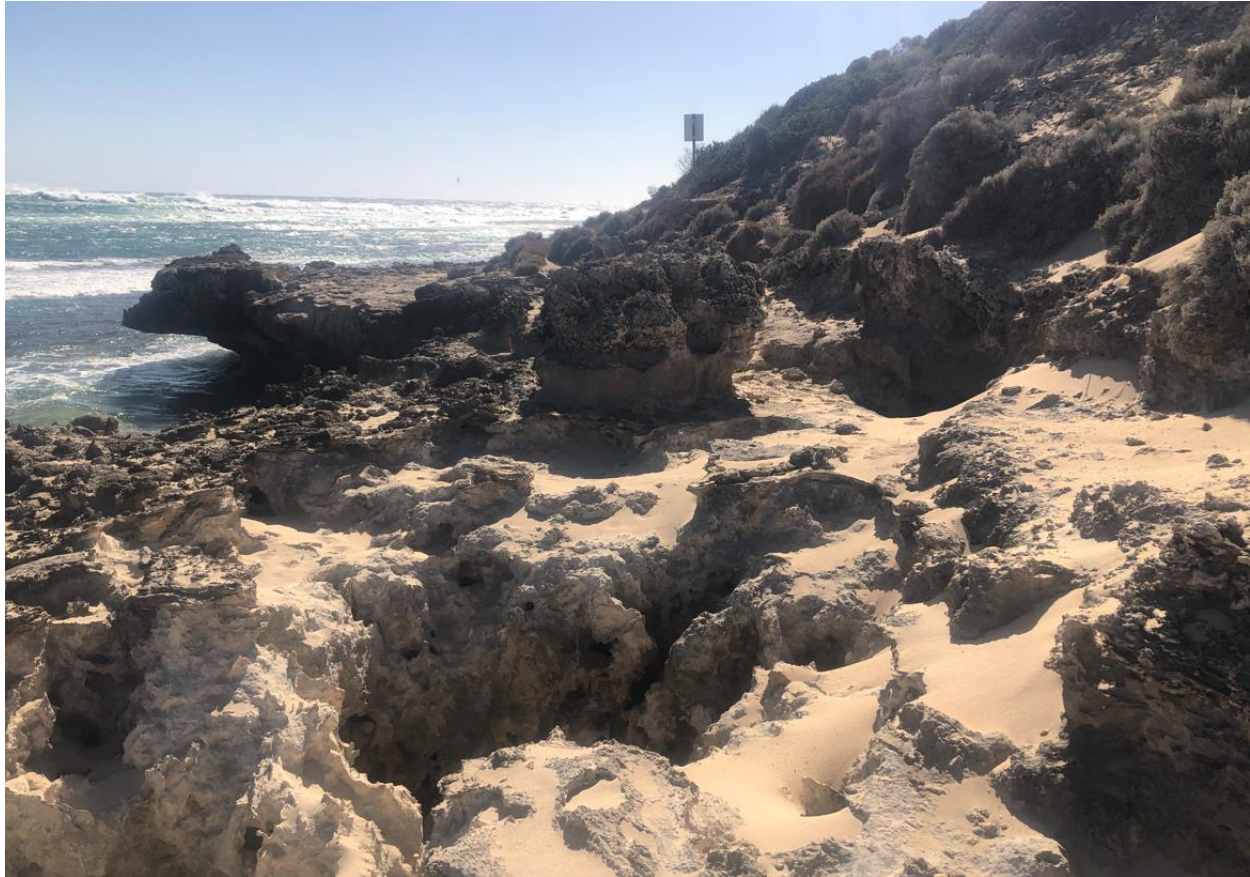
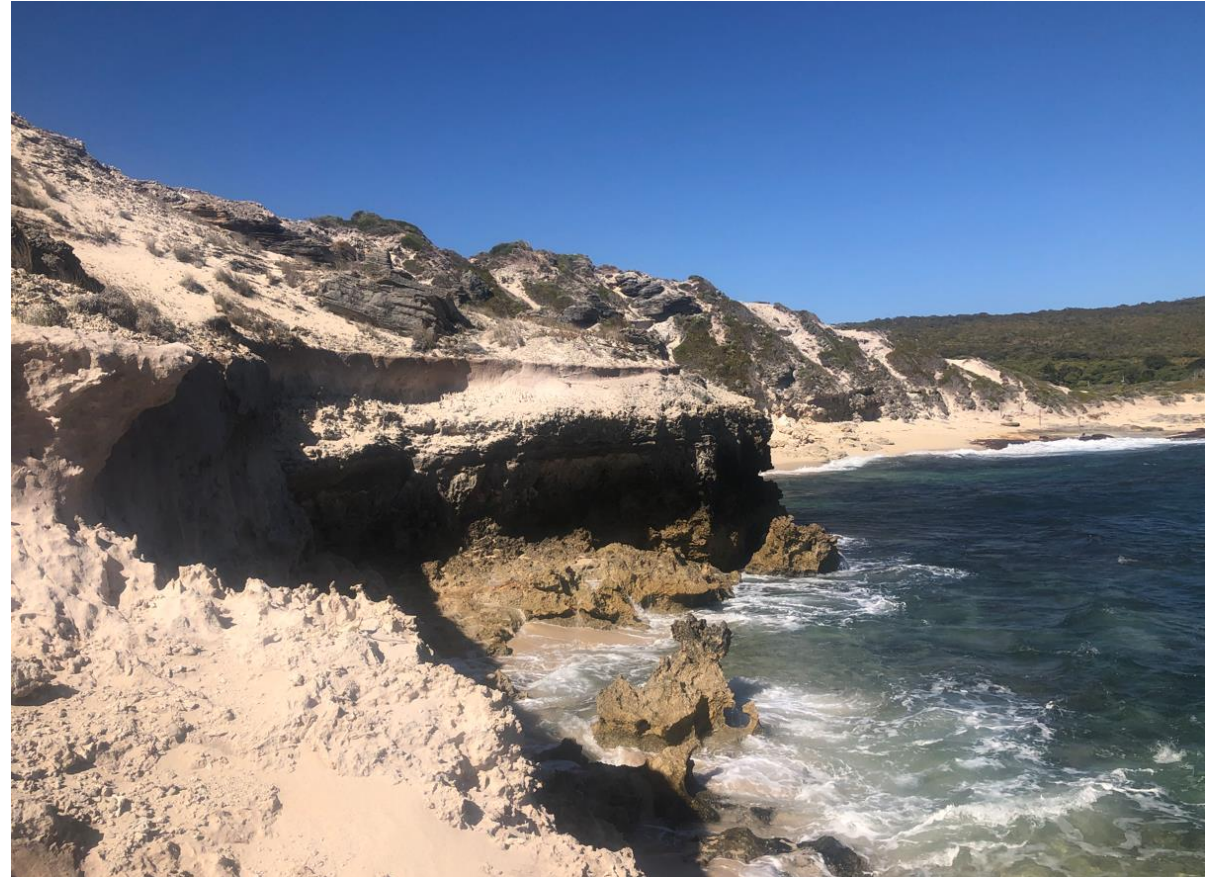
Site conditions similar to previous assessment.
Risk to Individual Most at Risk (R_{DI}) has not changed
since previous assessment (2021):

$$R_{DI} = 1.5 \times 10^{-6}$$

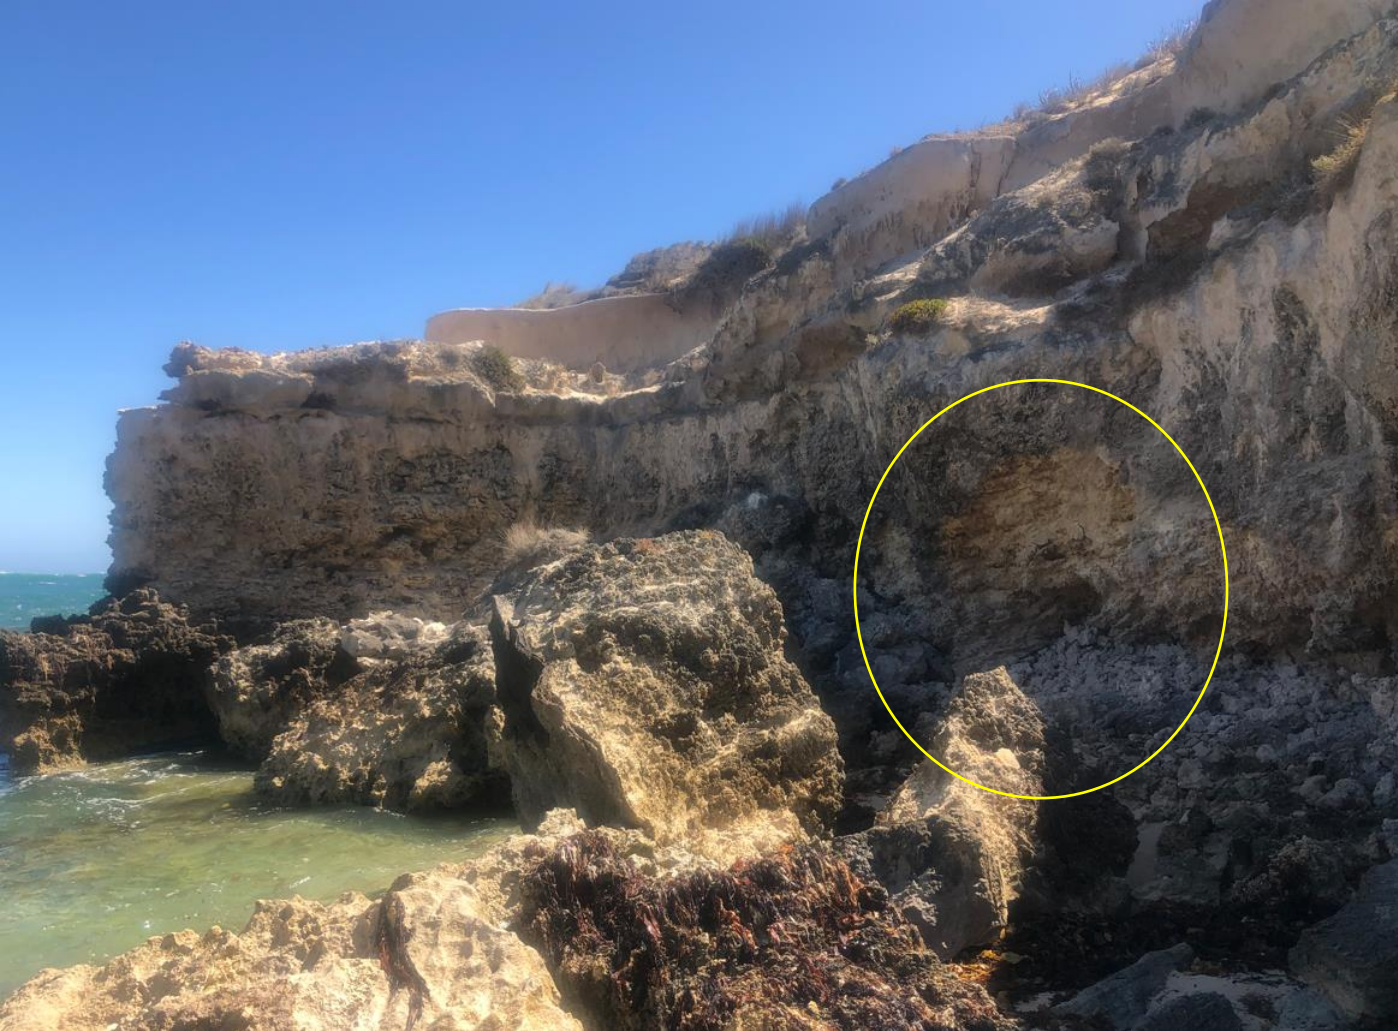
Evidence of spalling of cliff – cliff is being actively undercut at this location and future rockfalls in this location are expected.

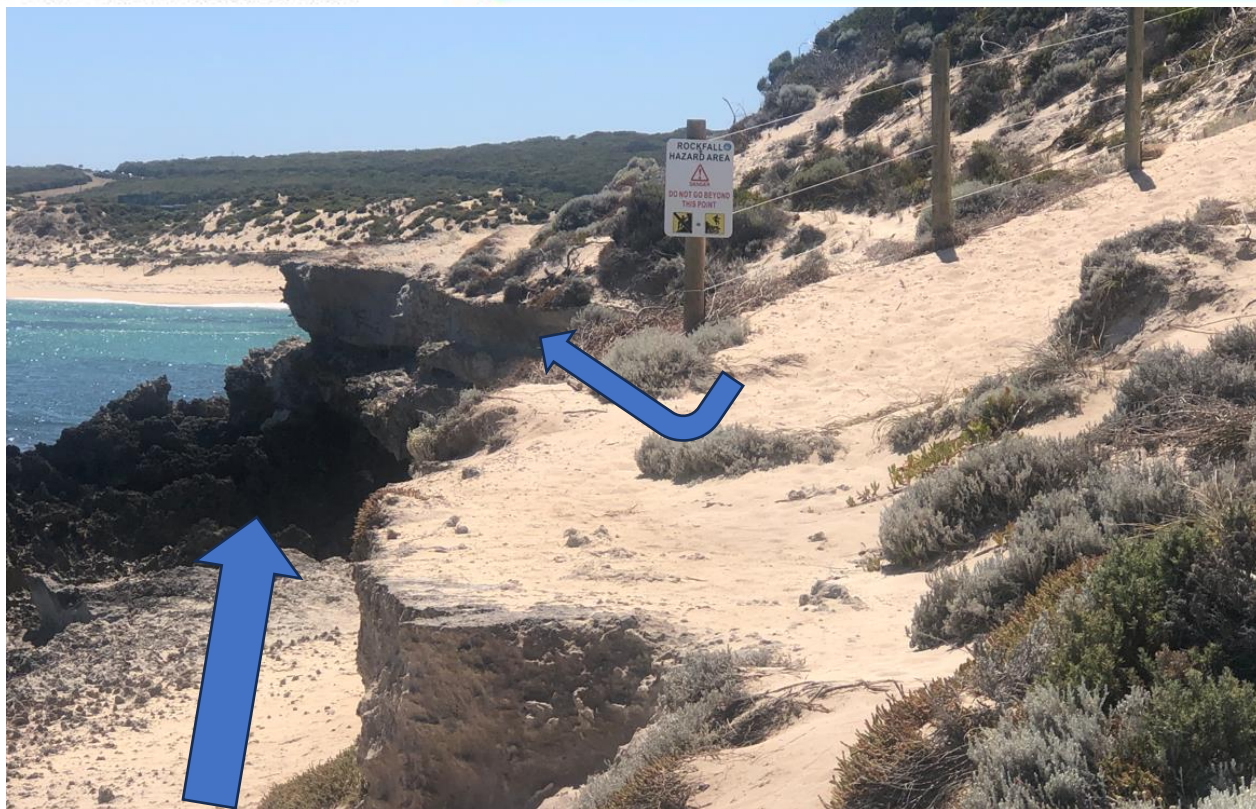
People are accessing the lower bench (straight arrow) – this access leads to an undercut section. People are also accessing the upper bench (kinked arrow) resulting in access along the top of undercut ledges.

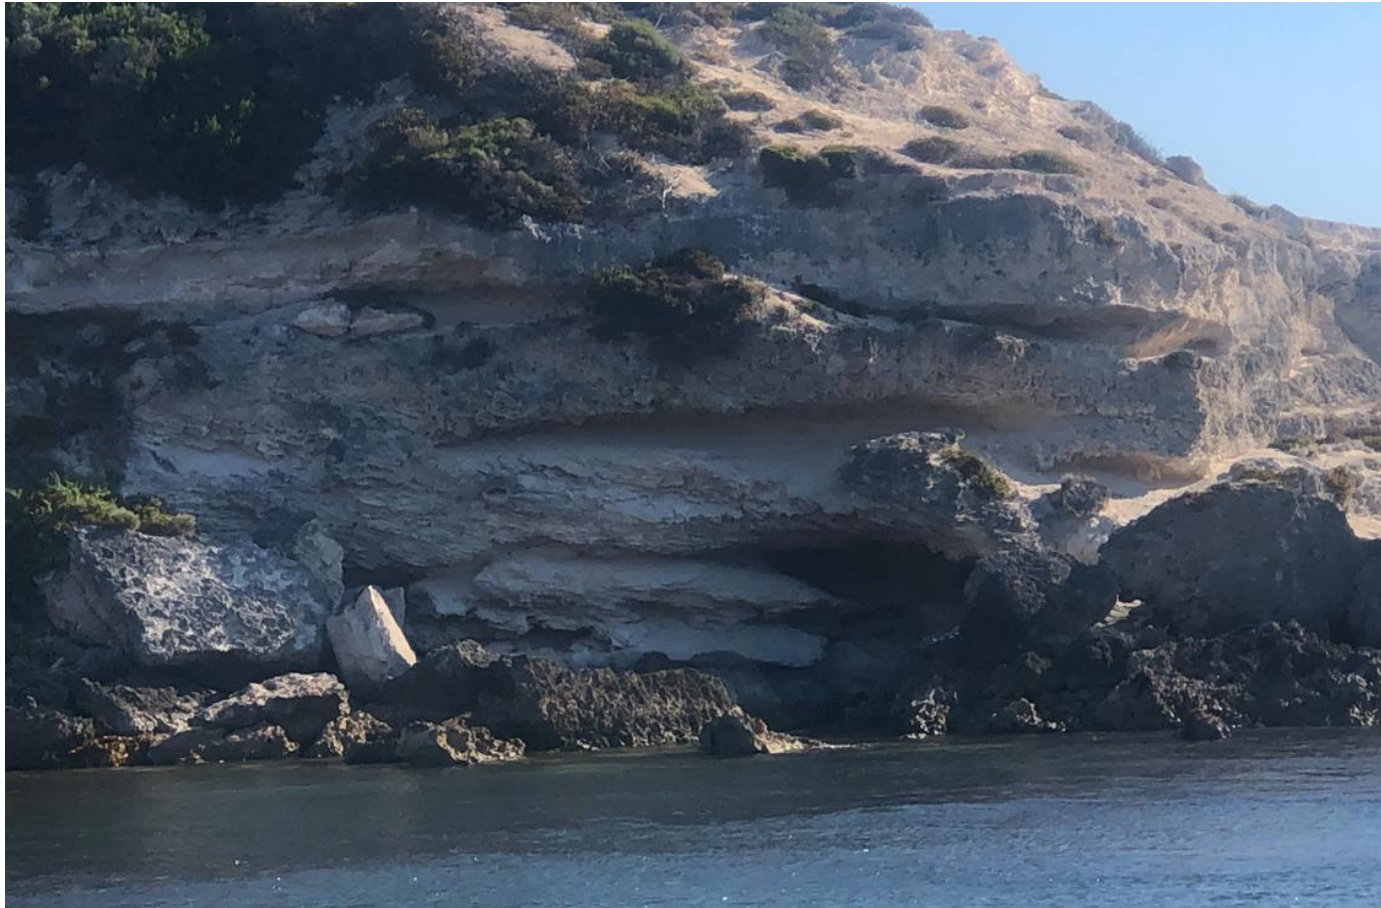
The Gnarabup Beach Cave - The level of Risk to the Individual Most at Risk (R_{DI}) remains similar to 2017 at 8.3×10^{-7}

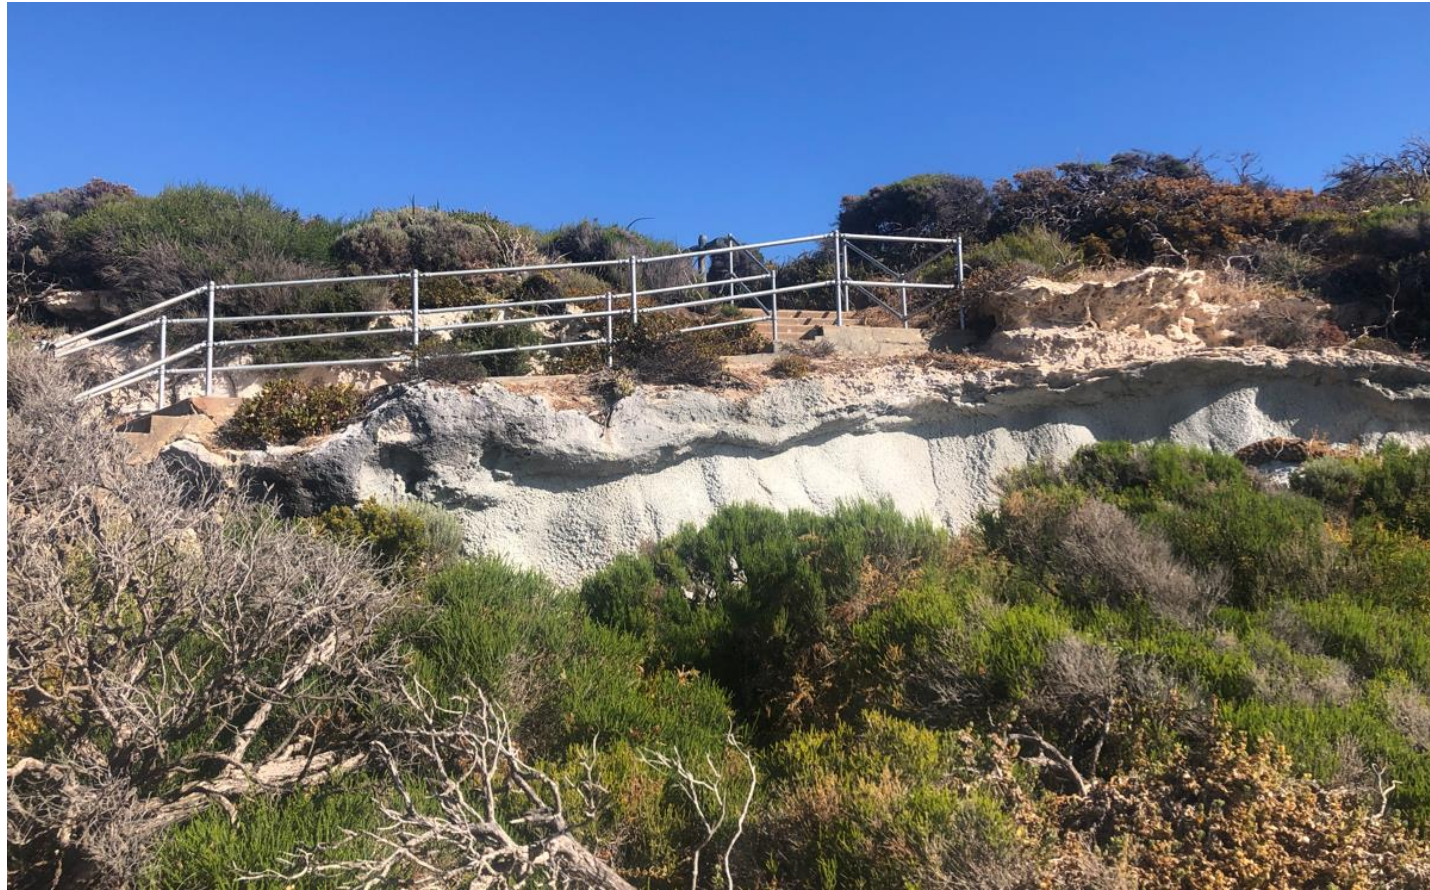
Control/remedial measures put in place in 2021 to reduce weathering under the overhang and to underpin the stairs. Risk to the Individual Most at Risk assessed following these remedial works (March 2022 assessment report) to be 2.3×10^{-7} . This risk remains unchanged.

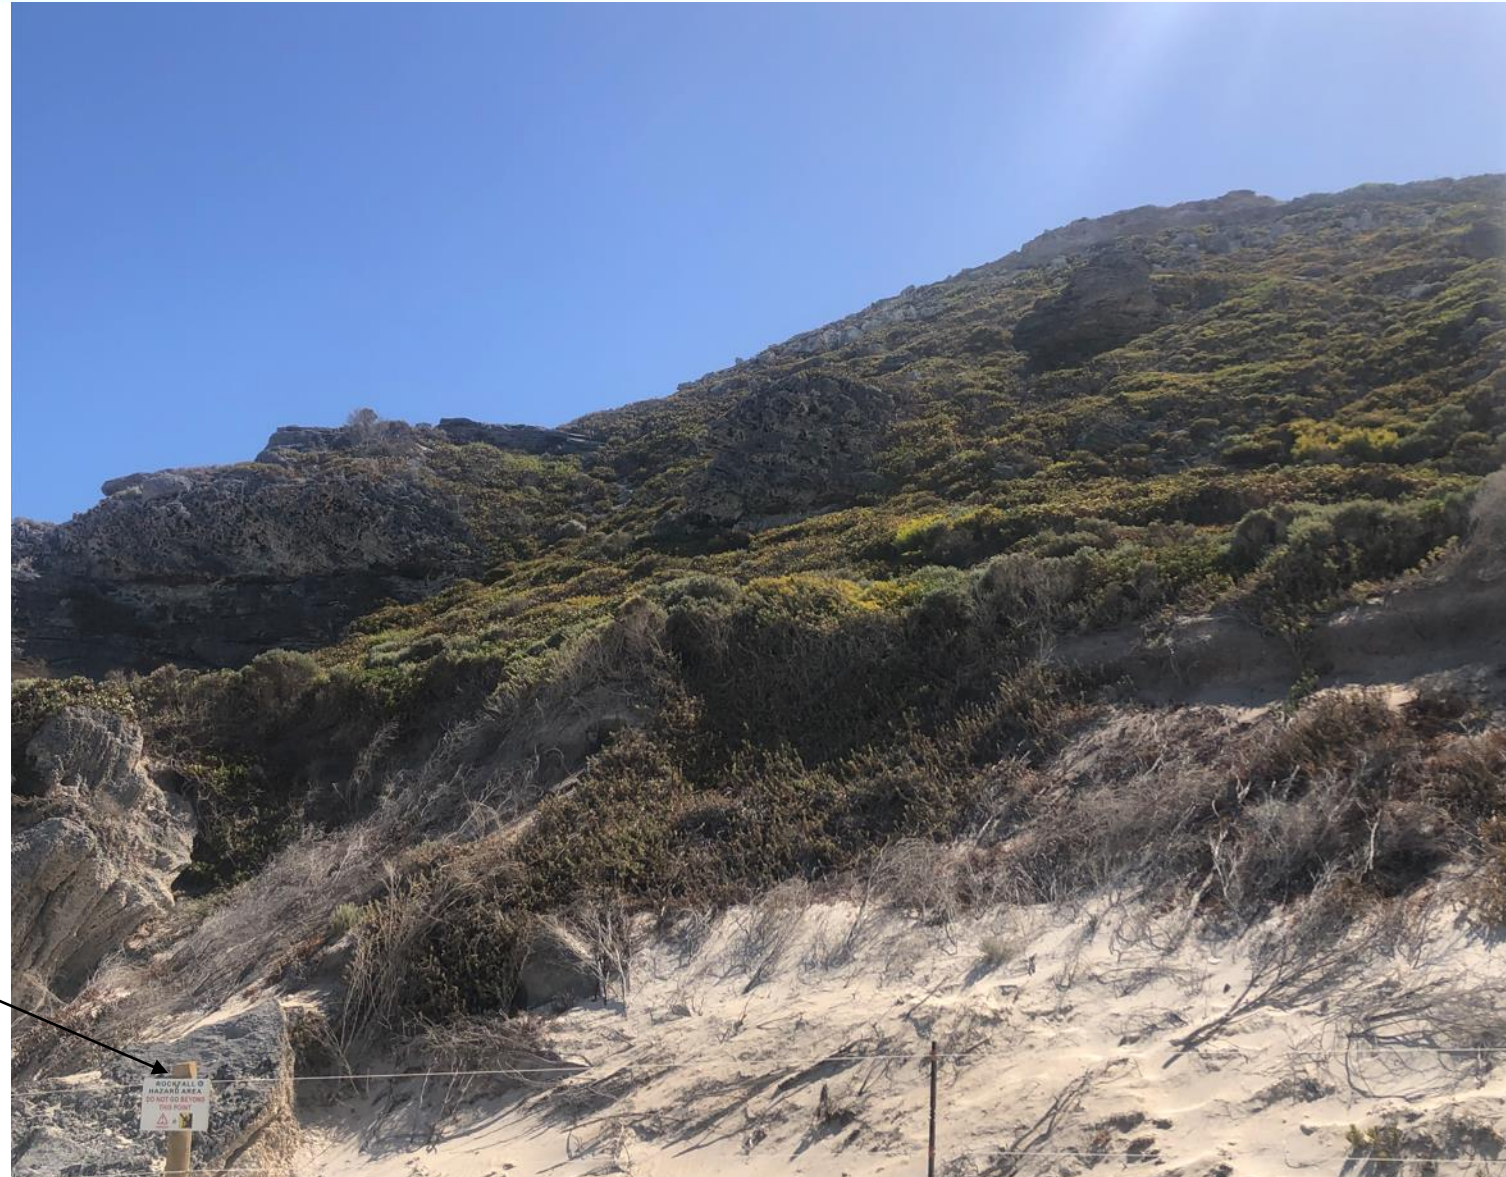
Temporary fence
visible in this March
2024 photograph

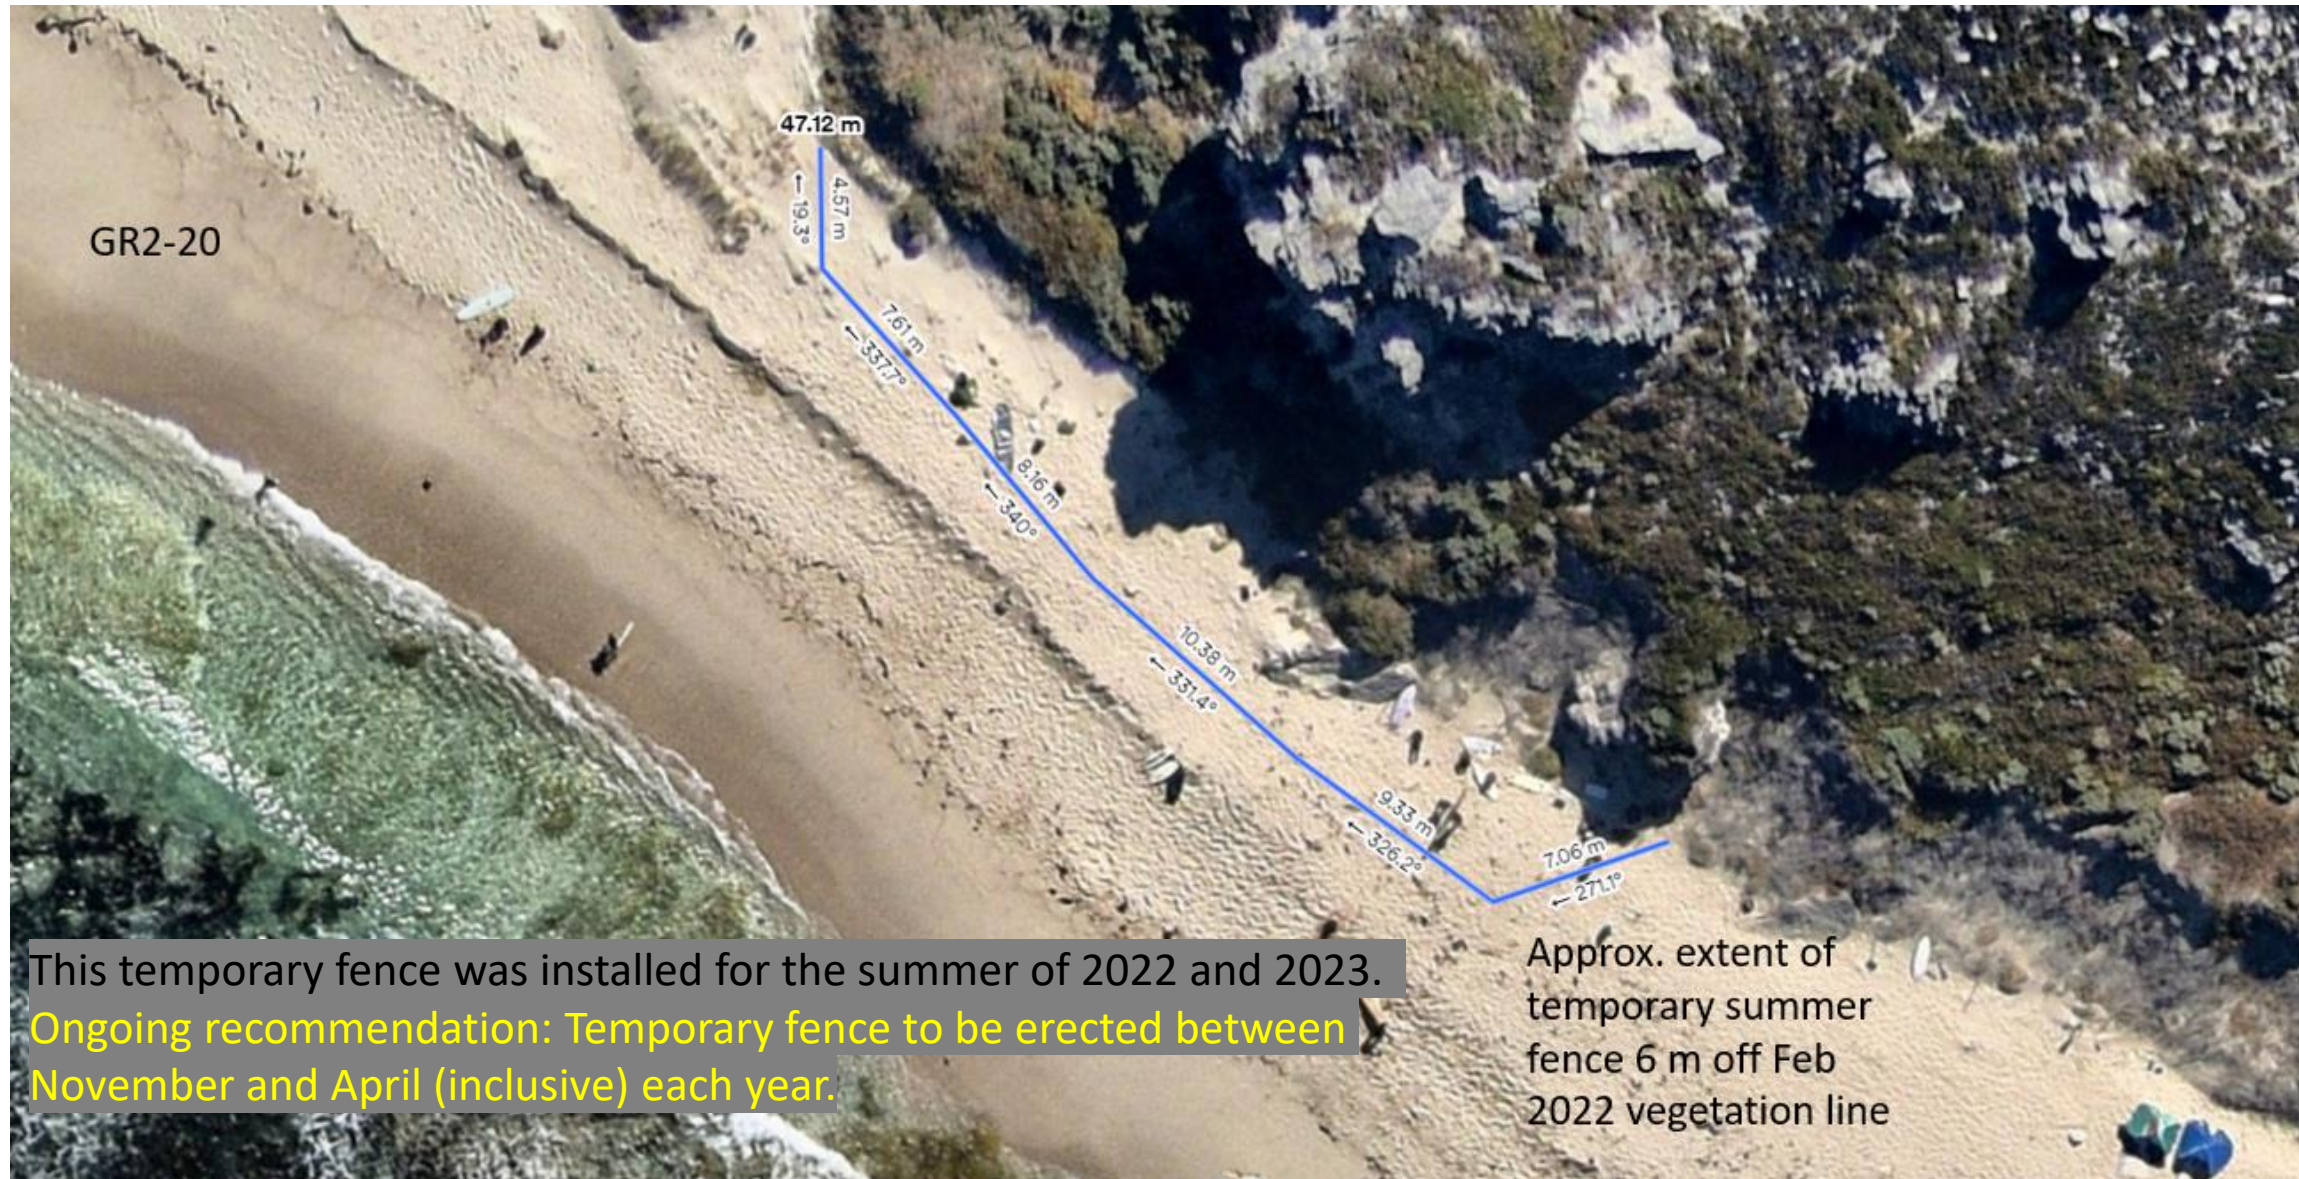
Approximately
3m overhang
