LIMESTONE STABILTY ASSESSMENT

**GRACETOWN, PREVELLY, GNARABUP, WESTERN
AUSTRALIA**

**INSPECTION, RISK ASSESSMENT AND
REMEDIATION DESIGN REPORT**

PER2019-0229AA Rev 1

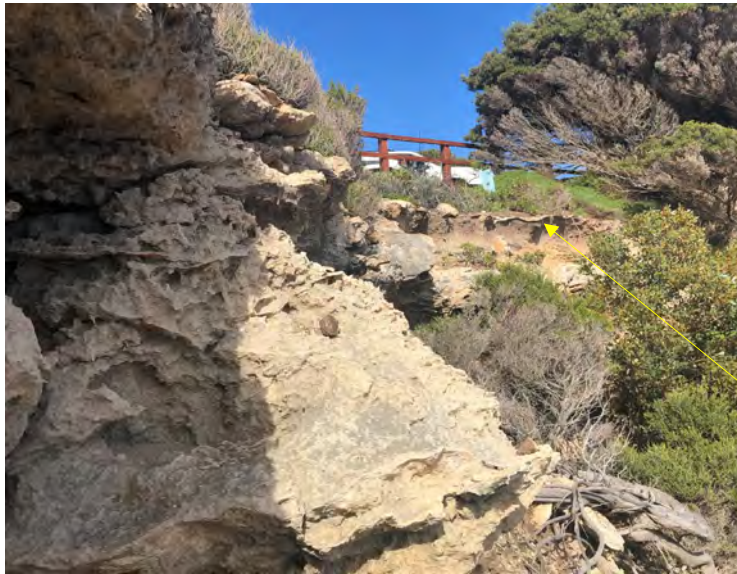
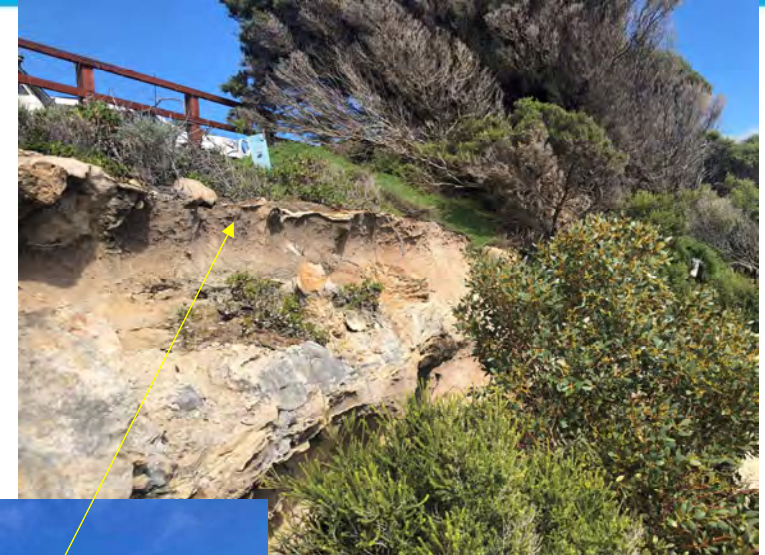
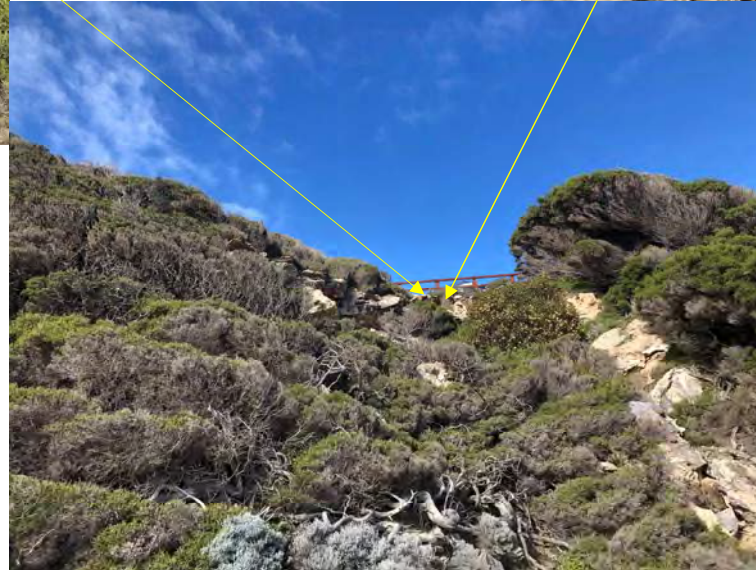
No retrogression of embayment to west of GC6-60 since 2017 is apparent. Healthy establishment of native vegetation has occurred (see photo on right)

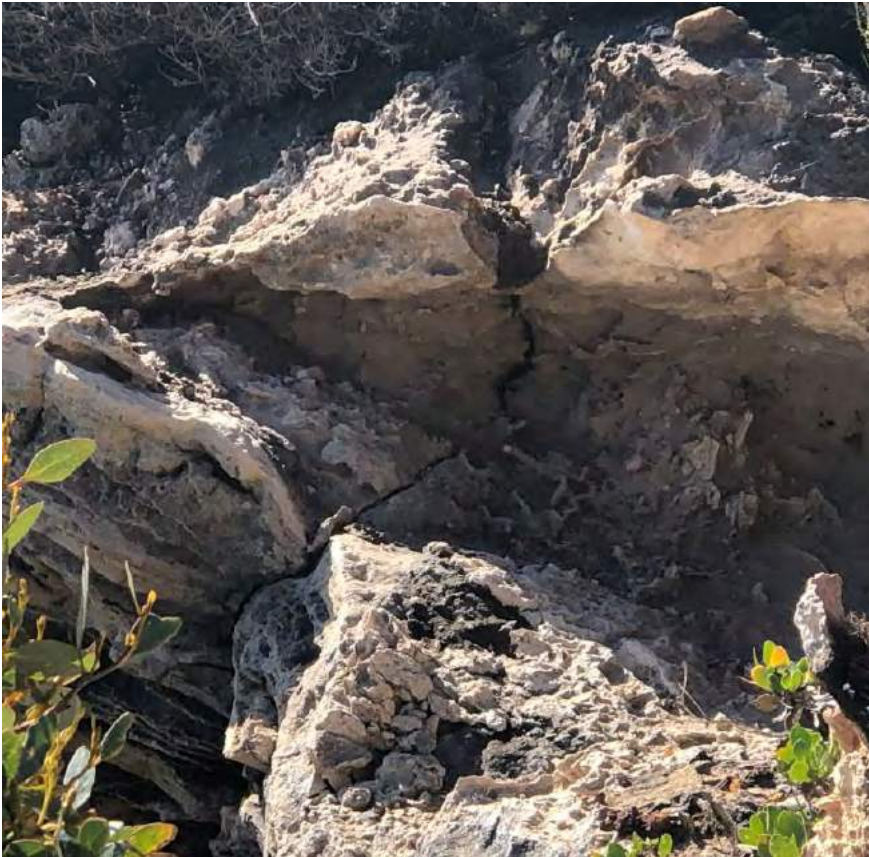
August 2019 inspection indicates little change from 2017

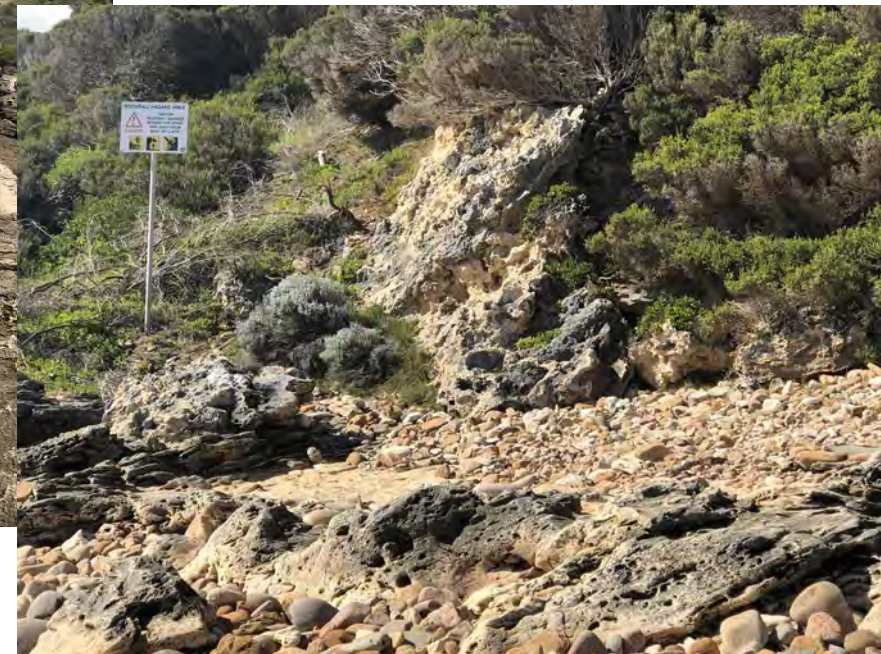
August 2019 – Undercut outcrop on which lookout formerly stood.

Following the recommendation of the 2017 report the lookout was removed.

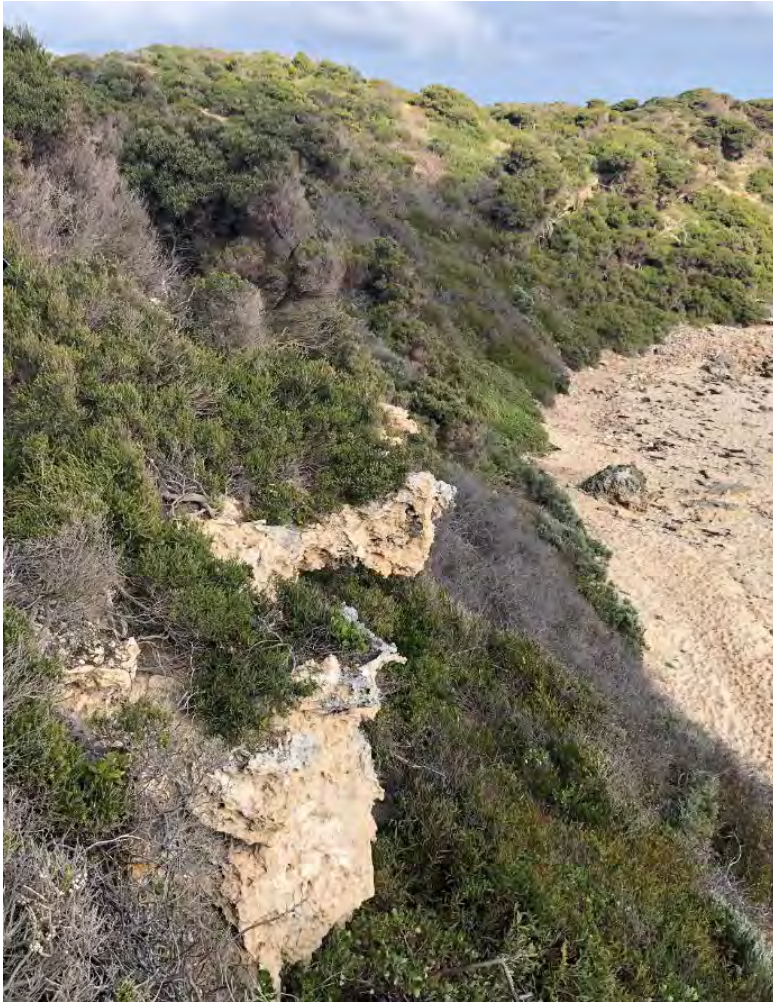
- Access to GC5-75 is difficult from below. Pedestrian access will be required however to
- a) survey overhang and establish points to needle drill and,
 - b) b) to fragment and bar down fallen rock that does not roll to base of slope

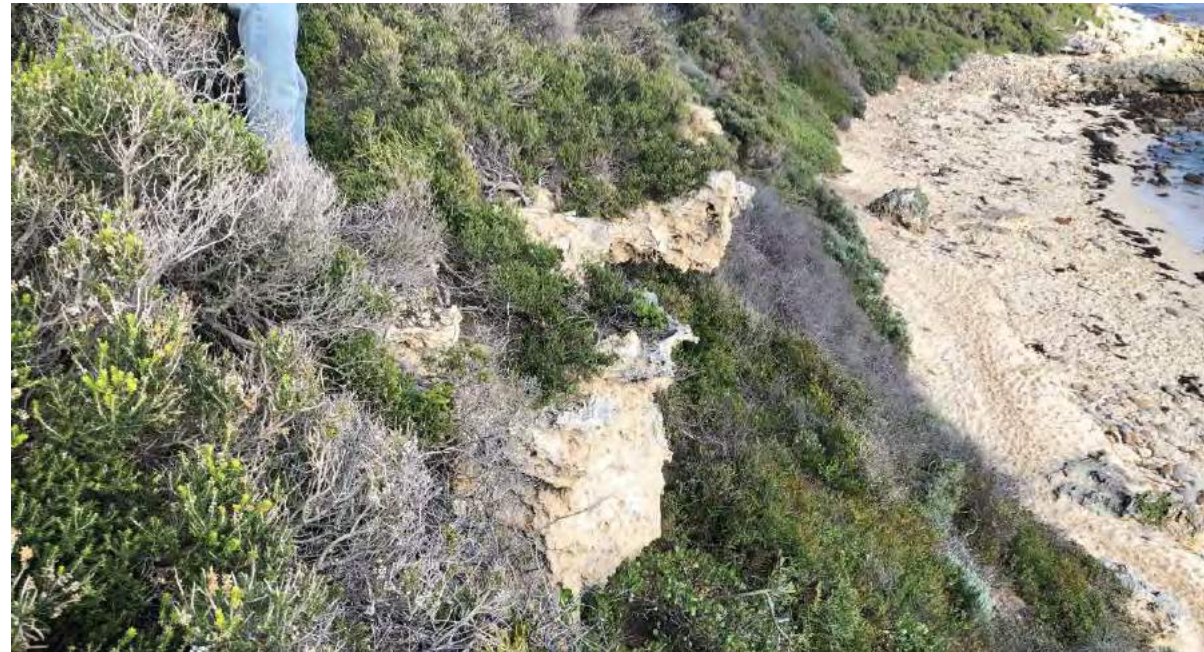
Access to top of overhang will be via footpath to South Point and will be pedestrian only. Some cutting of scrub between footpath and edge of overhang will be required. Anchor points for safety harness will need to be established and a line set out defining the overhang and no-go zone so no personnel stand or work in the no-go zone.

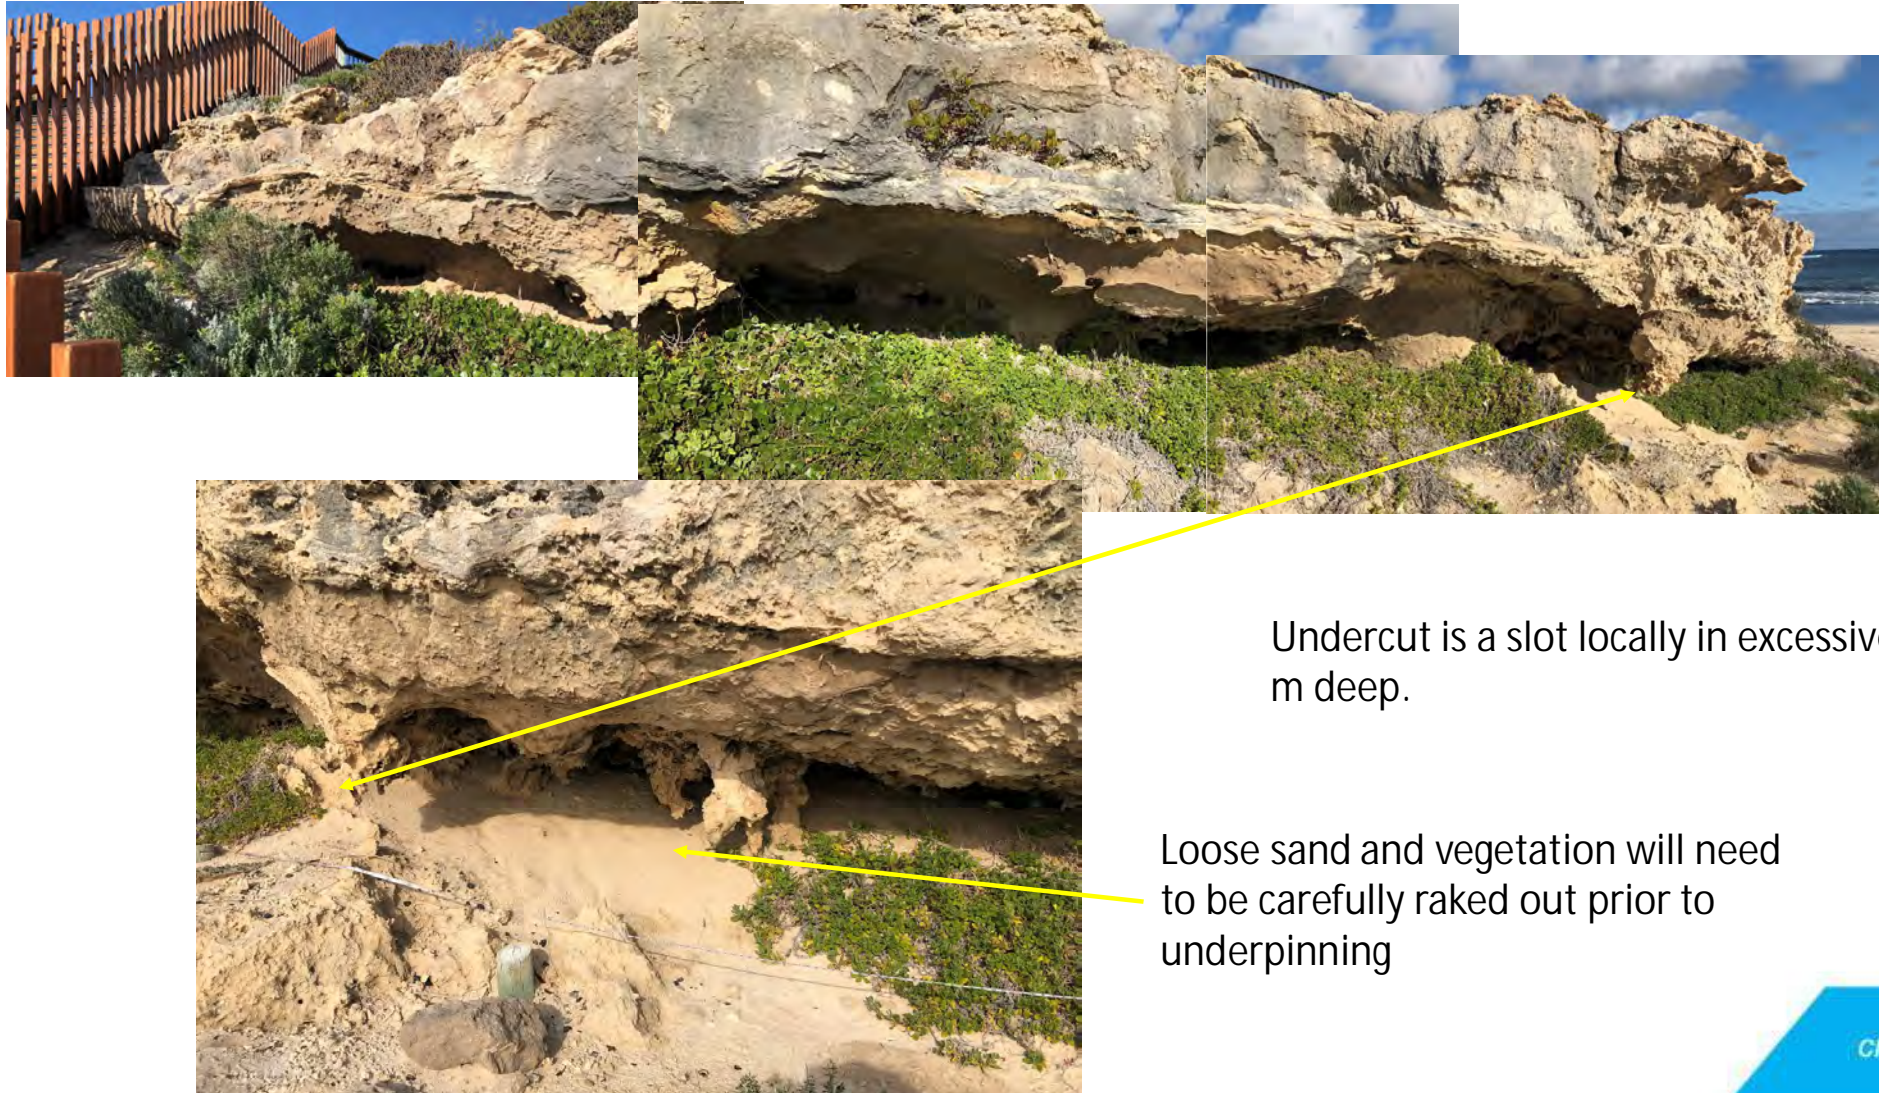
Overhang is approximately 14 m long, generally between 0.2 and 2.9 m wide (deep) (locally measured to be 3.5 m deep) with a height along outside face between 0.2 and 1.5 m tapering rapidly to a narrow slot a few centimetres high.

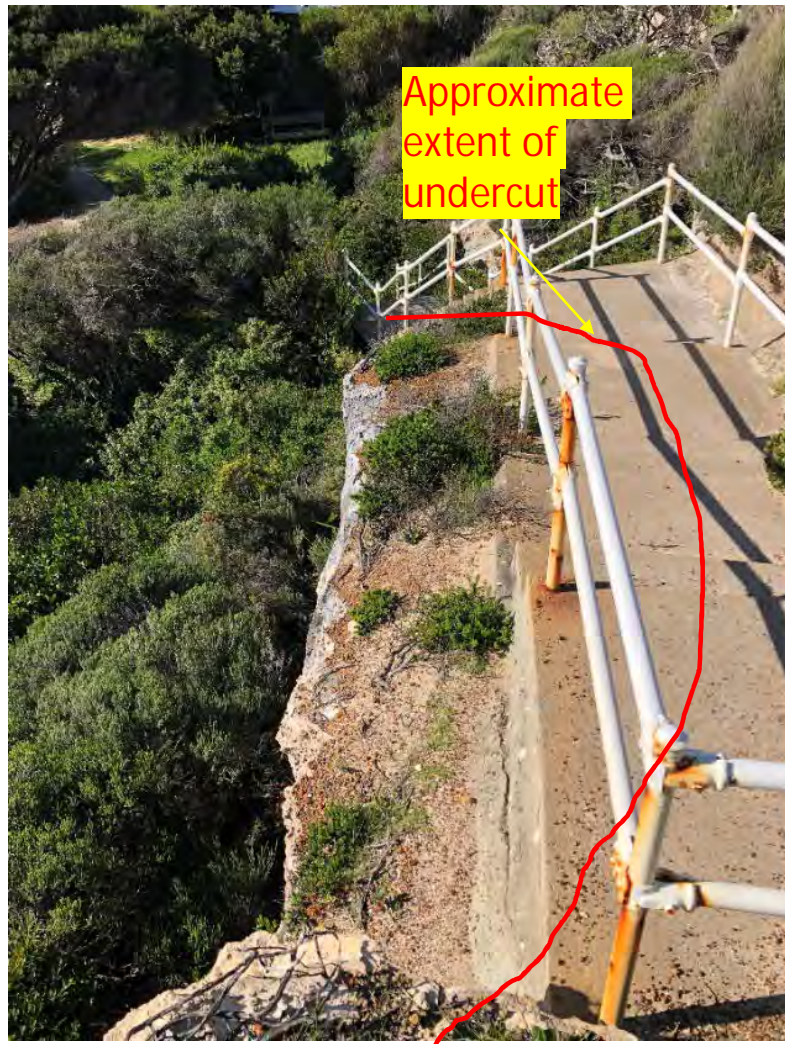
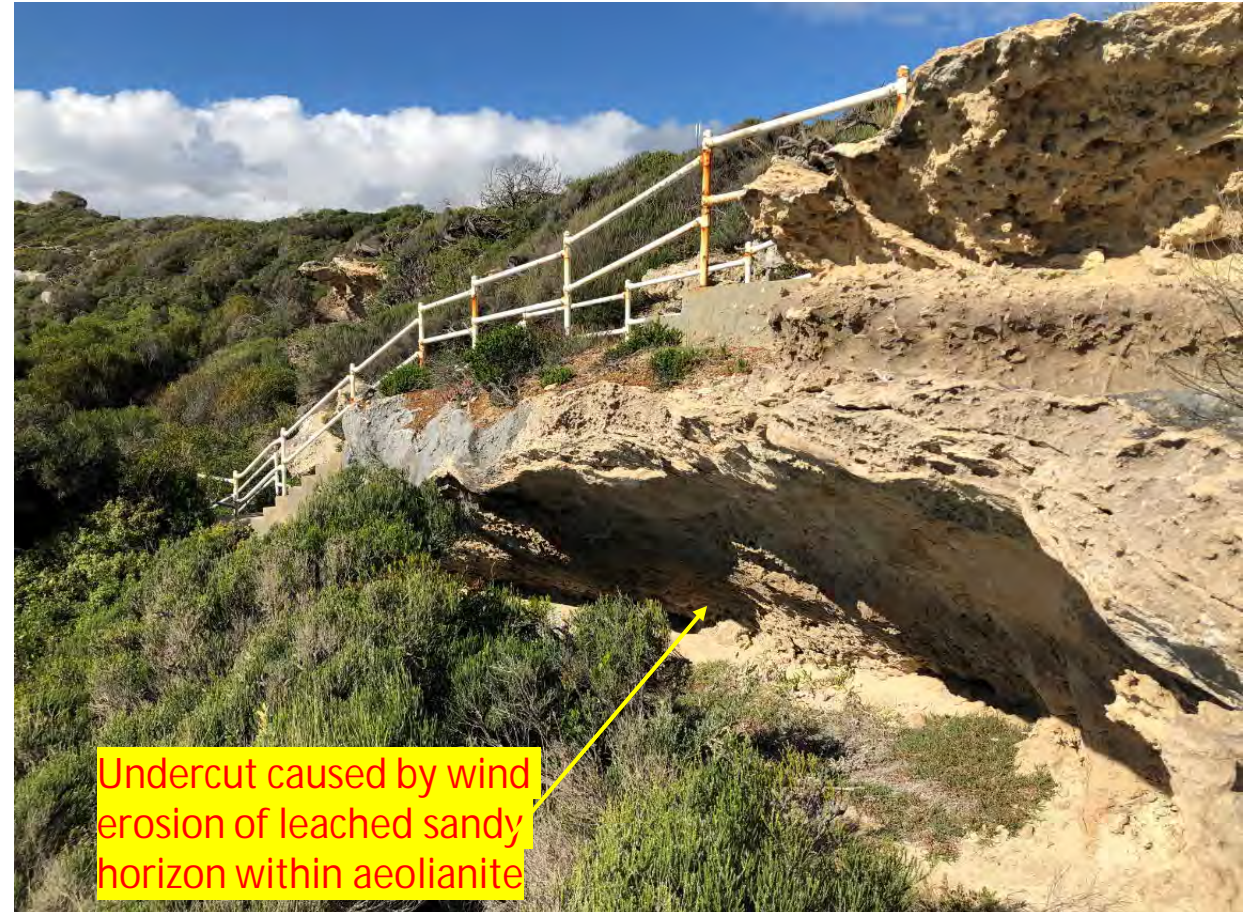
Undercut to steps leading down from carpark to White Elephant Café highlighted in this August 2019 Nearmap Image

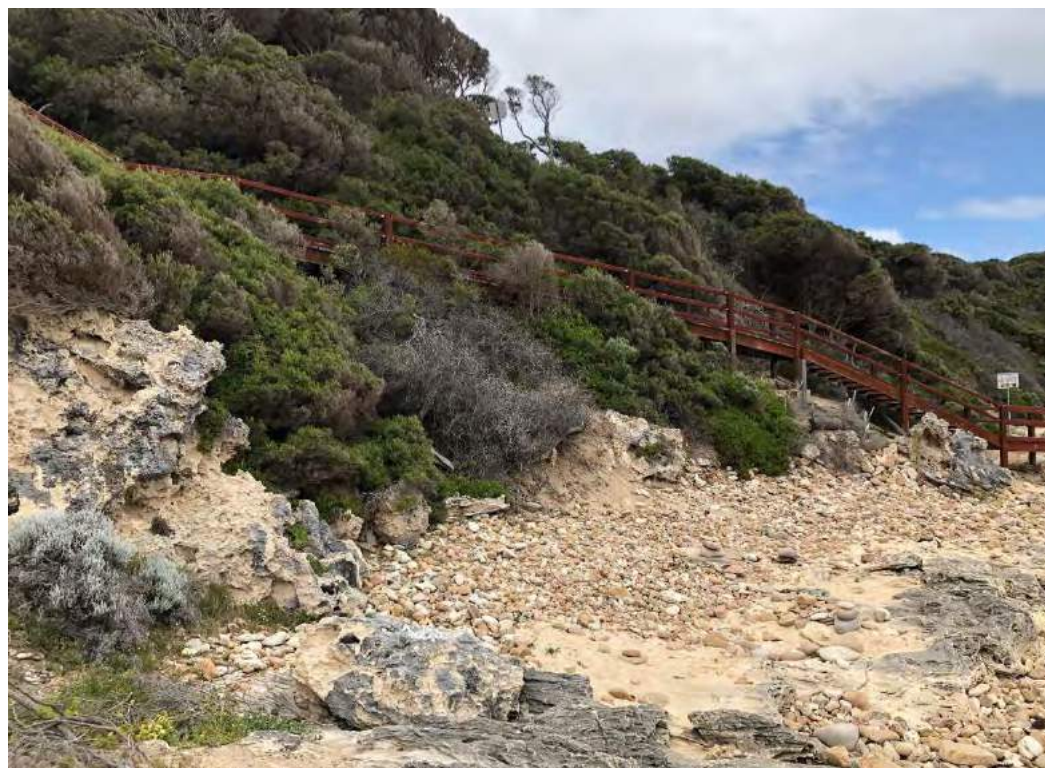
Reference photograph of stairs from outcrop showing erosion as at 11 October 2019

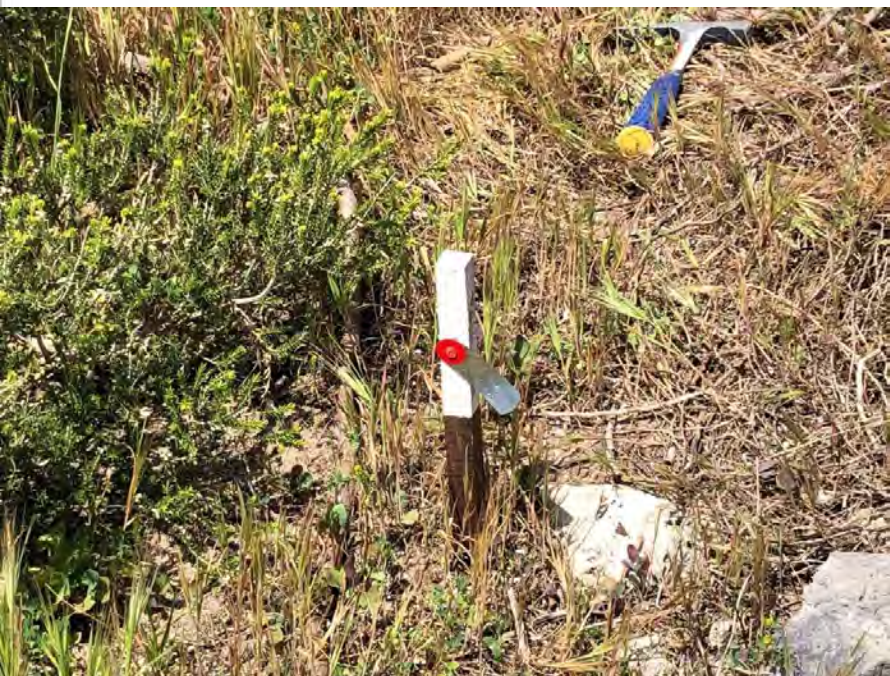
Reference photograph of
undercut outcrop for future
reference

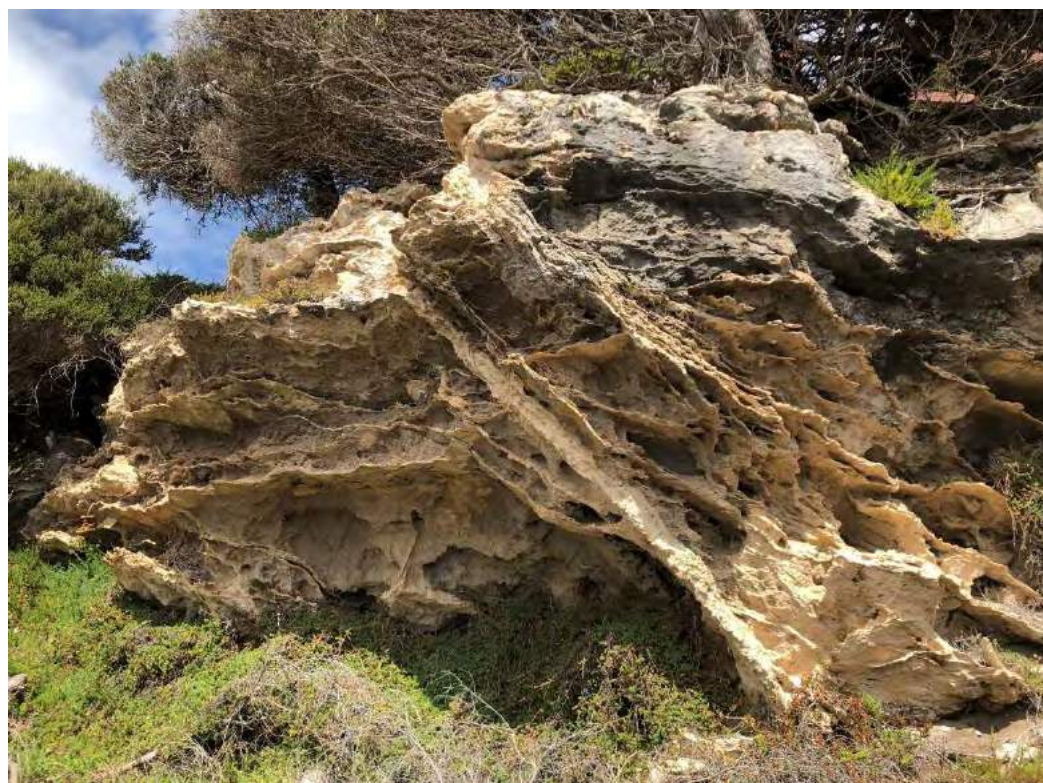
Reference photograph of erosion
on west side of outcrop with stair
in background for future
reference

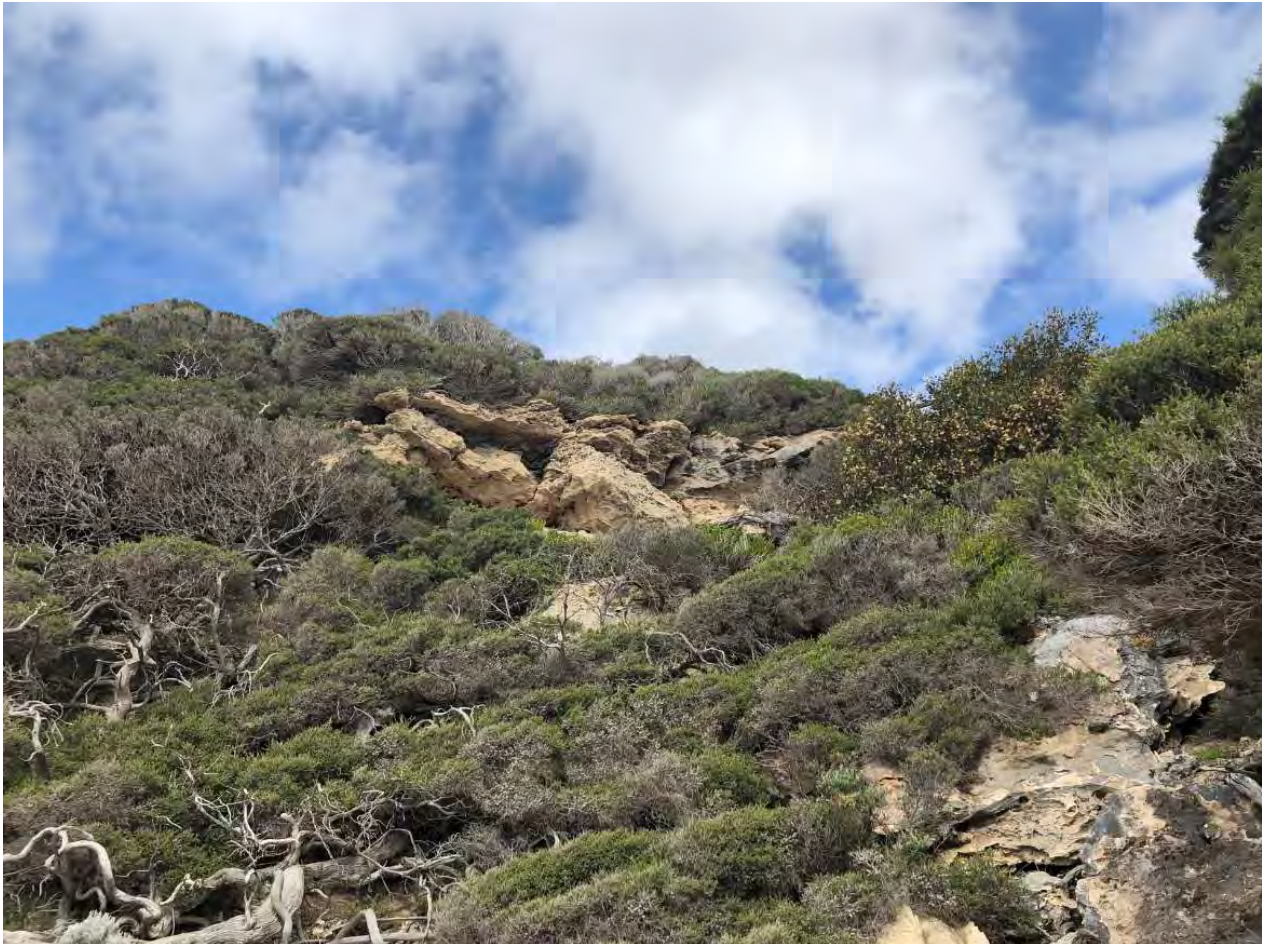
Reference Photograph from Site 1.
Note this slope comprises boulders in a sandy matrix and it is dangerous to scramble up and thus survey should be conducted from beach and carpark.

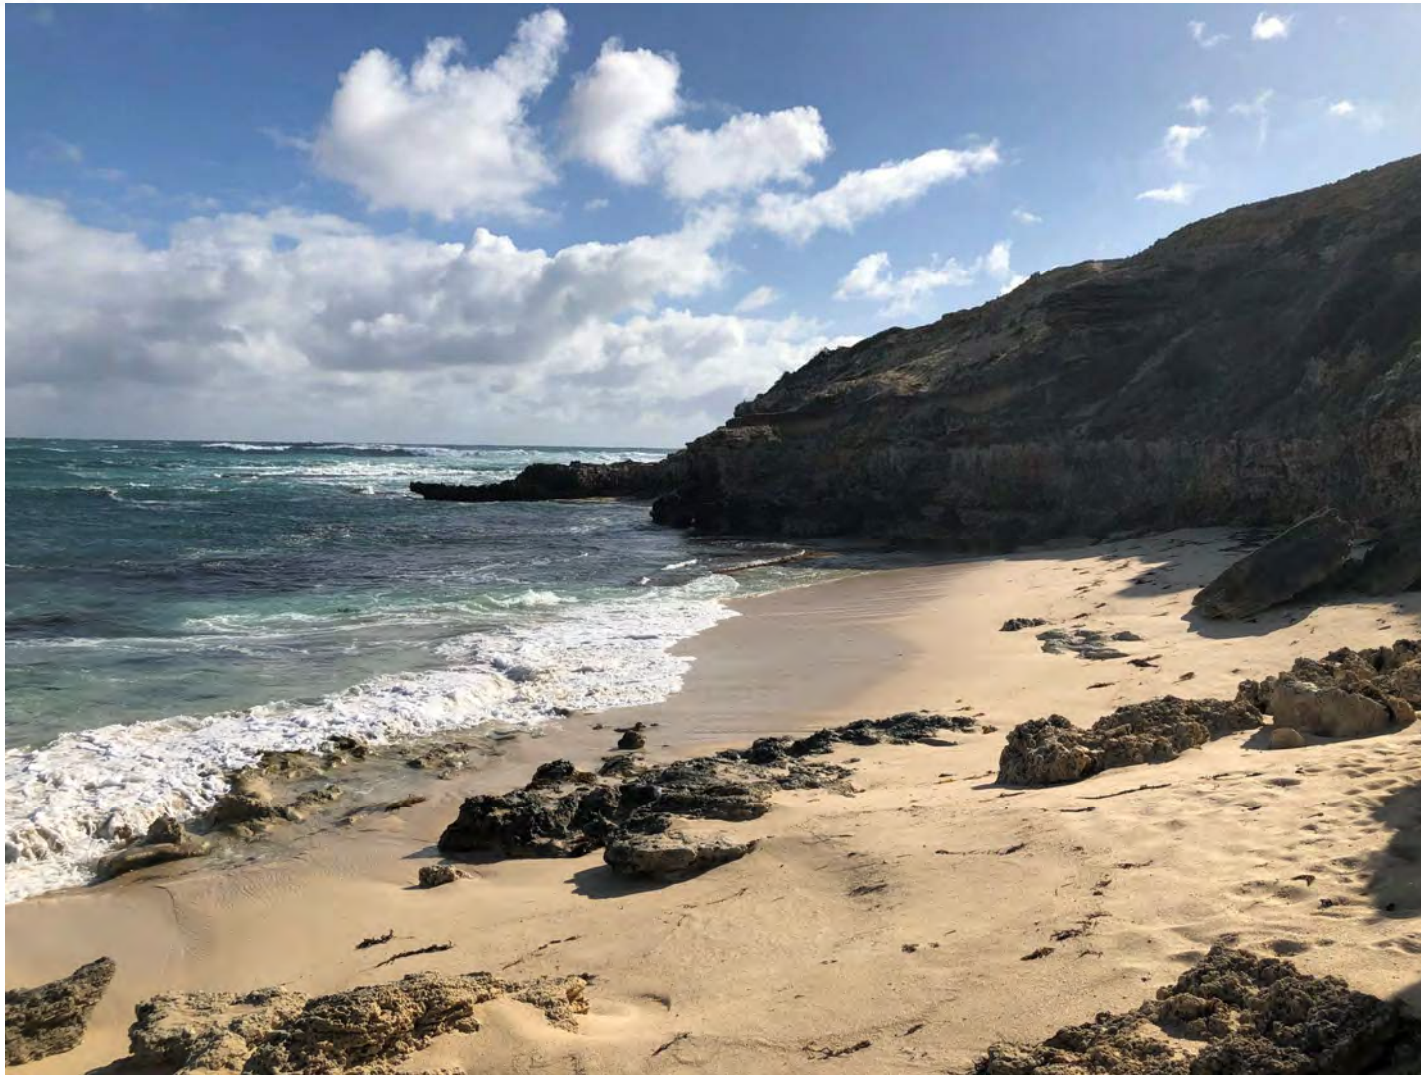
View from rockfall sign. Look for and note new rocks and boulders on beach that have fallen since last survey

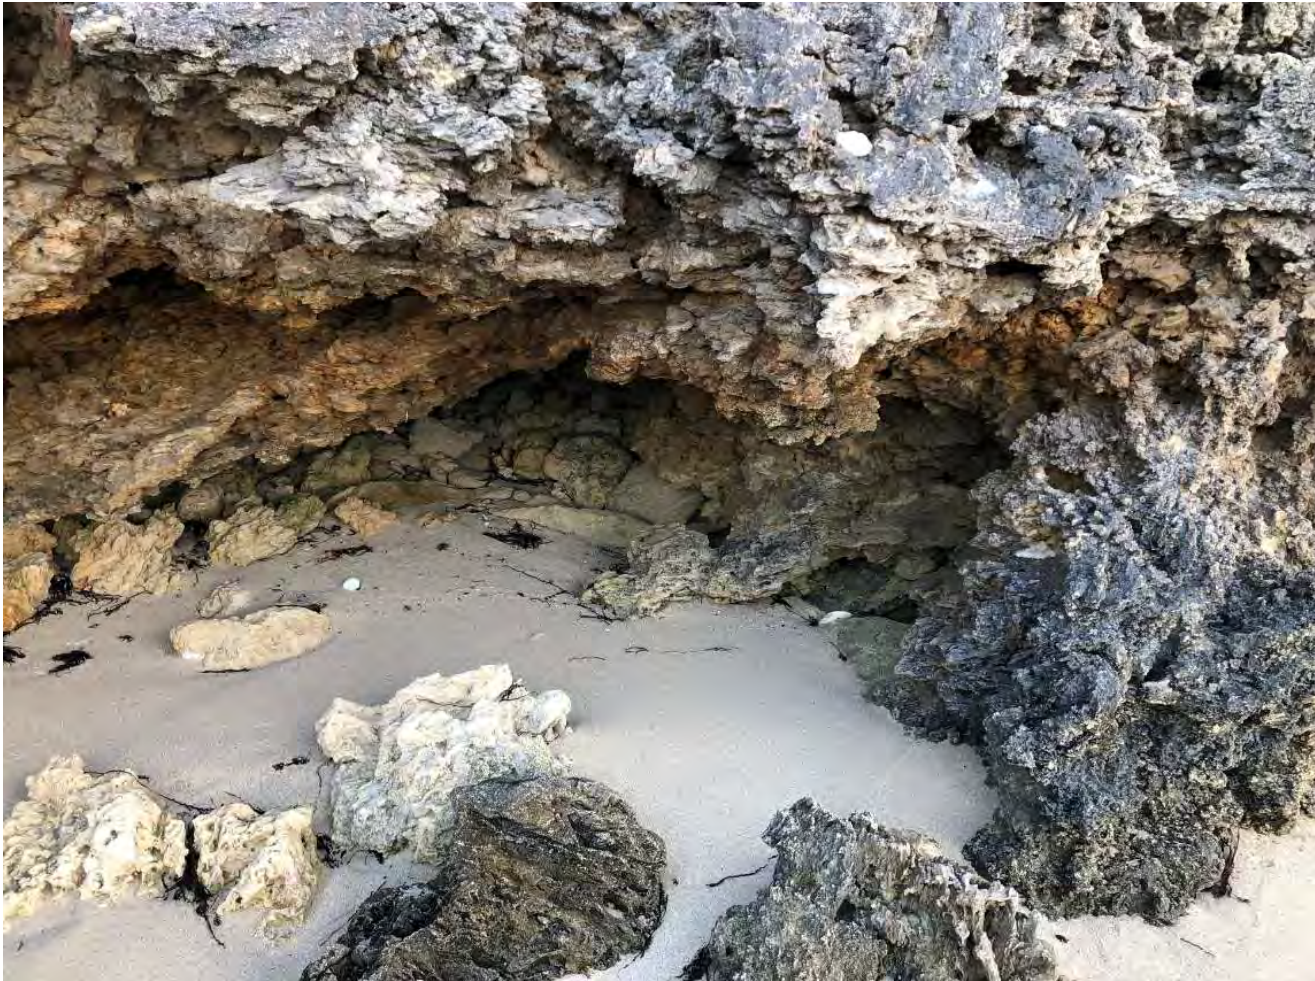
Observe if undercutting is increasing or active. Undertake surveys following major storm events.

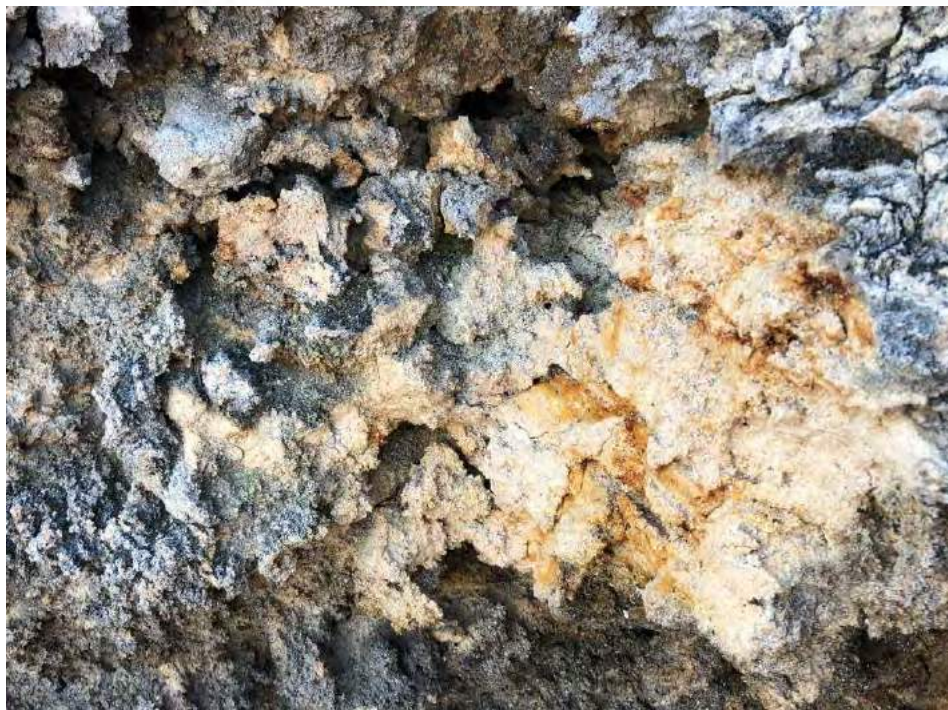
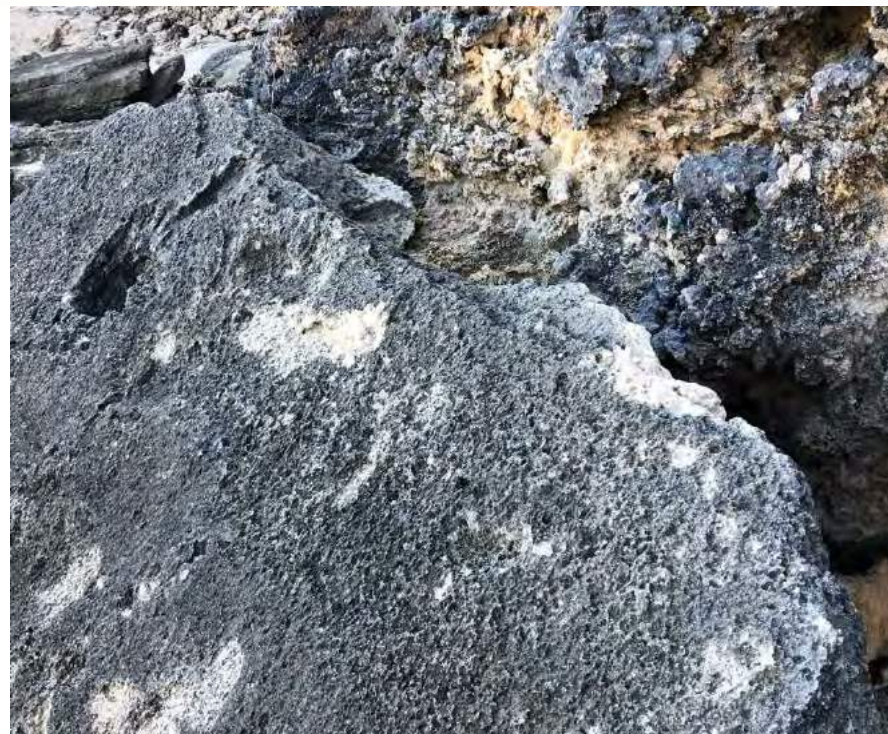
Look for and record fresh features like these. White indicate recent drop-outs (left photo) and impact marks (right photo)

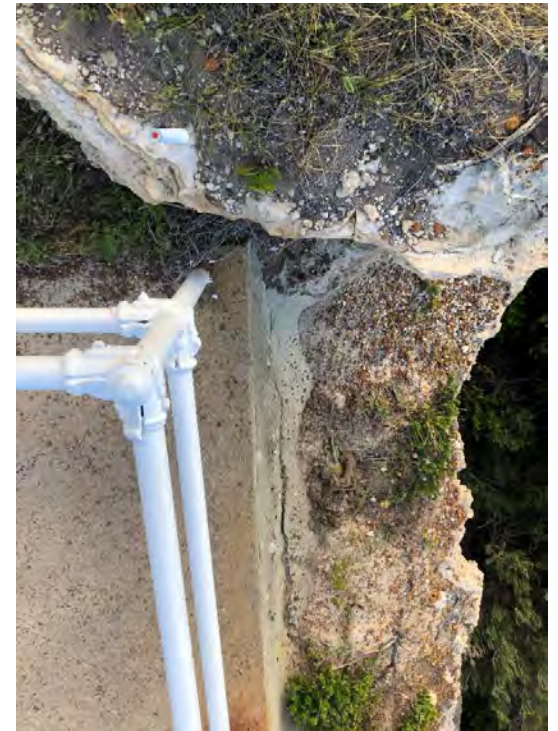
Survey nails at Site 2

Separation should be measured each survey. Separation (centre to centre) on 11 October 2019 was 101 mm and crack width at nails (6 mm) indicating 6 mm of subsidence to wall beneath stairs
