LIMESTONE CLIFF RISK ASSESSMENT

**GRACETOWN, PREVELLY, GNARABUP, GRUNTERS,
WESTERN AUSTRALIA**

INSPECTION AND RISK ASSESSMENT

PER2021-0300AB Rev0

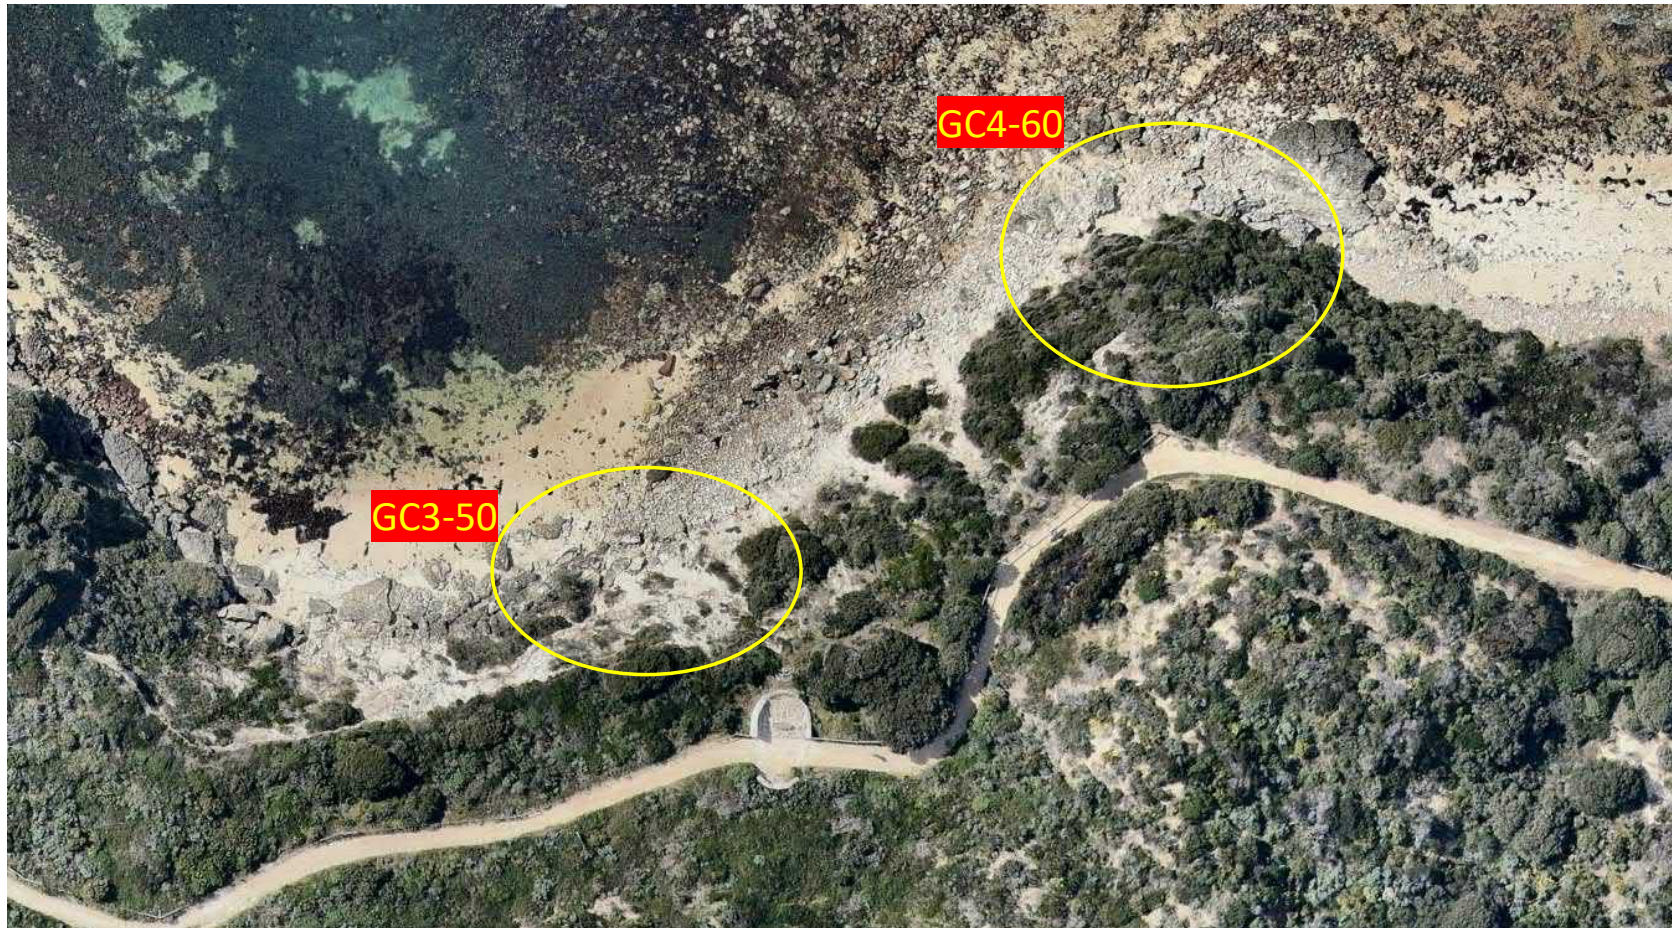
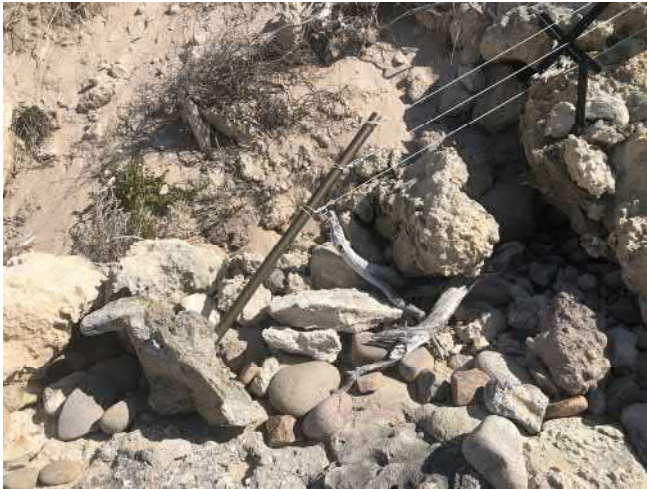
Gracetown GC3-50 and GC4-60

The location was inspected during a very low tide and on an exceptionally still day (almost no swell). It is apparent coastal erosion due to wave attack has occurred during the winter of 2021 cutting into palaeosol material and limestone colluvium in front of the notch that forms the Huzzas cliff overhang. This has mainly occurred at the eastern end of GC3-50. The erosion has caused the existing fence to be undercut and it is broken at its eastern end (refer Slide 2, Appendix A).

The risk from this hazard has increased since the 2017 Golder inspection.

It is noted that the existing fence is too close to the hazard to keep people out of the hazard zone should a major collapse occur. The problem is that there is not enough space to move the fence seaward by any substantial distance. Risks have been assessed based on the current fence position.

It recommended that 'Informative' signage be installed in positions similar to those indicated on Slide 4. The informative signs need to be positioned such that the hazard at Huzzas cliff can be seen from the sign, and the sign secured to rock and sufficiently high up the beach not to be washed away or damaged during stormy weather. The signs should clearly explain (ideally through photographs, and diagrams) the Huzzas Cliff hazard and present a message to discourage people from traversing in front Huzzas Beach particularly at times when a high tide or large swell forces people up to and potentially inside the fence fronting the cliff and therefore well into the hazard zone. The safest passage (with respect to rockfall risk) is along the waterline at low tide.

It is also recommended a large "Rockfall Hazard Area" sign is installed each end of GC3-50 to further warn the public who traverse the area.

Finally, it is recommended that the existing fence fronting both SAMR and DBCA controlled parts of the cliff, which is damaged, is replaced with a more resilient fence similar to the one installed by SAMR at Riflebutts beach. This replacement fence should be extended eastwards to prevent access to an area of recent coastal erosion and should be installed slightly seaward of the existing fence where practical to keep the public out of the hazard zone as far as possible. The proposed alignment of the fence is shown on Slide 3. It is noted it would not be practical to install a fence sufficiently set back from the undercut cliff to keep the public entirely out of the hazard zone from larger events. The risk from larger and less frequent events can be mitigated but not eliminated by discouraging access through signage and education (informative signage).

Improve fencing including extending eastwards to prevent access to area of recent coastal erosion and moving further away from hazard (refer Slide 3). Add a 'Rockfall hazard sign' also include information signson approaches to Huzzas cliff from both directions (refer Slide 4 for approximate positions)

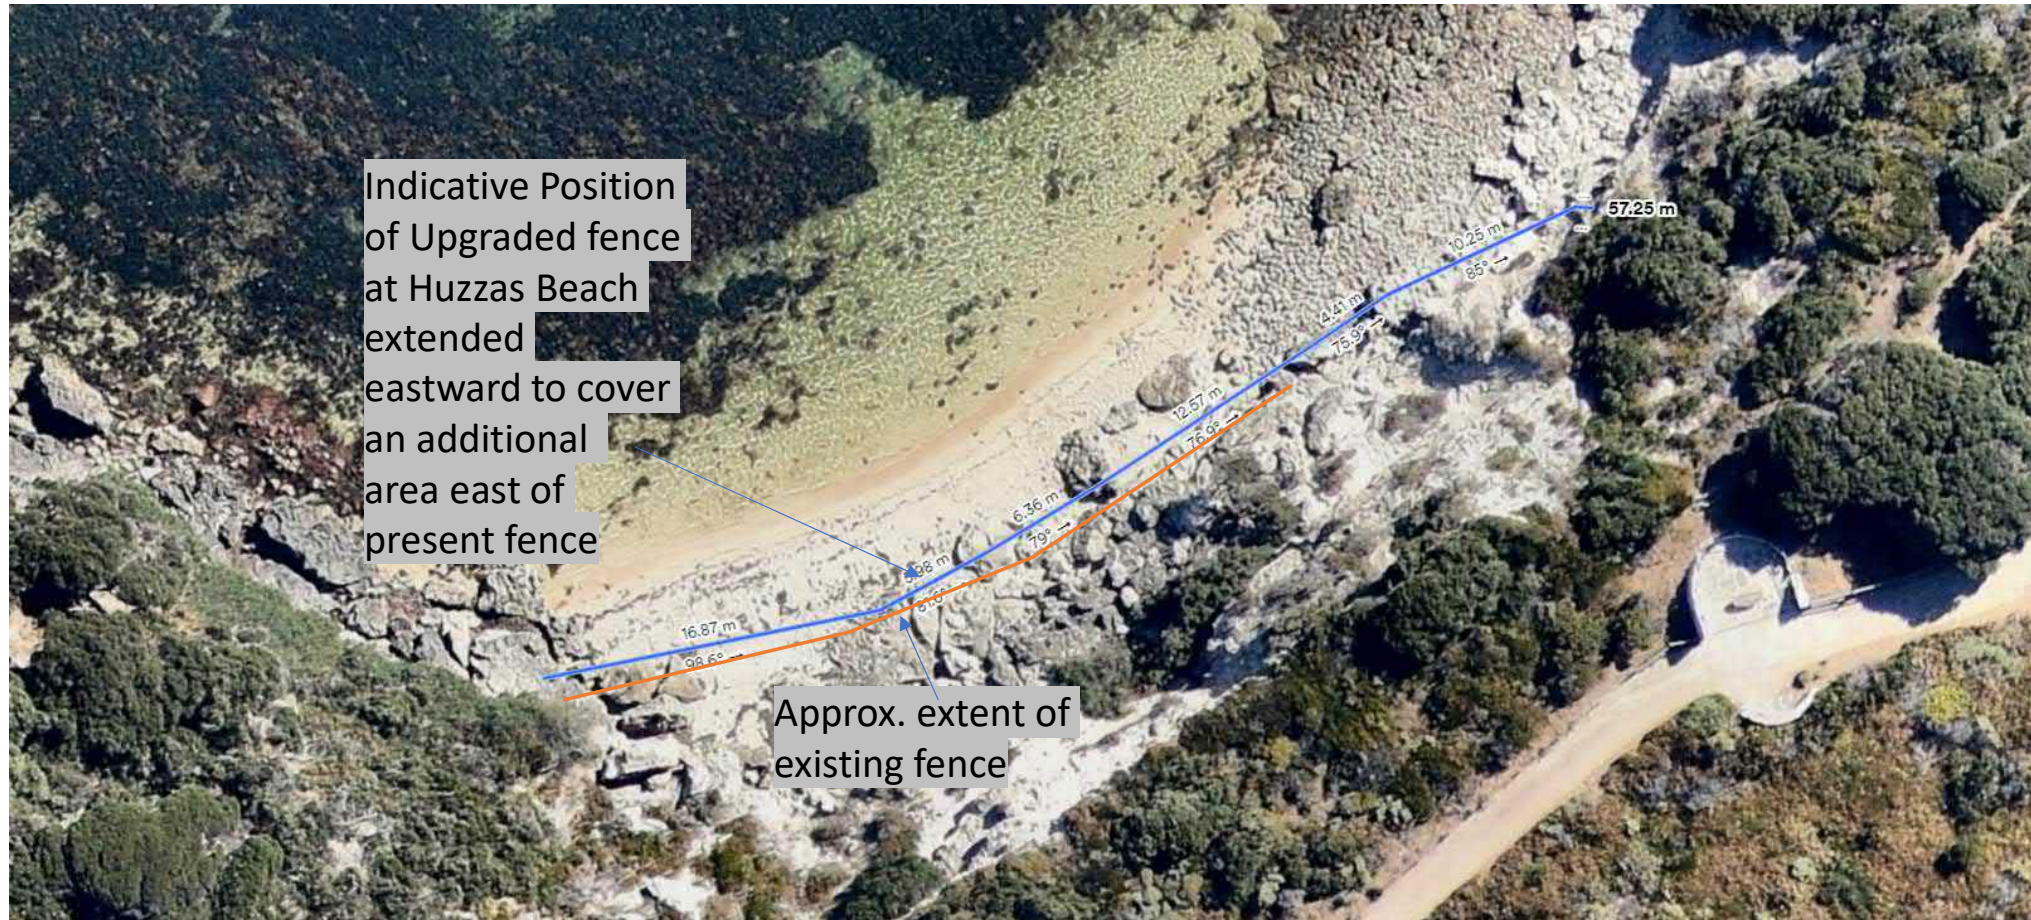
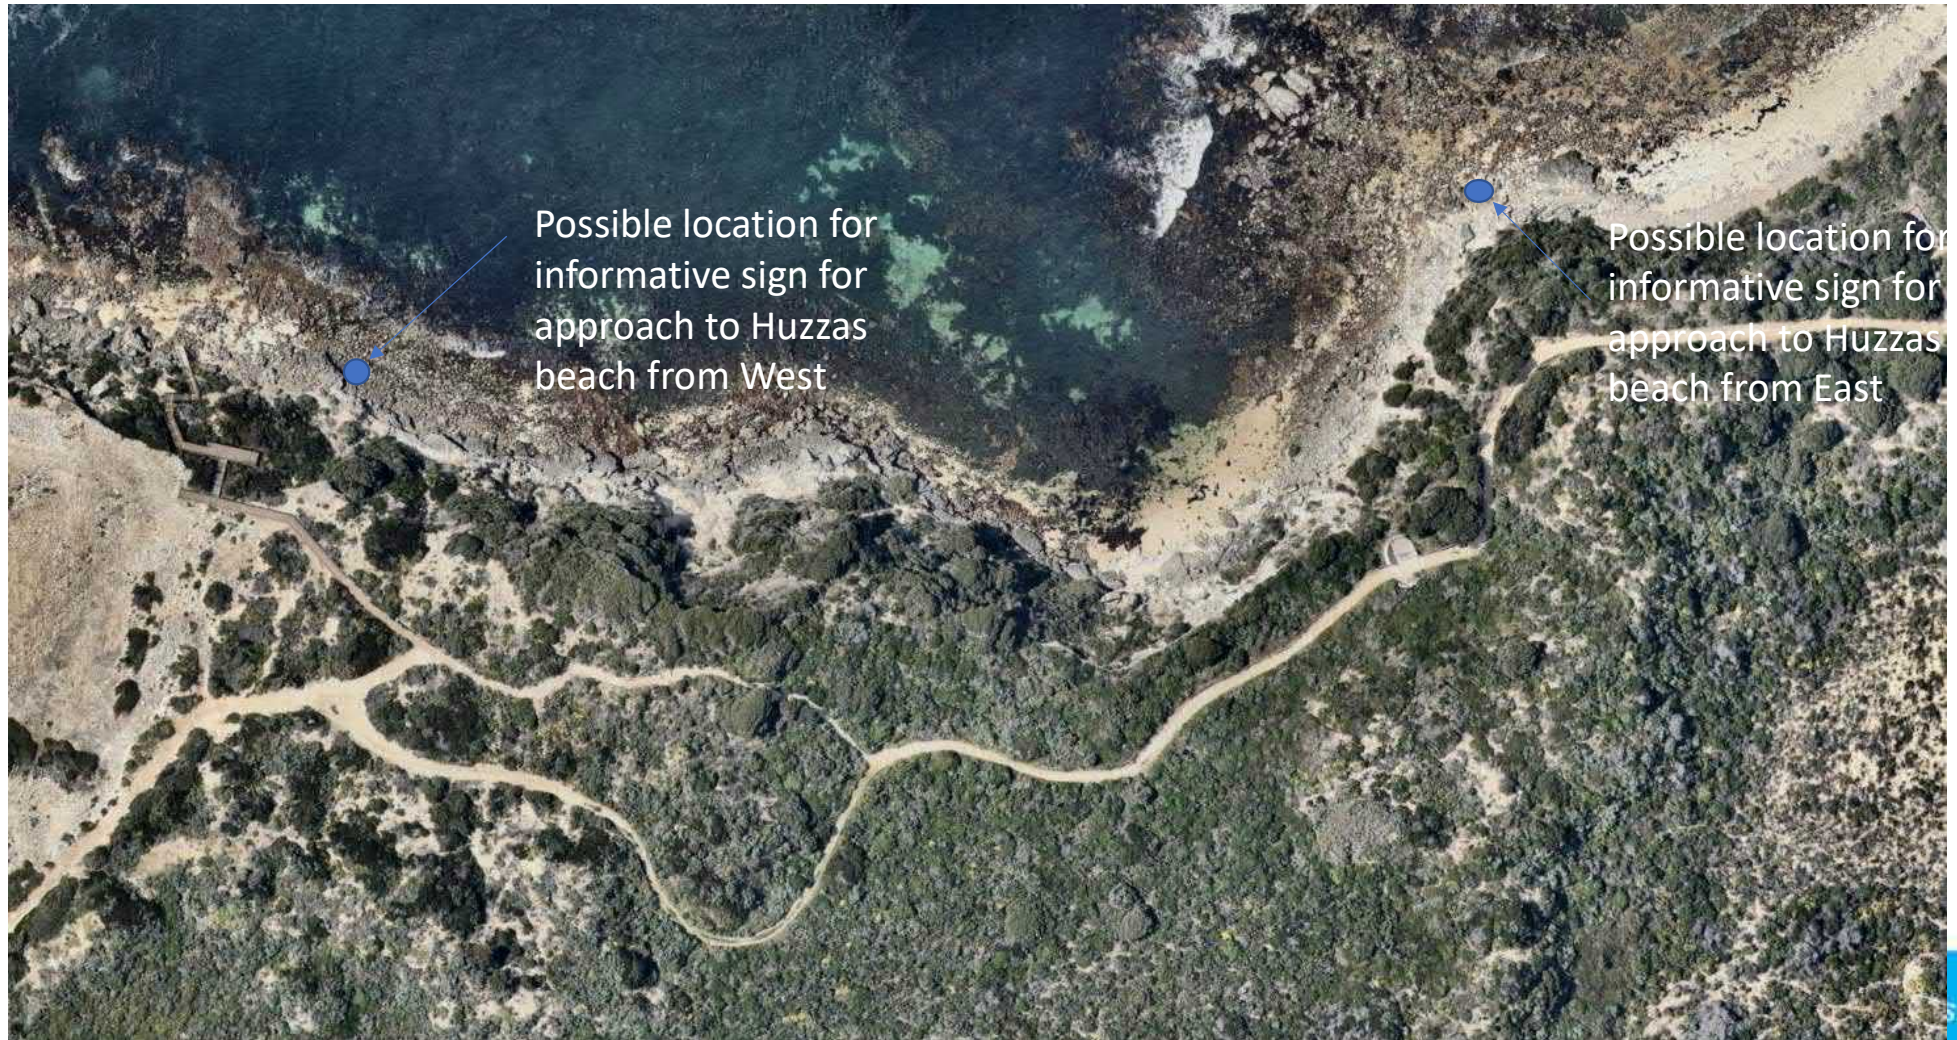
Cliff overhang – Level of Risk to Individual Most at Risk (R_{DI}) increased due to coastal erosion at east end of Huzzas Cliff
Nov 2021 $R_{DI} = 4.3 \times 10^{-6}$

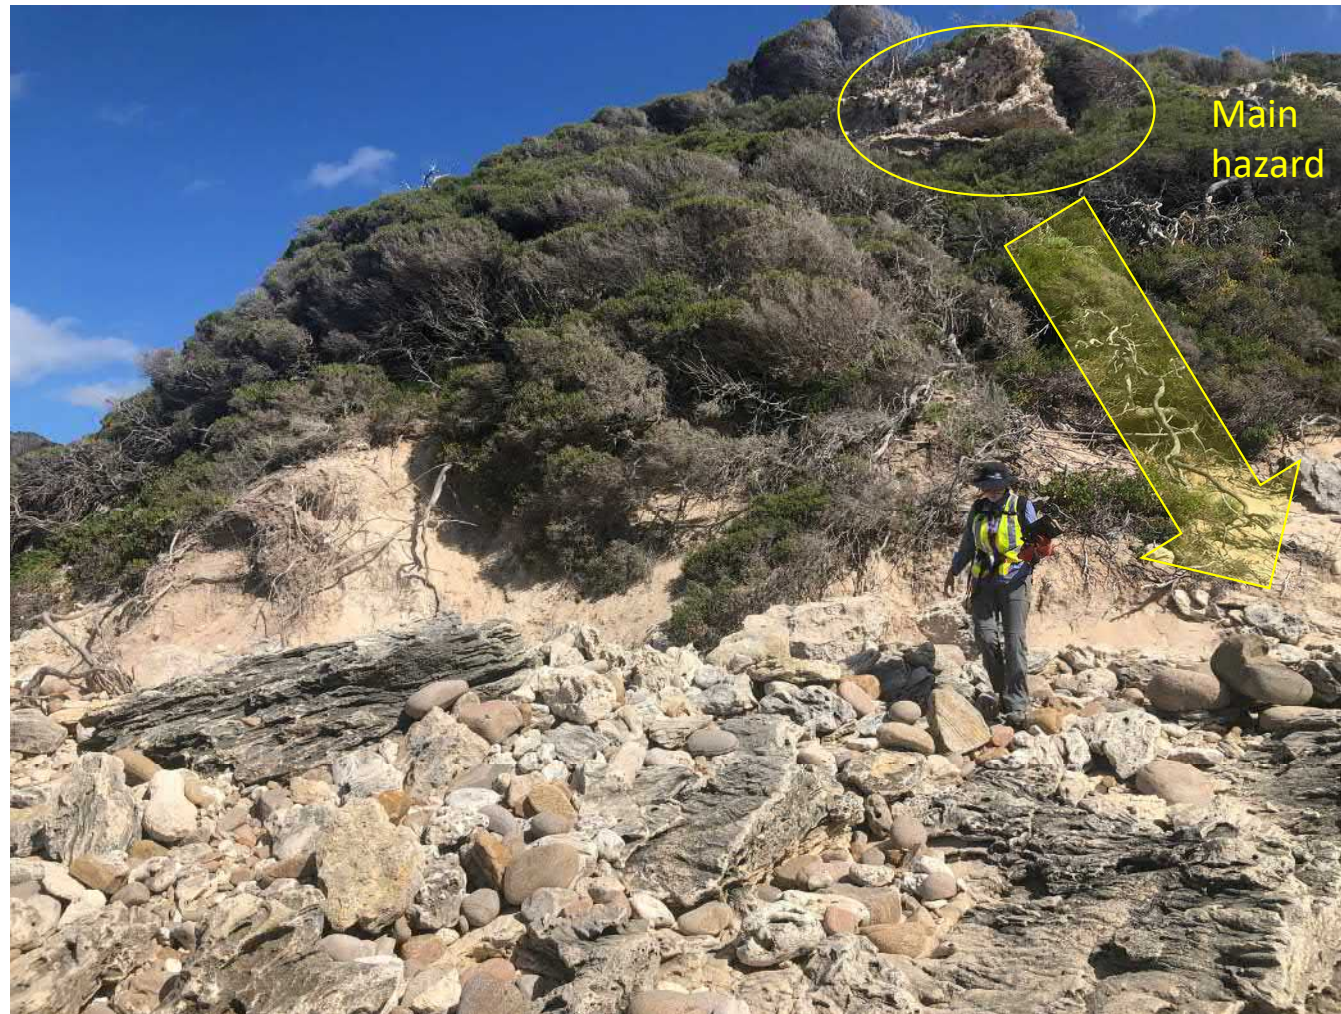
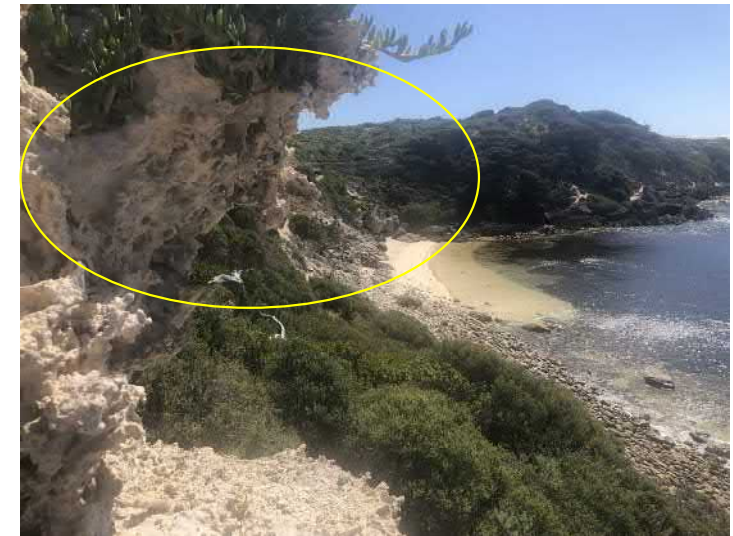
Side view of overhang (Huzzas Beach/Cliff in background)

Level of Risk to Individual Most at Risk (R_{DI}) remains the same as previous assessment – Nov 2021 $R_{DI} = 6.1 \times 10^{-7}$

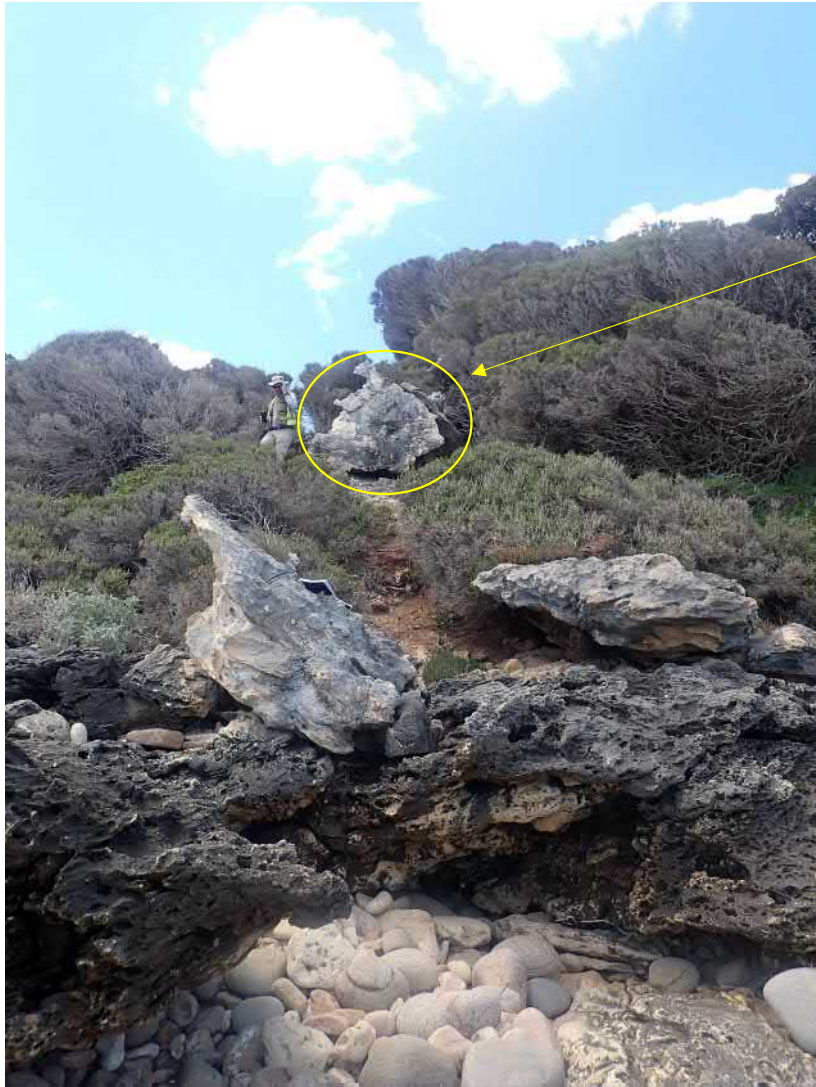
Main Hazard

Level of Risk to Individual Most at Risk (R_{DI}) is now relates to a person traversing the rocky foreshore below the hazard rather than the steps above the hazard $R_{DI} = 2.9 \times 10^{-6}$

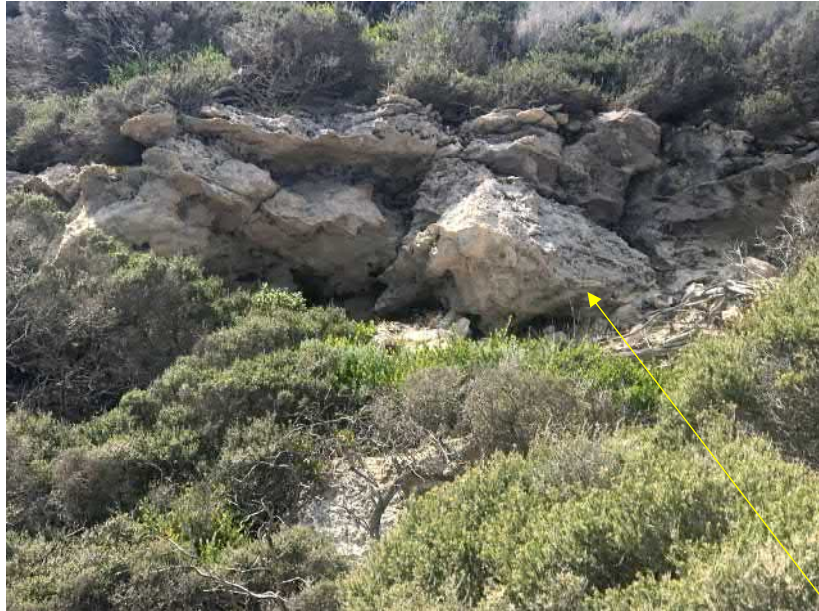
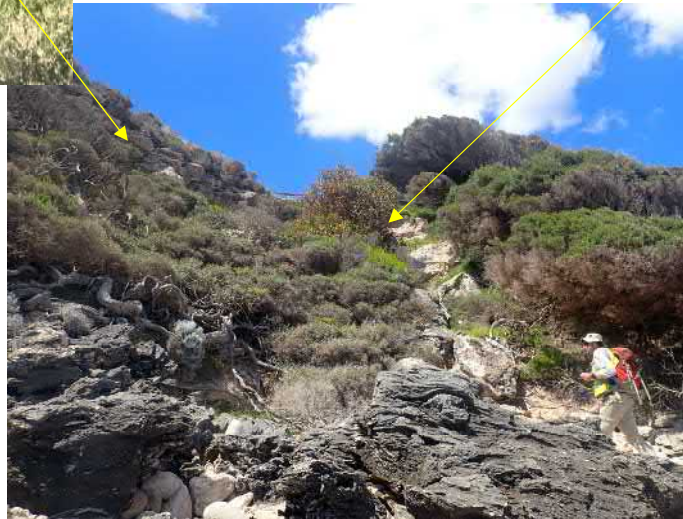
If rockfall was to occur, it is not expected to reach the beach due to vegetation and other boulders breaking its fall. If it topples, it is likely to fragment into small pieces. Risk is assessed to be relatively low $R_{DI} = 8.6 \times 10^{-7}$
Recommend additional sign.

No apparent retrogression of embankment to west of GC6-60 since 2019. Further establishment of native vegetation has occurred which is helping to maintain status quo (see photo on right)

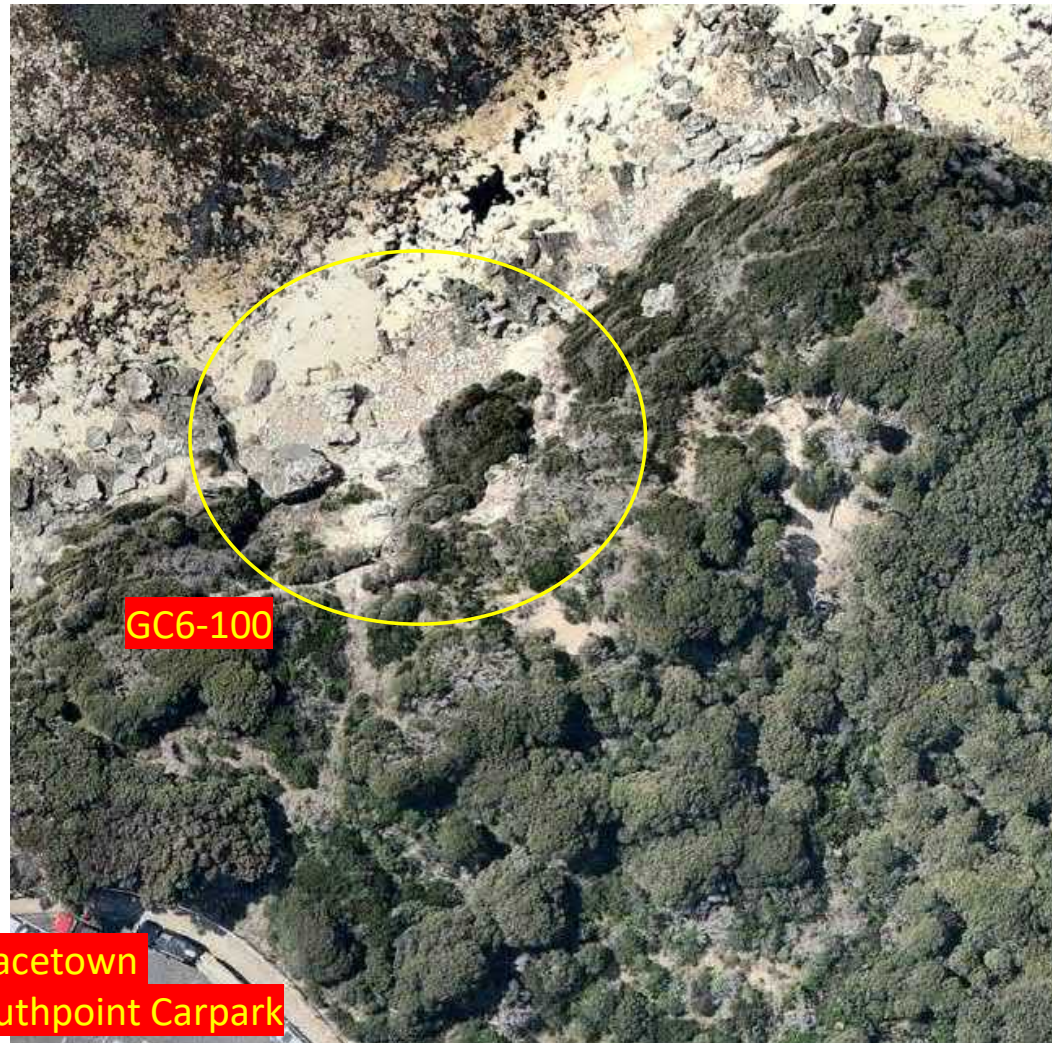
Gracetown GC6-100

Main Hazard is
part of this
overhanging
breaking off and
rolling down to
beach

Level of Risk to Individual Most at
Risk (R_{DI}) not changed since
previous assessment – Nov 2021
 $R_{DI} = 8 \times 10^{-7}$

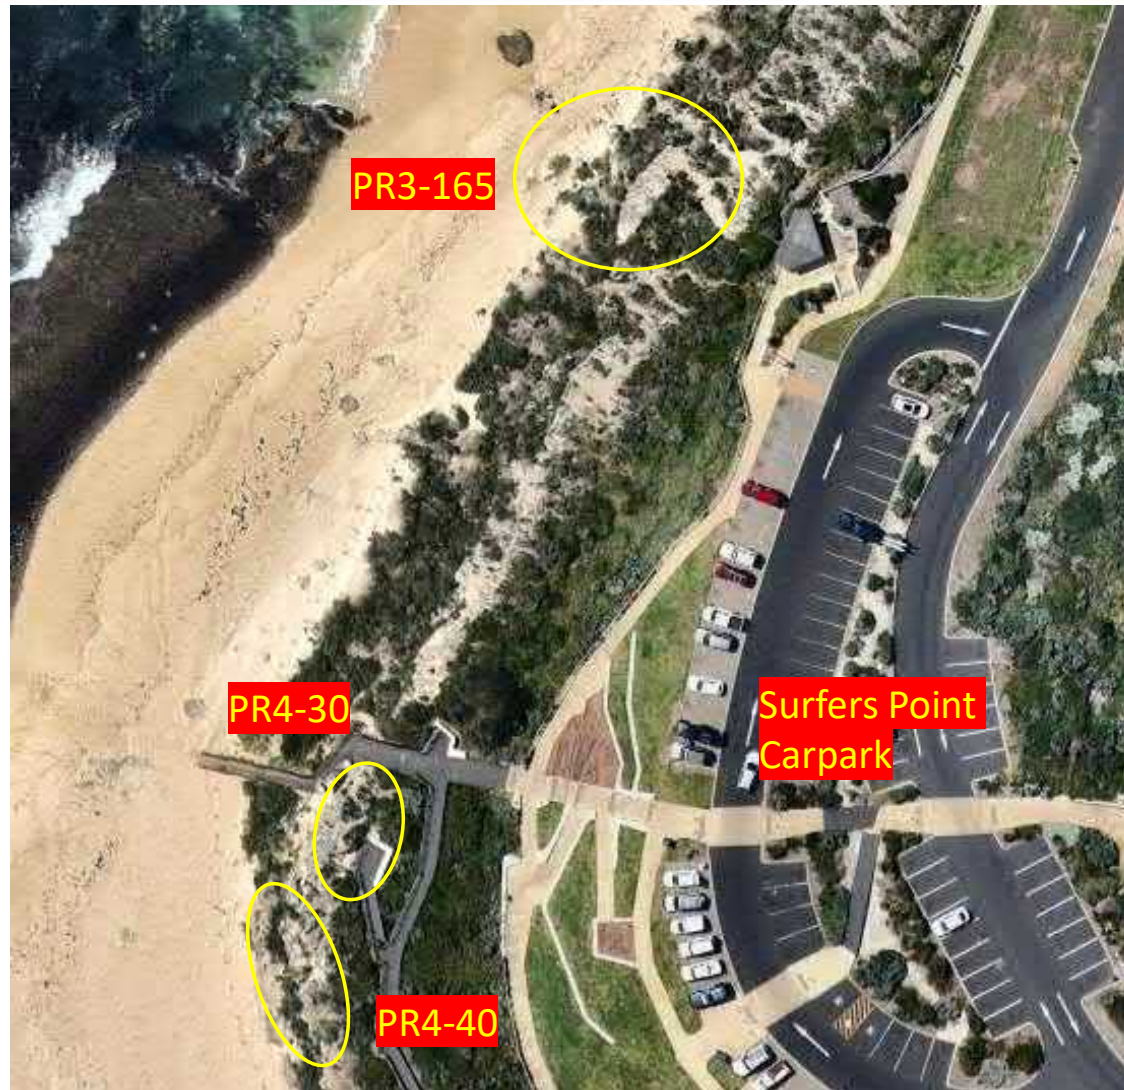
Prevelly PR3-165 and PR4-30

Hazard is overhang
breaking off and
rolling onto beach

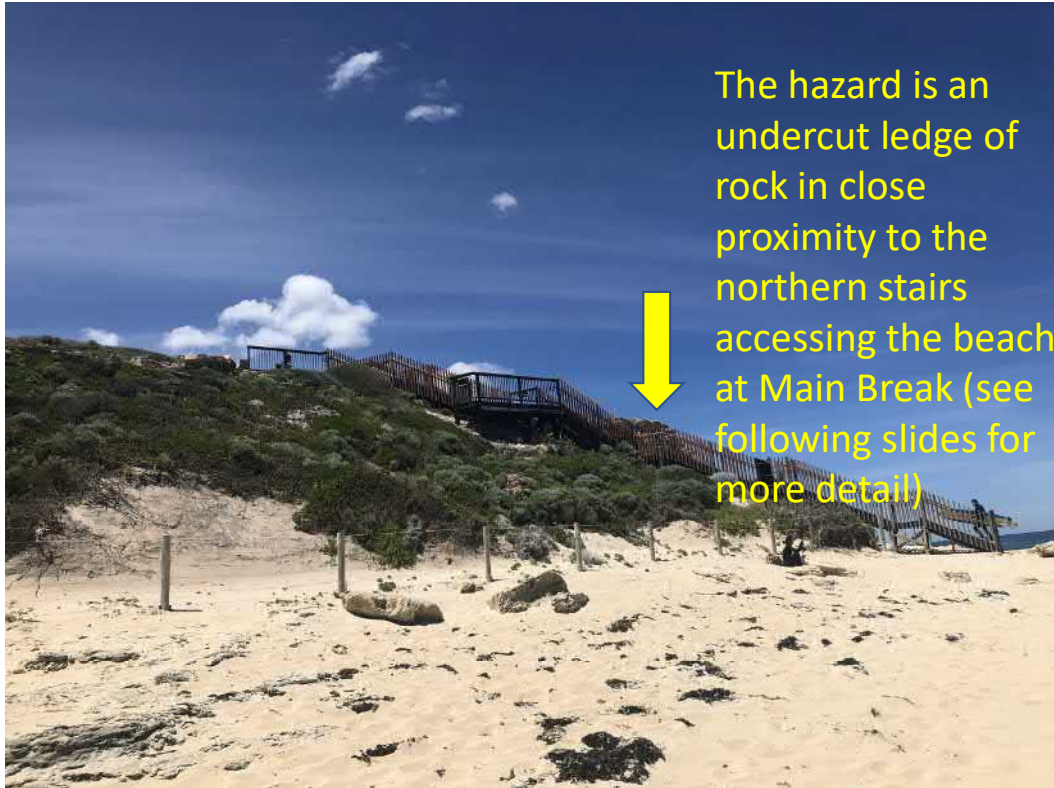
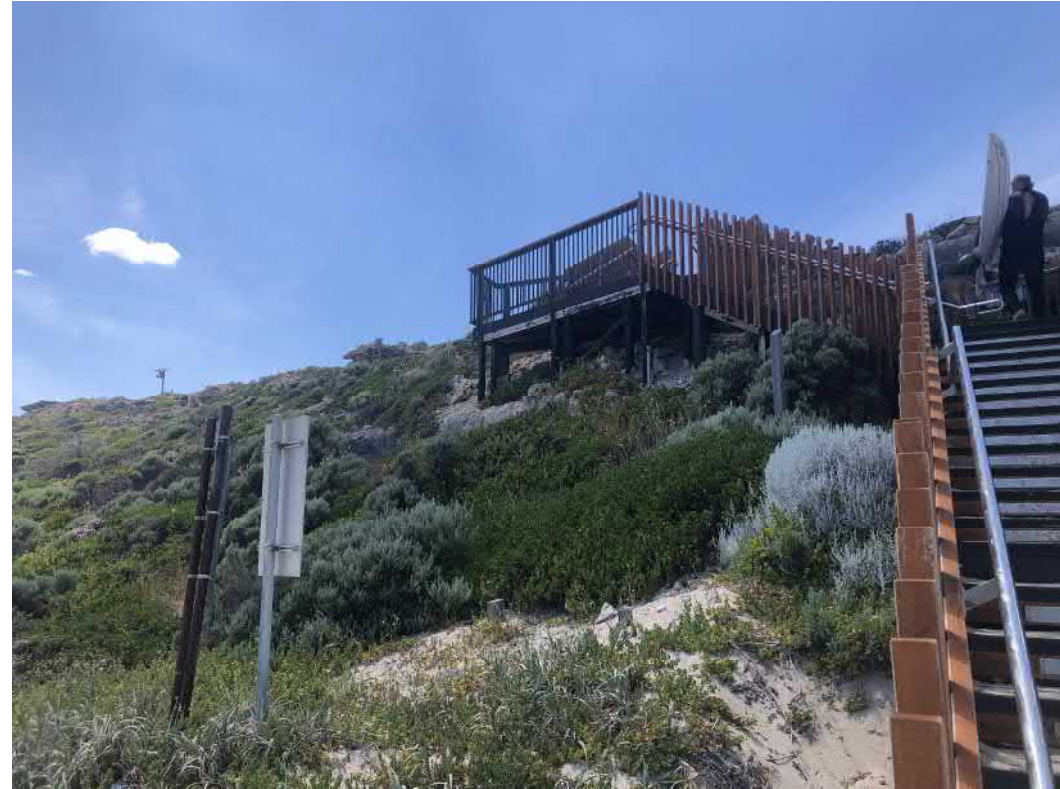
Main Risk would be to people sitting on top of this rock ledge if it was collapse

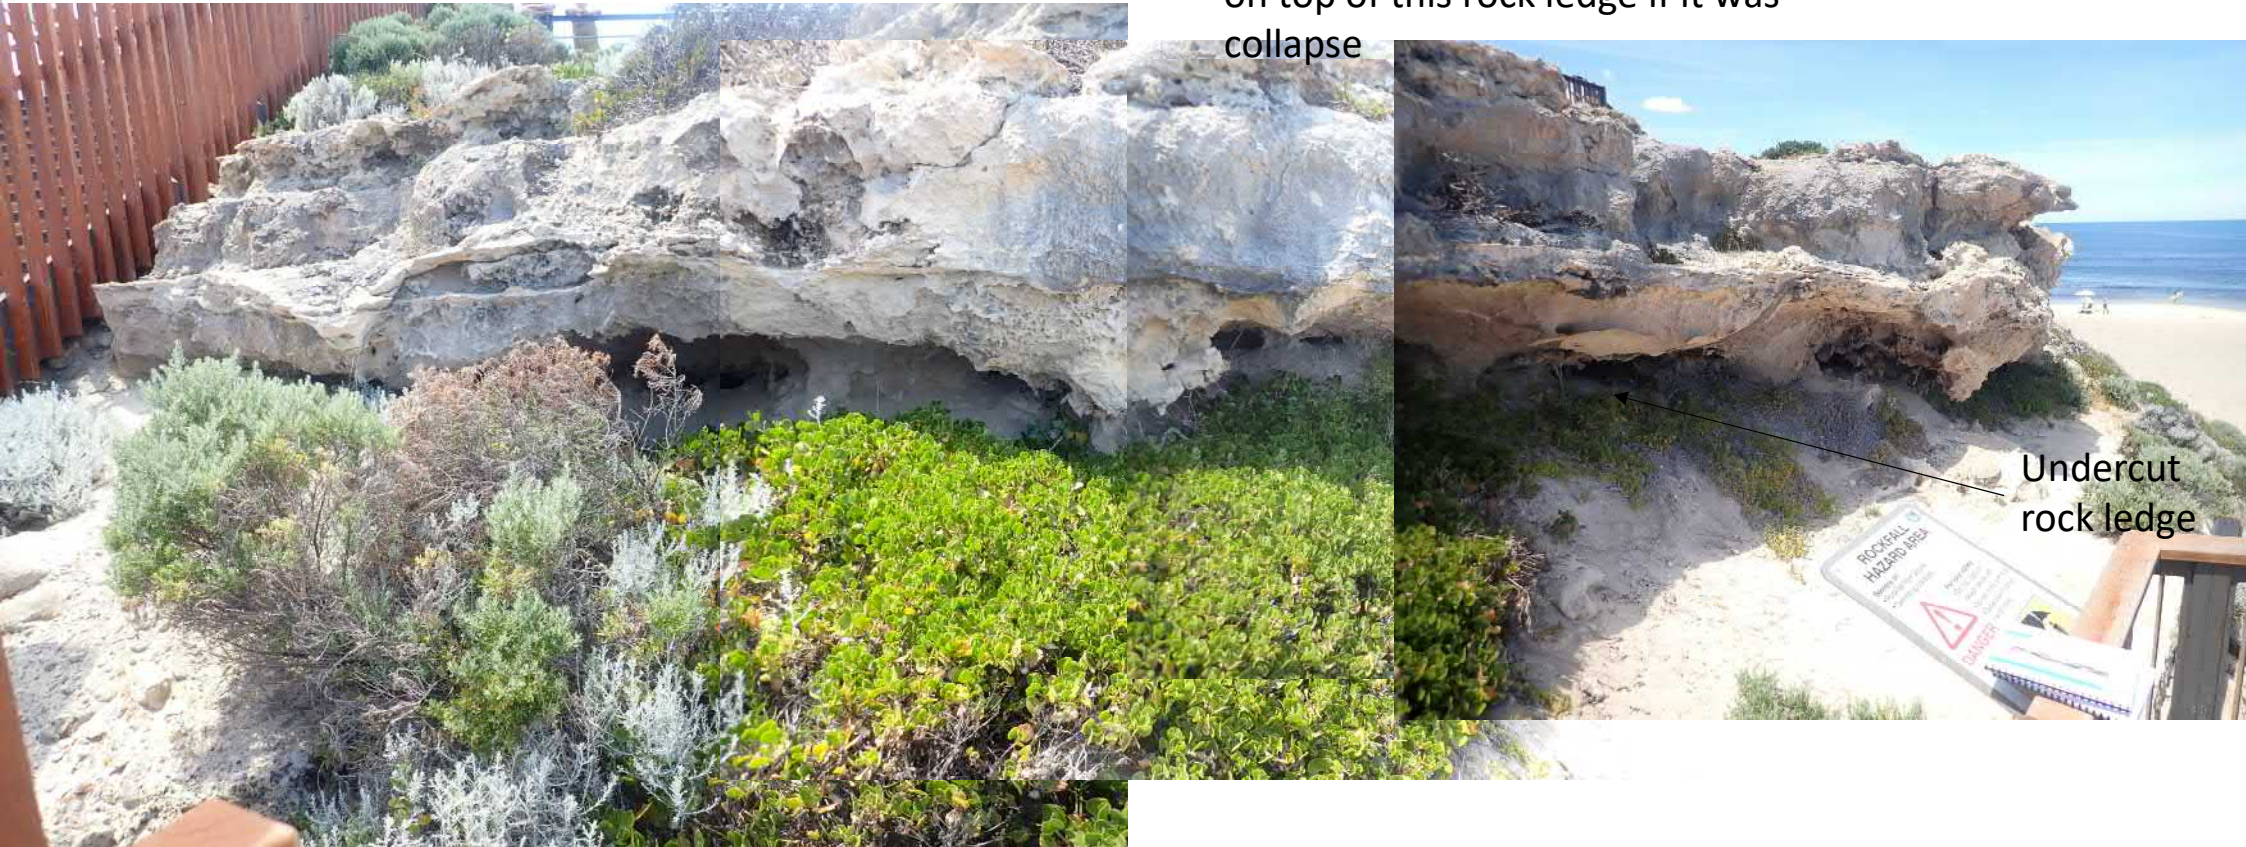
Vegetation cover in front of rock ledge and protecting the ledge from wind erosion is similar to the previous (2019) inspection.

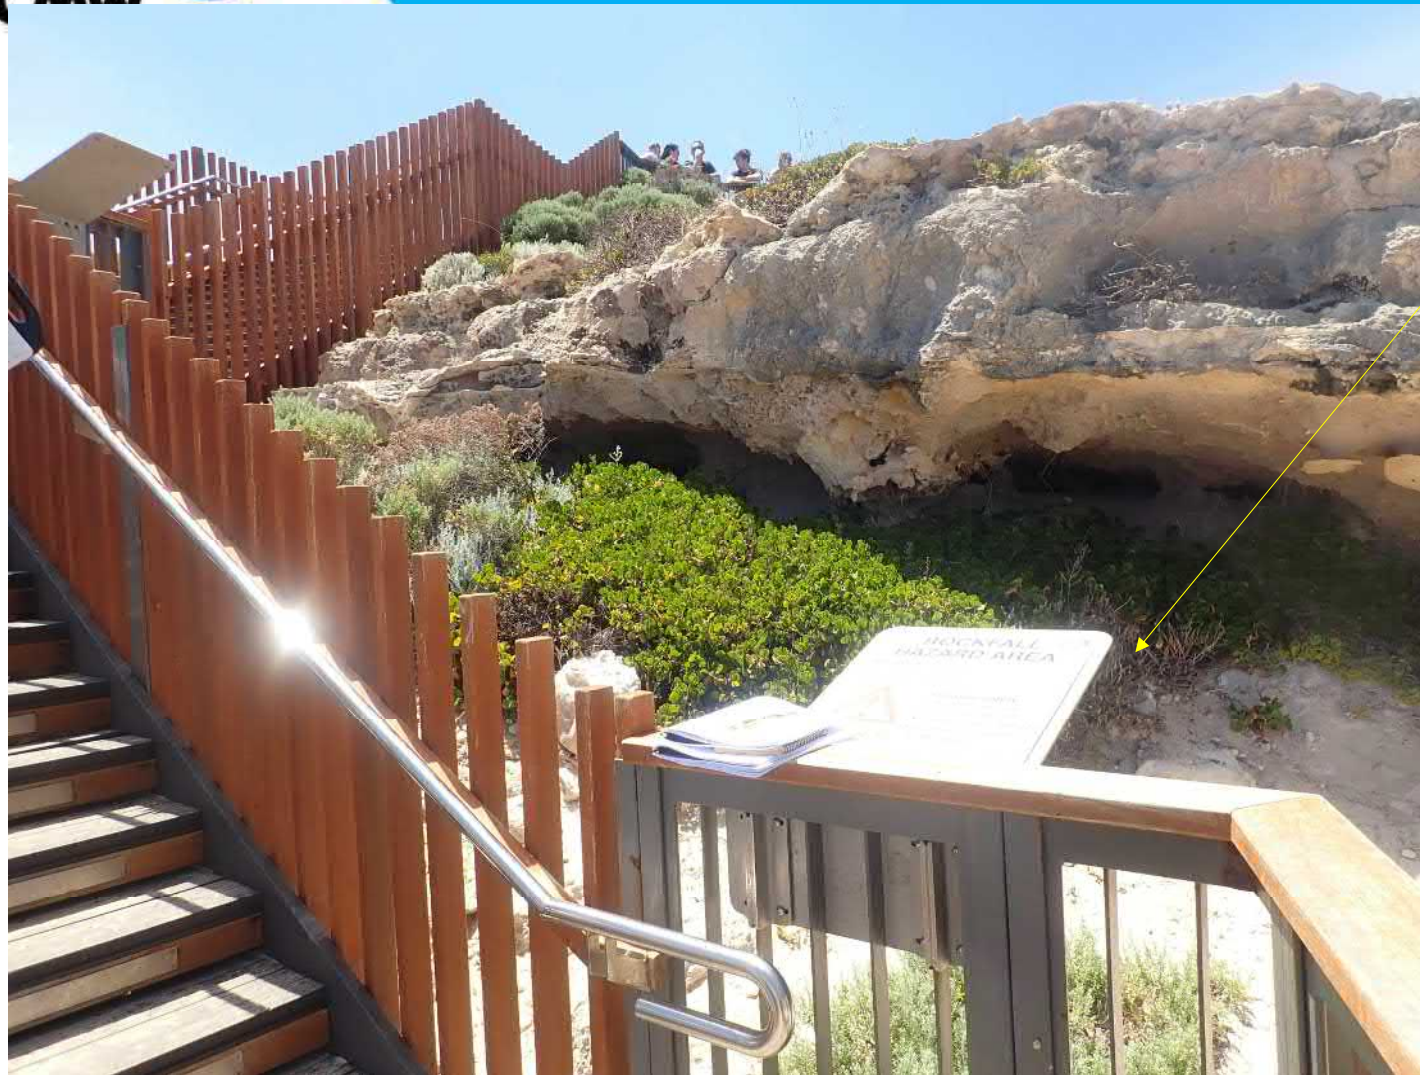
Bench and lookout has been removed since 2017 inspection removing a major element at risk. Sign has been put in place. Main risk is now to people sitting on rock ledge above (e.g. spectating during surf events).

Risk to Individual Most at Risk (R_{DI}) sitting on top of rock ledge as spectator has been assessed as $R_{DI} = 2.9 \times 10^{-6}$

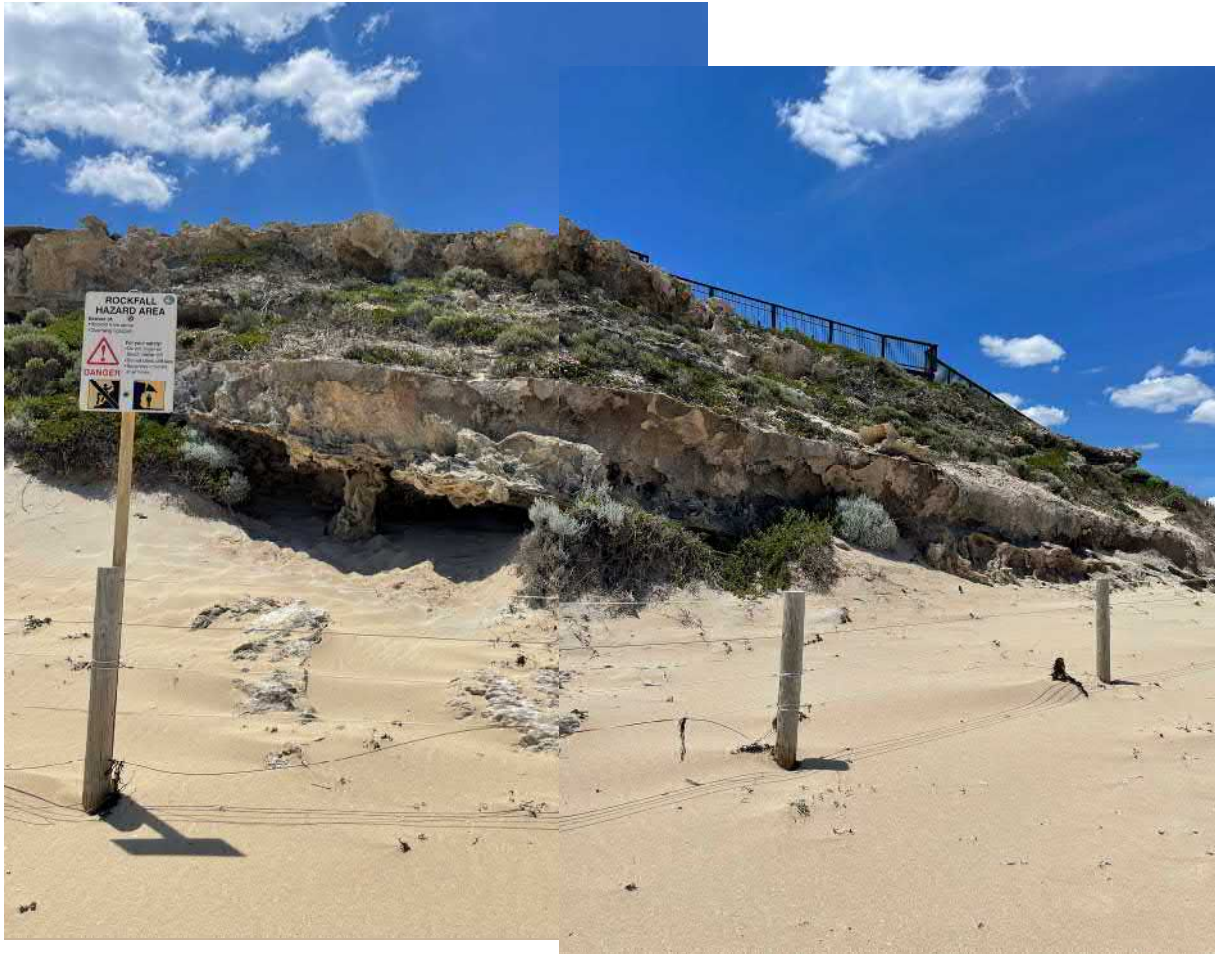
Risk to Individual Most at Risk (R_{DI}) has not changed since previous assessment (2017)

$$R_{DI} = 1.2 \times 10^{-6}$$

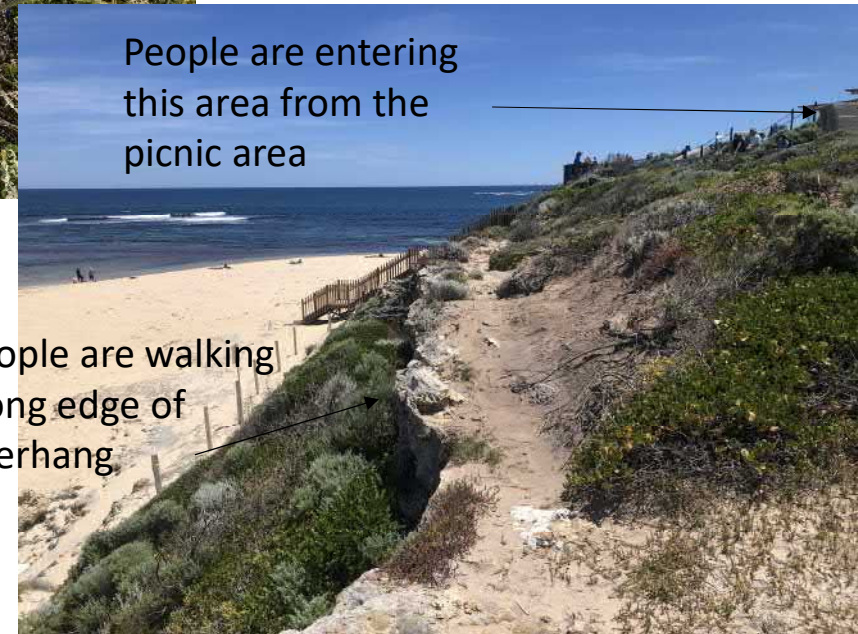
The risk in this area has increased due to the re-assessment of the hazard and impact zone. There is evidence of pedestrian traffic including on the overhang itself (refer Slide 25). To reduce the risk, it is recommended that pedestrian traffic be reduced and ideally stopped in this area through the use of 'Rockfall Hazard Area' signs (set at a suitable height for eye-level or angled similar to those used at PR4-30 and GN5-5) and to place brushwood to reduce traversing informal paths and to encourage vegetation growth. Fencing could be improved to further reduce entry into this area from the picnic area at Mainbreak (refer Slide 25).

People are entering
this area from the
picnic area

People are walking
along edge of
overhang

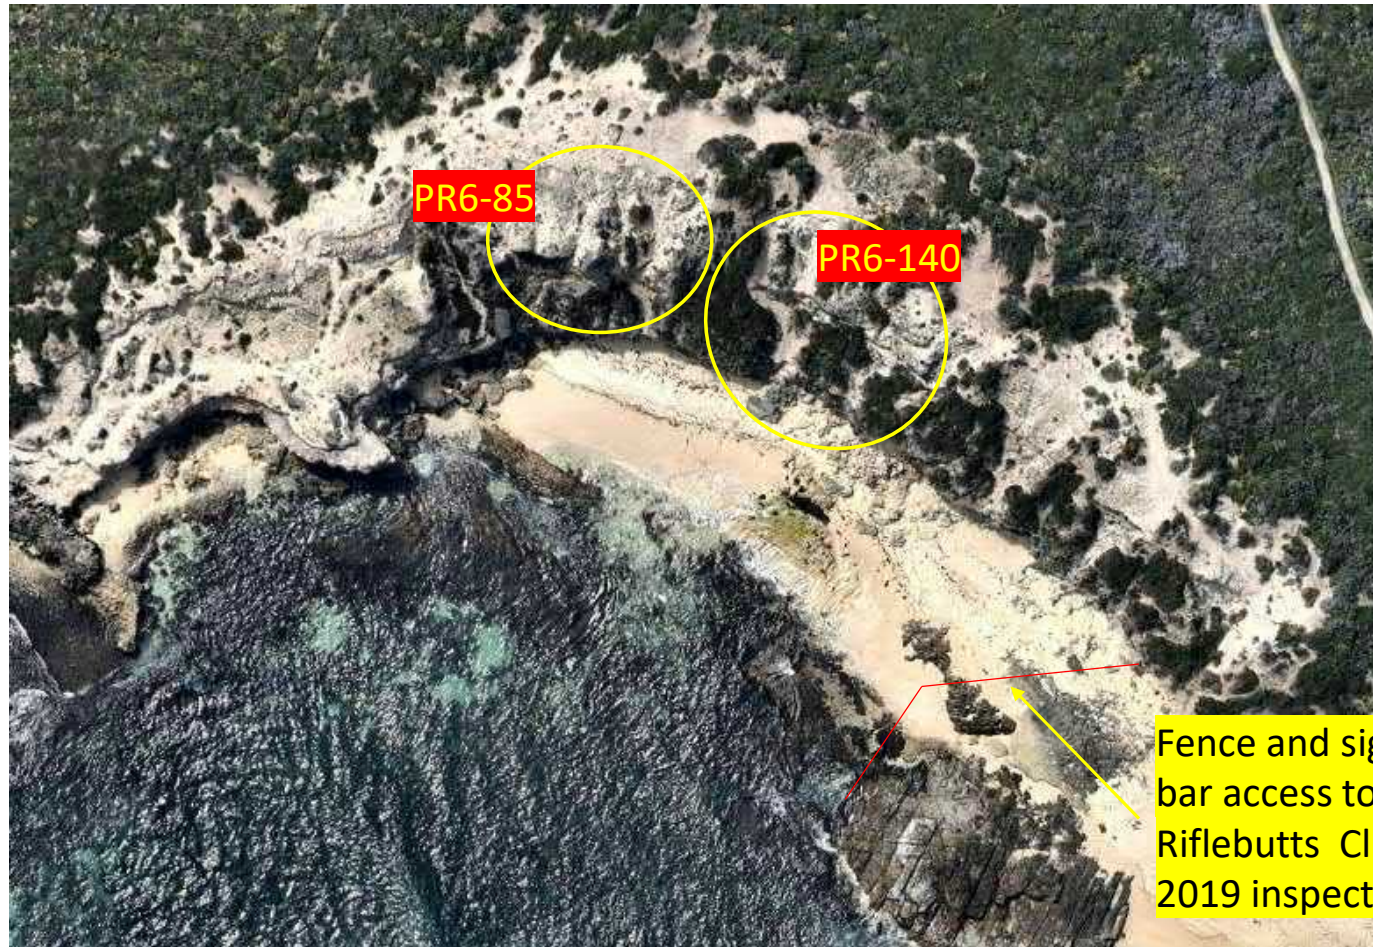
Prevelly PR6-85 & PR6-140 (Riflebutts Beach)

This is a major hazard area and there is much evidence of ongoing rockfalls (refer Slides 30, 35, 36 and 38). The most recent is a rockfall that occurred in August 2021 (refer Slide 35) and resulted in about 15 m³ of limestone falling onto the beach and spilling out about 8 m across the beach from the cliff. This occurred after the erection of a substantial fence earlier in 2021 to discourage public access and extensive warning signs including an informative sign panel (refer Slides 28, 32 and 33).

Fence and signage erected to bar access to beach below the Riflebutts Cliff erected since 2019 inspection

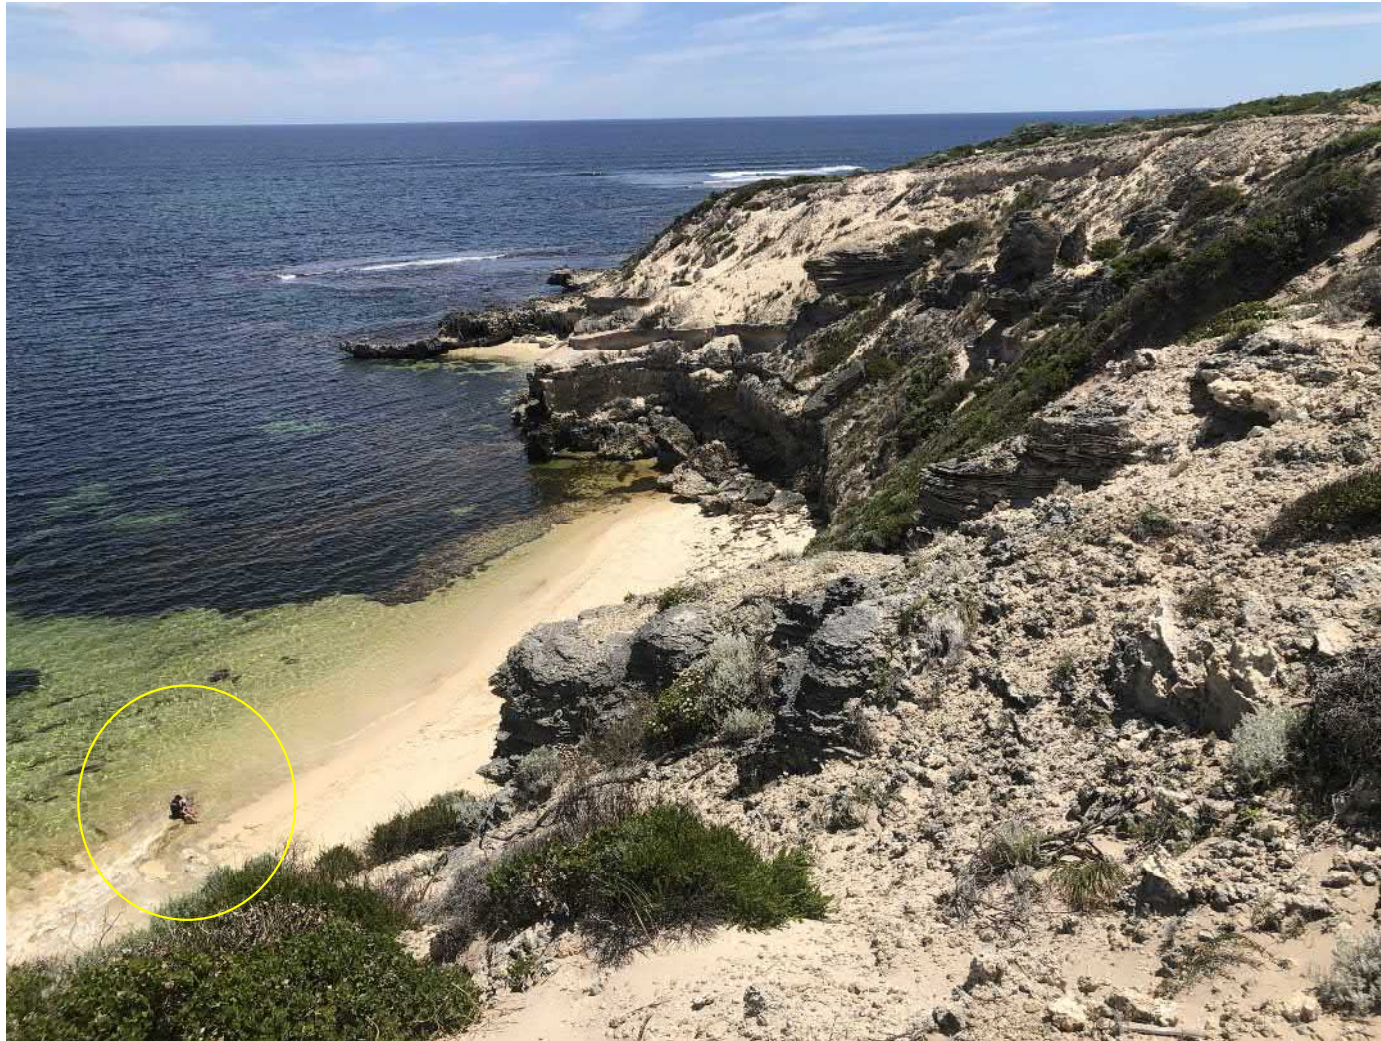
Three sets of recreational users (5 people) who have crossed the fence to access the beach.

Recent rockfall approx. 15 m³ (August 2021) with a recreational user sitting directly in front of the rockfall.

Recreational
user in fenced
off area
