LIMESTONE CLIFF RISK ASSESSMENT

**GRACETOWN, PREVELLY, GNARABUP, GRUNTERS,
WESTERN AUSTRALIA**

INSPECTION AND RISK ASSESSMENT

PER2021-0300AB Rev0

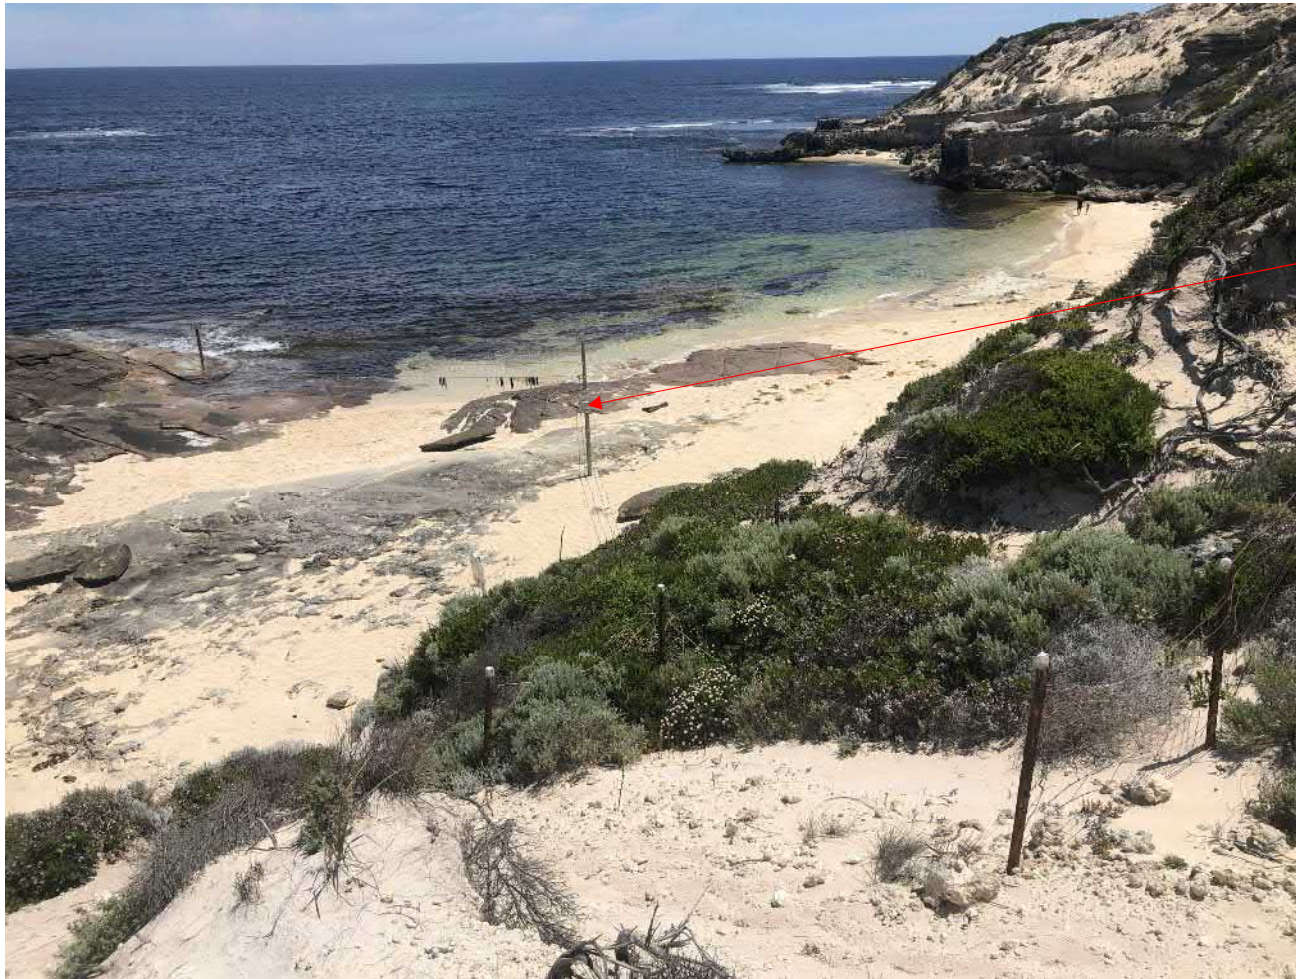
Fencing in place to with signage to limit access and use of beach by recreational users.

Debris from August
2021 rockfall

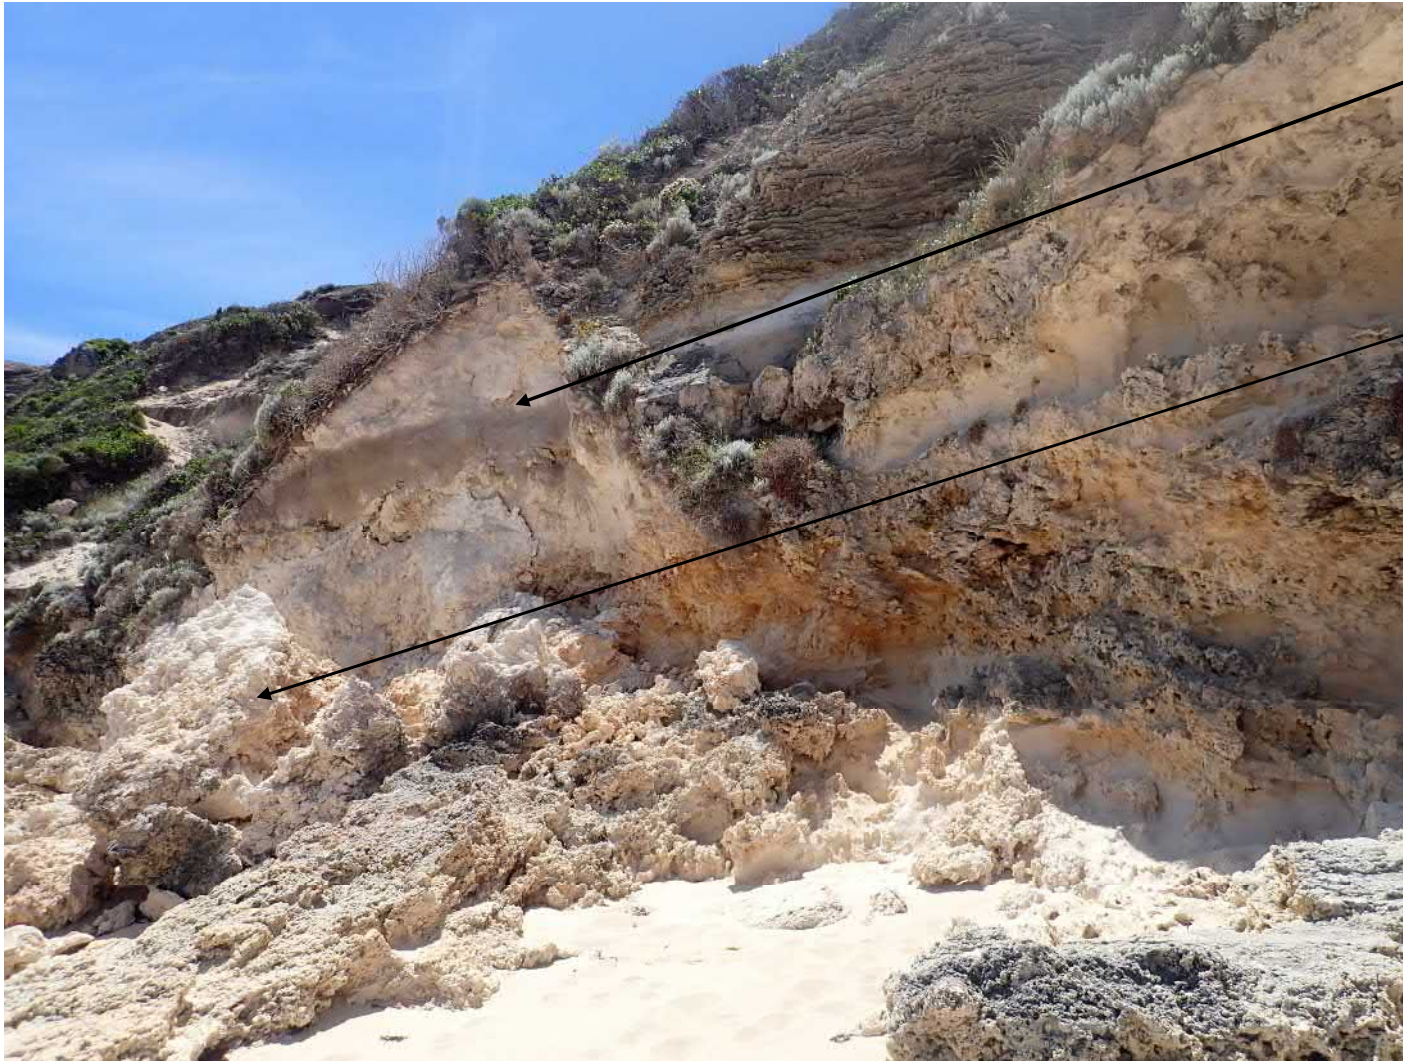
Scar of rockfall of August 2021.

The landslide was estimated to be about 15 m^3 and run out about 8 m onto the beach. The larger pieces of debris remain but much of the smaller sized debris has been removed by wave action.

Risk to Individual Most at Risk (R_{DI}) assessed to be relatively low in this area but only due to people not accessing the beach due to the fence and signage
November 2021 $R_{DI} = 2.2 \times 10^{-6}$

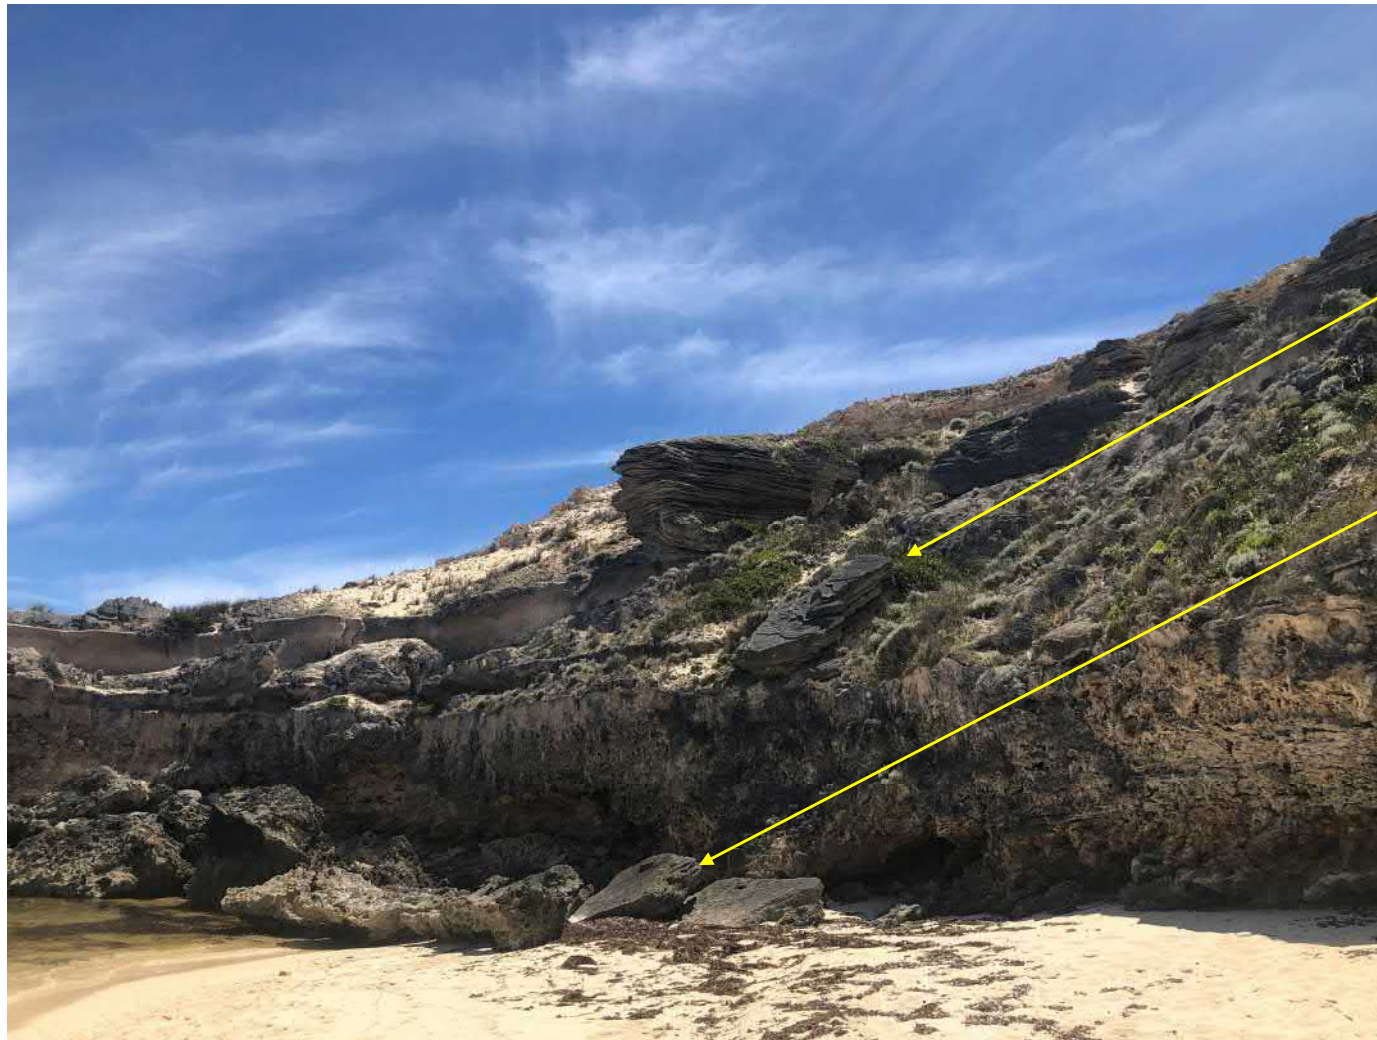
Historic
Rockfall debris
resting on
steep slope
and at base of
cliff.

Paleosol layers are undercut by wind action. There is a Reasonably high likelihood of collapse in next 5-10 years

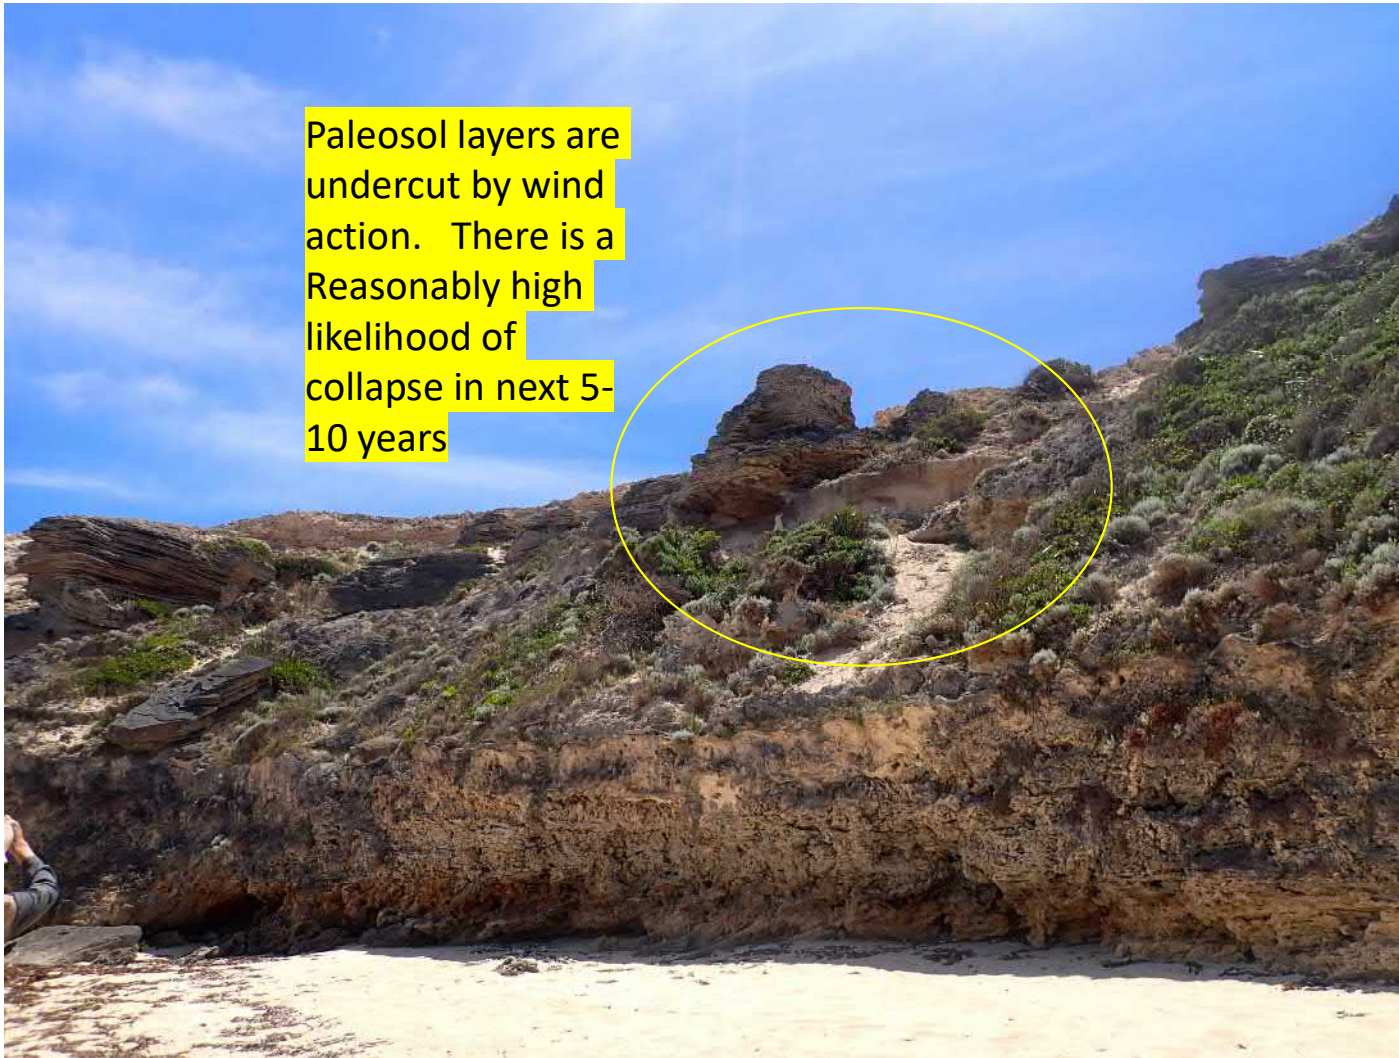
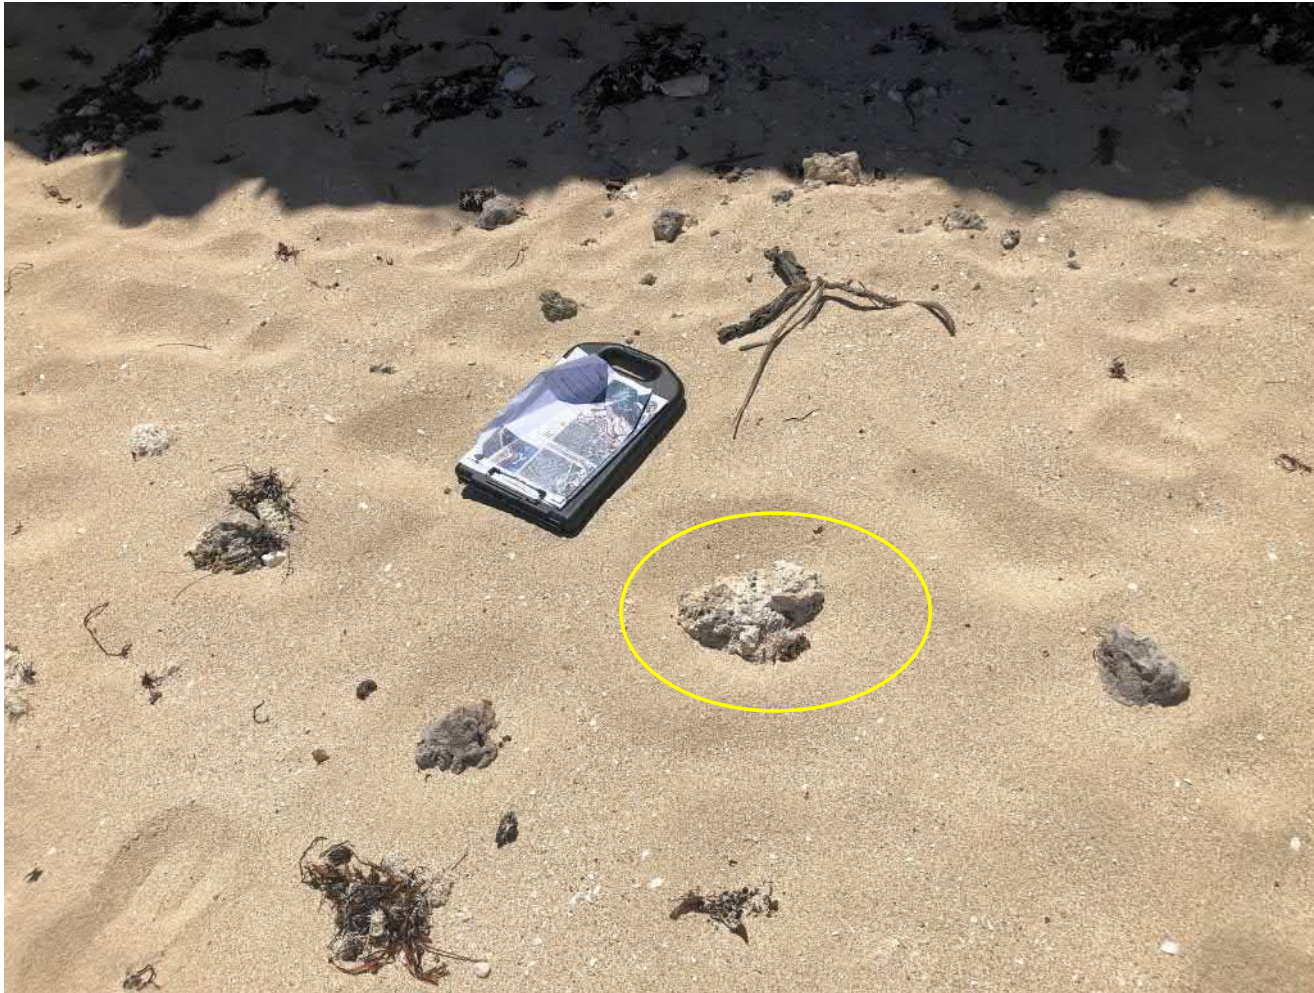
Recent cobble fall.

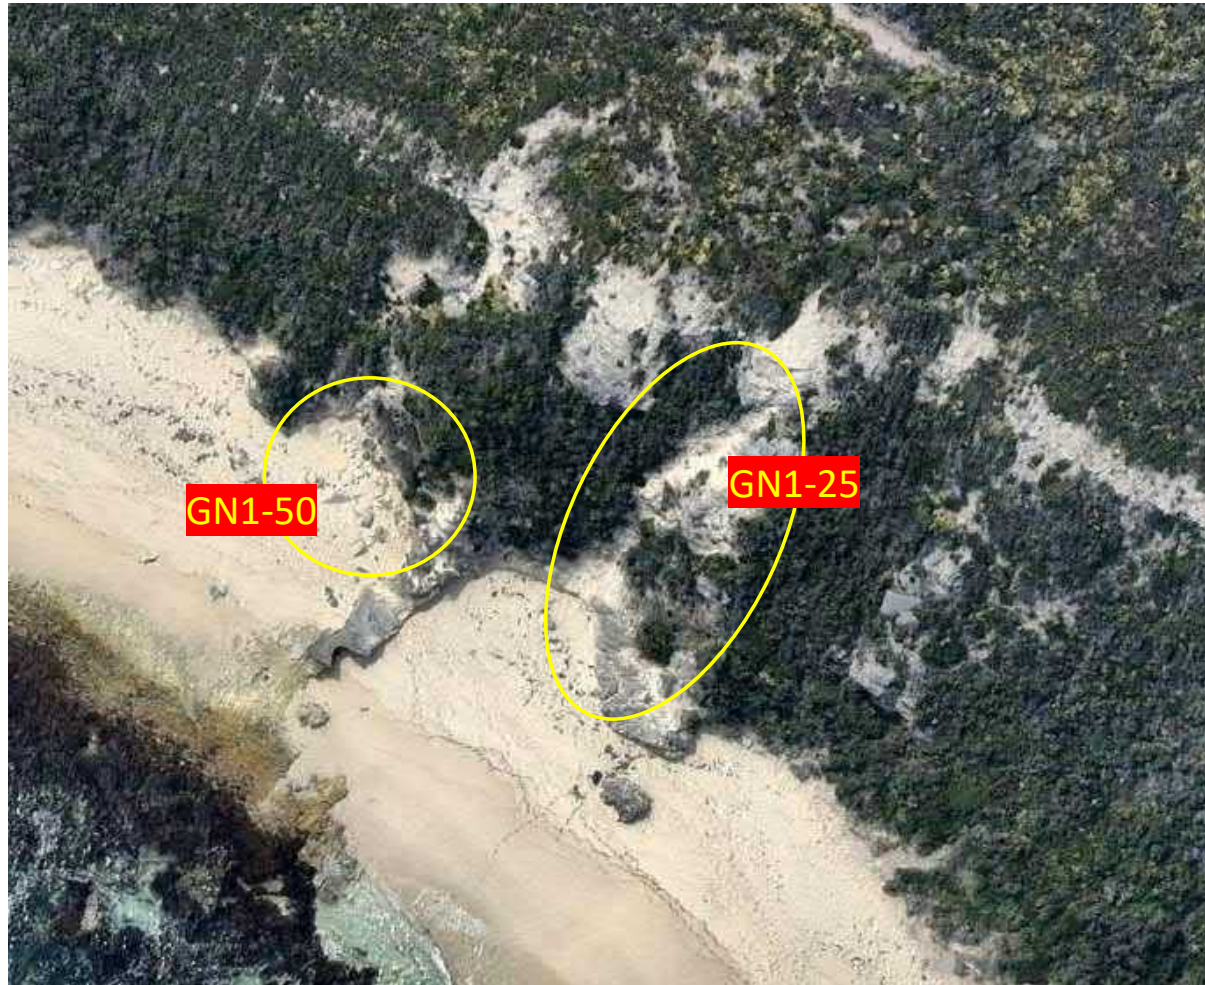
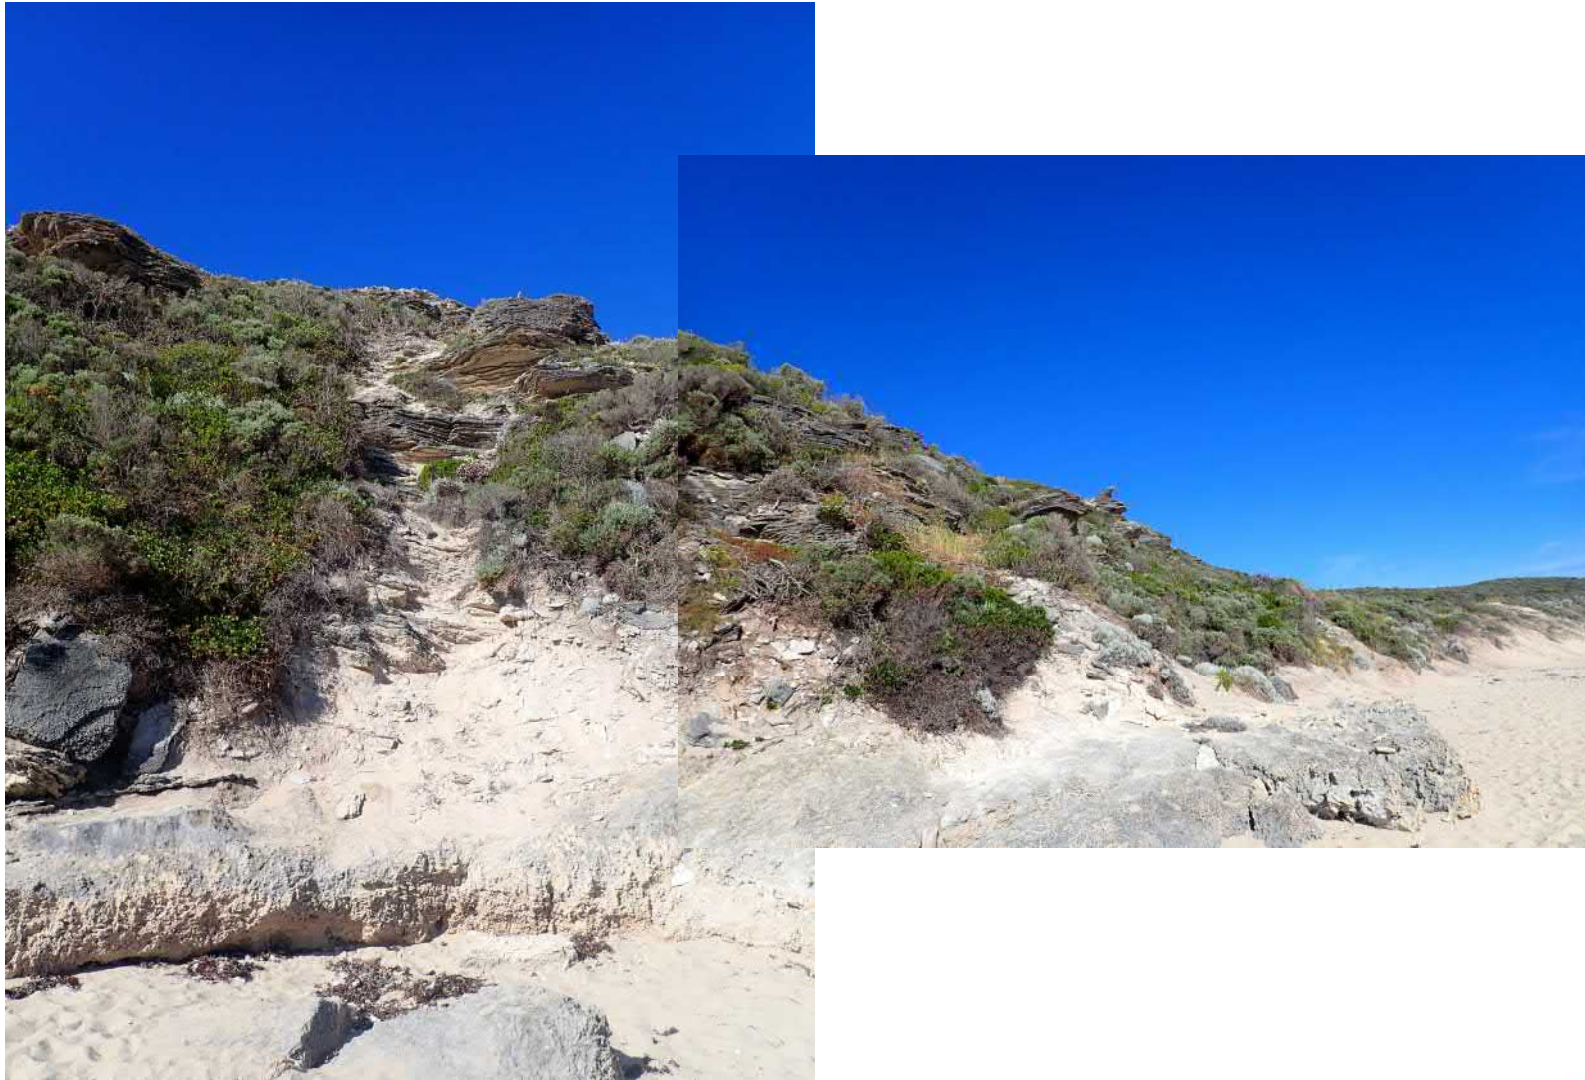
Gnarabup – GN1-25 & GN1-50

Risk to Individual
Most at Risk (R_{DI}) has
not changed since
previous assessment
(2017)

$R_{DI} = 9.6 \times 10^{-8}$
Vegetation and
shallow gradients in
front of hazard
reduce likelihood of
rockfall reaching
beach

It is recommended a "Rockfall Hazard Area" sign be erect on the beach either side of the hazard of this hazard to be viewed when approaching from both the north and south. The signage will also be applicable to hazard GN1-25.

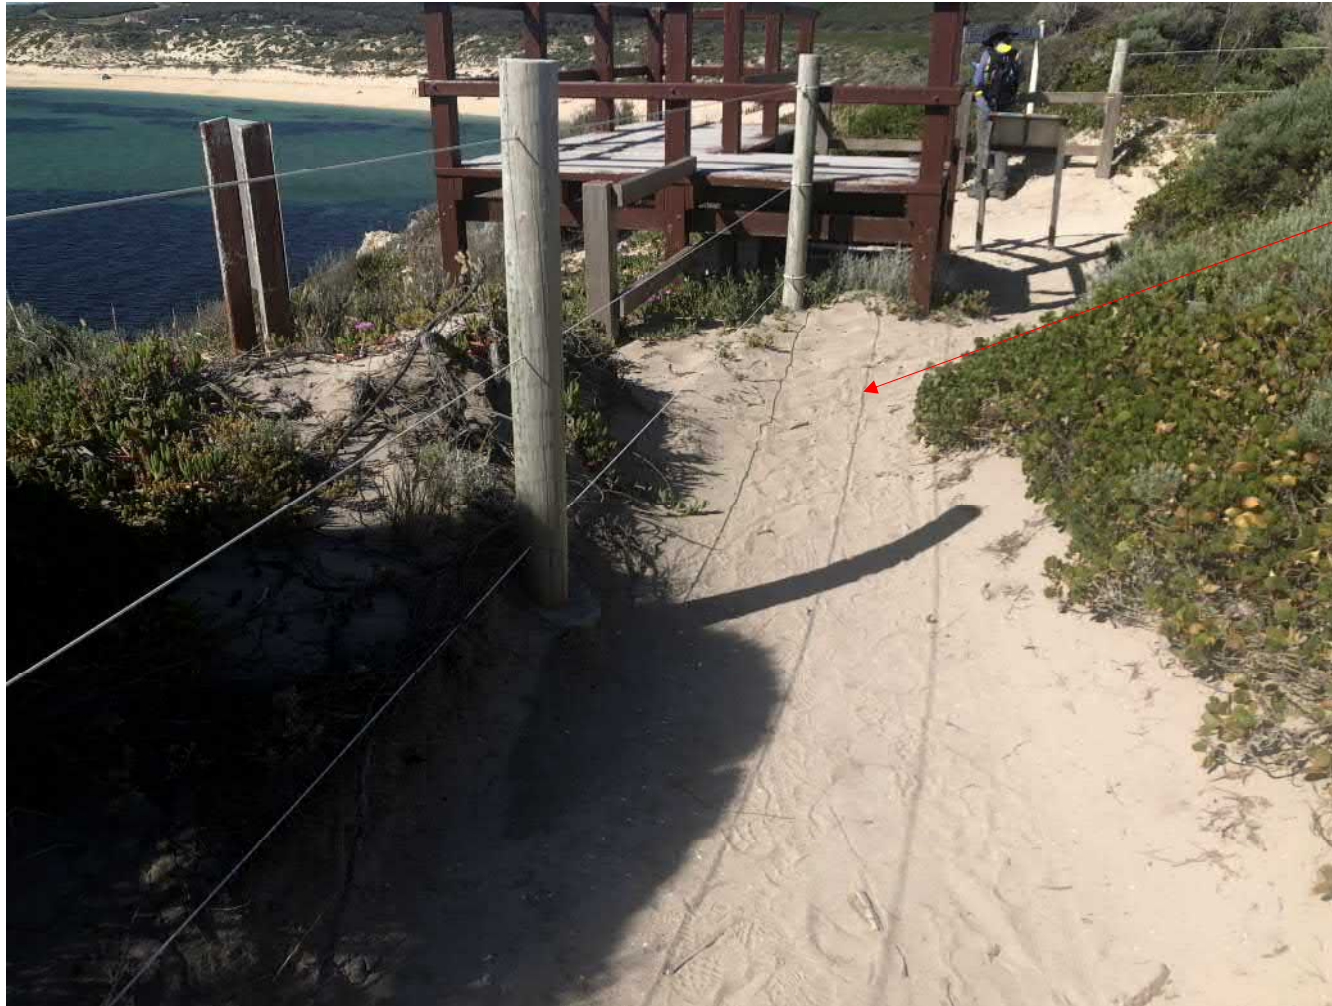
Heavily trafficked. Improve fencing to restrict access.

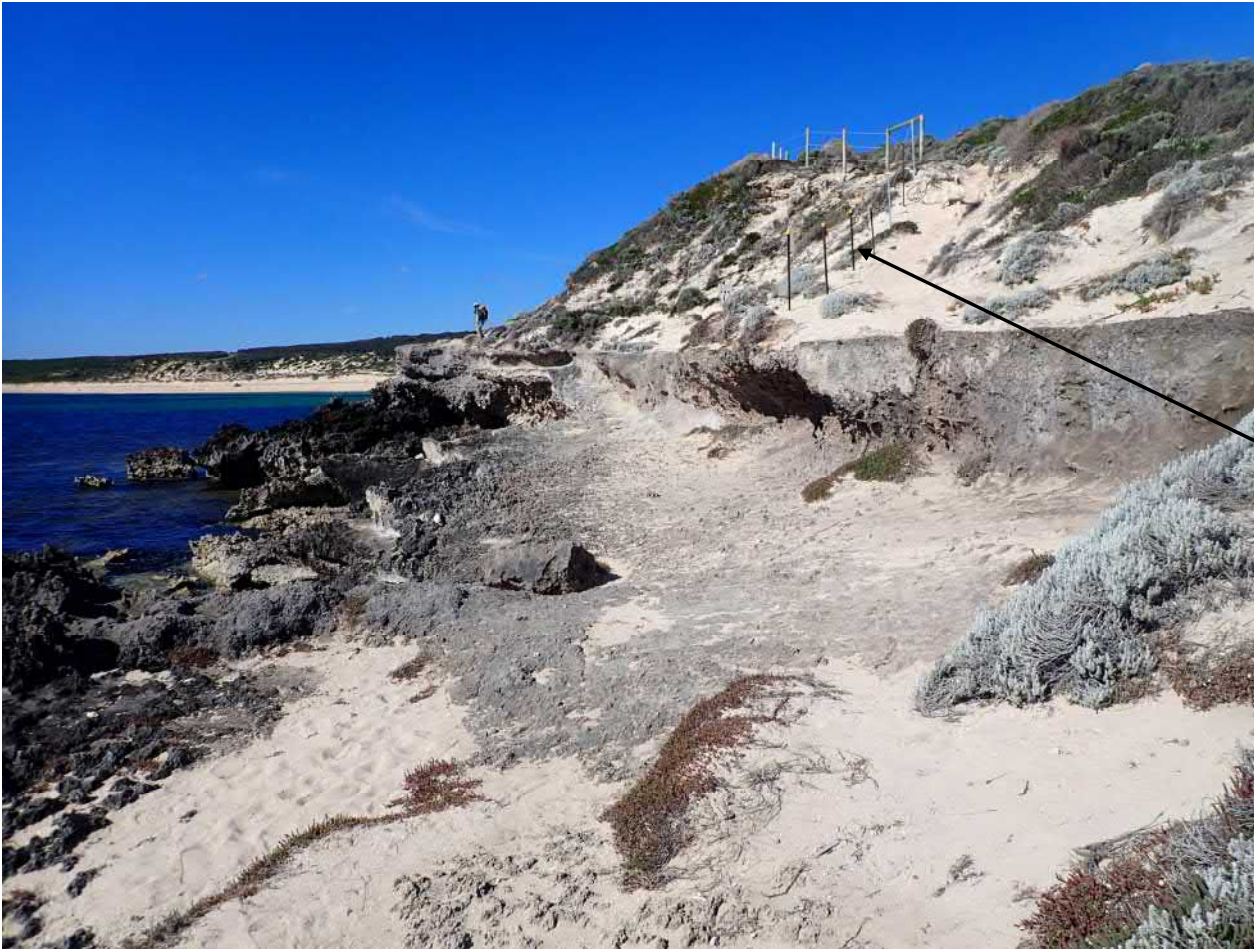
Gnarabup – GN3-40 and GN3-90

Risk to Individual Most at Risk (R_{DI}) = 4.6×10^{-6} and 1.5×10^{-6} for GN3-40 and GN3-90 respectively. Ongoing erosion is likely to see these risk levels increase. Measures are needed to prevent further erosion and to discourage public access to the ledge below the lookout.

Temporary sign and fence present following collapse earlier in 2021.

Improve temporary fencing and signing to permanent. Discourage pedestrian traffic. Some access appears to occur down the slope from the lookout. Other people access along the ledge from the south traffic.

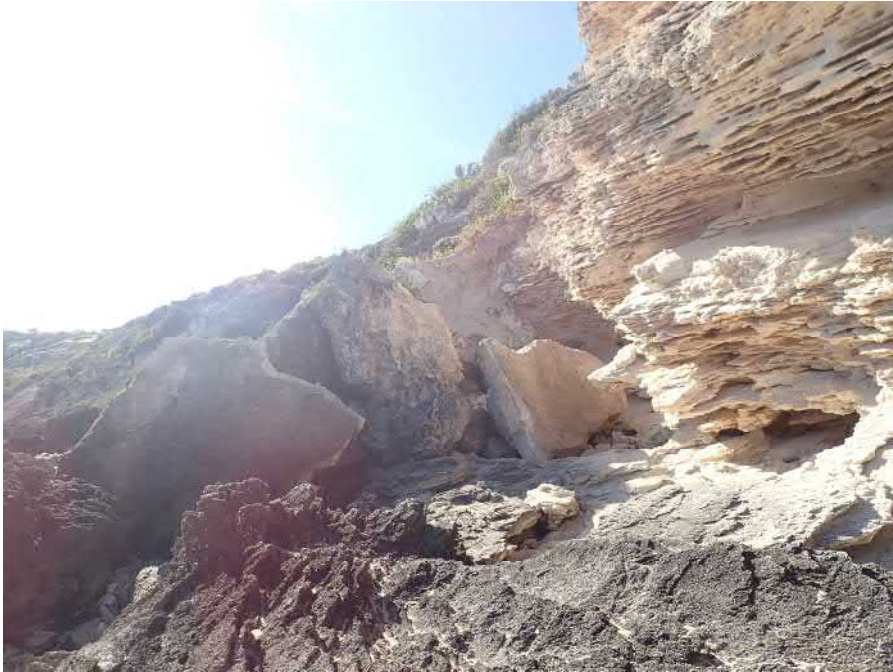
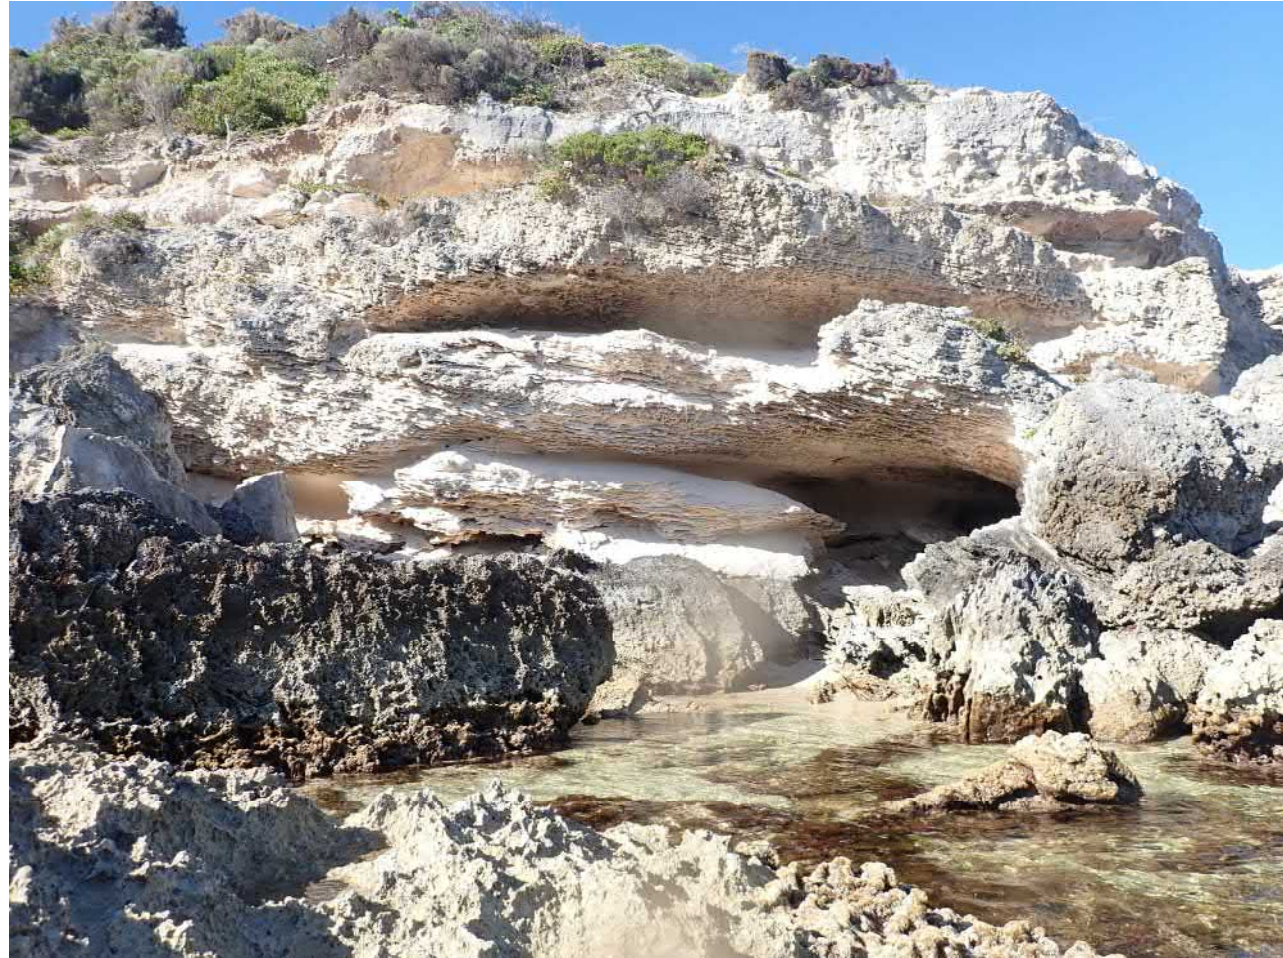
The Gnarabup Beach Cave The level of Risk to the Individual Most at Risk (R_{DI}) remain similar to 2017 at 8.3×10^{-7}

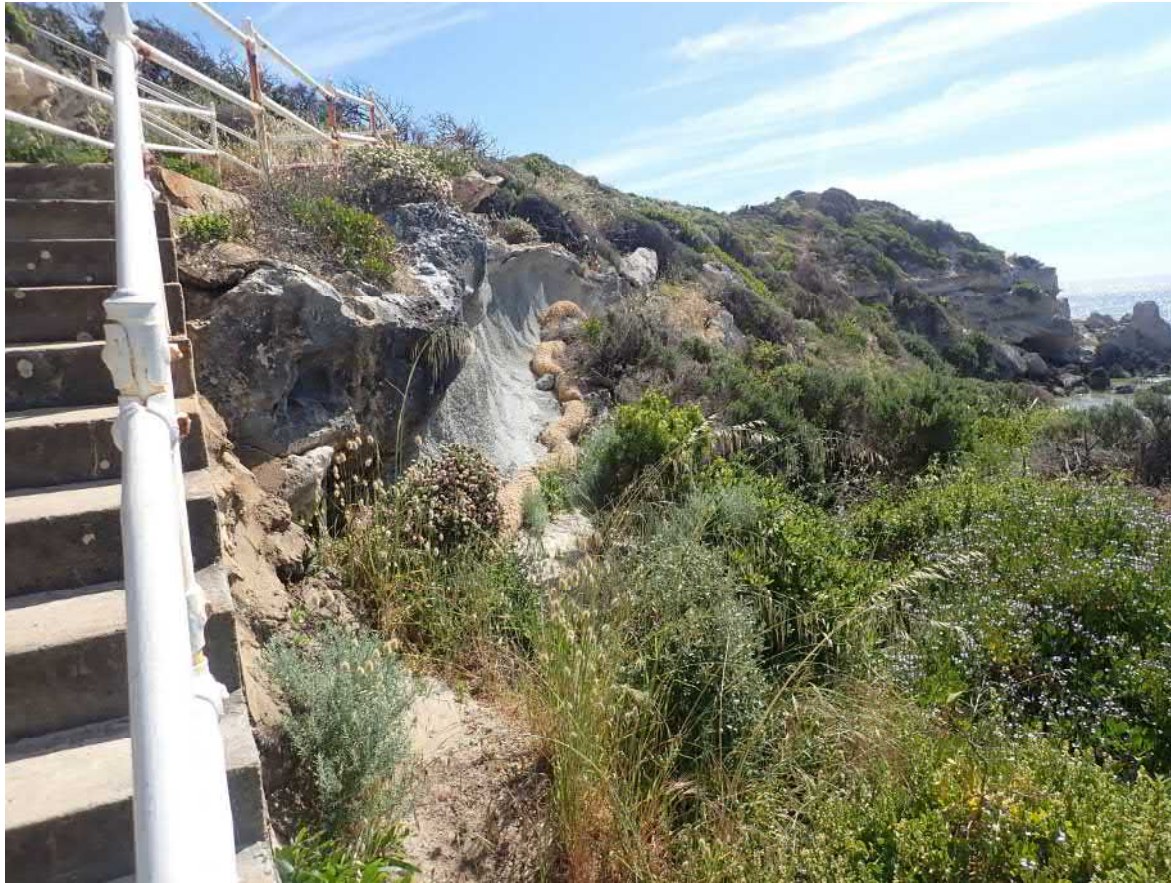
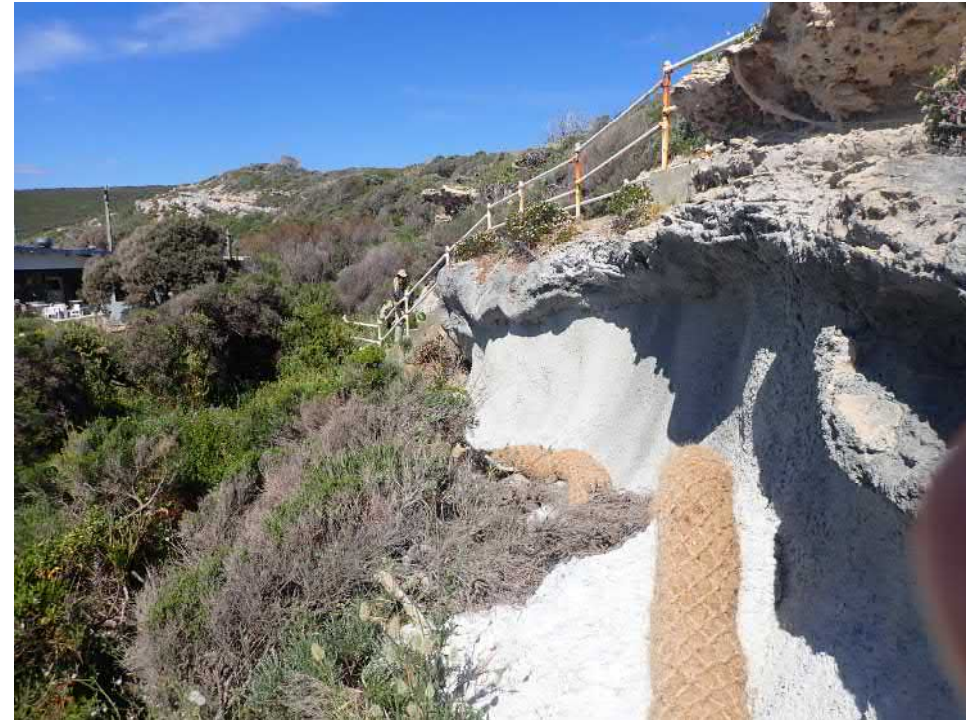
The risk level has reduced due to control/remedial measures put in place in 2021 to reduce weathering under the overhang and to underpin the stairs. Risk to the Individual Most at Risk assessed to be 2.3×10^{-7}

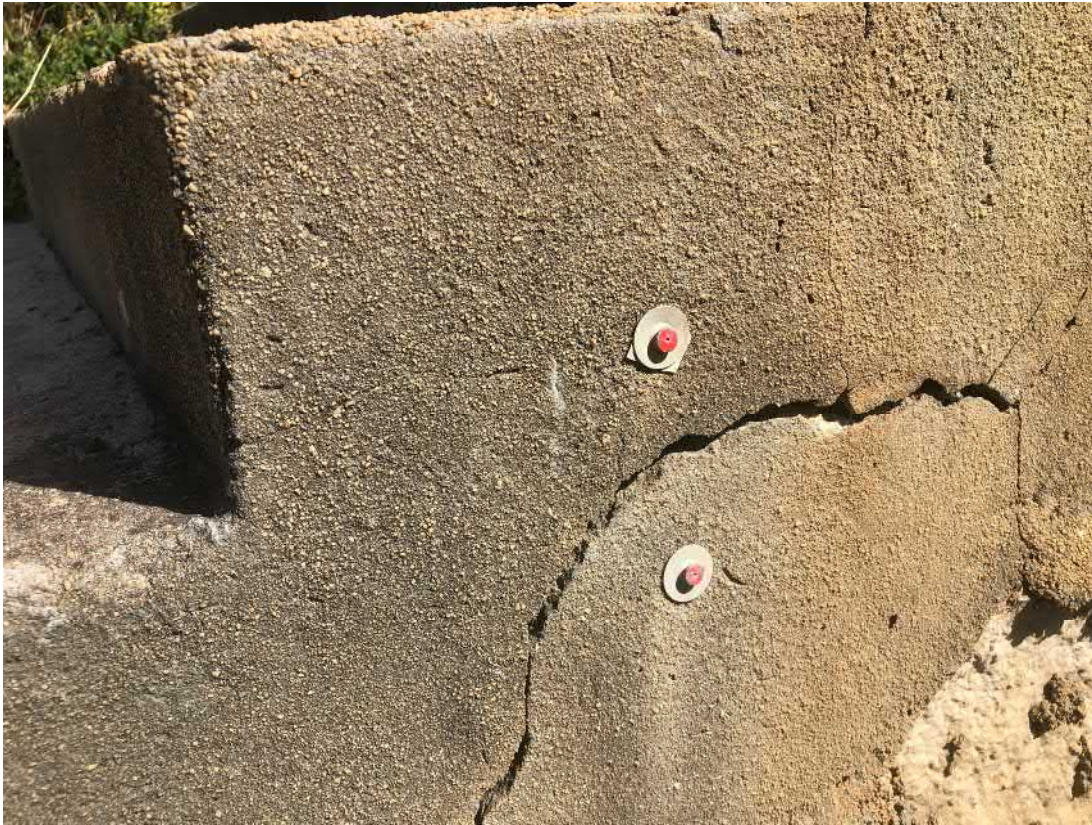
Pins previously installed approximately 101mm apart (previous visit 100mm separation).
Continue to monitor creep.

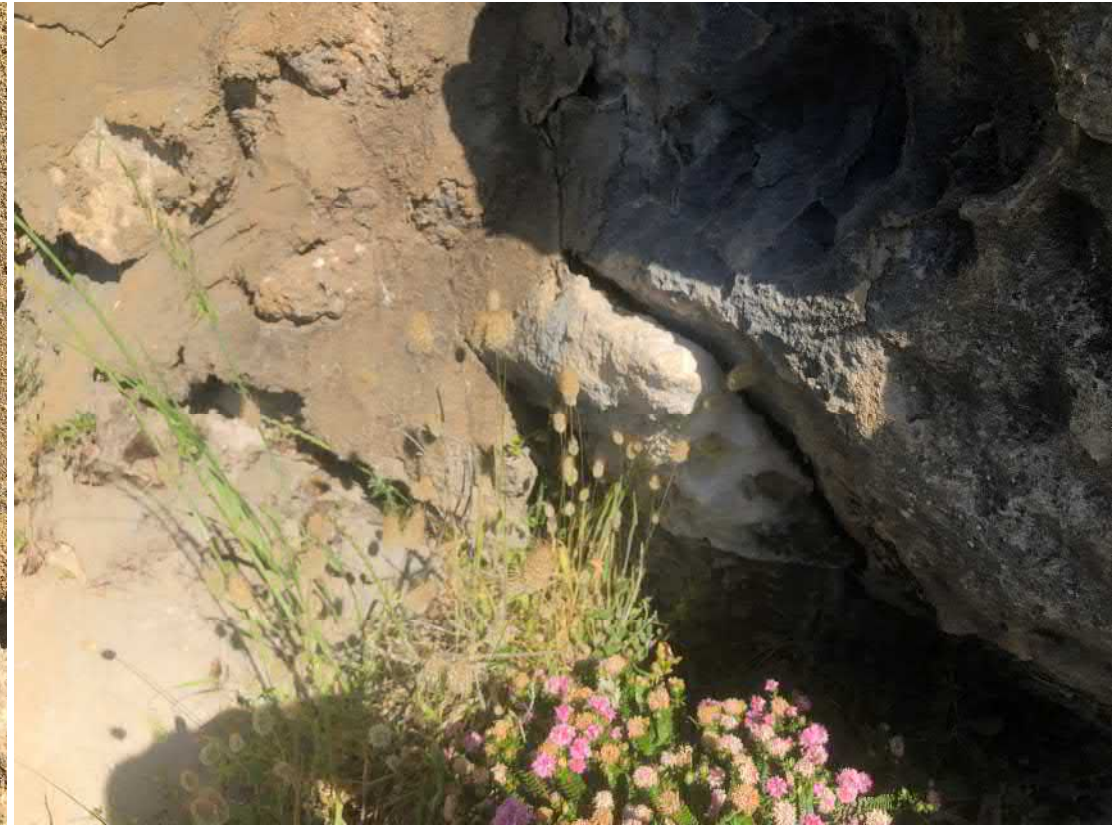
Continue to monitor undercutting.

The level of Risk to the Individual Most at Risk (R_{DI}) remains similar to the 2017 assessment.

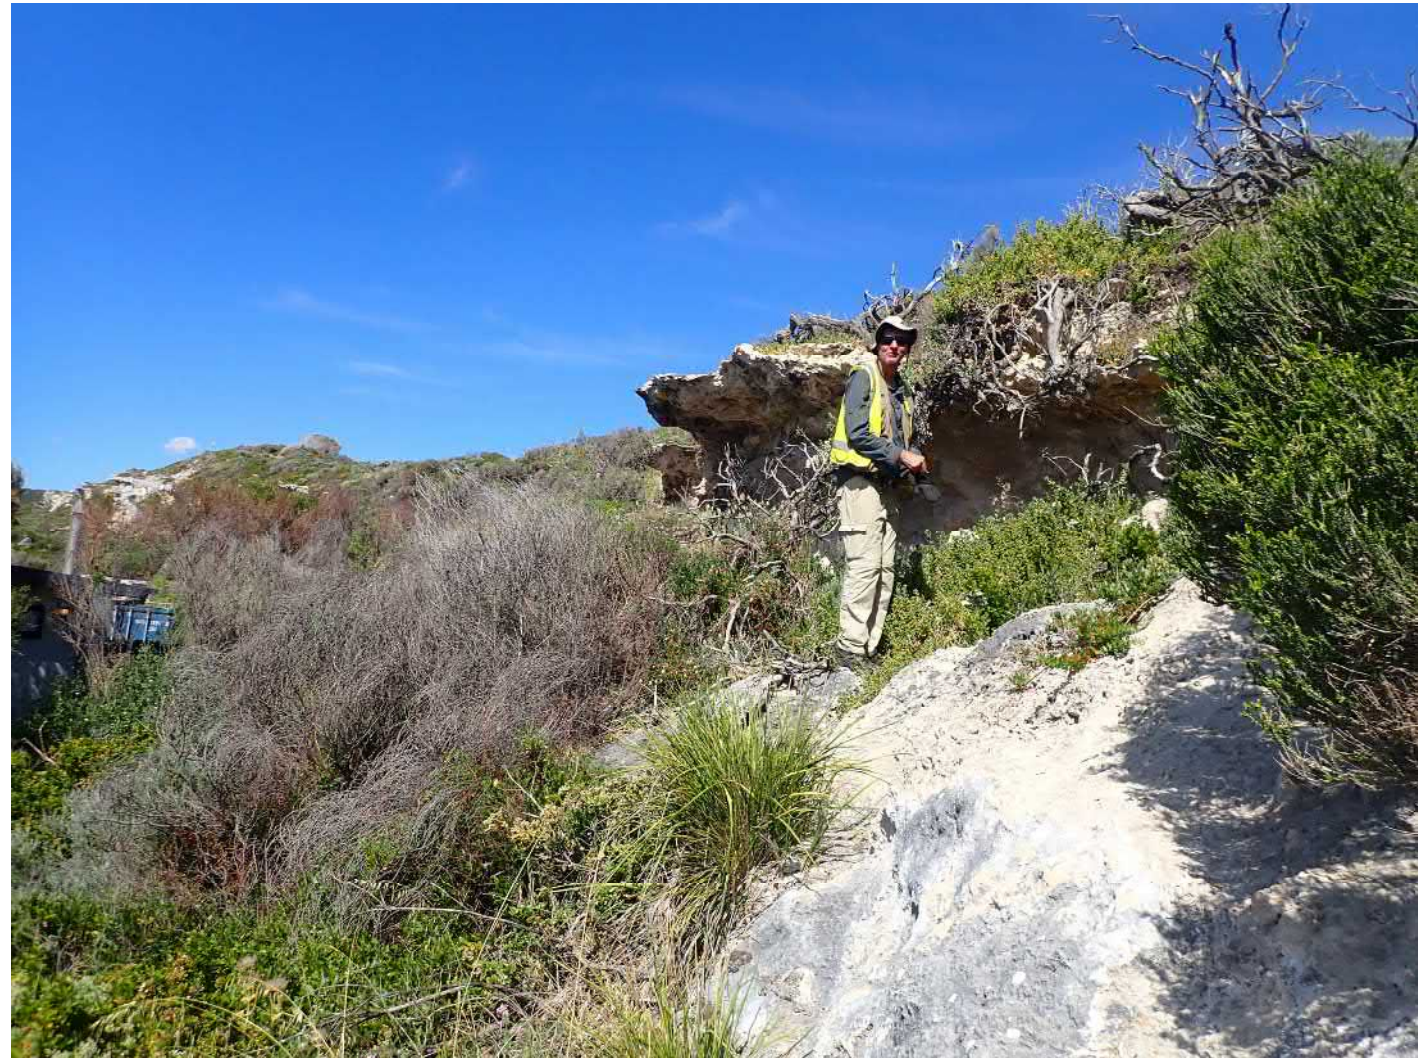
Note there is Minimal traffic in this area and the grassed area below is not used by the Café for customers. The level of risk would increase significantly if this area was used for seating

Add Rockfall Hazard sign in lawn area at base of this feature.

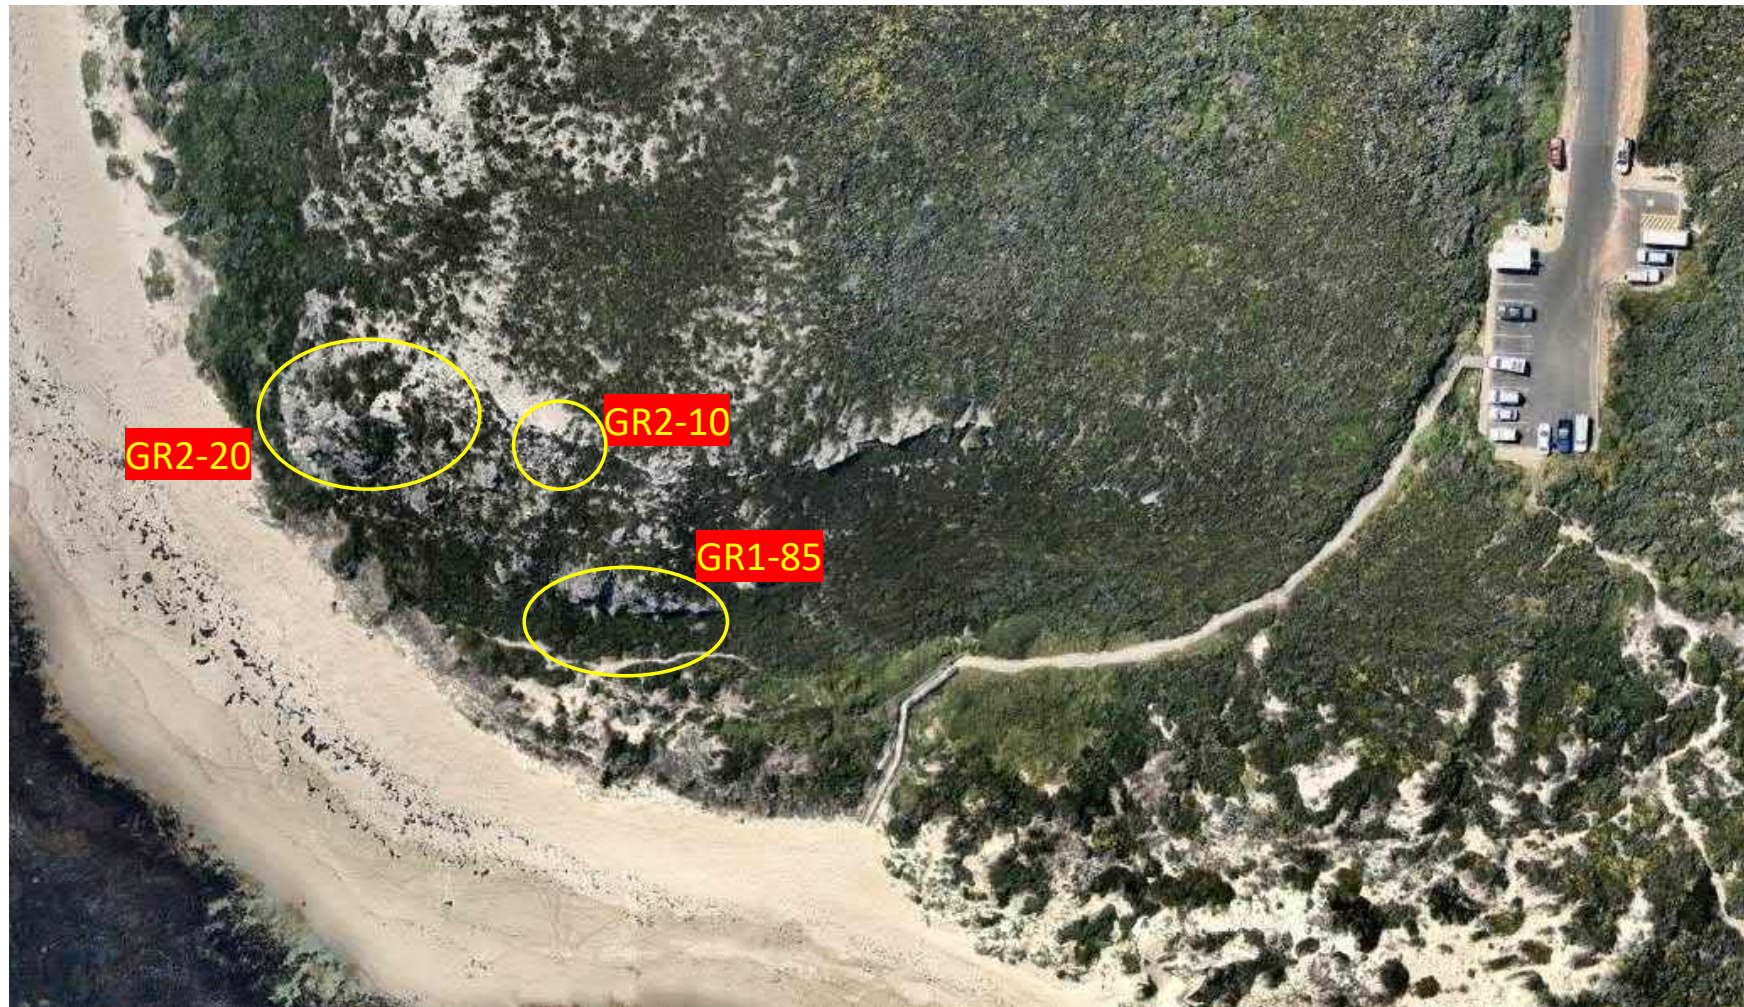
Grunters – GR2-20, GR2-10 & GR1-85

The level of Risk to the Individual Most at Risk (R_{DI}) remains the same as the 2017 assessment.

$R_{DI} = 7.8 \times 10^{-8}$
Repair fence and install rockfall hazard area signage.
