LIMESTONE CLIFF RISK ASSESSMENT

**GRACETOWN, PREVELLY, GNARABUP, GRUNTERS,
WESTERN AUSTRALIA**

INSPECTION AND RISK ASSESSMENT

PER2021-0300AB Rev0

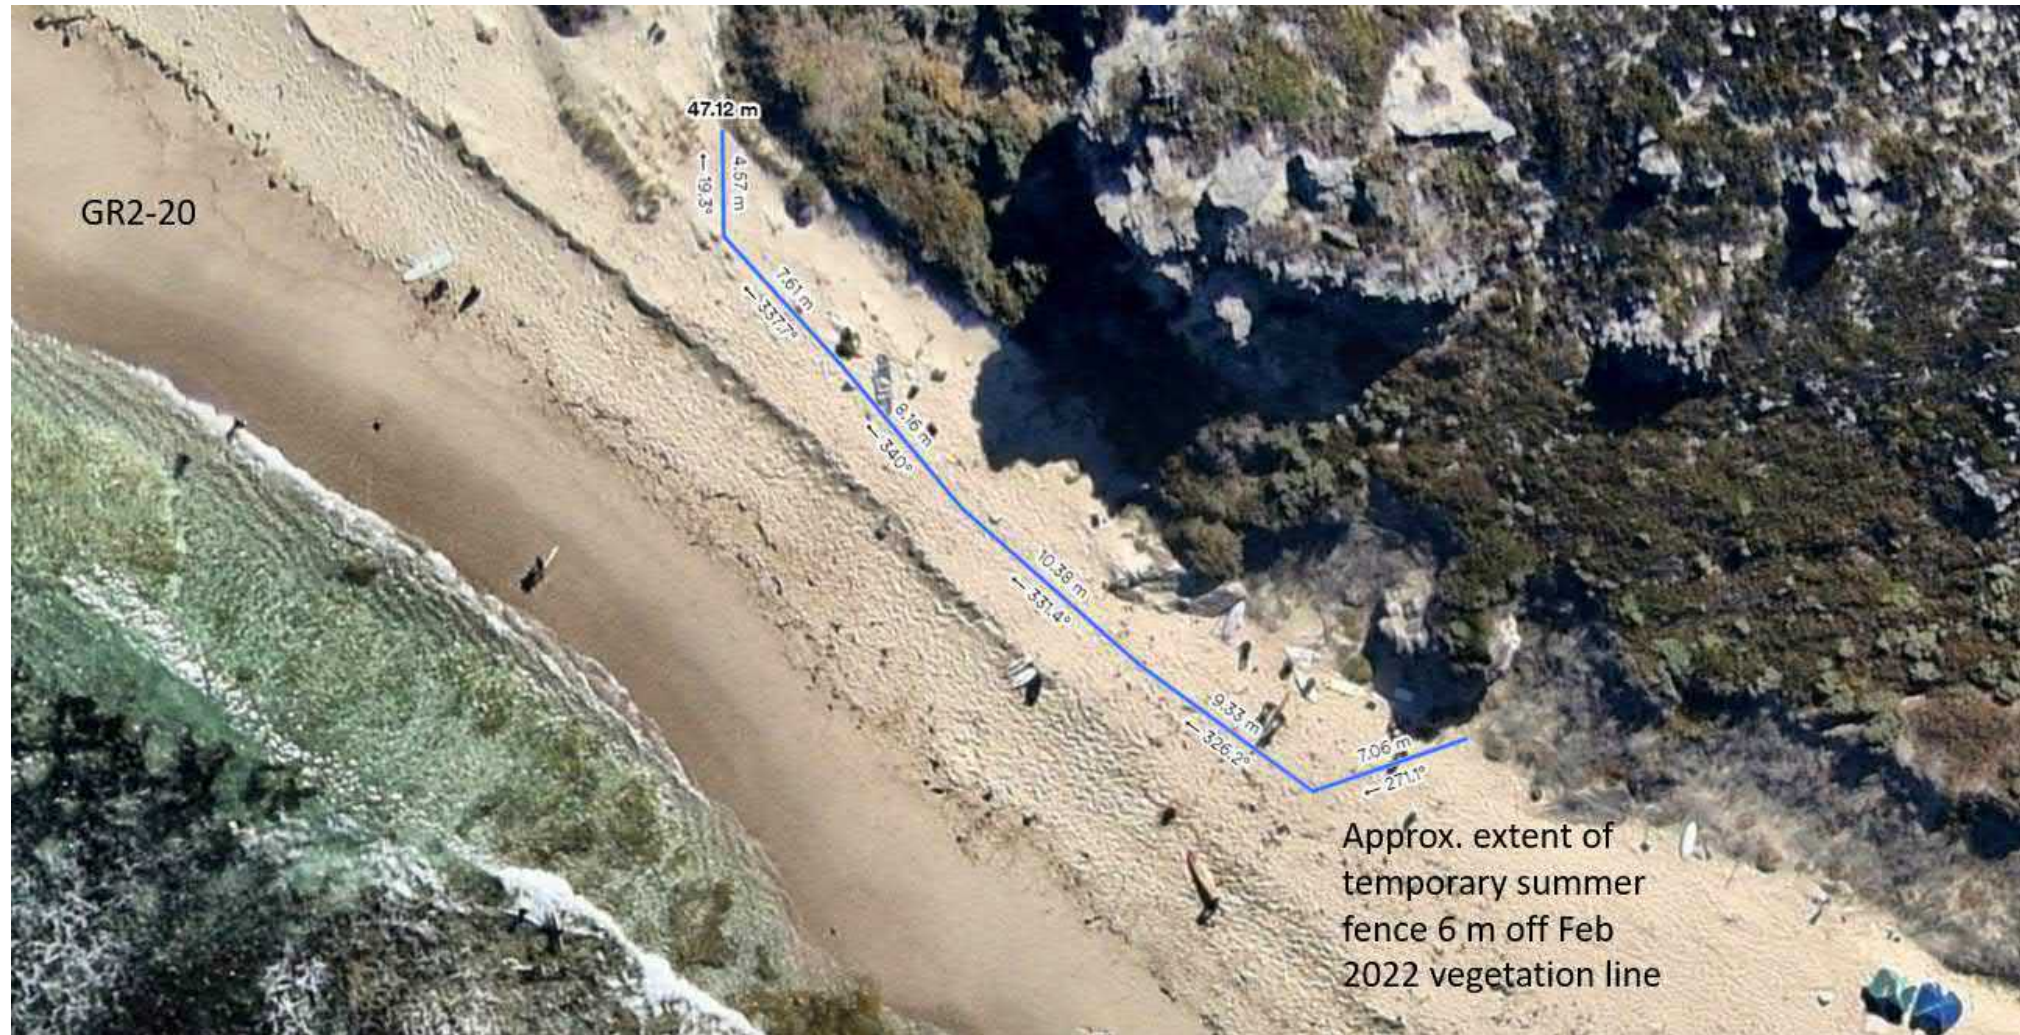
The level of Risk to the Individual Most at Risk (R_{DI}) remains the same as the 2017 assessment.

$$R_{DI} = 6.2 \times 10^{-6}$$

Add rockfall hazard sign on the beach as well as temporary fencing (Nov to April_ on beach 6 m from dune beach interface.

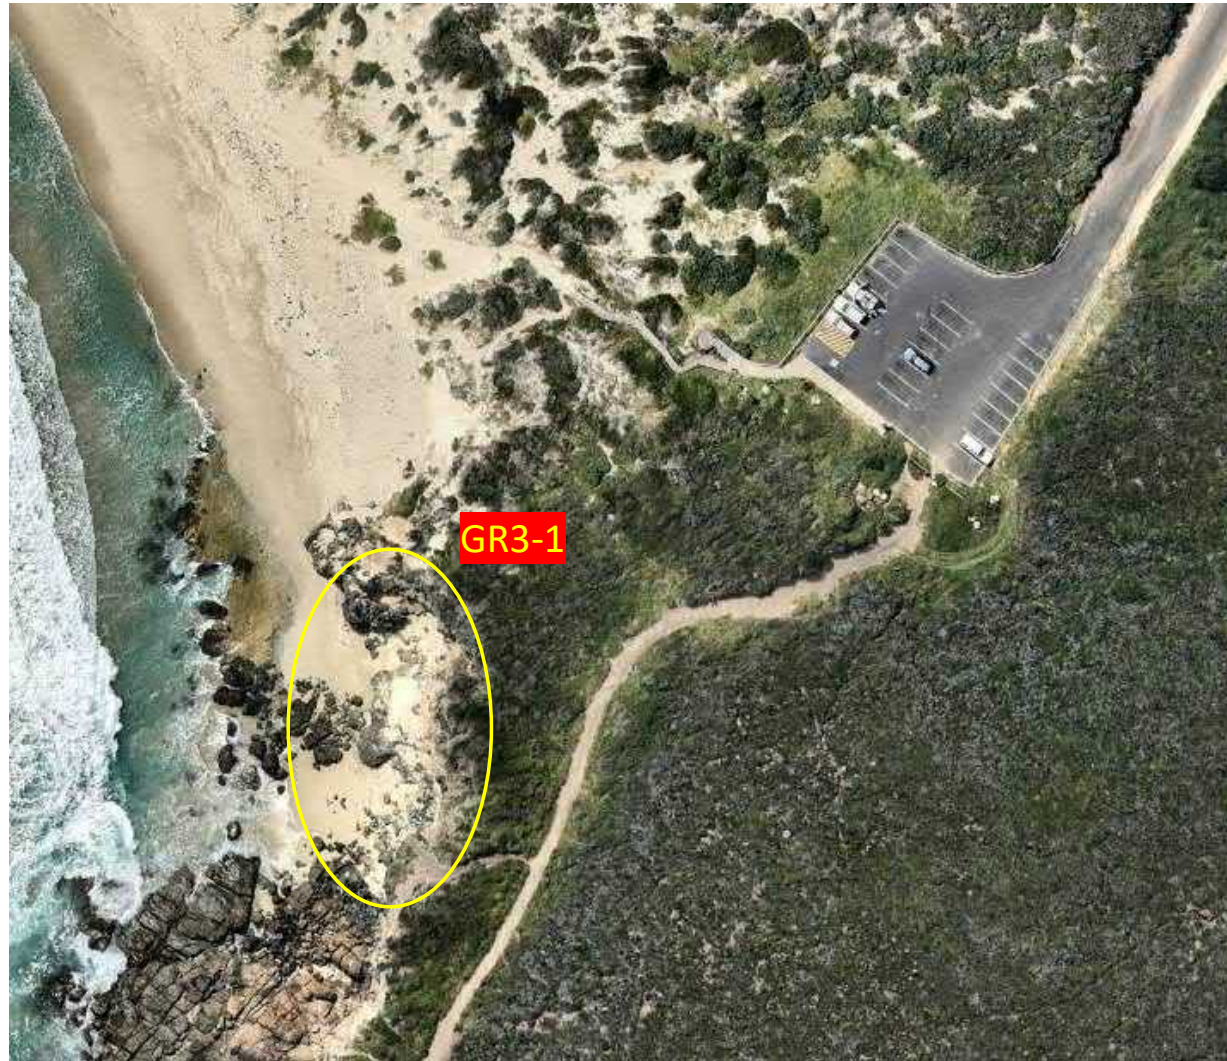
Grunters – GR3-1 (New location since 2017 inspection)

The level of Risk to the Individual Most at Risk (R_{DI}) = $R_{DI} = 6.2 \times 10^{-6}$

Recommend adding a rockfall risk sign at the base and re-vegetating informal pathway across rocks leading to this area to discourage pedestrian traffic.

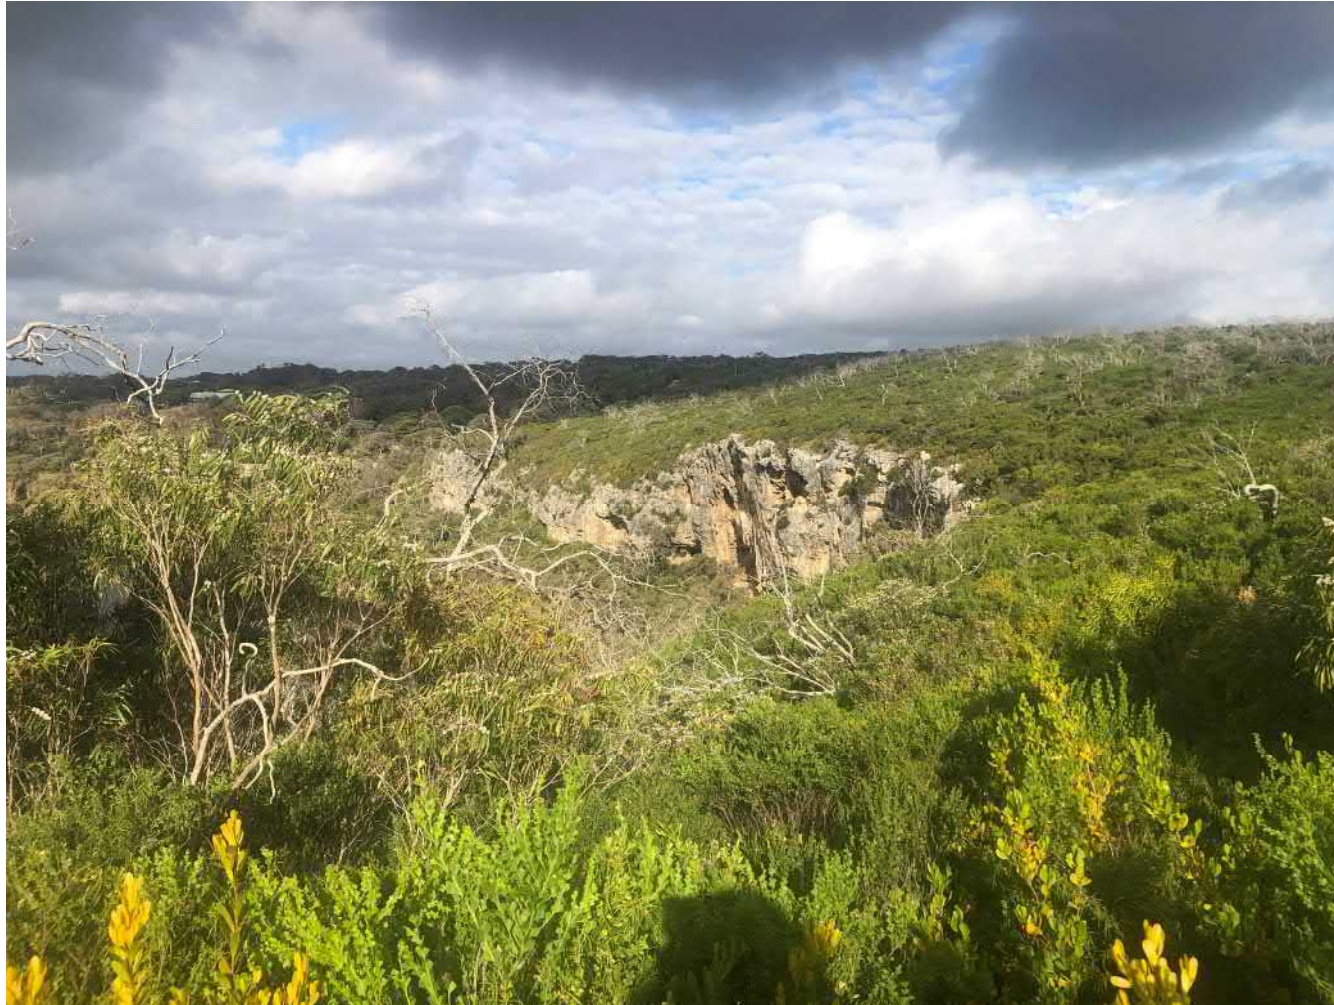
View of Wallcliffe,
surrounded by dense
vegetation. Care
should be taken to
preserve vegetation
whilst undertaking
climbing bolt removal

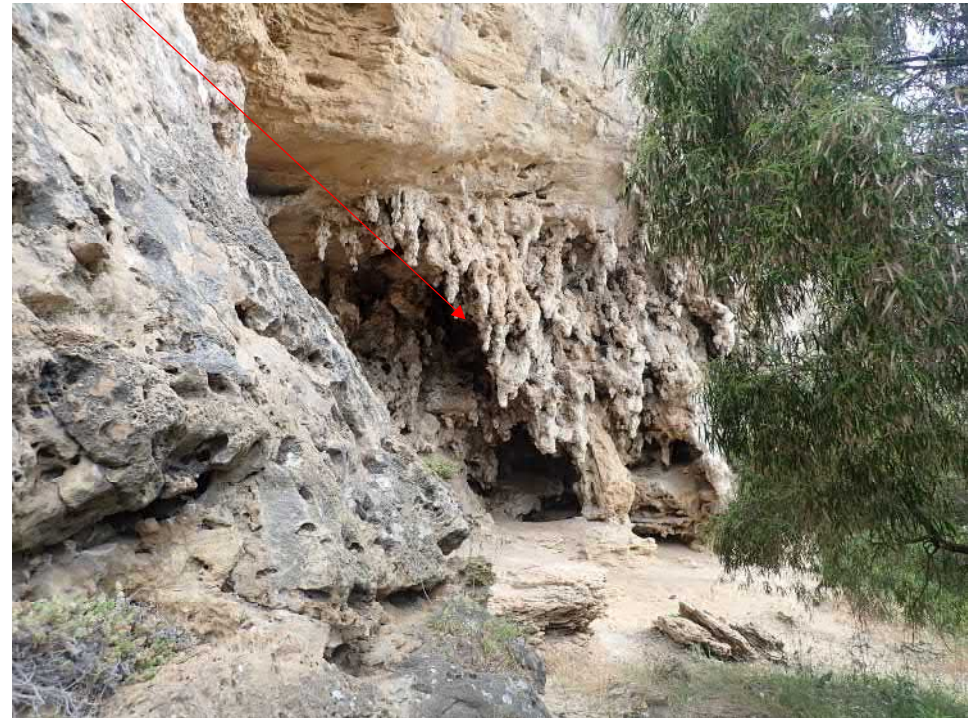
Stalactites potentially can drop process pf removing climbing Keeping people out of the potential drop zone will manage the safety risk but a methodology that avoids descending on ropes into this stalactite zone would help also preserve these features from damage as well as manage safety risk

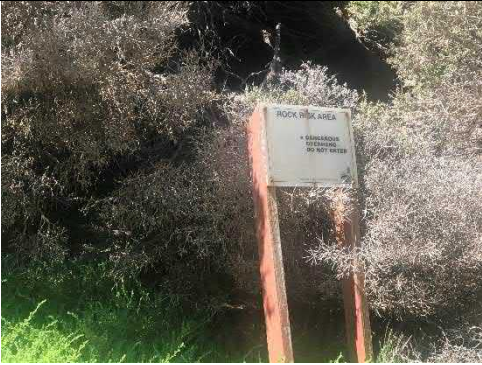
A white rectangular sign on a metal pole. The sign has a red triangle with an exclamation mark and the word 'DANGER' in red. Below this, it says 'CAUTION ROCKFALL HAZARDS BEYOND THIS POINT. STAY AWAY FROM BASE OF CLIFFS'. There are three small pictograms at the bottom: a person falling, a person standing near a cliff, and a person walking away from a cliff. The background shows a coastal area with a sandy beach and blue water under a clear sky.
SR02	125	313679	6251010	Sign not present but not required	
SR03	127	313623	6251001	Poor condition. Replace with 'rehabilitation area' sign

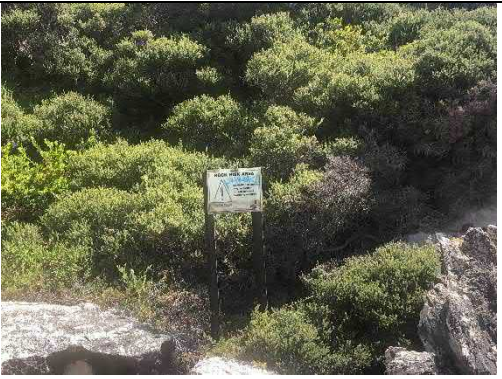
SR08	-	313342	6250918	Not on shire database. Remove sign as it is not directly applicable to the rockfall area.

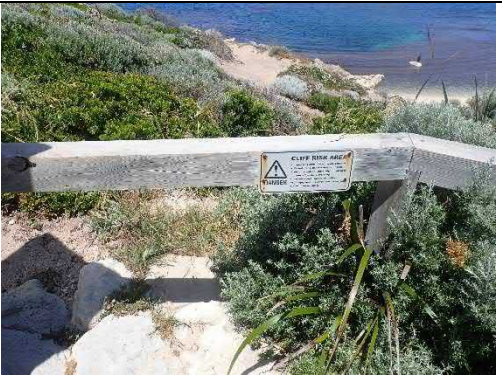
SR25	0	313940	6238562	Signage to be improved. Install "Rockfall Hazard Area" sign at eye level. Also consider signage relating to not damaging vegetation, such as a rehabilitation area sign.

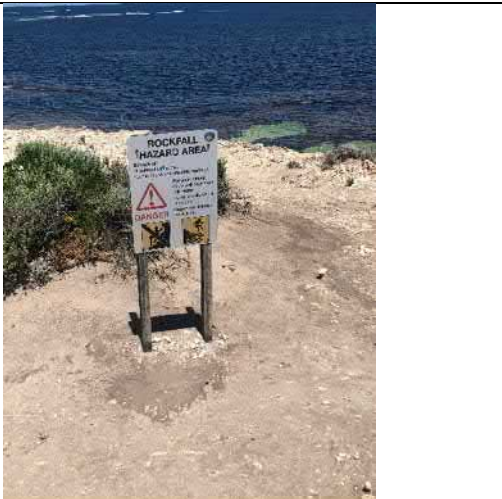
SR26	340	313986	6238518	Good condition and well positioned for the hazard. However for someone to see this sign they will have already traversed many metres off formal tracks from the Main Break Carparking area. This sign is however located on an informal track.

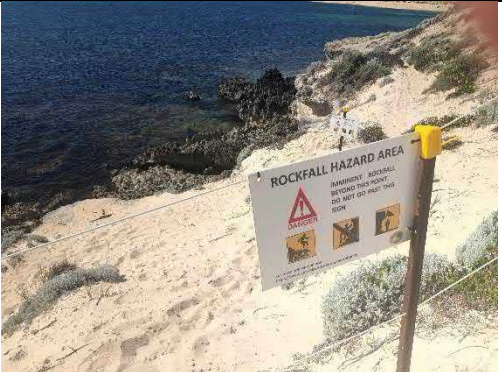
SR37	-	314306	6236992	Temporary signage to be made permanent.

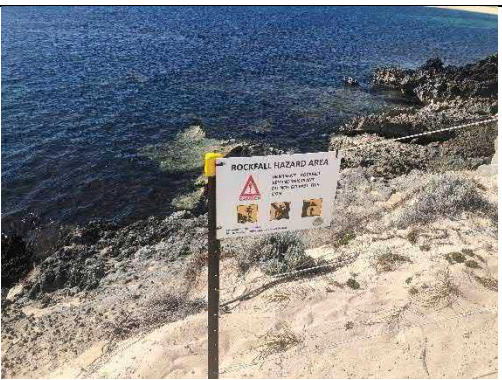
SR38	91	314302	6236991	Temporary signage to be made permanent.

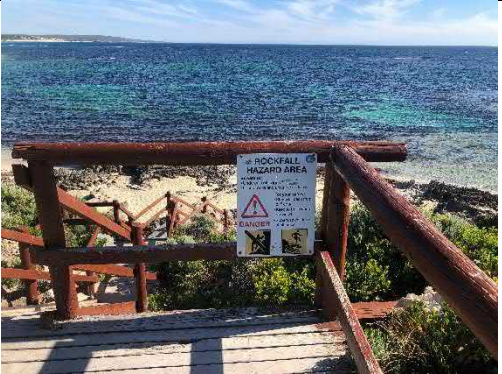
SR41	-	314334	6236838	Good condition and position. Recommend adding new rockfall hazard signs as informative sign to both entrances to the Back Beach (bottom of stairs), with a map showing hazard locations and suggested areas to avoid i.e. parts of the beach below GN1-25 and GN1-50
