May 2017

# Limestone Cliff Stability Assessment

Report Number. 1666765-001-R-Rev0 Distribution:

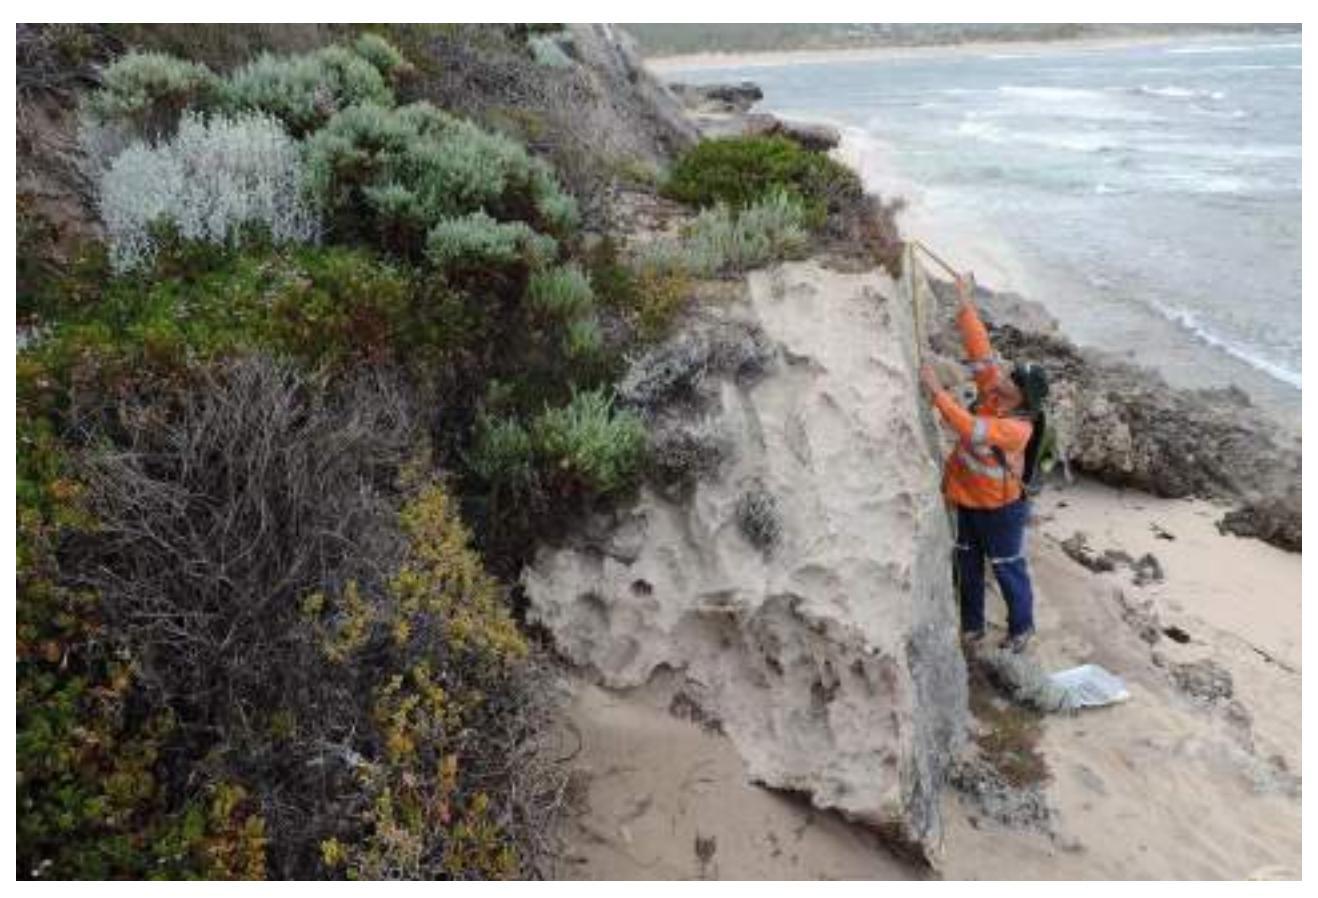
Photograph A9: An example of a toppled overhang south of Surfers Point (Date of Photograph: 23 January 2017).

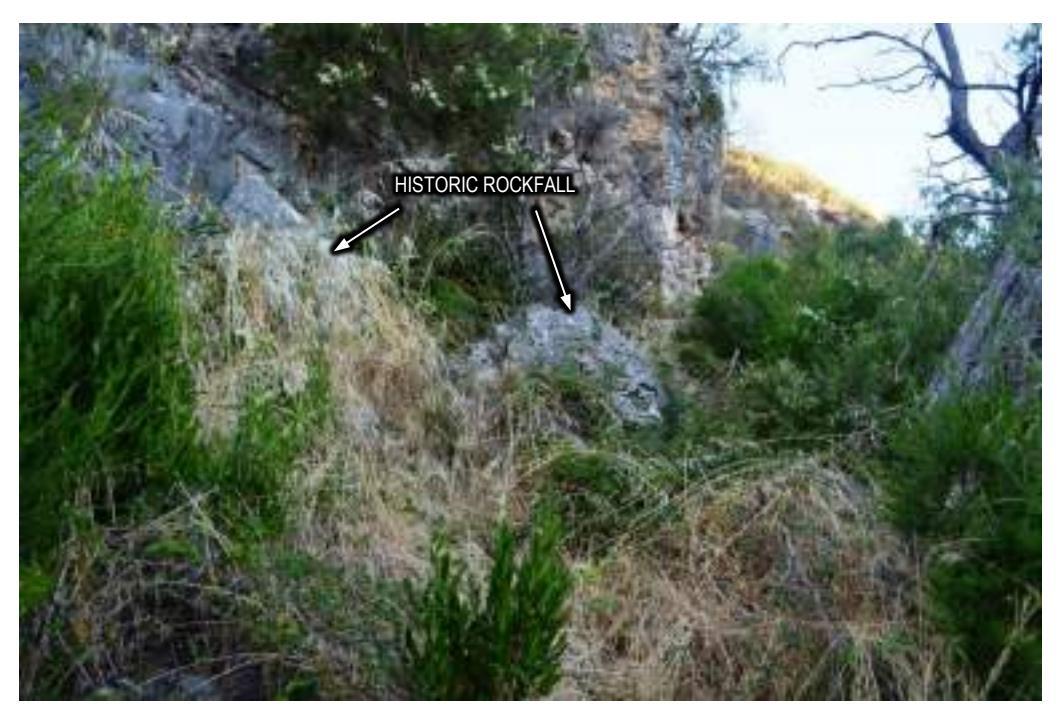
Photograph A13: Historic rockfall on the northern side of the Wallcliffe site (Date of Photograph: 25 January 2017).

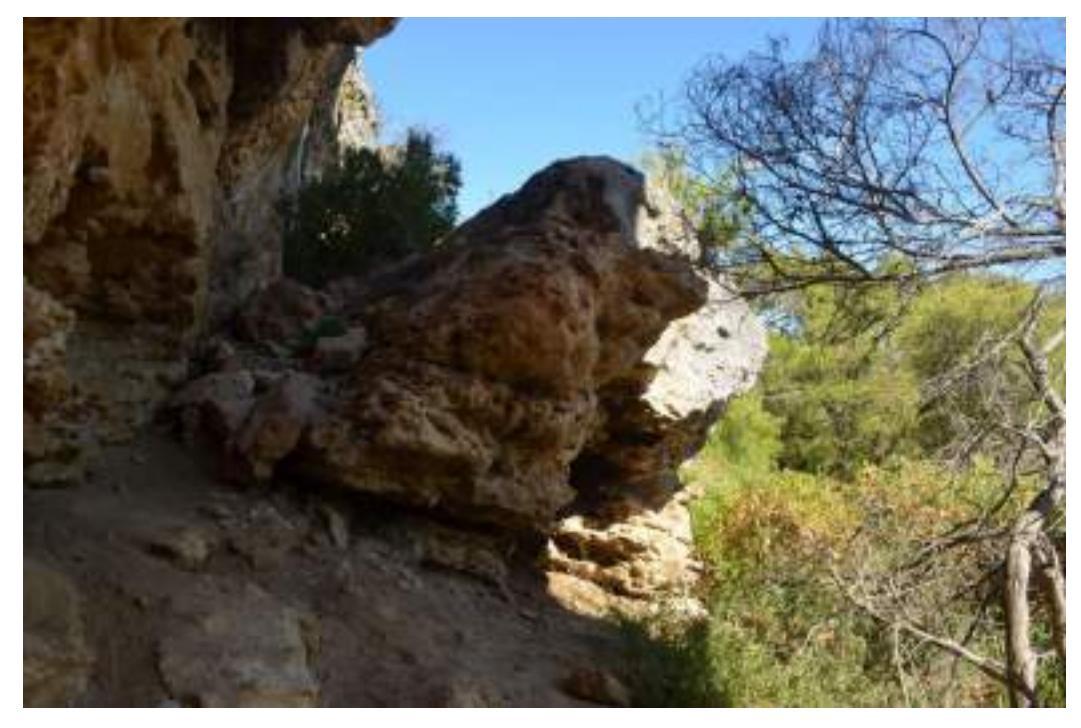
Photograph A14: A large ( $\sim$ 3.5 m × 3.5 m × 7.0 m) limestone block that appears to have dropped or relaxed from the main rock face behind it near the southern end of the Wallciffe site (Date of Photograph: 25 January 2017).

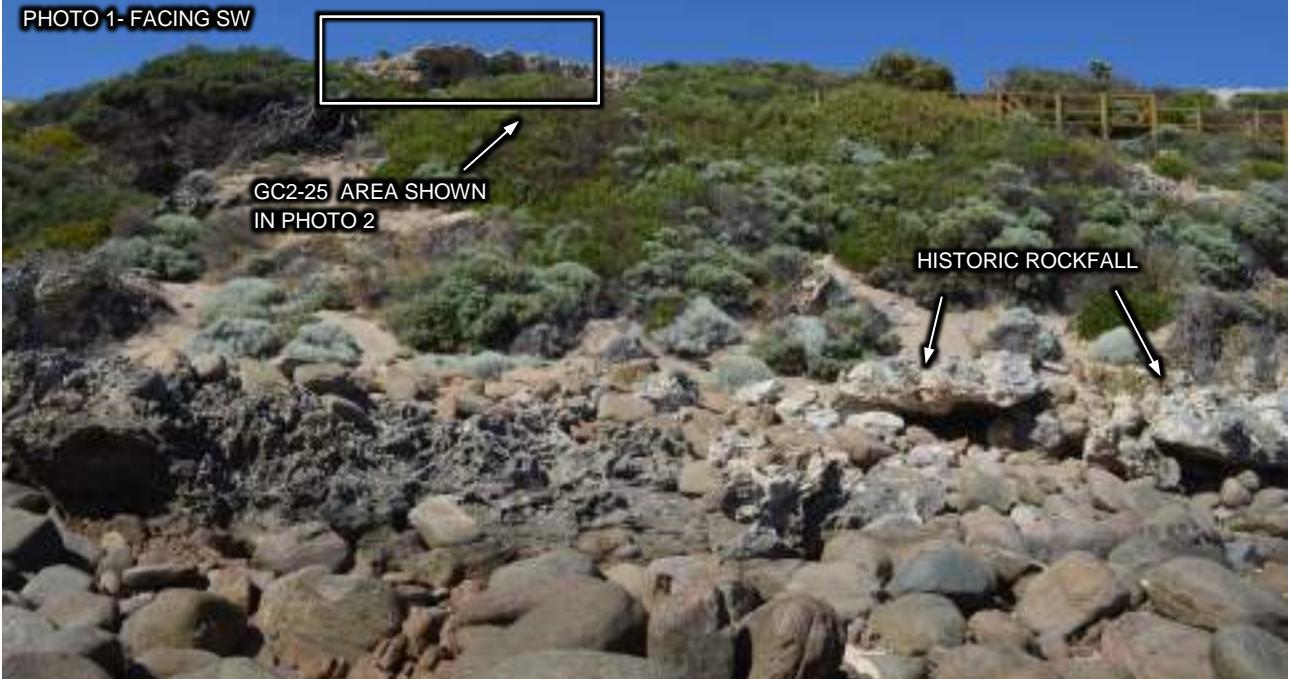
<u>Description:</u> Layer of steeply dipping eolianite overlying more erodible paleosol leading to undercutting and relaxation of the layered eolianite out of the slope. Relief fractures visible due to relaxation.

- Continue monitoring every 3 years AND;
- Install large rockfall hazard signs on exits to the beach from access stairs.

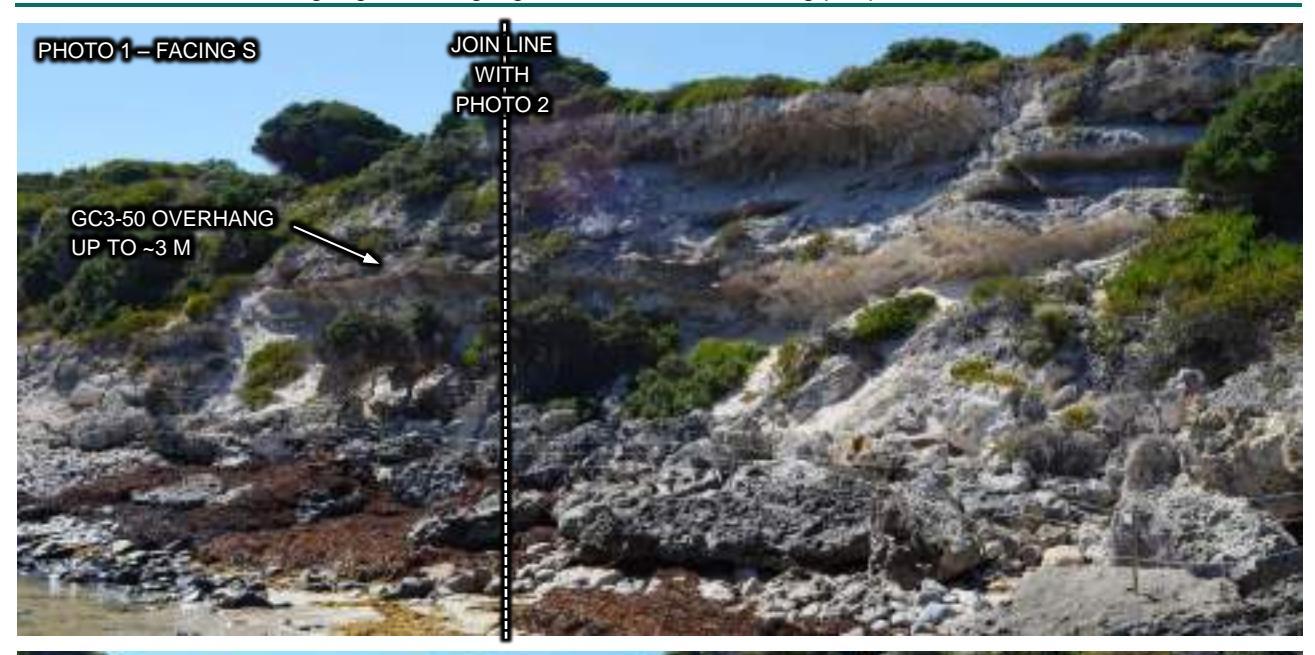
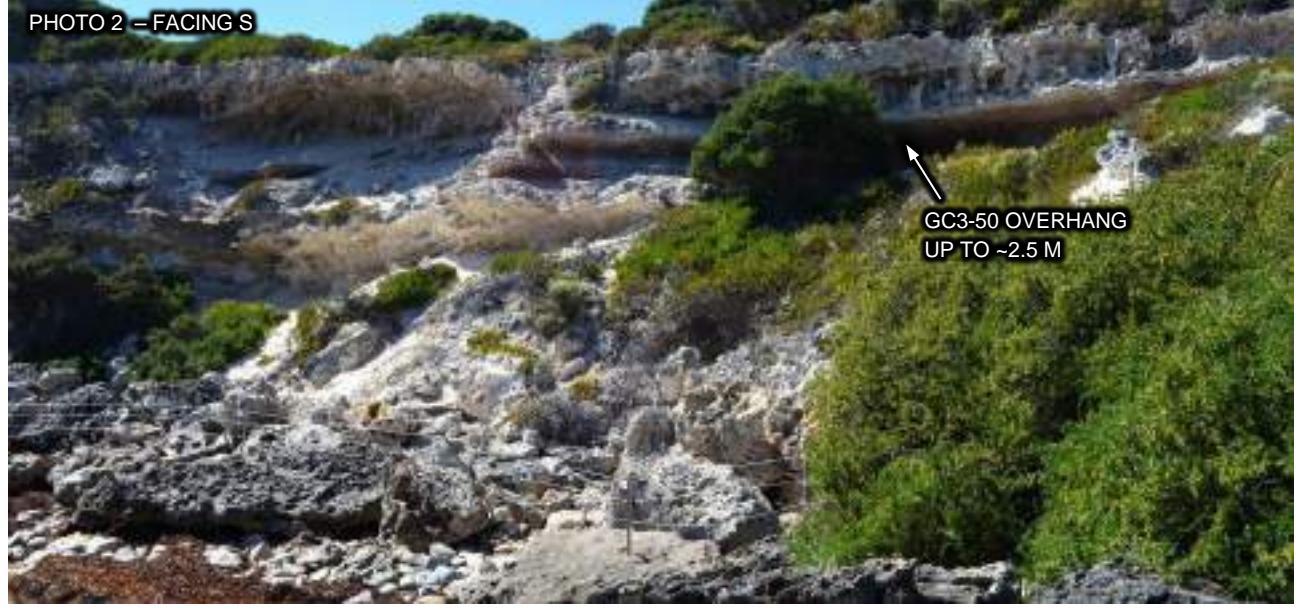
<u>Description</u>: Overhang of up to ~1.5 m of caprock with relief fractures present at the back of the overhang observed (see photos).

- Continue monitoring every 3 years AND;
- Install large rockfall hazard signs on exits to the beach from access stairs.

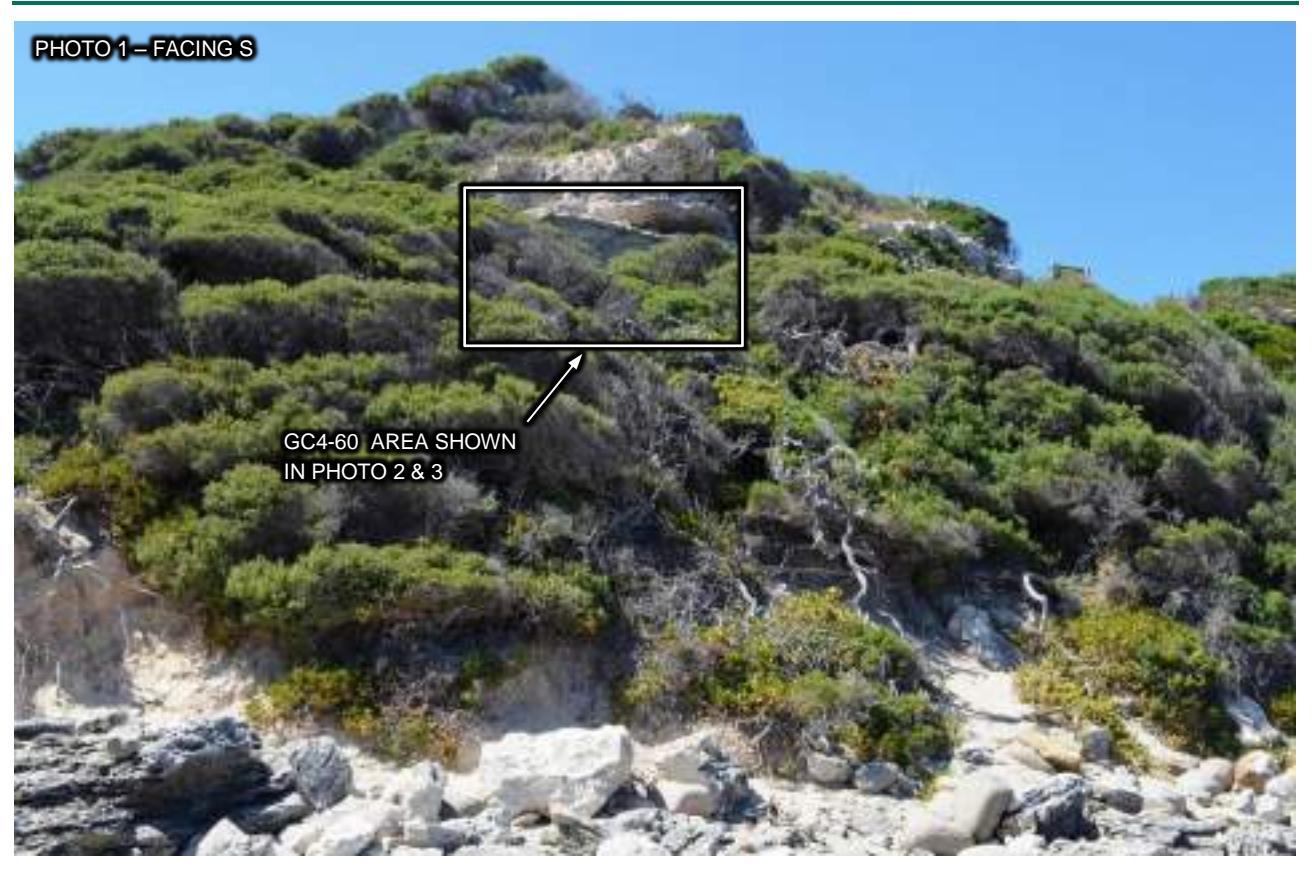
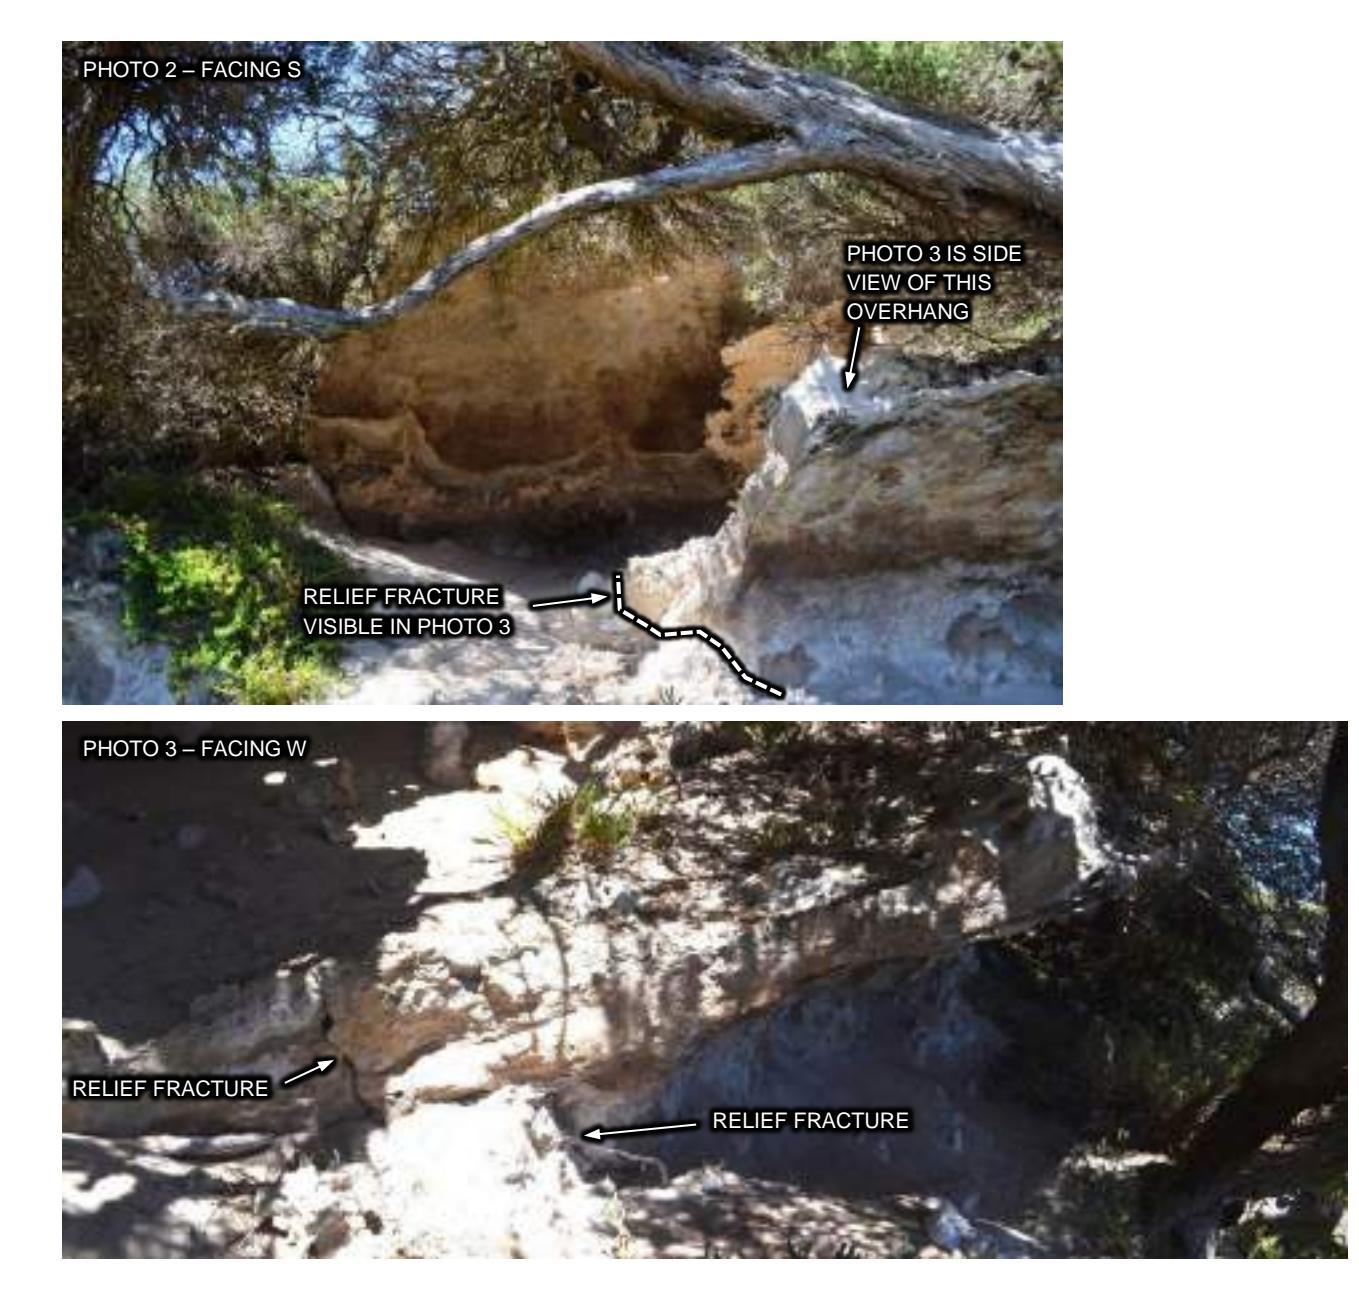
<u>Description:</u> Overhang of up to ~1.5 m of caprock with relief fractures present at the back of the overhang observed (see photos).

- It is recommended that one of the mitigation options below should be implemented within 2 years of this report for this site.
- Install warning signs and fencing (offset 5 m from edge of vegetation) below hazard to keep people from entering the hazard zone and continue to monitor annually AND,
- Stabilise overhanging blocks with mesh or bolts, slope stabilisation design required, and continue monitoring annually OR,
- Remove overhanging blocks with excavator or by blasting.

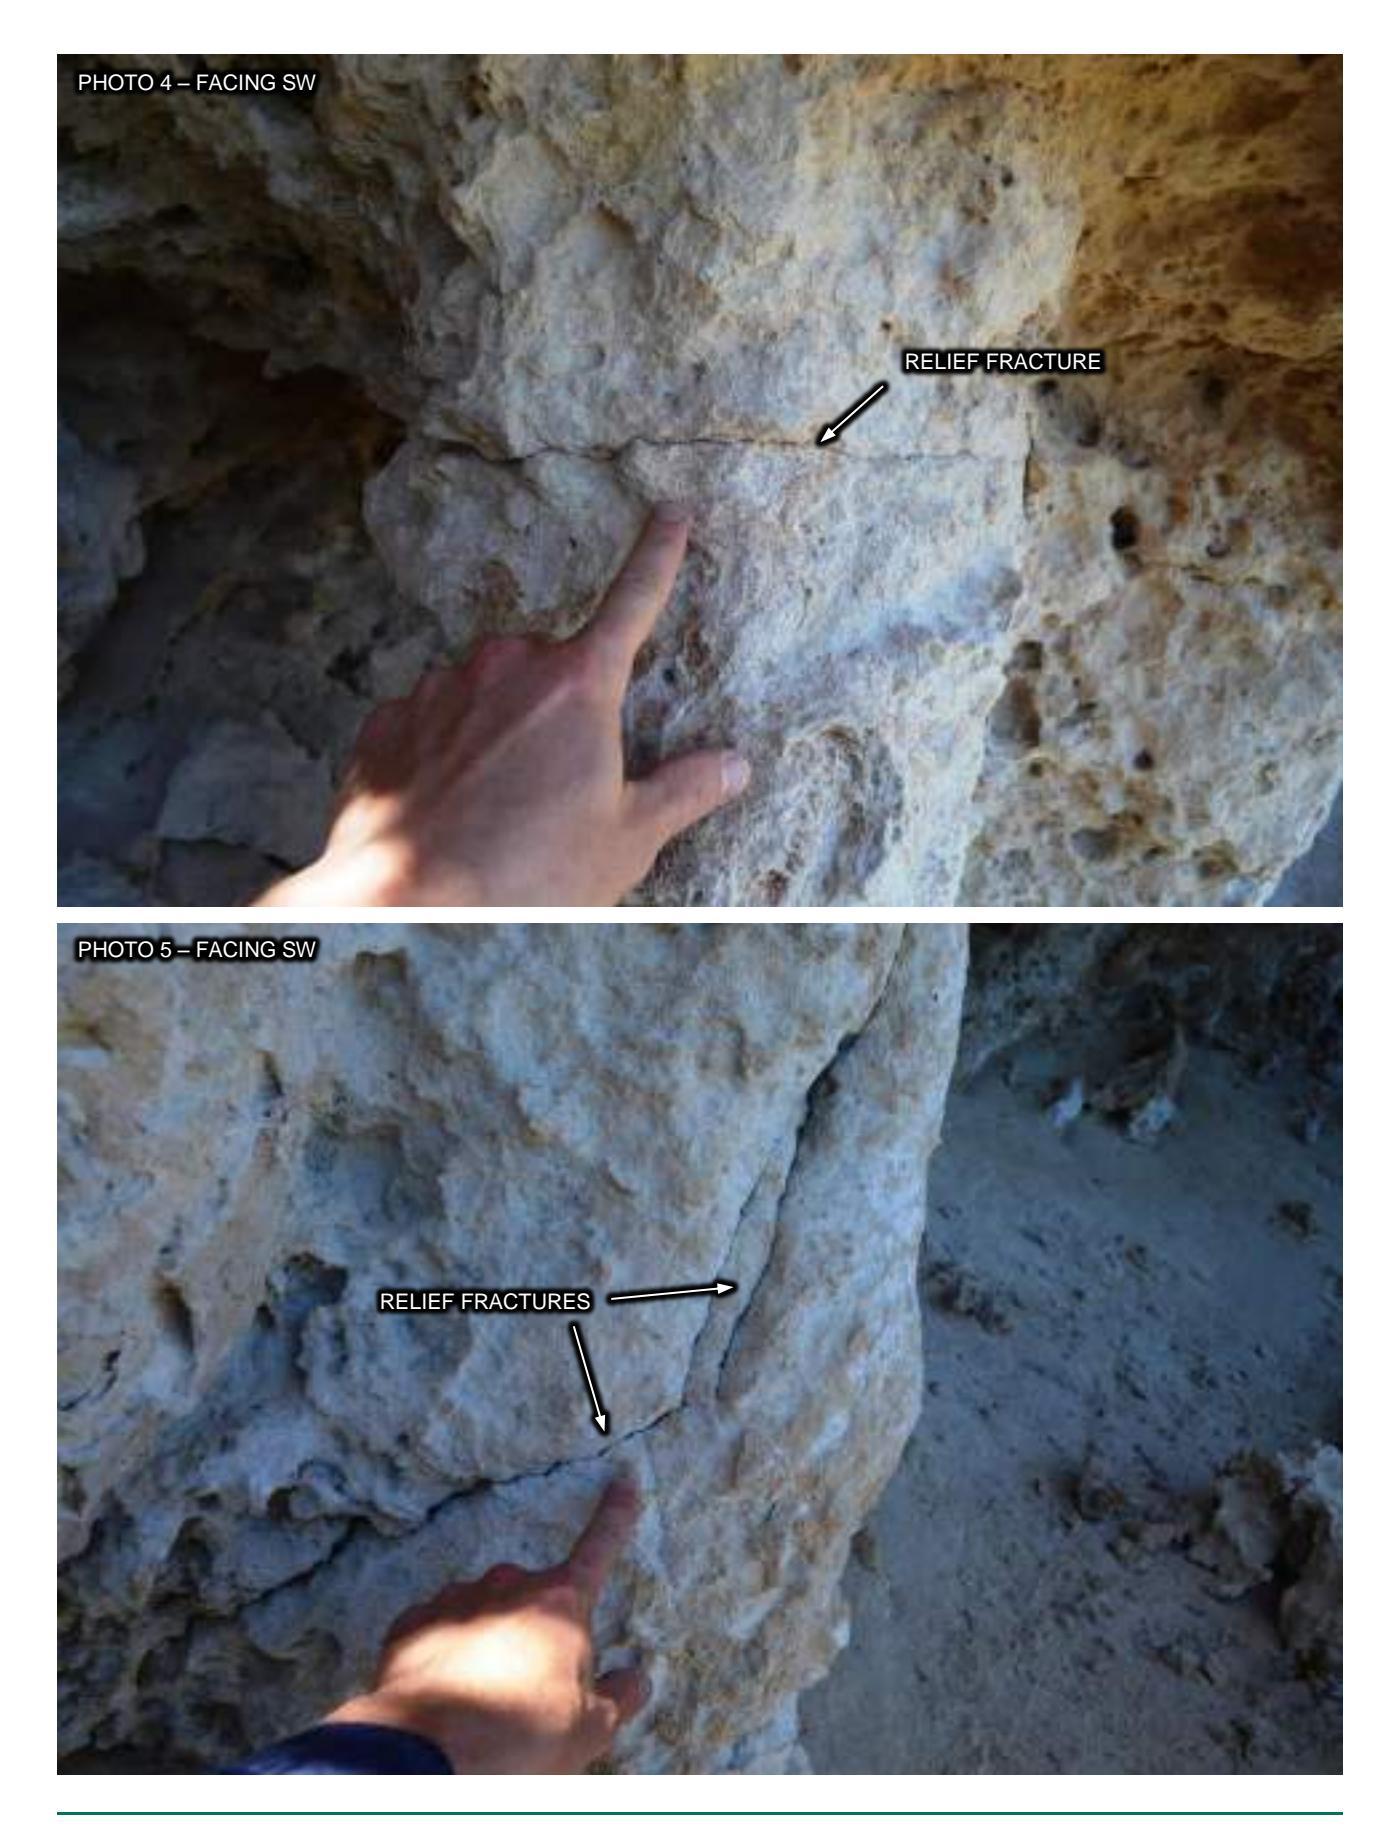
the east side of the feature and possibly through to the other side of the main outcrop supporting a pedestrian lookout (see photos). High priority rockfall hazard for both recreational users and Shire assets.

- Close the lookout, install warning signs below the lookout to KEEP OUT and do not linger below cliff AND apply either of the following mitigation options within 1 year.
- Support overhang and relaxing blocks, slope stabilisation design required and continue monitoring annually.
- Remove overhanging blocks and reconstruct the lookout.

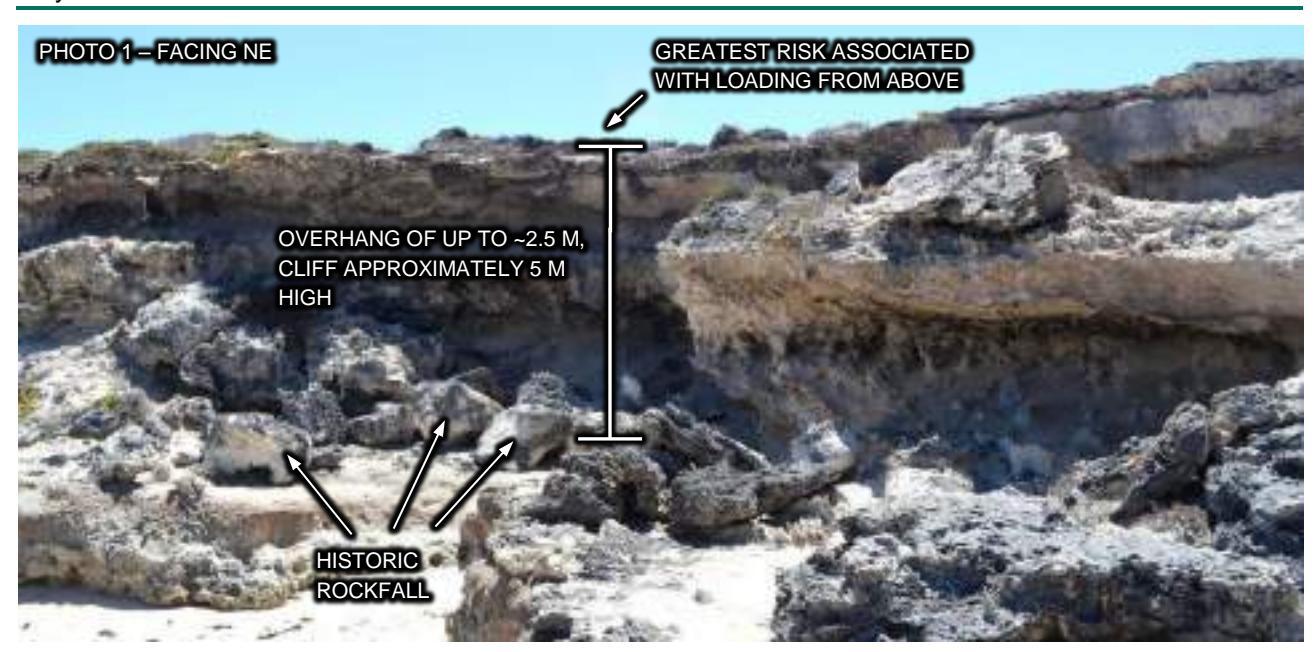
#### PREVELLY PR5 Hazard ID: PR5-150

<u>Description:</u> Overhanging rock platform that is significantly undercut in places (not measured) and may collapse. Although most recreational users for the area will never access this location, fisherman and coastal walkers are likely to pass over the area regularly.

<u>Preliminary Mitigation Options:</u> Place rockfall warning signage on approach paths, continue monitoring every 3 years.

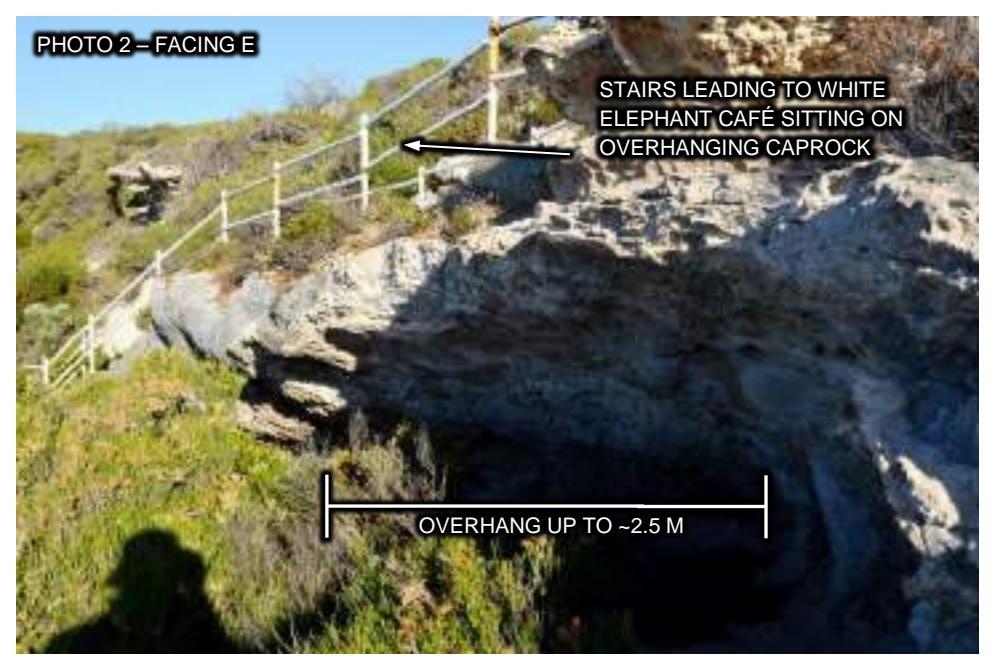
#### Hazard ID: GN5-30

<u>Description:</u> Small overhang (not measured) above the White Elephant Café and the stairs leading down from the upper car park. A large limestone block from historic rockfall is located at the base of the stairs.

- Continue monitoring every 3 years AND;
- Do not allow any further development from the White Elephant Café below this area OR;
- Remove the overhanging section of the rock mass.

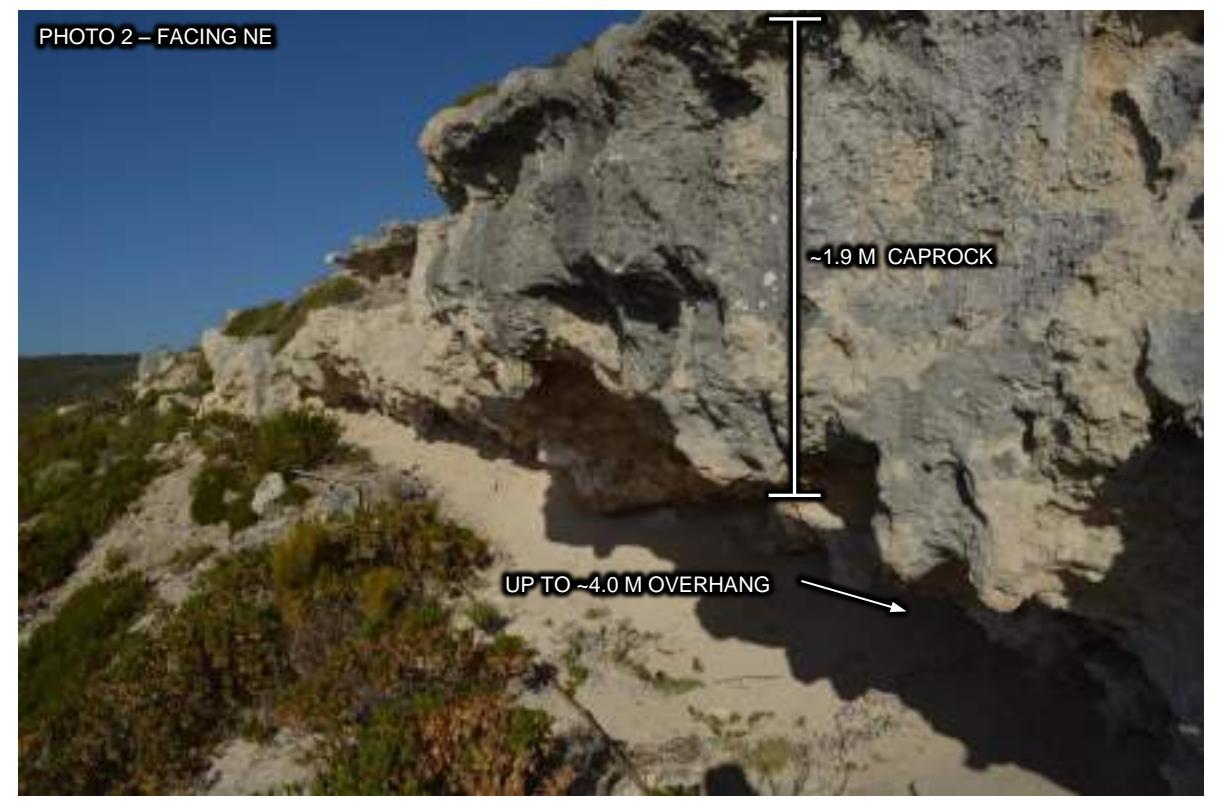
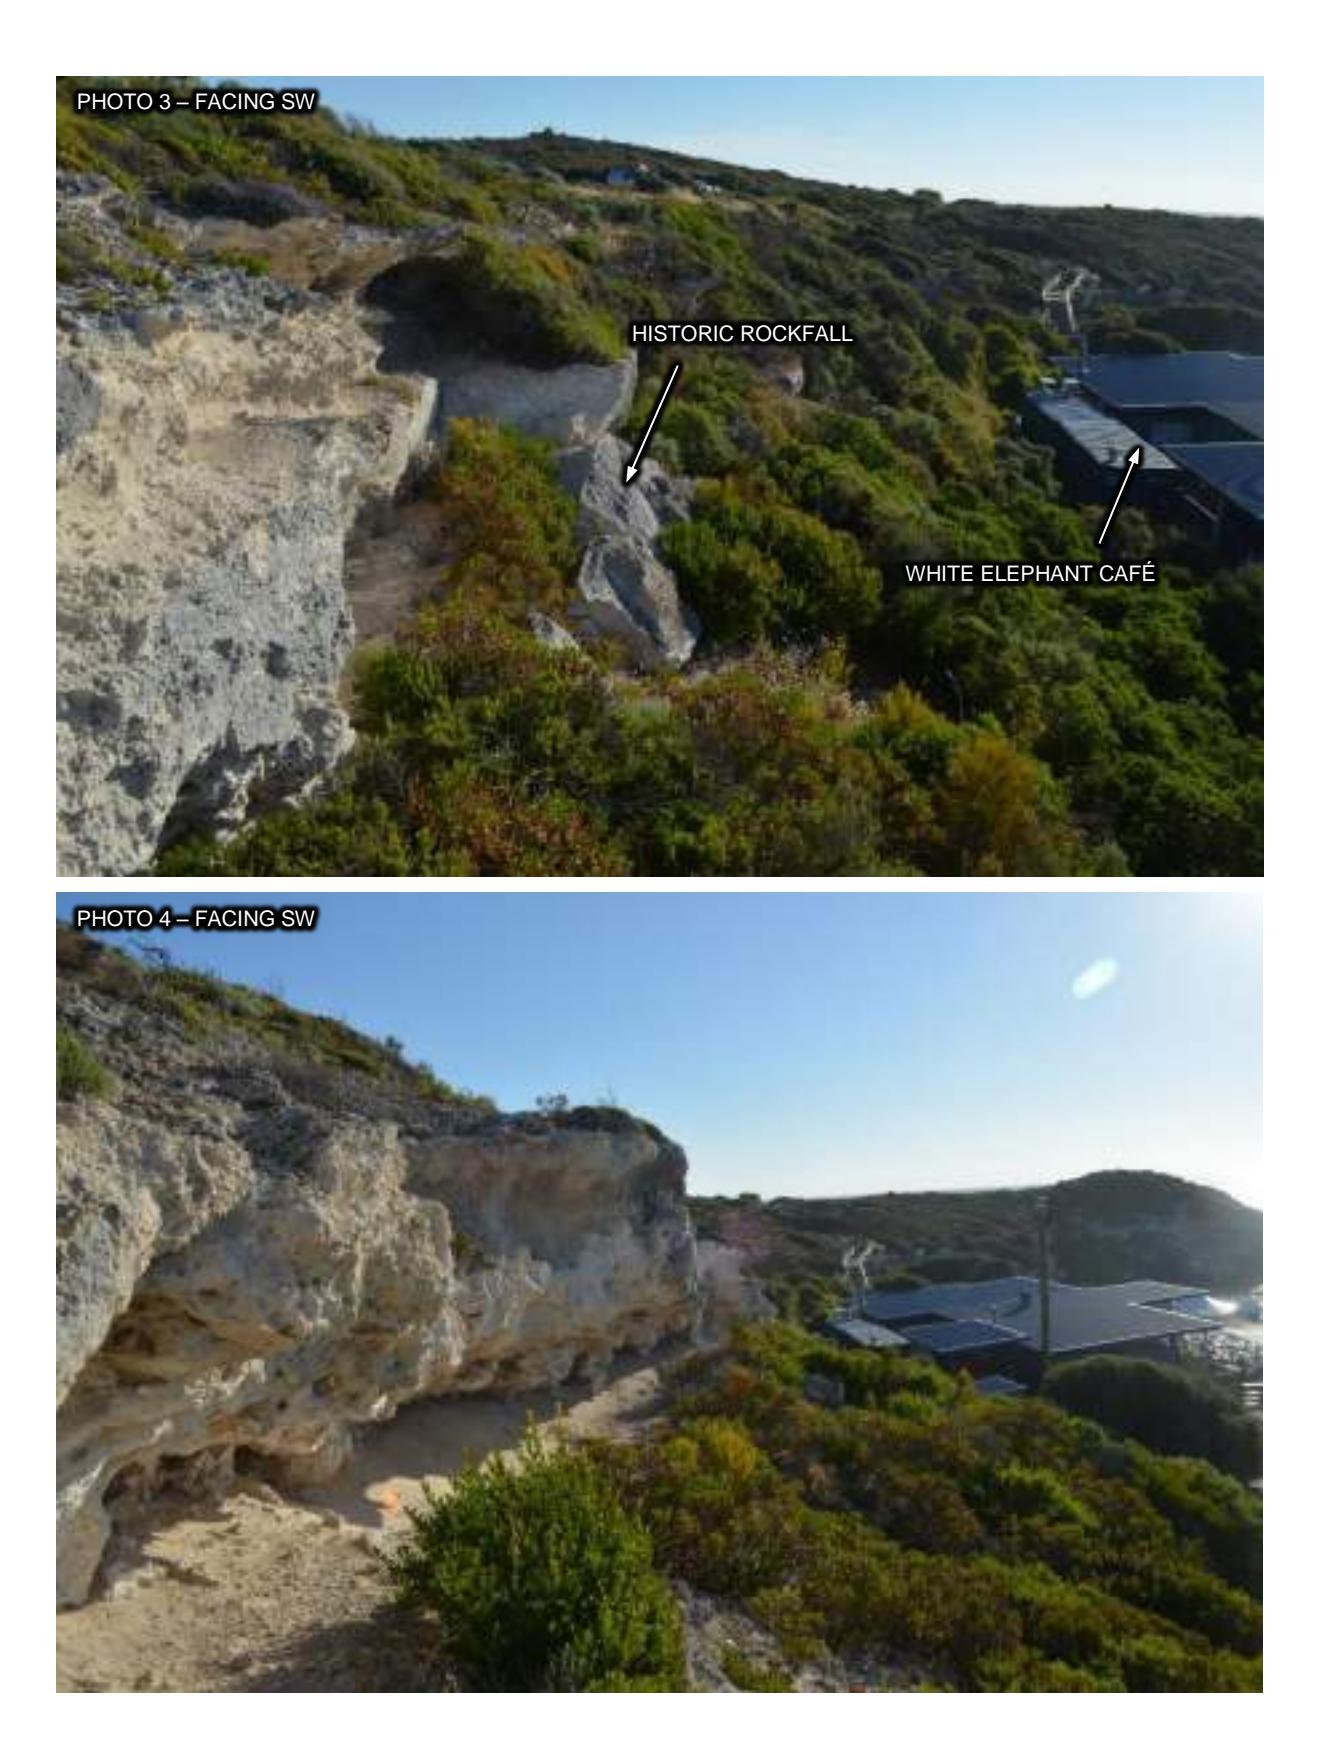
# **GRUNTERS GR1 Hazard ID: GR1-85**

Description: Large limestone block being undercut by wind erosion. If failure were to occur it is likely that sand dunes beneath the block would prevent impact to recreational users.

Install rockfall warning sign on coastal walkway warning users to stay on established tracks AND Continue monitoring every 3 years.

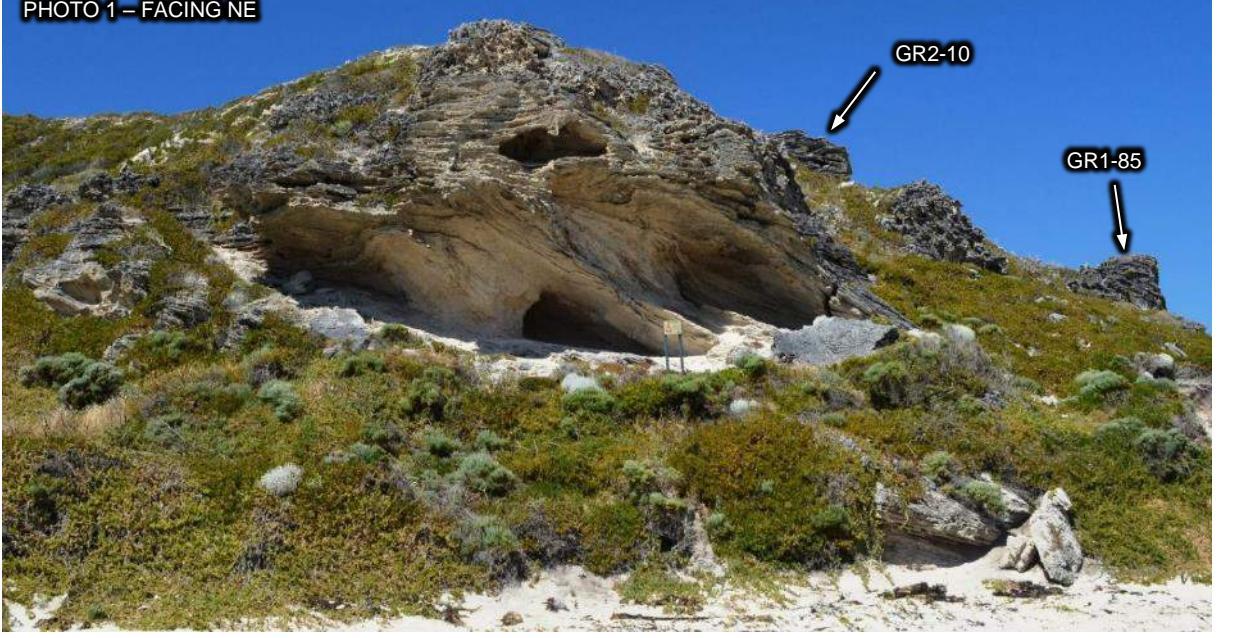
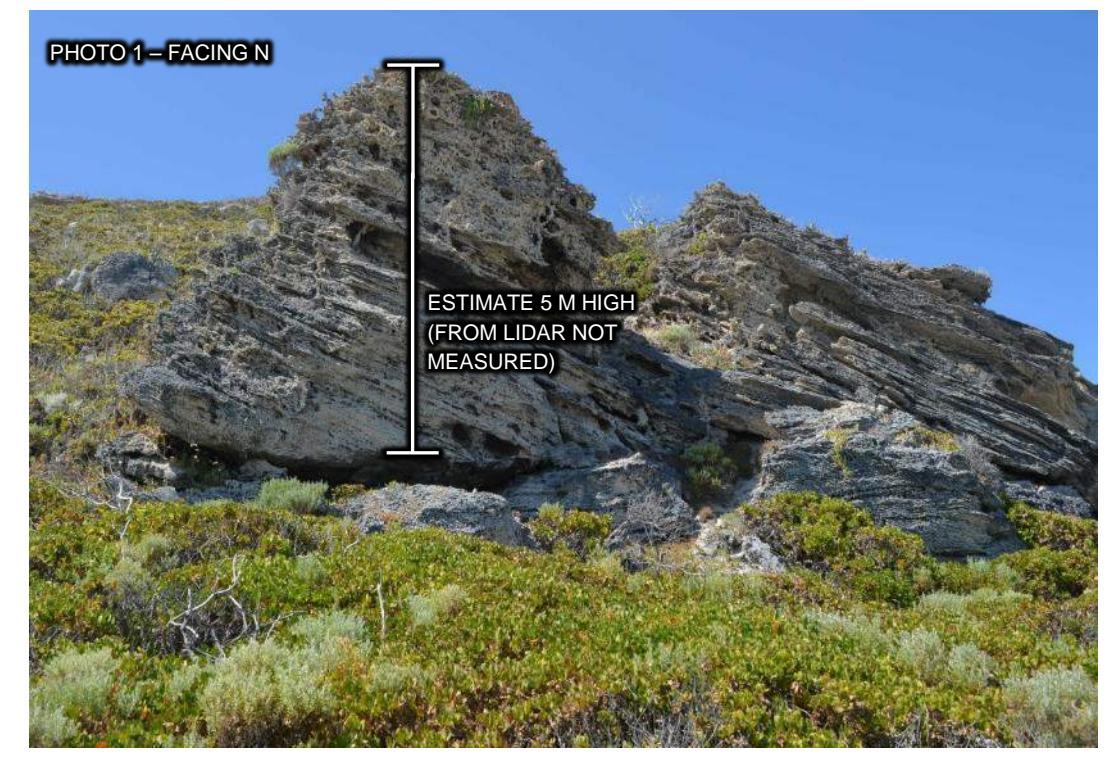
#### GRUNTERS GR2 Hazard ID: GR2-10

<u>Description</u>: Undercut bedded eolianite sitting above a steep slope leading down to sandy beach. Significant failure here would likely reach the beach as the slope is steep (>45°) and there are no protective dunes to catch rockfall

<u>Preliminary Mitigation Options</u>: Install large warning signs at hazard to prevent people from approaching or sitting and lying on the beach below the hazard and continue monitoring every 3 years.

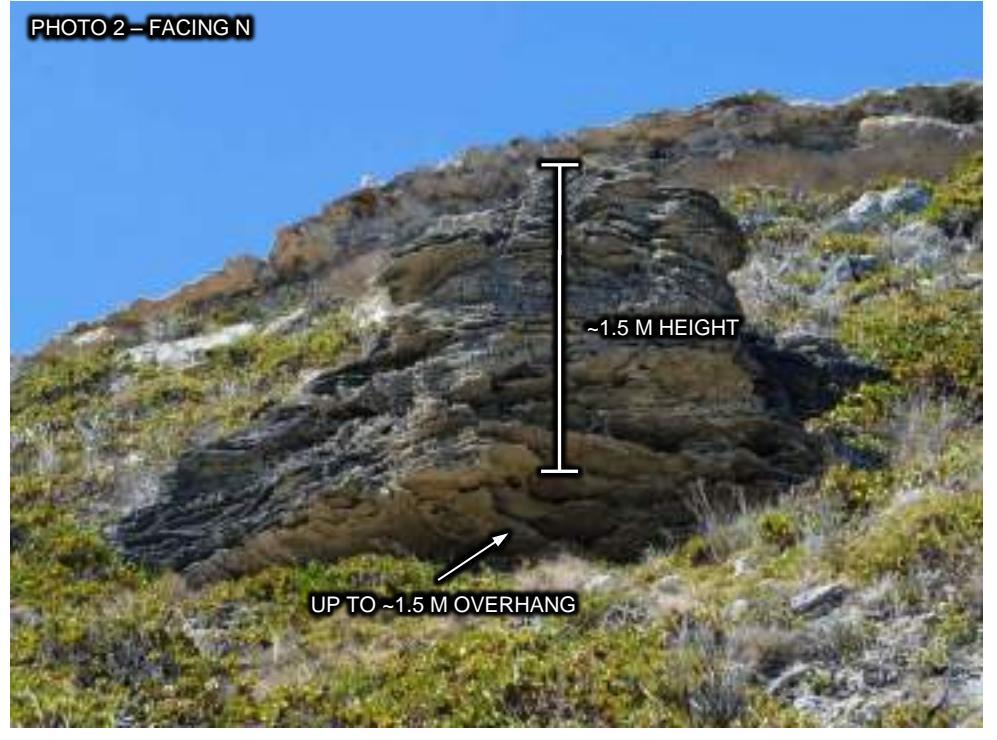
# GRUNTERS GR2 Hazard ID: GR2-20 HIGH PRIORITY ROCKFALL HAZARD

<u>Description:</u> Large limestone outcrop with multiple caves developed along steeply dipping eolianite. Relief fractures noted in the North side of the outcrop may extend a significant distance behind the rock mass. Hazards associated with large slab failures from cave roofs and overall instability in the outcrop.

- Install large rockfall hazard warning signs on the beach below the feature indicating recreational users should keep out of caves and warn against lingering below these cliffs AND;
- Continue monitoring every 3 years.
